Project Study on the Effective Countermeasures against Earthquake and Tsunami Disasters

Bulletin (No. 3)

Study Team Conducted the Field Survey

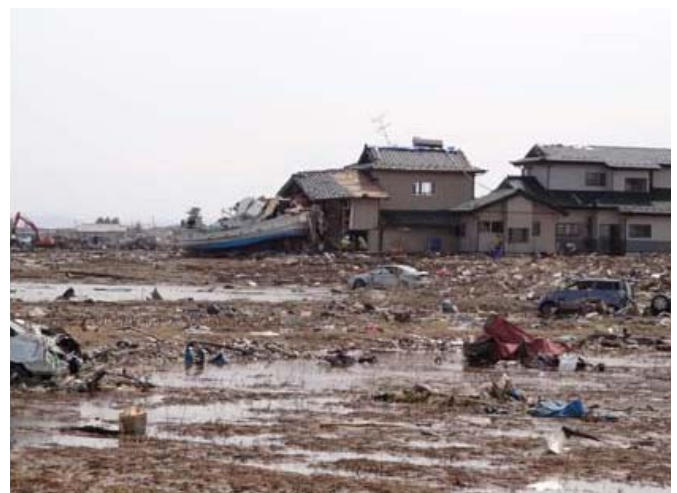
Photo 1 Damaged residential area and surrounding agricultural fields

These areas are located in the Sendai Plain and the tsunami with the maximum height of 10 m at the coastline reached about 4 km (in average, maximum 6 km) inland from the coast as the area has very flat topographic features.

Since the area is very convenient to commute to Sendai City, housing development was active and land use has changed recently from paddy and crop fields to residential areas. Due to this situation, human damages (deaths and missing) reached about 2,000 for these areas (as of April 23, 2011). In addition to the human damage, wide areas of paddy and crop fields were damaged as agriculture is still one of the main industries of the area.

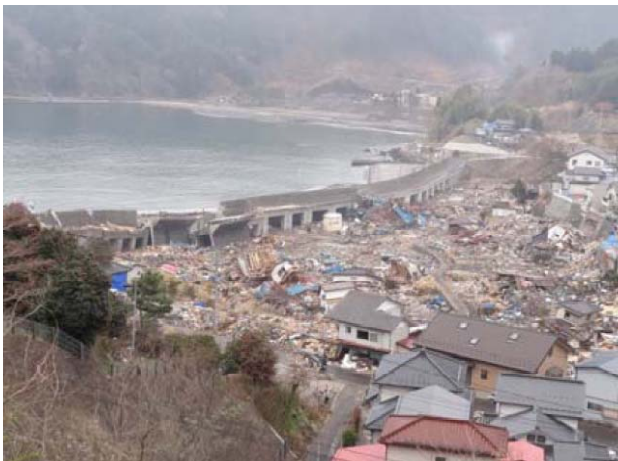
Photo 2 Sea wall collapsed and residential area was washed away

On the Day 2 and Day 3 of the field survey, the study team visited Sanriku area. According to the result of the tsunami survey conducted by the research group, the tsunami height mostly exceeded 10 m in these areas and the tsunami run-up height exceeded 30 m in some parts.

Sanriku Area has the “ria’s” type coastline. Because of these topographic features, many of the bays in Sanriku have been utilized as ports and cities and towns have been developed at the heads of the bays. The tsunami hit these areas and caused serious damage to human life and infrastructures even though these areas have relatively high awareness regarding tsunamis acquired through previous tsunami experiences and countermeasures to mitigate tsunami damage have been implemented.

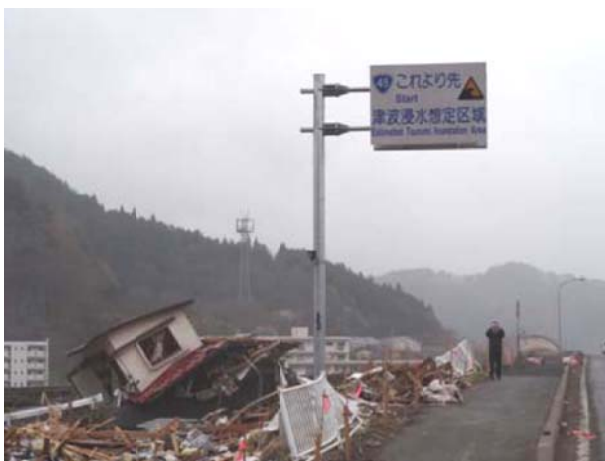
Photo 3 Sign Board of “Estimation of Tsunami Inundation Area”, however, the tsunami reached more than estimated

The city government and communities did not prepare for this scale of tsunami. The observed height of the tsunami was 12.1 meters, while the predicted tsunami had a 3.5 meter height. The risk area portrayed on a hazard map produced before the disaster is much smaller than the actual damaged area. While the hazard map indicates narrow areas a few hundred meters in width along the sea coast as risk areas, the tsunami devastated all low land areas in the city, or some one third of the total area of the city, covering two kilometers inland from the sea at the furthest point. Also, the last tsunamis in 1933 and 1960 caused only small damages. The city hall is located in a hilly area, and was not damaged in either of those two tsunamis, but two members of the city government staff lost their lives.

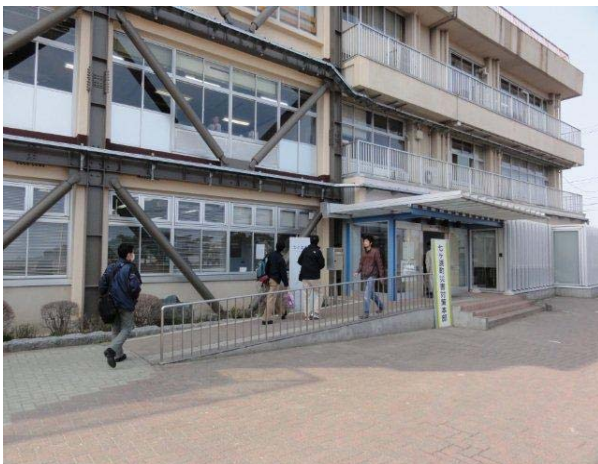
Reinforcement of the building was done in recent years
Photo 4 Shichigahama City Government Building

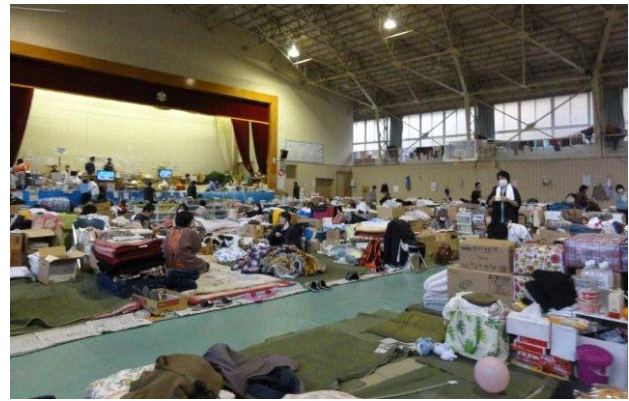
Photo 7 Evacuation Center (Gymnasium of Yamada High School)

Since Yamada High school had a sufficient space to accommodate many evacuees, the number of evacuees reached about 1,400 persons on fourth day after the earthquake. An evacuees list was prepared by the school teachers and the teachers took care of the evacuees as they are familiar with the facilities.
