## Theme 5. Reducing Non-Revenue Water

## 1. Introduction

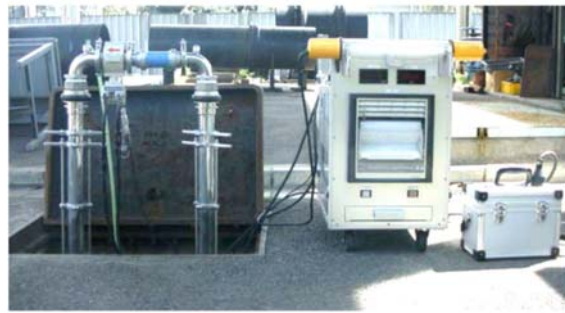
**Figure 12. Mobile Block Meter for Measurement of Minimum Night Flow**
