イラン国バム地震とJICAによる支援活動

Bam Earthquake in Iran and JICA's Assistance Activities

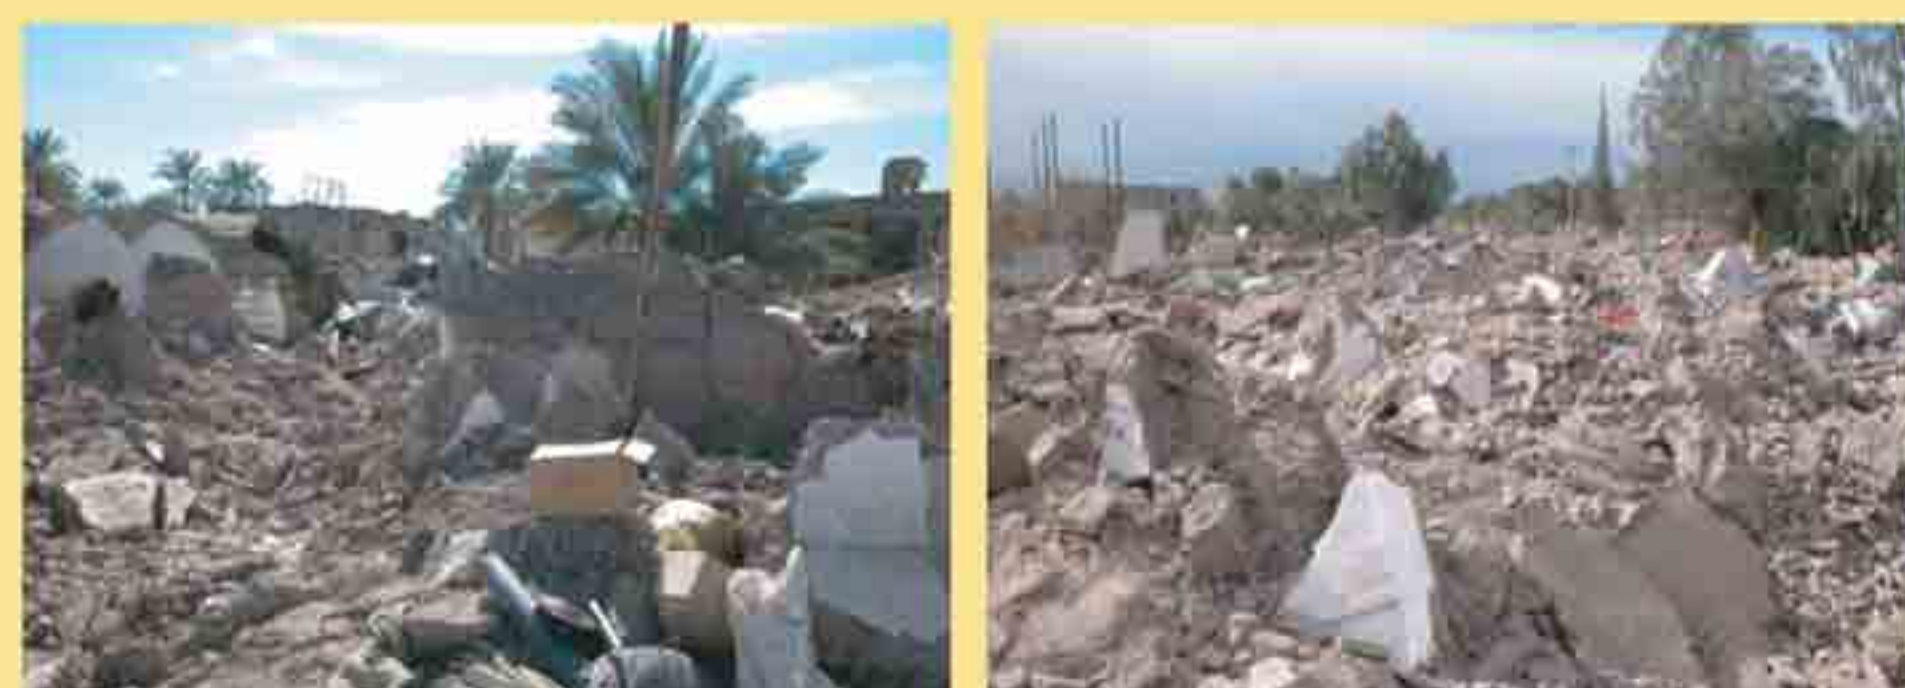
地震は、古代遺跡アルゲバムの周辺に広がっていた旧市街地を中心にして、壊滅的な物理的被害を与えました。バム市東部の一部地域においては、建物倒壊率が85%を超え、街全体がまるで瓦礫の山に埋もれたようになりました。

The earthquake inflicted devastating physical damage to Bam, particularly in old town area surrounding Arg-e-Bam. Building collapse ratio reached over 85% in some areas in the eastern part of the city, resulting in a chaotic city covered by a lot of debris.

壊滅的被害を受けたバム
Seriously Damaged Bam city

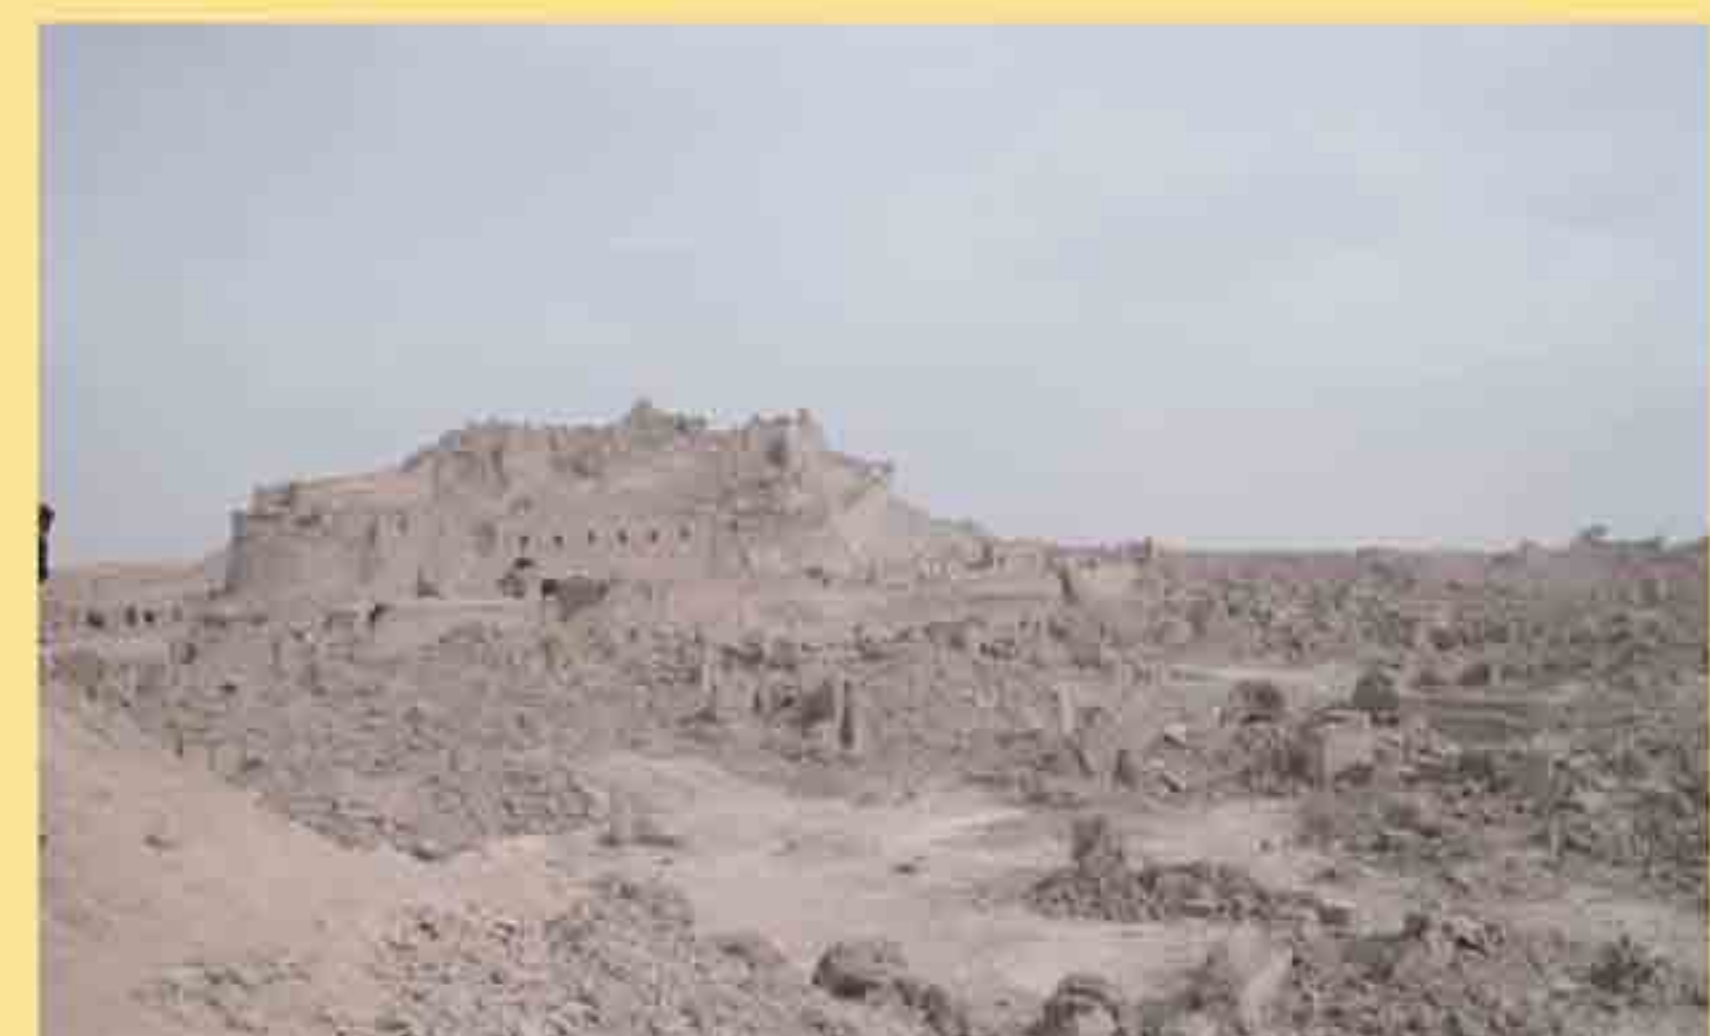
崩壊した古代遺跡アルゲバム
Collapsed Ancient Ruin 'Arg-e-Bam'

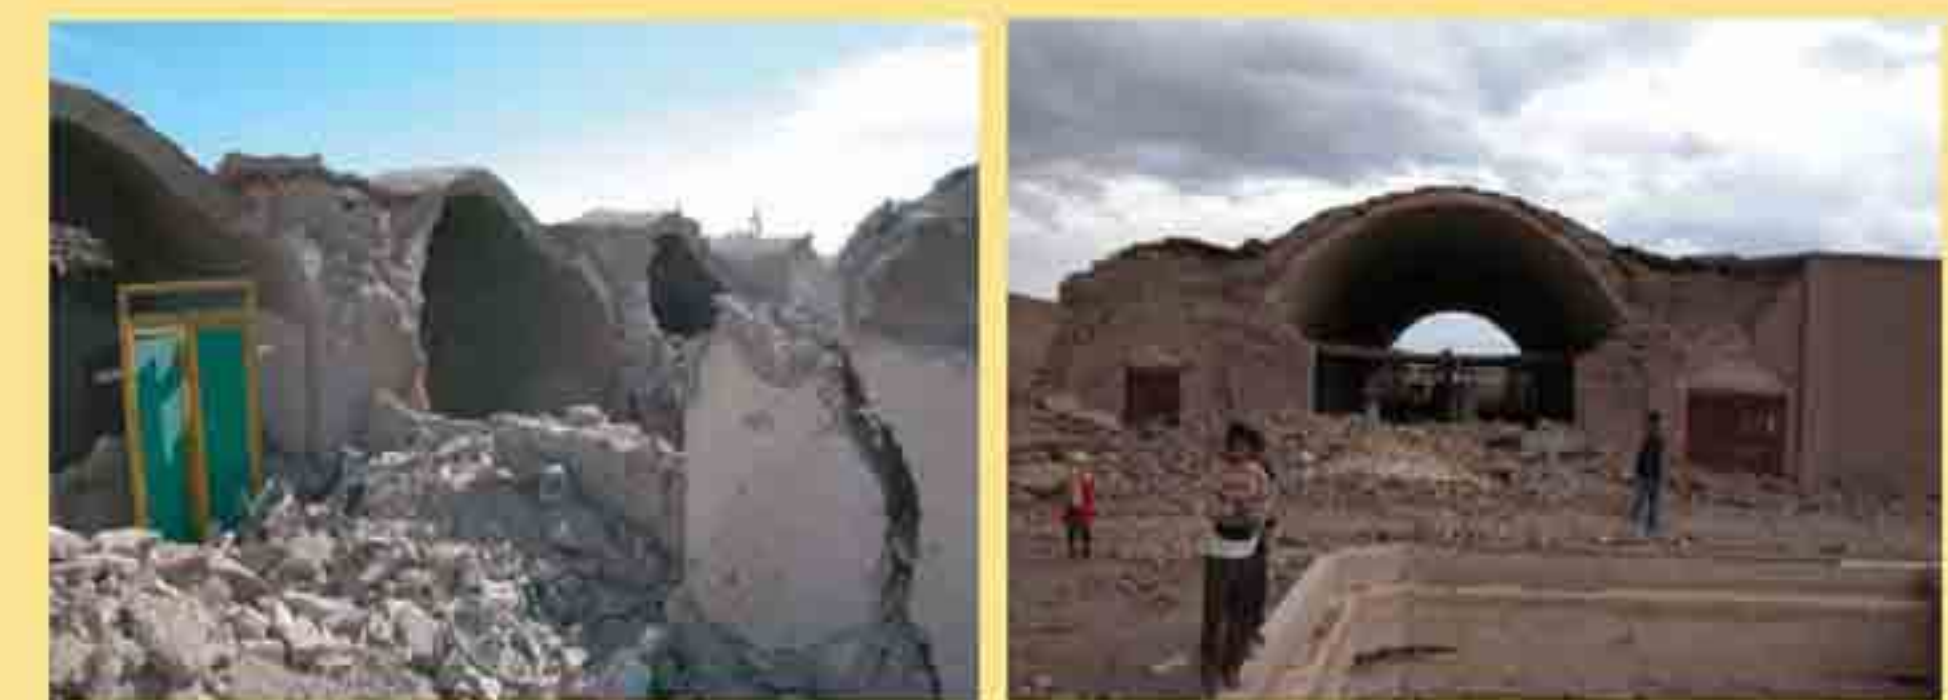
地震の規模としては中程度であったにもかかわらず、バム地震が甚大な人的及び物理的被害をもたらしたのは、建築物の地震に対する脆さが原因であると考えられます。バム市に数多く存在していたアドベ（日干し煉瓦による組積造）は、耐震性が非常に低く、今回の地震によってほぼ全棟倒壊しました。アドベ以外の構造物も地震に対して強いとは言えず、アドベ以外の組積造や鉄骨造、RC造なども多くが倒壊しました。

Although the scale of the earthquake was not so large, it caused enormous physical damage and a great number of casualties. It is thought that a vulnerability of buildings against earthquake is a leading cause. The dominant structures in Bam were made of sun-dried brick called 'Adobe', which has a very low seismic resistance. And almost all of them were collapsed. The other types of building structure such as masonry, RC frame and steel frame structures were also collapsed in many cases.

倒壊した日干しレンガ造のアドベ
Collapsed 'Adobe' made of Sun-dried Bricks

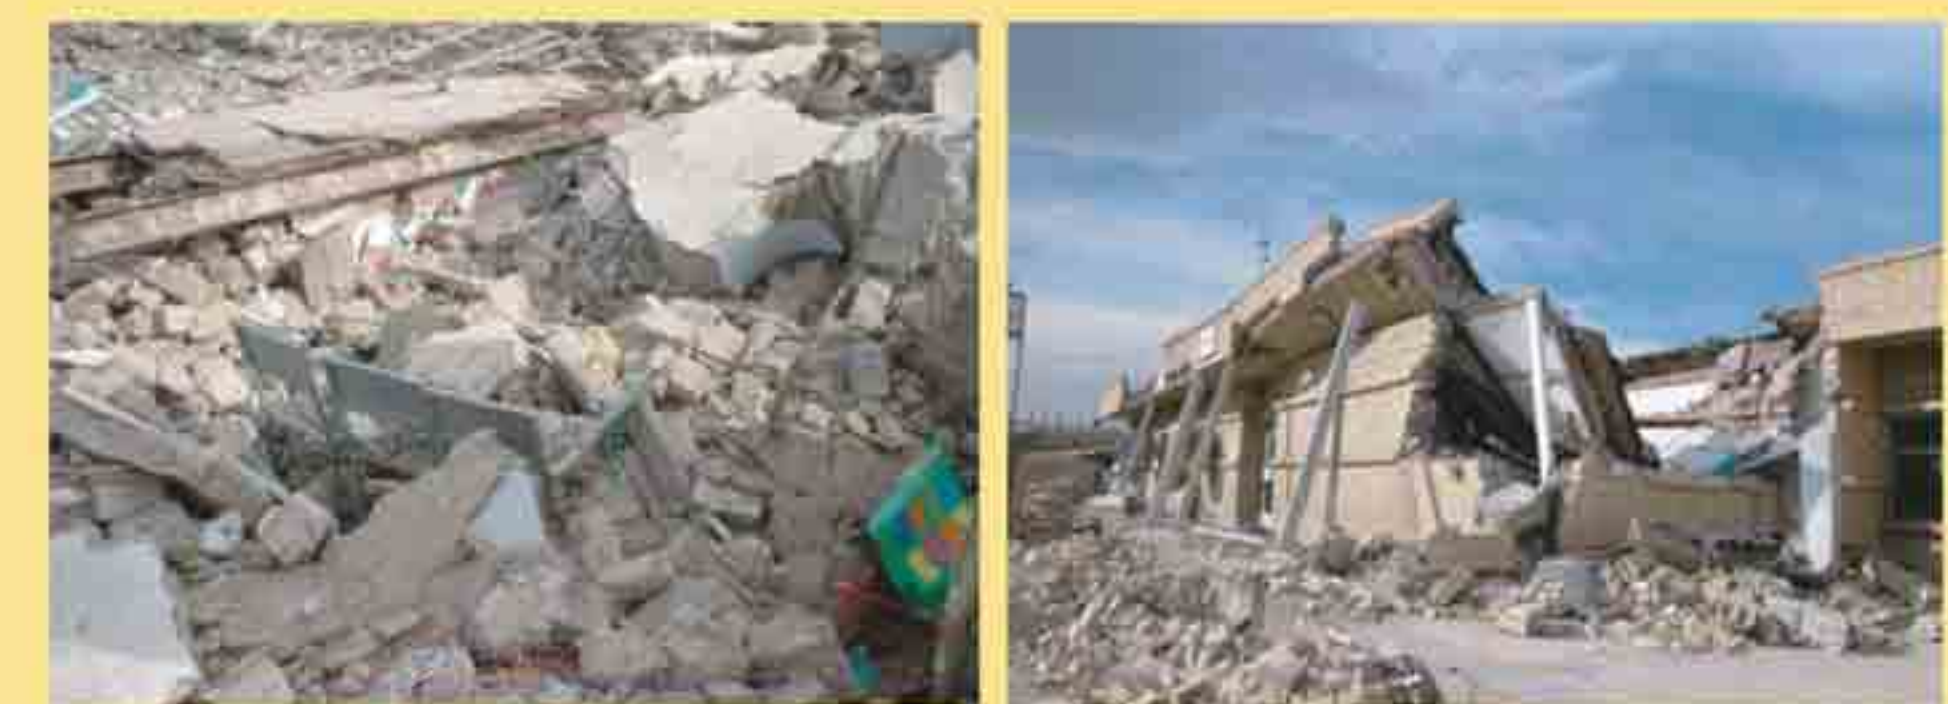
また、住宅と同様に公共建物も大きな被害を受けました。122棟に及ぶ医療施設や200棟近い教育施設が全壊または建替えが必要と判断され、被災後の公共サービスに多大な影響が及ぶことになりました。

Public Facilities, as well as residential buildings were also seriously damaged. 122 of medical facilities and nearly 200 of educational buildings were judged as collapsed or heavily damaged, resulting in a serious problem of public service provision.

倒壊した小学校・病院
Collapsed Elementary School and Hospital

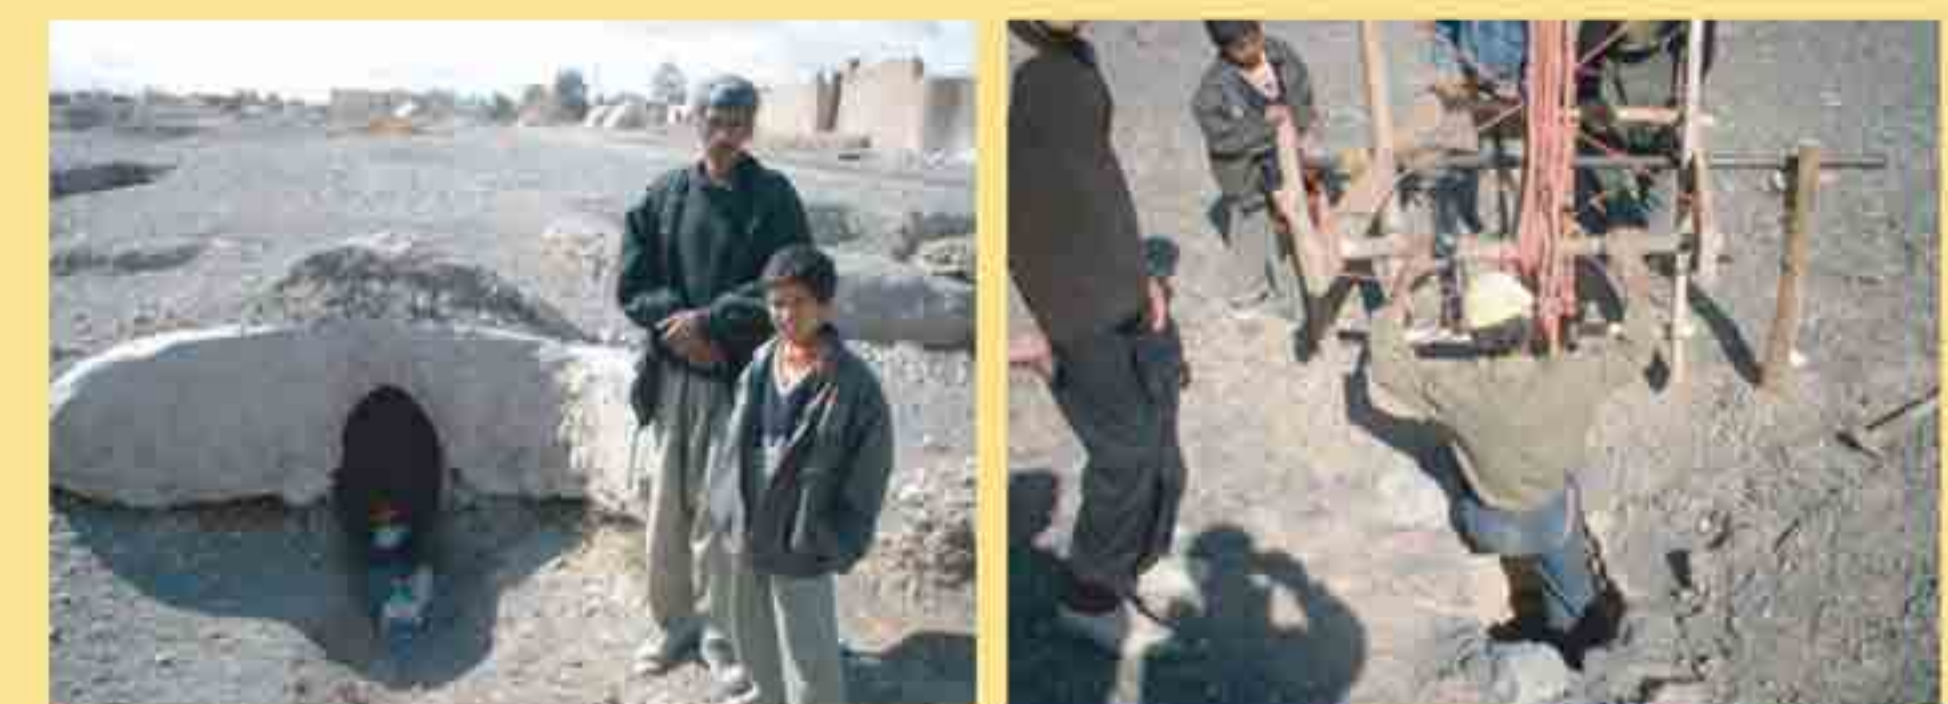
水道・電気などのライフラインや農業施設にも甚大な被害が及びました。上水道管路網や、カナートと呼ばれる乾燥地帯における伝統的な農業用水路は、応急的な復旧作業では対応できないほどの被害を受け、被災者の一日も早くくらしの復興が懸念されました。

Lifeline facilities such as water supply and electricity, and agricultural facilities were also heavily damaged. It was anticipated that earliest possible rehabilitation of people's life would be delayed because of the level of damages to water supply network system and traditional water irrigation system in dry region, so called "Qanat".

崩壊したカナート
Collapsed 'Qanat'
