THE PROJECT FOR STRENGTHENING ADDIS ABABA WATER AND SEWERAGE AUTHORITY'S MANAGEMENT CAPACITY OF NON-REVENUE WATER REDUCTION IN FEDERAL DEMOCRATIC REPUBLIC OF ETHIOPIA

March 2025

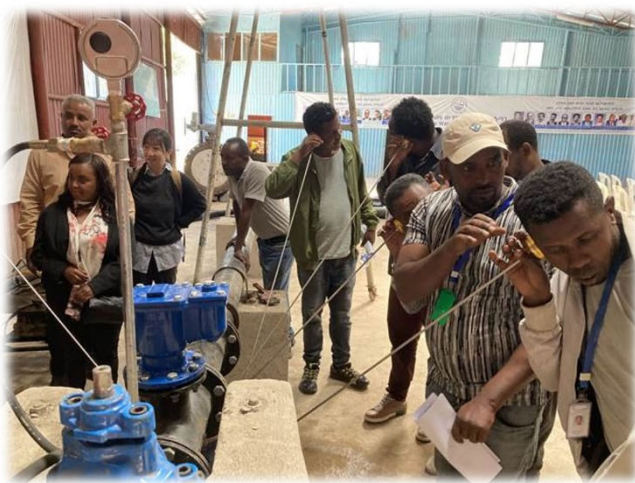
Training on the leak detection by use of listening rods

after conducting training on leakage surveys, on-site leakage surveys were conducted. The surveys were conducted by listening for the sound of water leakage using a listening rod, which is the most basic method.

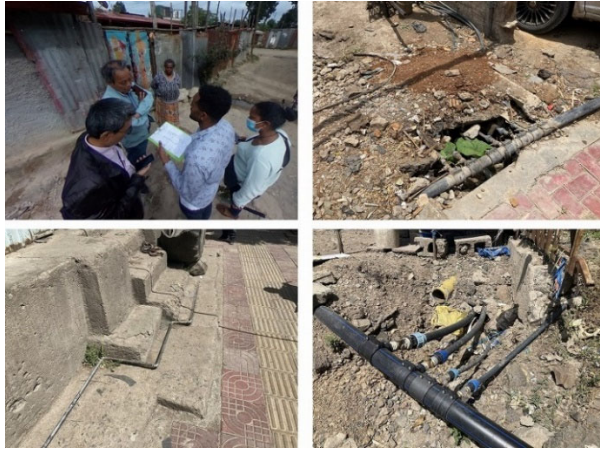
Photo 1 Situation of exposed piping and spaghetti pipes

The survey was conducted in the Kirkos area by collecting data and conducting interviews and field surveys at the Nifas Silk and Mekanisa branches. As shown in Photo 1, exposed and sbageti pipes were found, and the situation was identified to have many issues.

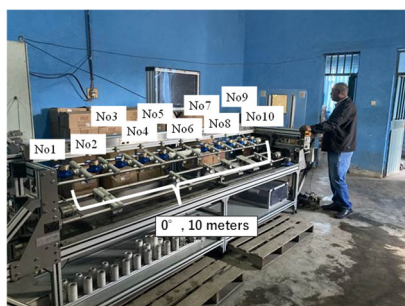
Photo 7 Test 1 (Standard Condition)

- Meter Test Bench: A test was conducted by allowing a fixed volume of water to flow and comparing the actual flow rate with the volume measured by the meter.
- Test Conditions: The experiment was conducted at four different flow rates.
- Test 1: Conducted under standard conditions with 10 meters installed without tilt (see Photo 7).
- Test 2: Conducted with 10 meters installed at an inclined position (see Photo 8).

- A greater inclined meter tended to result in larger measurement errors.
- Lower flow rates were associated with increased measurement errors.

Additionally, during the test, it was observed that under low-flow conditions, some inclined meters did not count water flow at all, meaning they failed to measure water consumption. This could contribute to increasing NRW.
