Japanese Technical Cooperation for THE ASSISTANCE RELATED TO DELHI WATER SUPPLY IMPROVEMENT PROJECT IN CHANDRAWAL WATER TREATMENT PLANT COMMAND AREA

- Accelerating Implementation of Delhi Water Supply Improvement Project -

March 2018

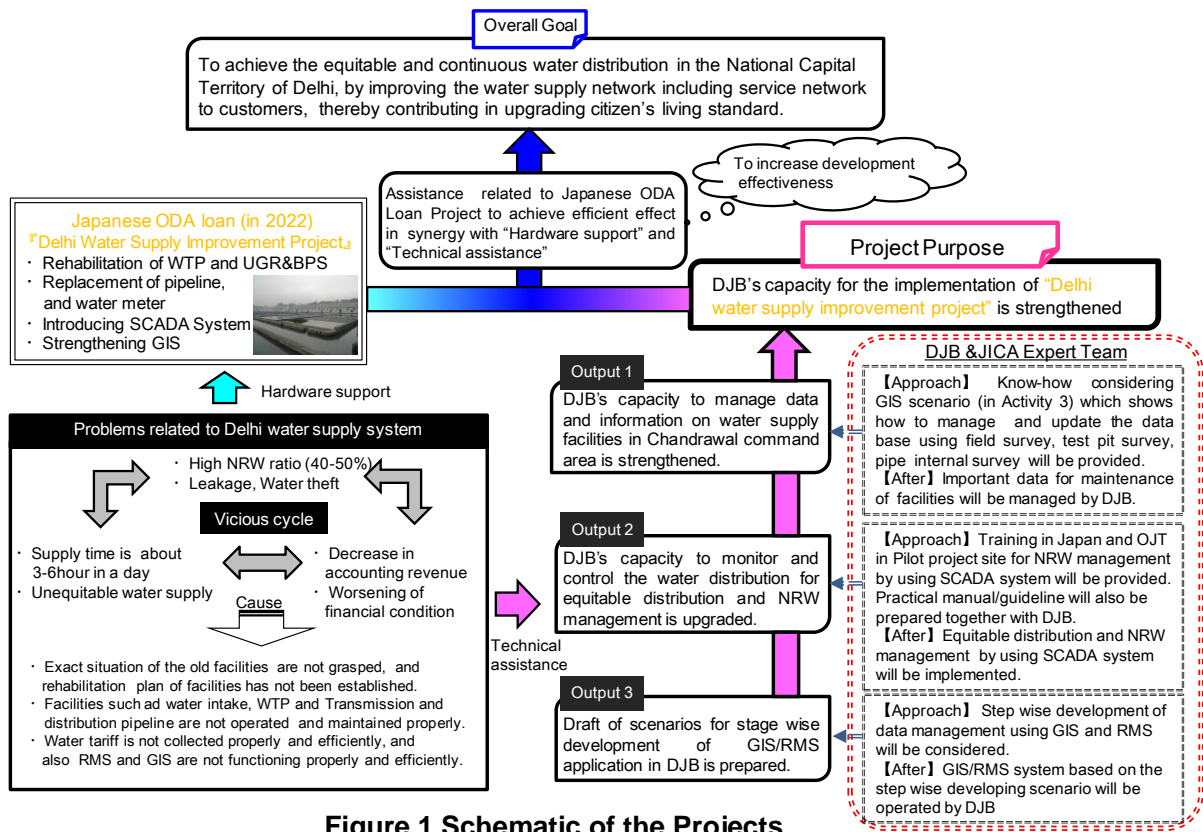
Figure 1 Schematic of the Projects

The relationship between the Japanese ODA project and the Project are shown in Figure 1.

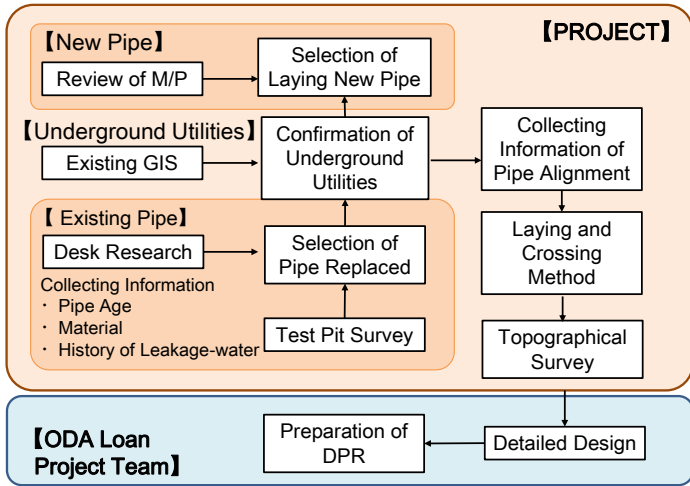
Figure 3 Allocation of activity with the Project and the Japanese ODA loan project in the Activity 1-1

The purpose of Activity 1-1 was to collect data on the existing pipelines and underground utilities. Survey of

WTP, pumping station, UGR and pipeline route was conducted under Activity 1-2. Relations of these activities under the Project and the Japanese ODA loan project are shown in Figure 3.

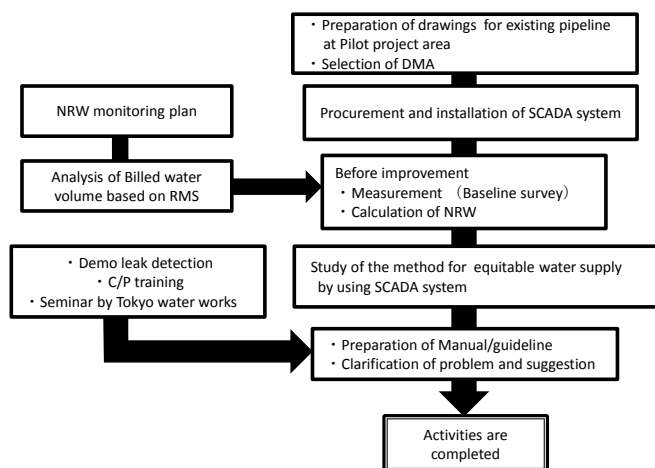
Figure 5 Flow Chart of the Pilot Project

Flow chart of the pilot project is shown in Figure 5. SCADA was procured and installed and after that test operation started in September 2017.

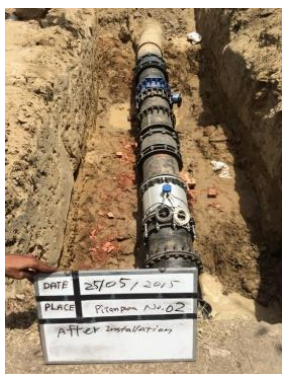
Valve and Flowmeter installation

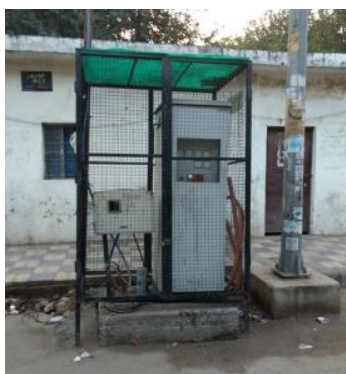
Local Measurement Stations

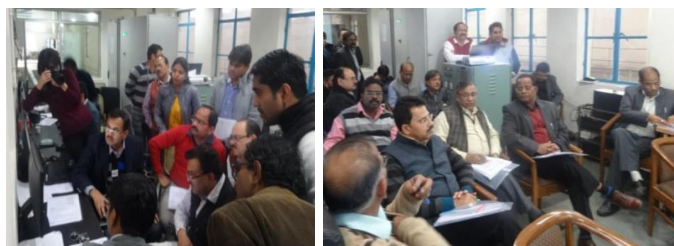
Training of SCADA

Trainings were held twice and guideline on SCADA operation and achieving equitable water distribution was prepared and stored in the DJB library.

Afterwards, the training cell of DJB will organize internal training of SCADA targeting the concerned officers of DJB. The trainees of the training held twice in the past will be the trainers and utilize the prepared guideline and the constructed SCADA system in the trainings.

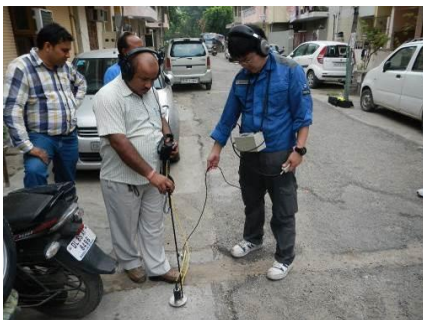
Technical Assistance for Leak Detection

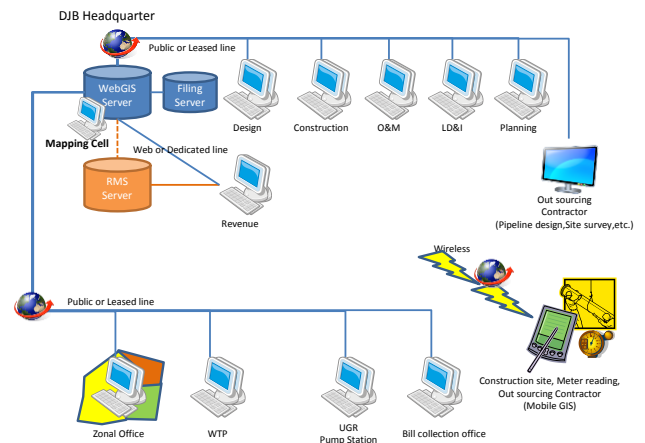
Figure 7 Schematic Diagram of Introducing Web-GIS System in DJB

DJB started reconstruction of GIS database and introduced web-GIS system partially that were recommended in the formulated scenario.
