■ Seminar for Topographic Interpretation

■ Topographic Survey by Drone

■ Improvement of Landslide Early Warning

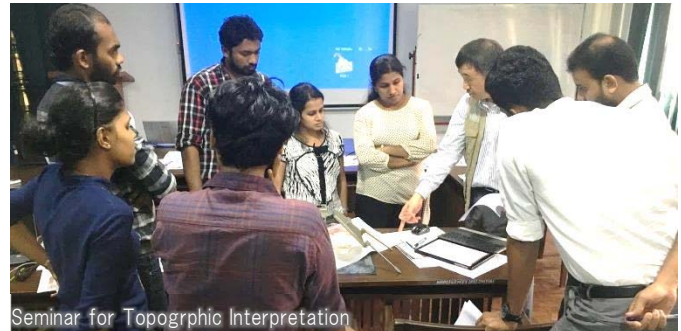
Topographic interpretation is the first step for the hazard assessment. In order to assess potential of landslide, we carefully inspect the landform history of the area and surface micro-deformation that would be a sign of landslide occurrence by using aerial photographs and stereo-scope. LiDAR DEM, which is the high resolution digital elevation model supported by JICA in the past, is also important source for topographic interpretation. With LiDAR DEM, it is possible to capture accurate ground surface condition that cannot be identified from aerial photograph due to thick vegetation cover.
