Project for Capacity Strengthening on Development of Non-Structural Measures for Landslide Risk Reduction (Project SABO)

National Building Research Organization (NBRO) & Japan International Cooperation Agency (JICA)

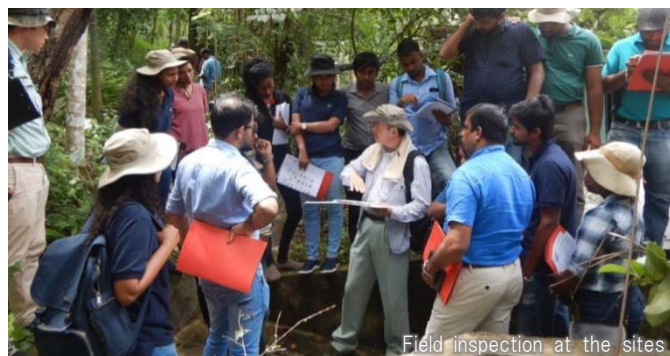
Field inspection at the sites

A workshop was held at NICD in Kandy district on October 23rd to 24th in order to discuss the landslide inventory sheet modified in the Project. About 50 NBRO officials from Colombo and District Offices gathered to discuss the contents of the inventory sheet, and conduct field inspection at the sites of landslide, rock fall and debris flow.

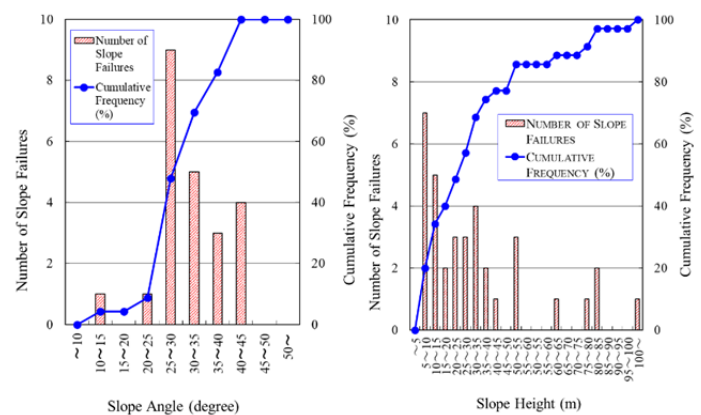
Out of 3,144 landslide records collected by NBRO, the landslides where the scale and topographic character can be identified were selected and studied in the Project. For instance, most of slope failures occurred when the slope is 25 degree or more (left in the figure below). Nearly 80% of slope failures occurred at the slope height 5 to 40m (right in the figure). Based on these trends, landslide hazard maps will be prepared considering the characteristics in Sri Lanka.

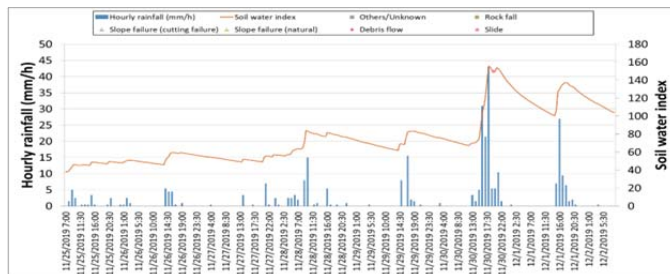
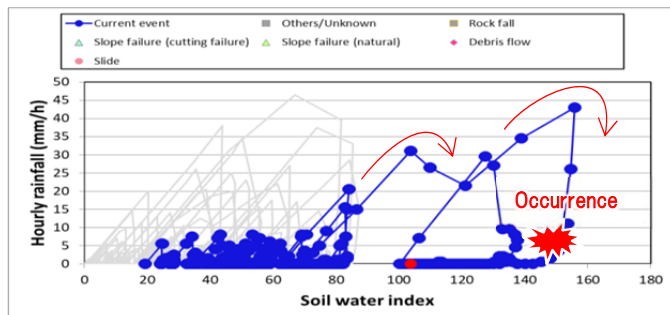
Cutting failure in November 30

WG2 members have been verifying relationship between rainfall and landslide occurrence by using “Snake Curve”, which indicates hourly rainfall in vertical axis and SWI in horizontal axis. The Snake Curves are drawn by WG2 at representative rainfall stations every morning.

During this rainfall event, the rainfall station at Munwatta records maximum hourly rainfall of 43mm, 24-hour rainfall of 130mm and SWI of 155. The slope failure occurred when the rainfall lulled. In other words, even after the peak rainfall, the SWI was still high, and landslide potential was also still high. We are accumulating such data and use it for improvement landslide warning criteria in future.
