DAVAO CITY BYPASS CONSTRUCTION PROJECT (DCBCP)

Package I-1

ENVIRONMENTAL MONITORING REPORT No.2

(01 APRIL 2021 - 30 JUNE 2021)

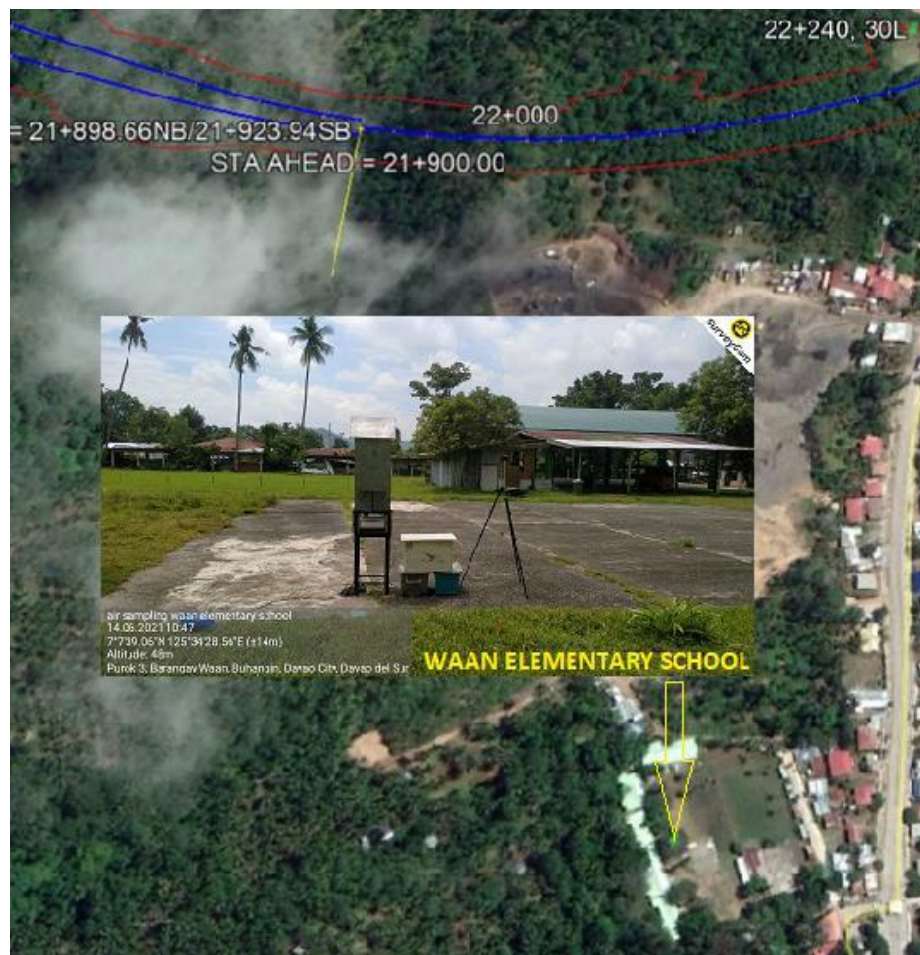
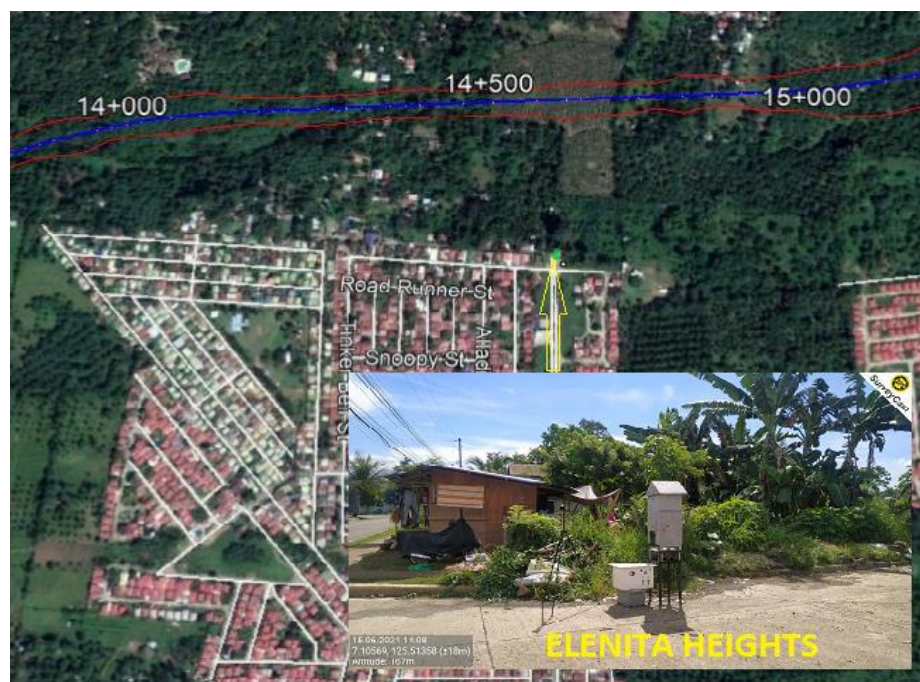
Air quality tests at Elenita Heights (Tacunan) and Waan Elementary School on 15 – 16 June 2021.

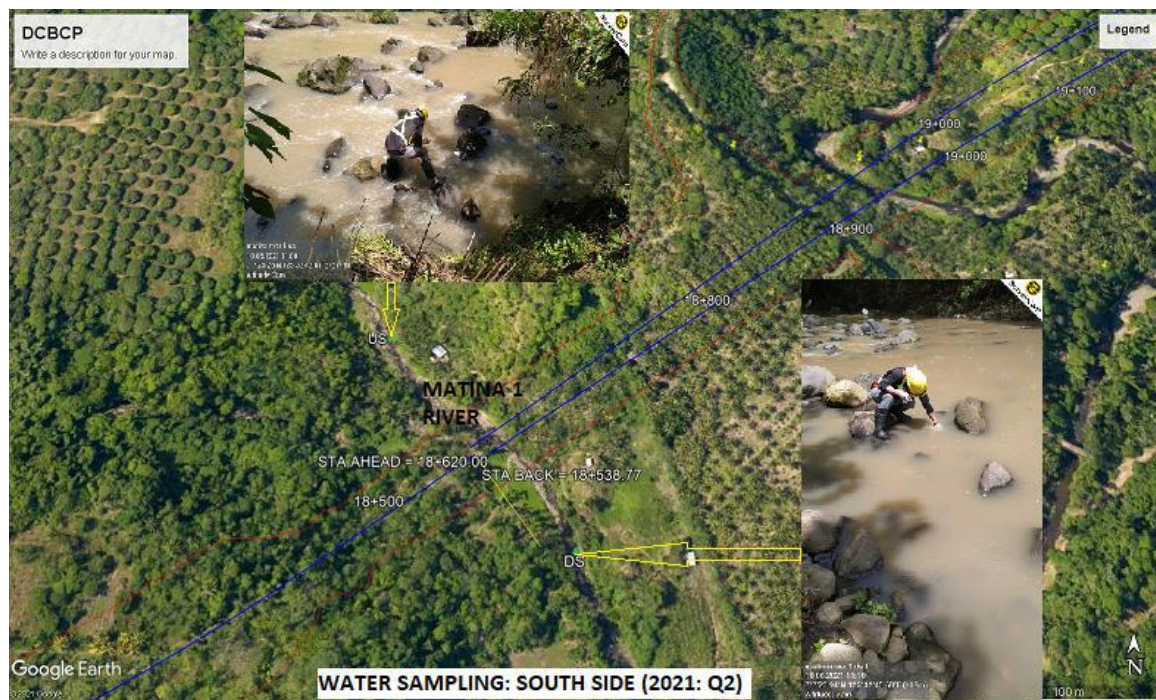
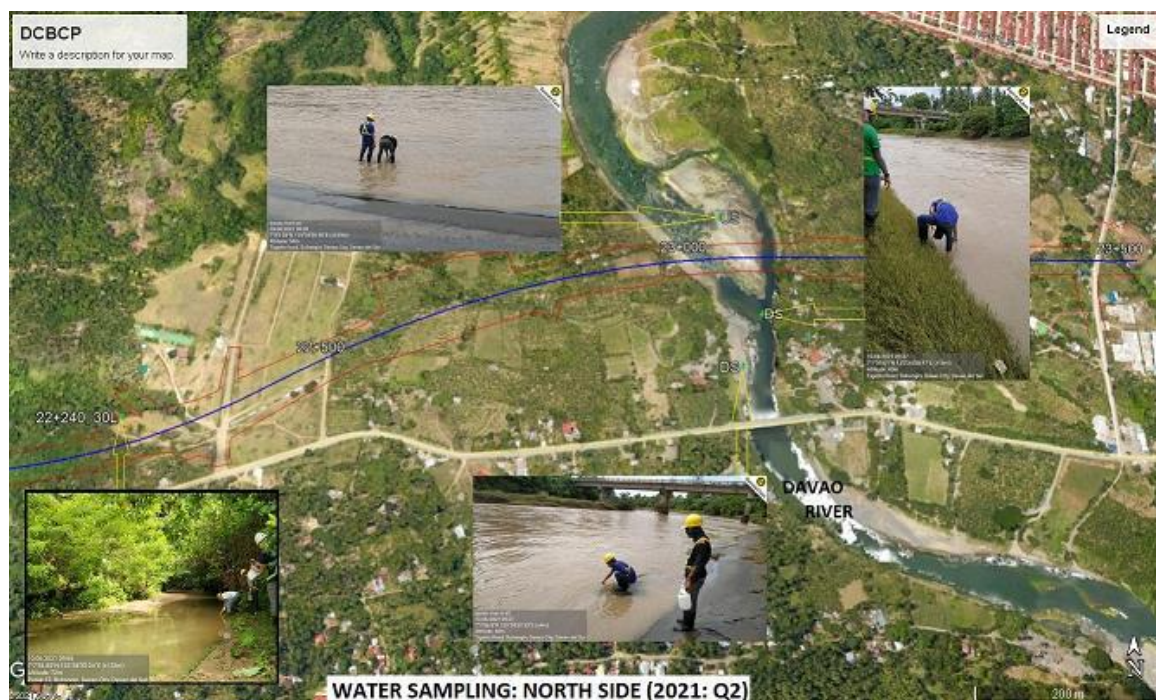
Photo taken on 18 June 2021 - Discoloration of water was observed. Based on the online research made by the contractor, it could be attributed to the leachate from the New Carmen landfill
