## Rehabilitation of Irrigation and Flood Alleviation Works

Report Date : October, 2002

Field Survey : August, 2001

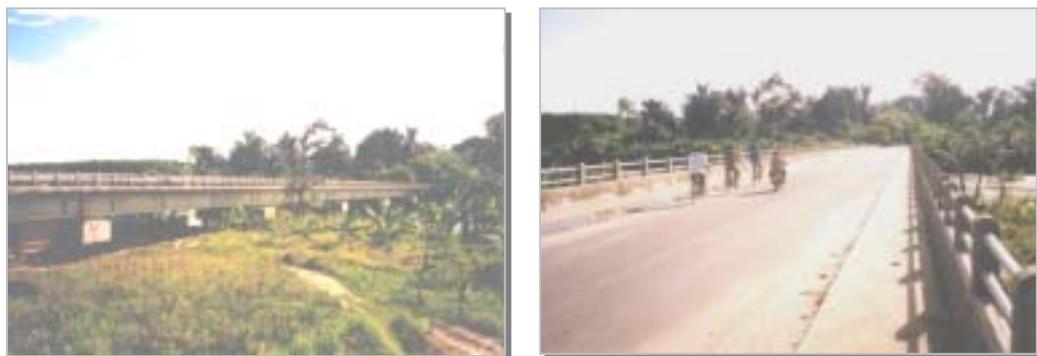
**Figure A-3 : View of Pulau Gambar Bridge**

A new bridge, namely Pulau Gambar Bridge, and approach roads totaling 360 m in length were constructed in 1995 under the Sub-project around the upper reaches of the Ular River. According to people who lived in the area before completion of the bridge, it used to take a long time to cross the river by boat, and ferry services ran only until 10 p.m. At present (post-completion), people and trucks transporting agricultural produce can cross the river anytime, thereby avoiding the inevitable loss of time. The Sub-Project can be said to have contributed to improving the inter-area transportation, especially in the upper reaches of the Ular River.

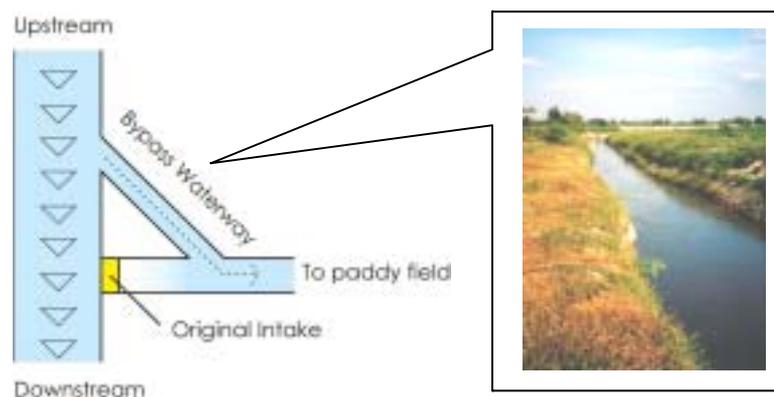
**Figure A-6 : Schematic Diagram of Bypass Waterway**

There is an urgent need to improve/rehabilitate the irrigation water distribution system. The original free intake system is inappropriate, but rehabilitation of the existing intakes is not enough to solve the current situation. Innovative measures are required to address this issue.

The project office of the local government has already prepared a basic plan for facility renovation, which consists of constructing a new weir upstream from the Ular River and installing connecting canals (link canals) on both sides of the river basin. Rehabilitation of Ular Irrigation System is included in Japan's ODA-assisted project, Water Resources Existing Facilities Rehabilitation and Capacity Improvement Project, Exchange of Note of which was signed in March 2002.
