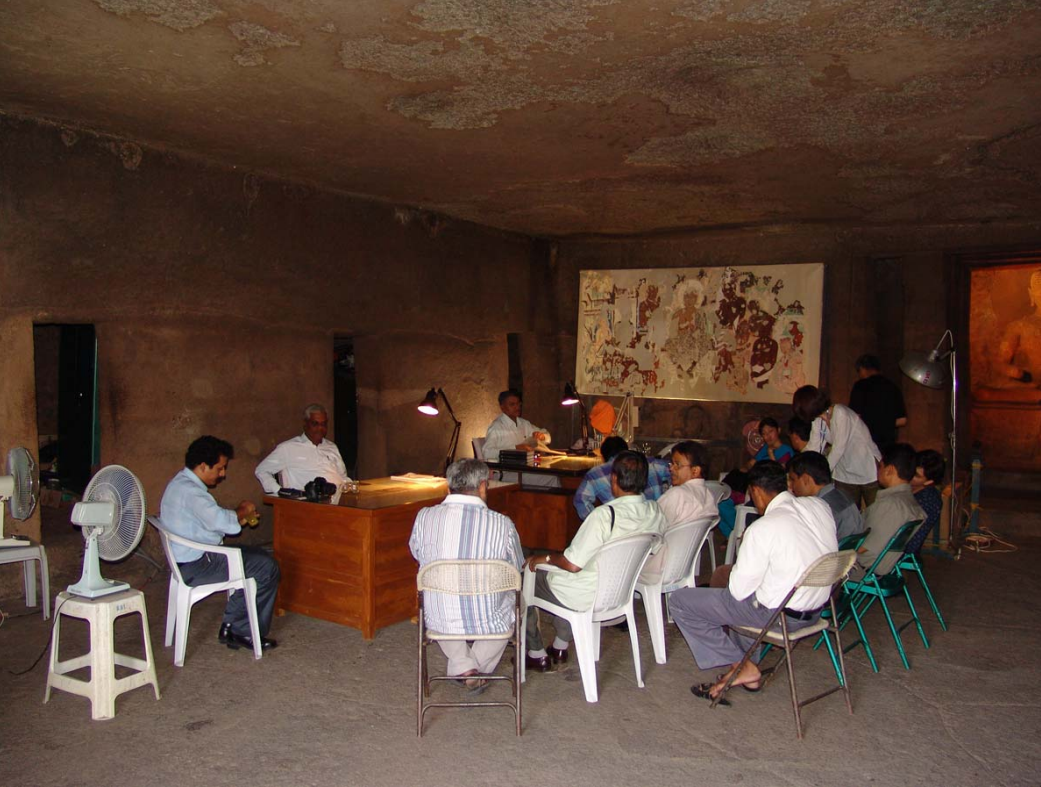
(Figure 36) Conservation and scientific research room set up inside cave 2

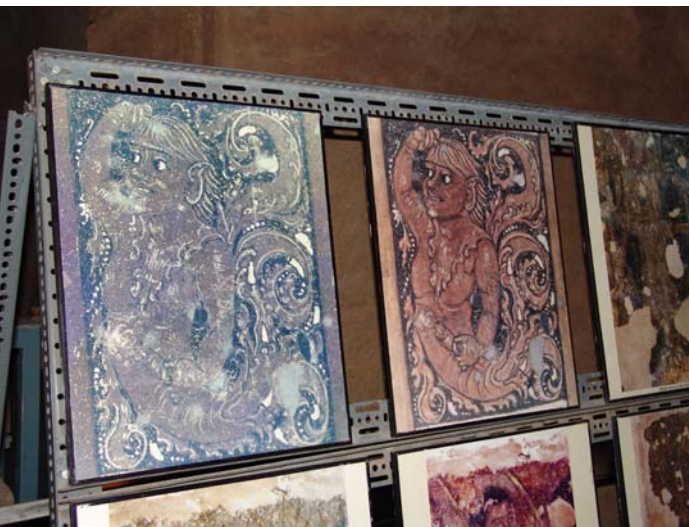
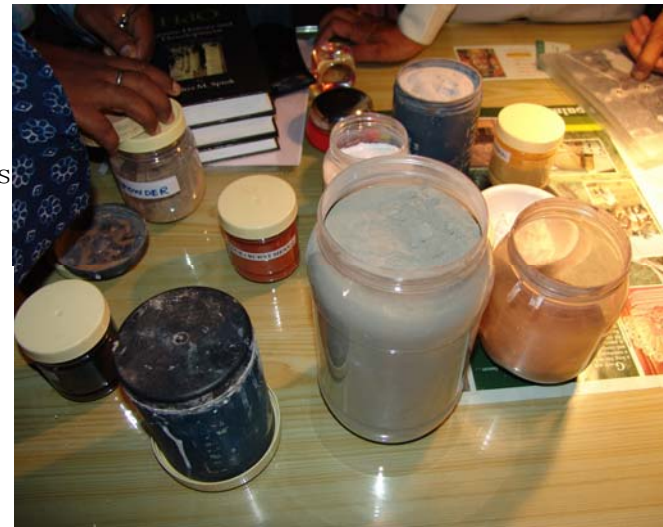
Model of the historic site, before and after photos of restoration of mural paintings (left), and samples of pigments (right) are displayed in the research room.
