(Figure 65) Sculpture at cave 30 of Ellora historic site

(Figure 67) Distant view of cave 10 at Ajanta historic site

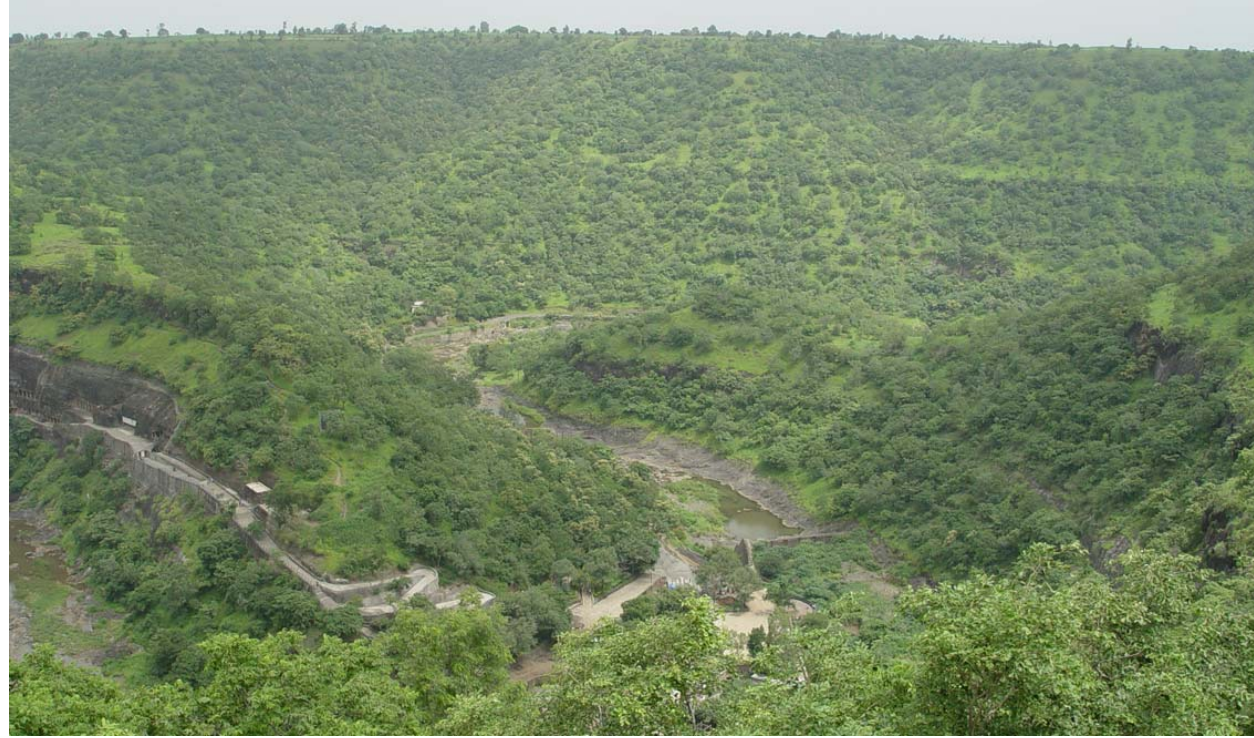
(Figure 73) Afforested areas on the bank opposite the Ajanta historic site

Afforested area that lies below Ajanta Viewpoint (left) and a view of the afforested area seen from the historic site (right)
