*Results of Inventory Survey for  
Proposed Rehabilitation Works in  
Roleang Chrey Headworks Rehabilitation Sub-project*

PREPARATORY SURVEY FOR IRRIGATION AND DRAINAGE  
SYSTEM REHABILITATION AND IMPROVEMENT PROJECT

Japan International Cooperation Agency

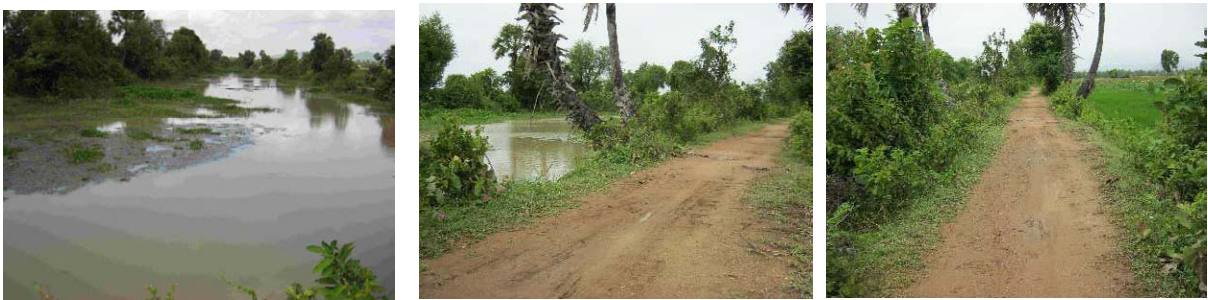
Canal No.: NMC	Proposed Works	Improvements of Kraing Speu embankment		Remarks: Raising of Kraing Speu embankment L = 1 km, W = 3 m, H = additional 1 m
Station: 0.00+600	Map Ref. NAC-3	Coordinate	X: Y:

Upstream View (Inundation area)		Existing embankment		Existing embankment

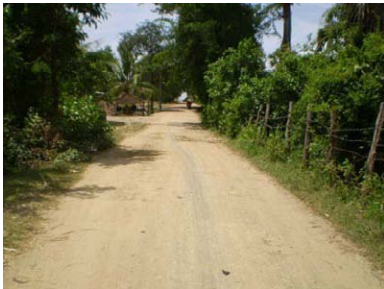
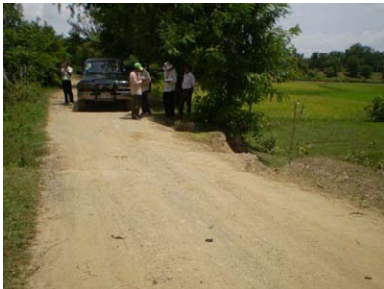
Canal No.: NMC	Proposed Works	Repair of embankment for flood protection dike	Remarks: L = 350 m, W = 6m, H = 2m (Additional)
Station: 0.00+680	Map Ref. NAC-6	Coordinate X: Y:

Upstream View		Downstream View

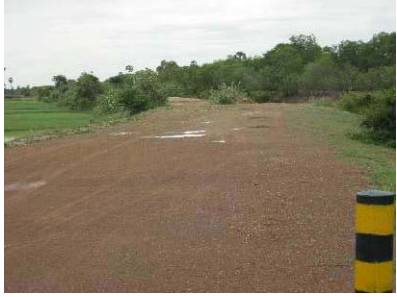
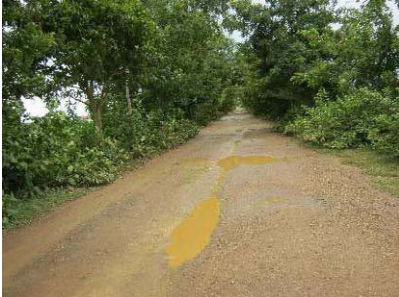
Canal No.: NMC	Proposed Works	Improvement of embankment	Remarks: Repair and provision of laterite pavement (both side)
Station: 0.00 ~1.00+150	Map Ref. NAC-7	Coordinate X: Y:

Upstream View		Downstream View

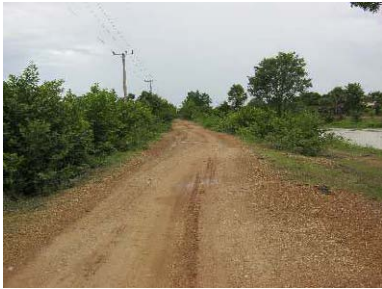
Canal No.: NMC	Proposed Works	Improvement of embankment	Remarks: Repair and provision of laterite pavement (both sides)
Station: 0.00 ~ 10.0 +0	Map Ref. NMC-1	Coordinate X: Y:

General View

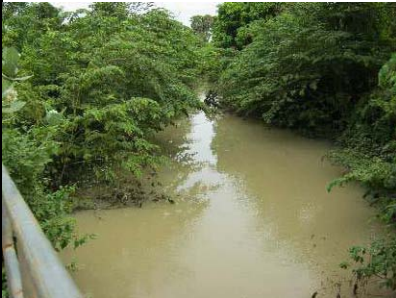
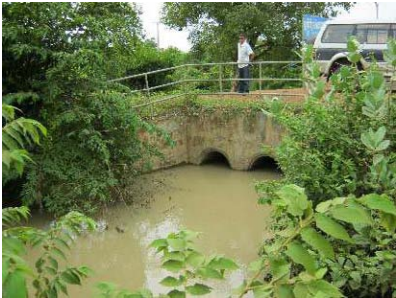
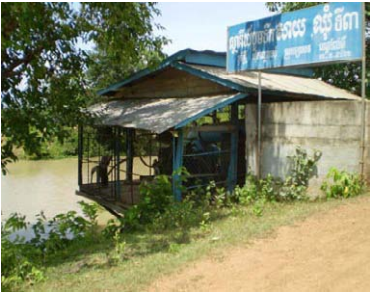
Canal No.: NMC	Proposed Works	Rehabilitation of Thmey-1 SC and construction of structures	Remarks: L = 2.5 km (A = 125 ha) 3 outlets and 3 drain inlets
Station: 1.00+950	Map Ref. NMC-2	Coordinate X: 0441188 Y: 1266620

Existing secondary canal		Outlet (View from downstream)

Existing pump station

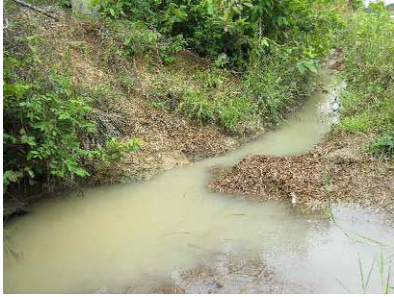
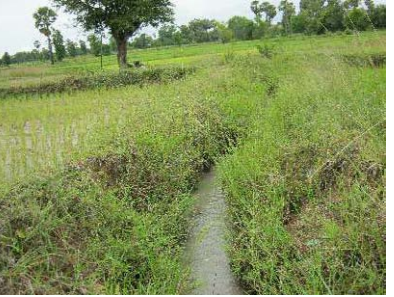
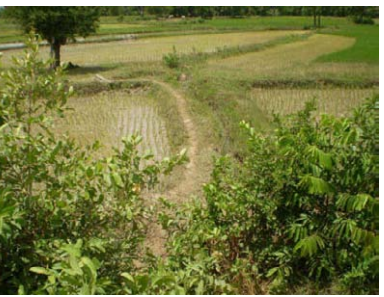
Canal No.: NMC	Proposed Works	Rehabilitation of Thmey-2 SC		Remarks: L = 850 m, A = 13 ha 2 checks/diversions
Station: 2.00+400	Map Ref. NMC-4	Coordinate	X: 0441656 Y: 1266846

<div style="display: flex; justify-content: space-around;"> <span>Existing secondary canal</span> <span>Existing secondary canal</span> <span>Existing secondary canal</span> </div>

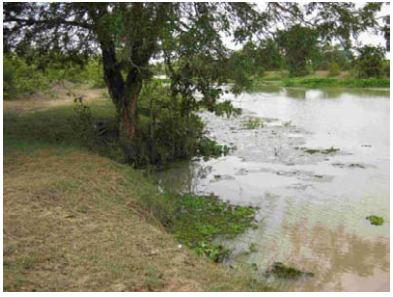
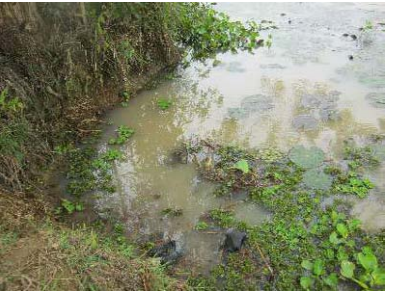
Canal No.: NMC	Proposed Works	Improvement of turnout for Phum Thmey-2 SC		Remarks: Provision of pipe culvert for Phum Thmey-2 SC (A = 13 ha)
Station: 2.00+400	Map Ref. NMC-5	Coordinate	X: 0441656 Y: 1266846

<div style="display: flex; justify-content: space-around;"> <span>Existing turnout (Inlet)</span> <span>Existing turnout (Outlet)</span> </div>

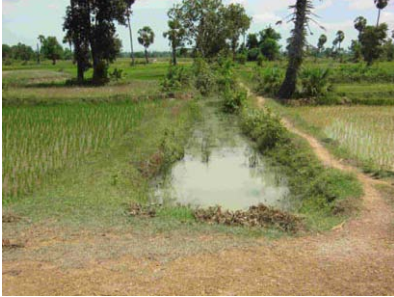
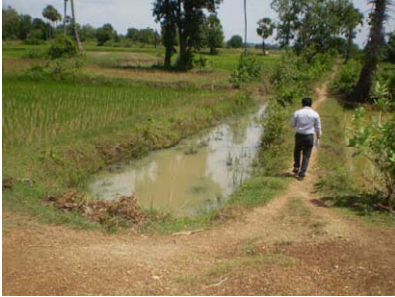
Canal No.: NMC	Proposed Works	Rehabilitation of Thmey SC-3		Remarks: L = 3 km (A = 300 ha) 3 checks/diversions
Station: 2.00+430	Map Ref. NMC-6	Coordinate	X: 0441611 Y: 1266870	
<div style="display: flex; justify-content: space-around; align-items: center;"> <div style="text-align: center;">

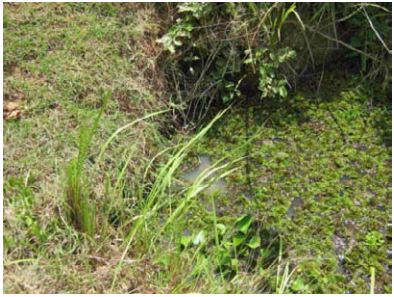
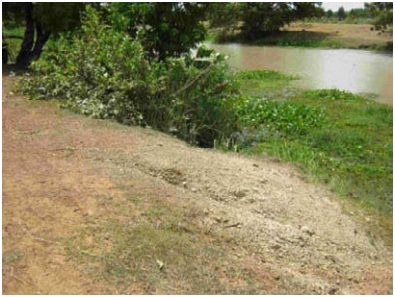
Canal No.: NMC	Proposed Works	Replacement of turnout for Thmey SC-3		Remarks: Turnout for Thmey-3 SC (A = 300 ha)
Station: 2.00+430	Map Ref. NMC-7	Coordinate	X: 0441611 Y: 1266870	
<div style="display: flex; justify-content: space-around; align-items: center;"> <div style="text-align: center;">

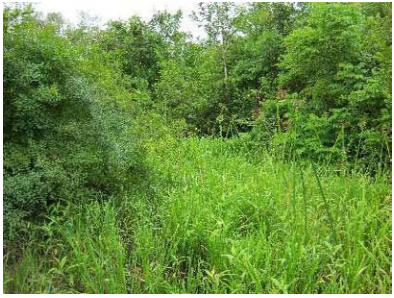
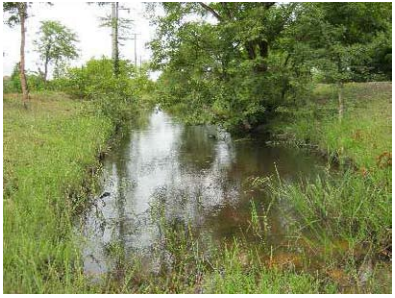
Canal No.: NMC	Proposed Works	Rehabilitation of Kravein-1 SC with construction of structures		Remarks: L = 2.45 km (A = 120 ha), 3 drainage and 8 outlet structures
Station: 3.00+350	Map Ref. NMC-8	Coordinate	X: 0442340 Y: 1267398	
<div style="display: flex; justify-content: space-around; align-items: center;"> <div style="text-align: center;">

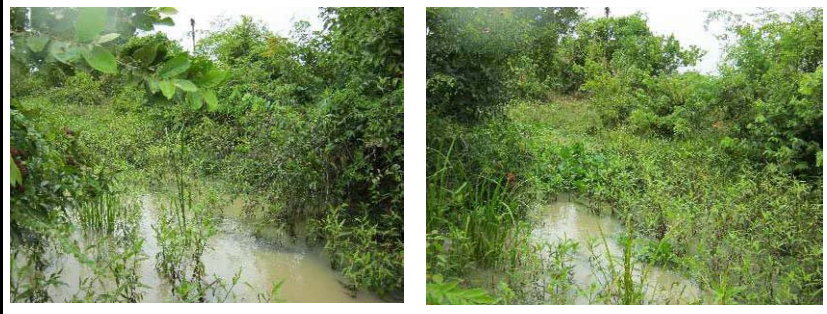
Canal No.: NMC	Proposed Works	Rehabilitation of Kravein-2 SC with construction of structures	Remarks: L = 810 m (A = 40 ha) 2 drain inlets and 3 turnouts
Station: 3.00+350	Map Ref. NMC-9	Coordinate X: 0442340 Y: 1267398

Existing secondary canal		Existing secondary canal

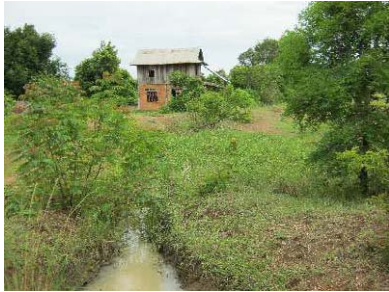
Canal No.: NMC	Proposed Works	Rehabilitation of Sampove-1 SC and construction of structures	Remarks L = 5 km (A =100 ha) 2 Checks/Turnout
Station 3.00+450	Map Ref. NMC-12	Coordinate X: 0442385 Y: 1267452

Existing secondary canal

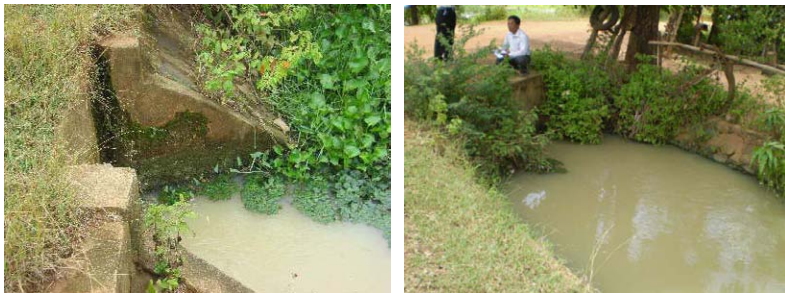
Canal No.: NMC	Proposed Works	Replacement of turnout for Prey Beng-1 SC	Remarks: Turnout for Prey Beng-1 SC (A = 60 ha)
Station: 5.00+100	Map Ref. NMC-13	Coordinate X: 0444065 Y: 1267913

Existing turnout (Inlet)		Existing turnout (Outlet)

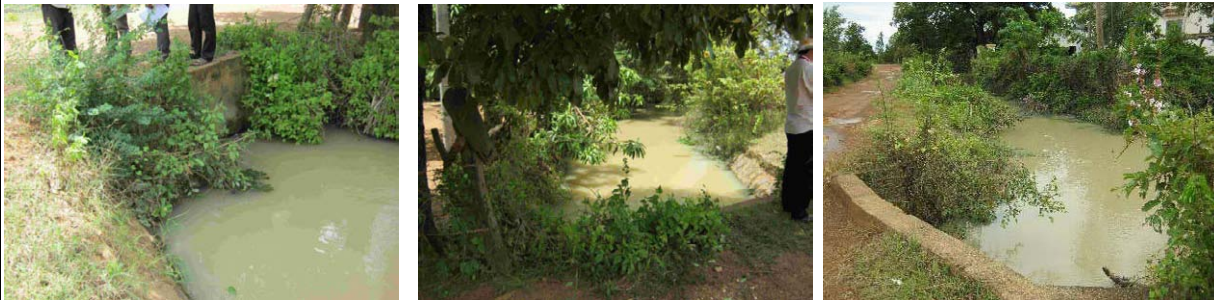
Canal No.: NMC	Proposed Works	Rehabilitation of Prey Beng-1 SC	Remarks: L = 1.64 km (A = 60 ha) 6 Checks/Turnout
Station: 5.00+100	Map Ref. NMC-14	Coordinate X: 0444065 Y: 1267913

Existing turnout (Outlet)	Existing secondary canal		Existing secondary canal

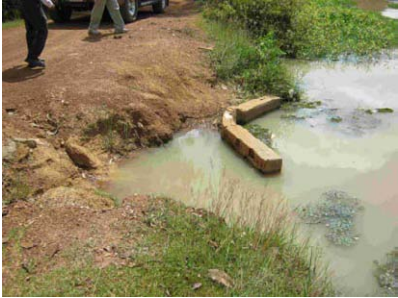
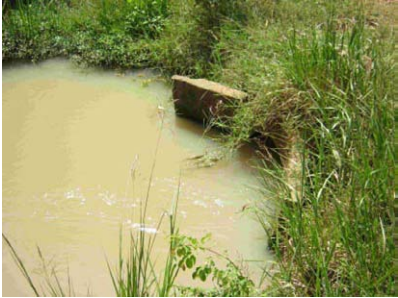
Canal No.: NMC	Proposed Works	Replacement of turnout for Sampove-2 SC		Remarks: Turnout for Sampov-2 SC (A = 100 ha)
Station: 5.00+200	Map Ref. NMC-15	Coordinate	X: 0444100 Y: 1267986

Existing turnout (Inlet)		Existing turnout (Outlet)

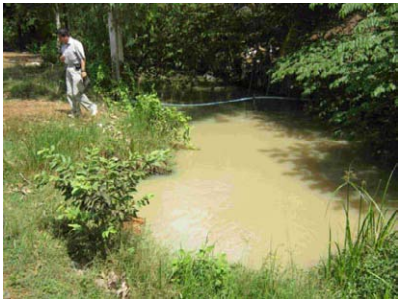
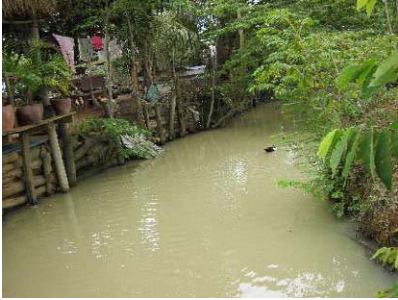
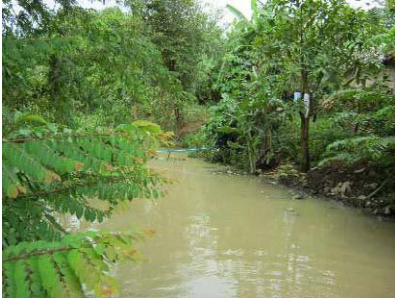
Canal No.: NMC	Proposed Works	Rehabilitation of Sampove-2 SC and construction of structures		Remarks: L = 1.2 km (A = 100 ha) 3 checks/diversions	
Station: 5.00+200	Map Ref. NMC-16	Coordinate	X: 0444100 Y: 1267986

Existing secondary canal			Existing secondary canal		Existing secondary canal

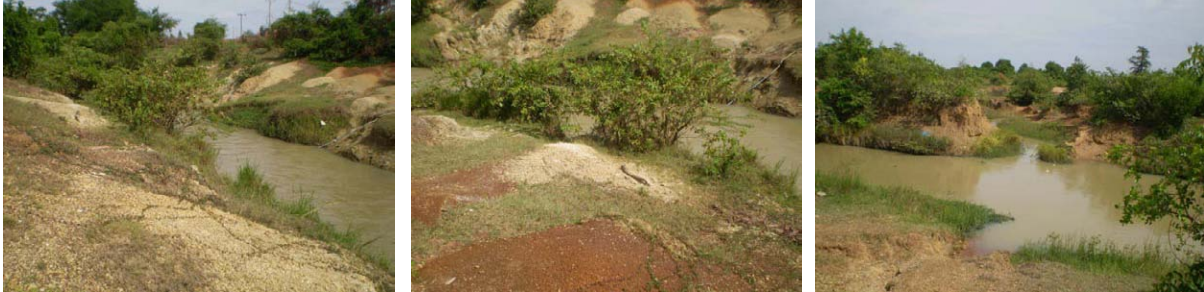
Canal No.: NMC	Proposed Works	Enlargement of canal section with improvement of both canal banks	Remarks:
Station: 5+250 ~ 7+750	Map Ref. NMC-18	Coordinate X: 0445272 Y: 1268599

<div style="display: flex; justify-content: space-around;"> <span>Existing narrow section</span> <span>Existing narrow section</span> <span>Existing narrow section</span> </div>

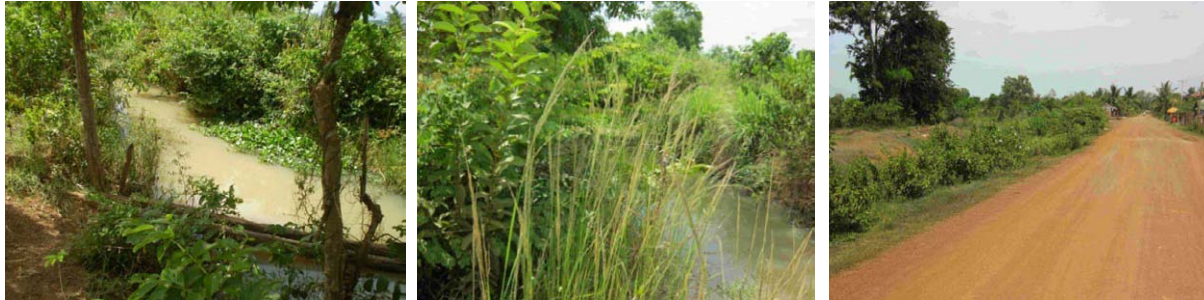
Canal No.: NMC	Proposed Works	Rehabilitation of Prey Beng-2 SC with construction of structures	Remarks: L = 1.8 km, (A = 70 ha) 4 checks/diversions
Station: 5.00+600	Map Ref. NMC-19	Coordinate X: 0444468 Y: 1267961

<div style="display: flex; justify-content: space-around;"> <span>Existing secondary canal</span> <span>Existing secondary canal</span> <span>Road along secondary canal</span> </div>

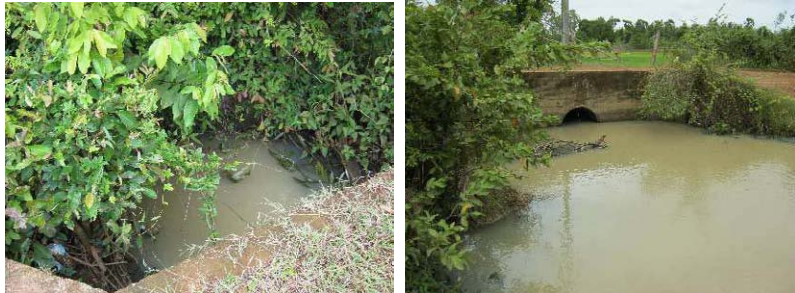
Canal No.: NMC	Proposed Works	Replacement of turnout for Prey Beng-2 SC	Remarks: Turnout for Prey Beng-2 SC (A=70 ha)
Station: 5.00+600	Map Ref. NMC-20	Coordinate X: 0444468 Y: 1267961

<div style="display: flex; justify-content: space-around;"> <span>Existing turnout (Outlet)</span> <span>Existing turnout (Outlet)</span> </div>

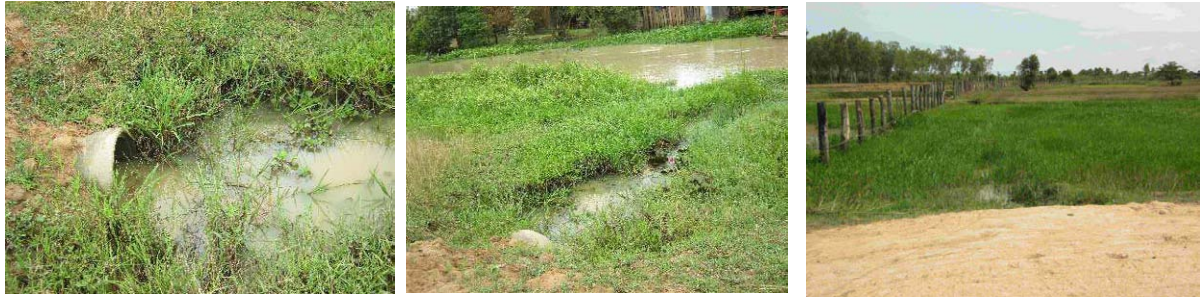
Canal No.: NMC	Proposed Works	Provision of drain inlet		Remarks:
Station: 5.00+300	Map Ref. NMC-21	Coordinate	X: 0444186 Y: 1268033

Existing drain inlet pipe (View form downstream)		Existing drain inlet pipe (View form upstream)		Drainage area

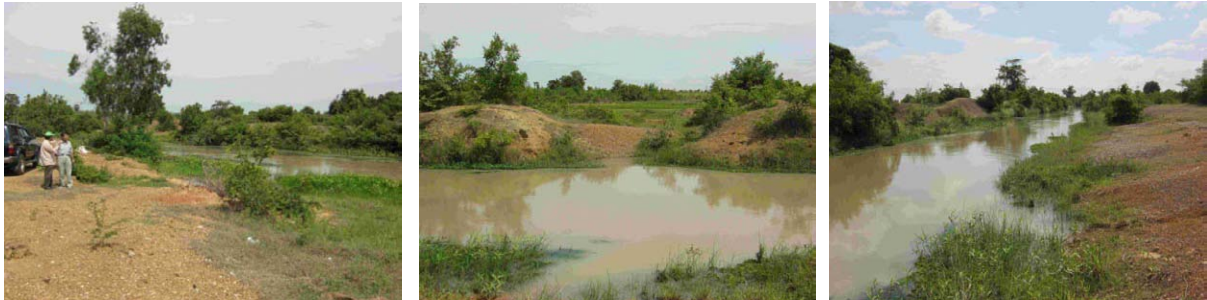
Canal No.: NMC	Proposed Works	Provision of drain inlet		Remarks:
Station: 6.00+000	Map Ref. NMC-21	Coordinate	X: 0444828 Y: 1268349

Upstream View		Upstream View		Downstream View

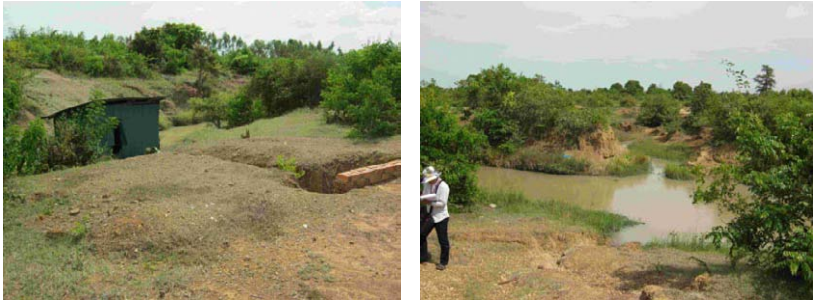
Canal No.: NMC	Proposed Works	Provision of drain inlet		Remarks:
Station: 6.00+250	Map Ref. NMC-21	Coordinate	X: 0444883 Y: 1268374

Drainage area		Proposed site of drain inlet

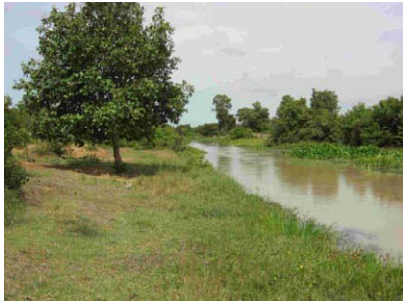
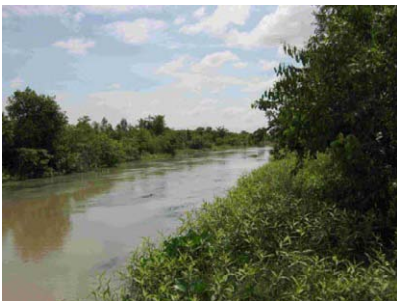
Canal No.: NMC	Proposed Works	Provision of drain inlet	Remarks:
Station: 6.00+500	Map Ref. NMC-21	Coordinate X: 0445039 Y: 1268473

Upstream View		Downstream View

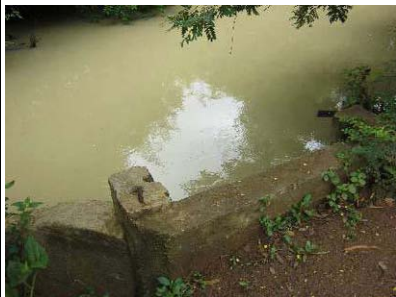
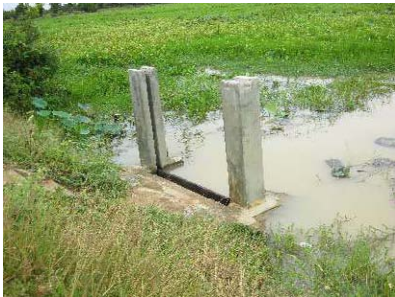
Canal No.: NMC	Proposed Works	Replacement of 3 outlets for small irrigated area	Remarks:
Station: 8+550 ~ 9+100	Map Ref. NMC-22	Coordinate X: 0447376 Y: 1269055

Existing turnout (Inlet)		Existing turnout (Outlet)

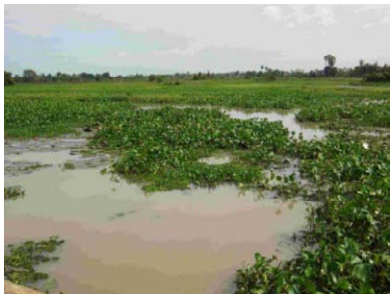
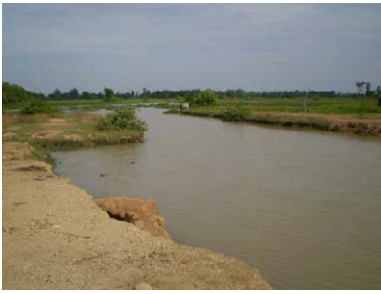
Upstream View		Downstream View

Canal No.: NMC	Proposed Works	Construction of embankment with flood spillway	Remarks:
Station: 8+550 ~ 9+100	Map Ref. NMC-23	Coordinate X: 0447680 Y: 1269034	L = 1.1 km at level crossing reservoir with flood spillway structure (Siphon is proposed by PDOWRAM)

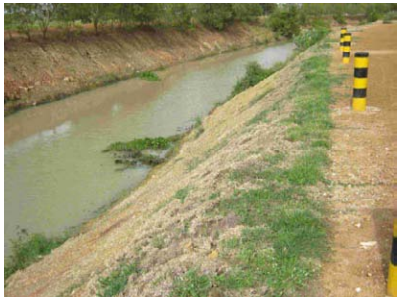
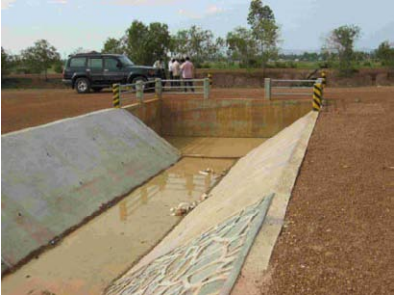
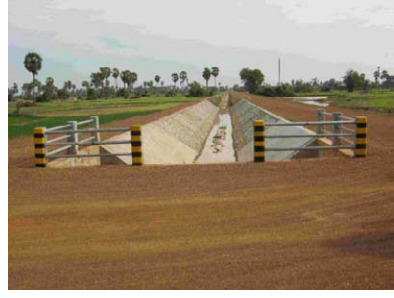
Proposed site of pump station		Downstream View of proposed pump station site		Existing secondary canal

Canal No.: NMC	Proposed Works	Construction of New Pumping Station		Remarks : Off taking secondary canal has already been constructed
Station: 10+000(E.P.)	Map Ref. NMC-25	Coordinate	X: 0448778 Y: 1269033

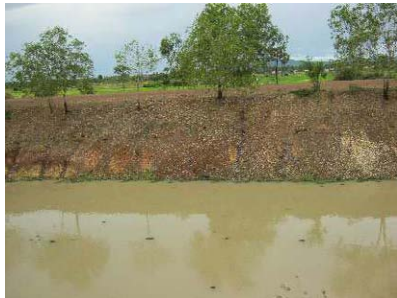
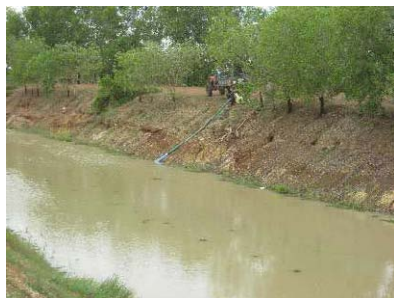
Upstream View		Downstream View

Canal No.: NMC	Proposed Works	Provision of a drain inlet		Remarks:
Station: 10+00	Map Ref. NMC-26	Coordinate	X: 0448778 Y: 1269033

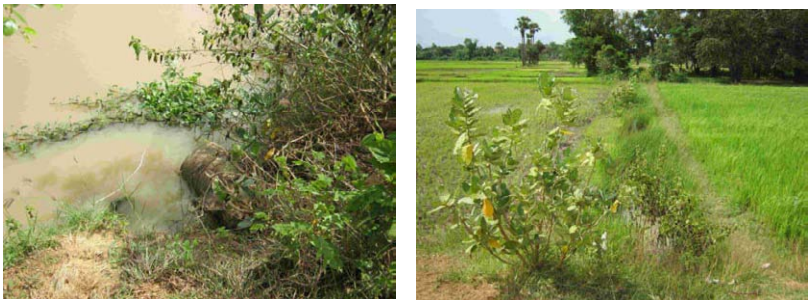
Existing turnout (Upsream View)		Downstream View

Canal No.: SMC	Proposed Works	Improvement of turnout (Concrete pipe)		Remarks: Turnout for Tompoung SC-1 (A = 10 ha) Provision of pipe culvert
Station: 0.00+950	Map Ref. SAC-3	Coordinate	X: 0439581 Y: 1263963

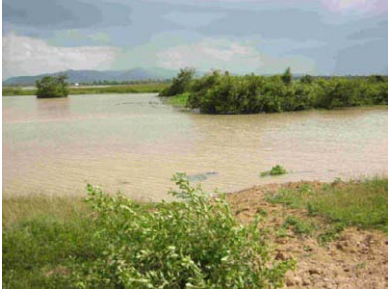
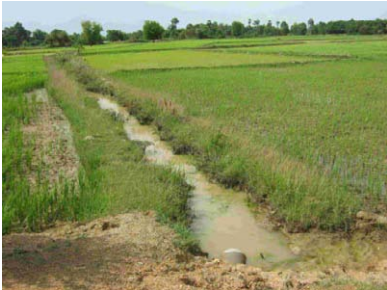
Upstream View (Inlet side)		Downstream View (Tompoung -2 SC)

Canal No.: SMC	Proposed Works	Improvement of turnout (Concrete pipe)		Remarks: Turnout for Tompoung -2 SC (A=10 ha) Provision of pipe culvert
Station: 1.00+350	Map Ref. SAC-4	Coordinate	X: 0439231 Y: 1264040

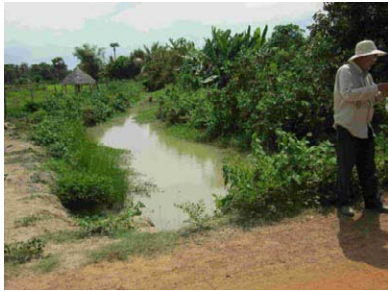
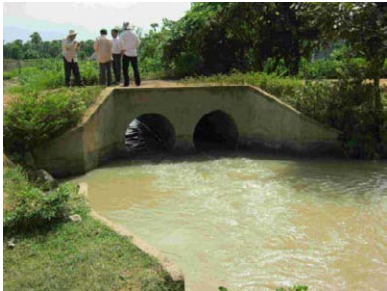
Existing Kraheng SC		Existing Kraheng SC

Canal No.: SMC	Proposed Works	Rehabilitation and Construction of structures of Kraheng SC		Remarks: L = 1.75 km (A = 125 ha) 4 Checks/Turnouts
Station: 2.00+600	Map Ref. SAC-5	Coordinate	X: 0439553 Y: 1265107

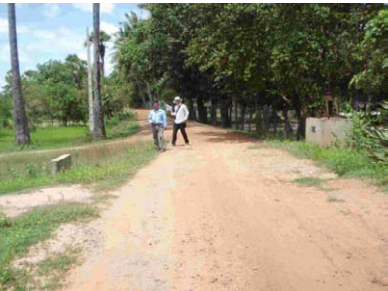
Existing embankment

Canal No.: SMC	Proposed Works	Laterite pavement with raising of embankment		Remarks: Repair and provision of laterite pavement (both sides) H = 1 m (additional), W = 6 m
Station: 1+ 650 ~ 2+600	Map Ref. SAC-6	Coordinate	X: Y:

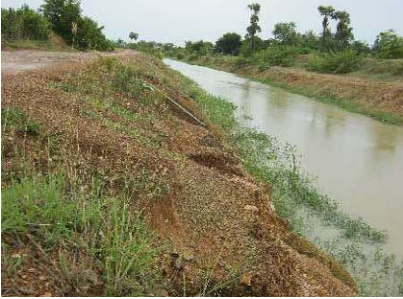
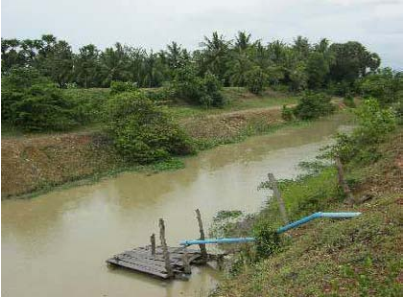
Upstream View		Downstream View

Canal No.: SMC	Proposed Works	Improvement of canal section (Excavation of canal bottom)	Remarks: Excavation : 1 m depth
Station: 0.00 ~ 1+650	Map Ref. SAC-7	Coordinate X: Y:

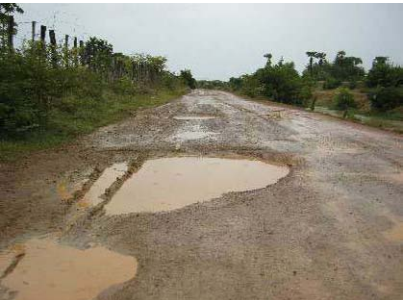
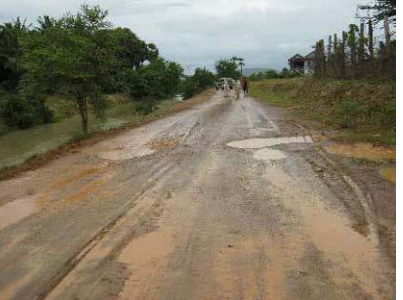
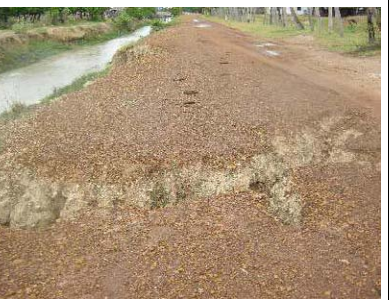
General View		General View

Canal No.: SMC	Proposed Works	Laterite pavement with improvement of embankment	Remarks:
Station: 0.00 ~ 7+800	Map Ref. SMC-1	Coordinate X: Y:

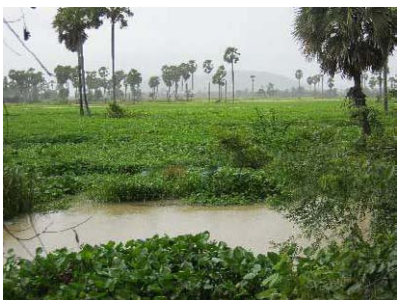
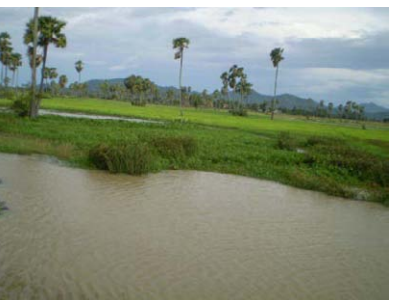
Upstream View		Downstream View

Canal No.: SMC	Proposed Works	Construction of embankment with flood spillway	Remarks: Left side : Enlargement of embankment (W = 6 m) Right side : new embankment at level crossing reservoir
Station: 7+800 ~ 9+620	Map Ref. SMC-2	Coordinate X: Y:

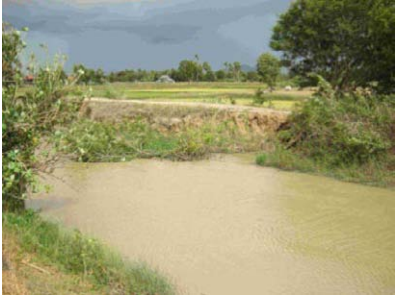
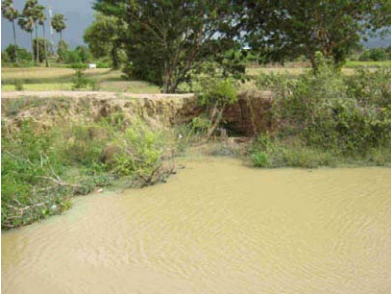
Upstream View		Downstream View

Canal No.: SMC	Proposed Works	Provision of drain inlet		Remarks: Diameter of pipe : 0.8 m to 1 m
Station: 0.00+ 600	Map Ref. SMC-3	Coordinate	X: 0441034 Y: 1263964

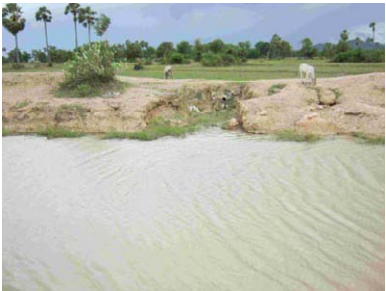
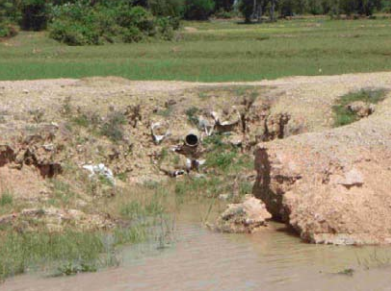
Existing condition (SMC right bank)		Existing condition (SMC side, zoomed in)

Canal No.: SMC	Proposed Works	Provision of drain inlet		Remarks: Diameter 0.8 m to 1 m (both sides)
Station: 2.00 + 700	Map Ref. SMC-4	Coordinate	X: 0442935 Y: 1264112

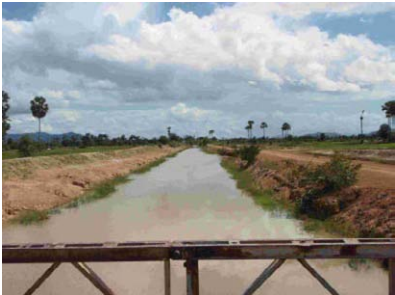
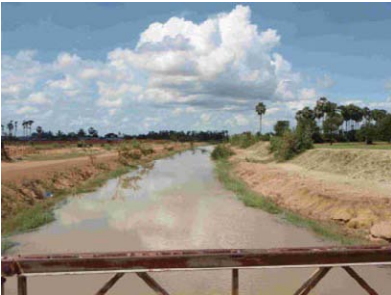
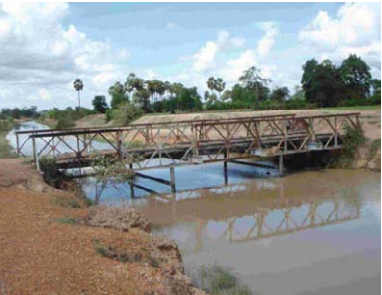
Upstream View		Downstream View

Canal No.: SMC	Proposed Works	Construction of check structure		Remarks: Check structure with new bridge at existing steel bridge
Station: 2.00 + 950	Map Ref. SMC-5	Coordinate	X: 0443137 Y: 1264220

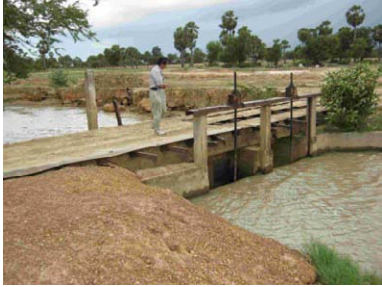
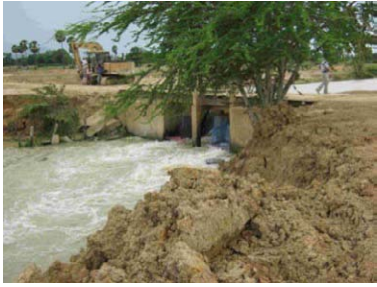
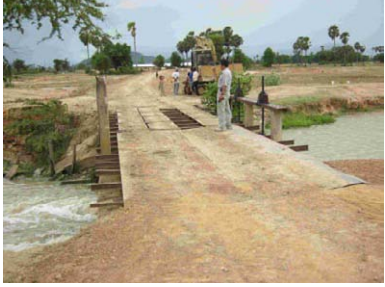
<p style="text-align: center;">Upstream View                      Downstream View                      Existing bridge</p>

Canal No.: SMC	Proposed Works	Removing check structure and construction of concrete bridge		Remarks:
Station: 3.00 + 500	Map Ref. SMC-6	Coordinate	X: 0443631 Y: 1264474

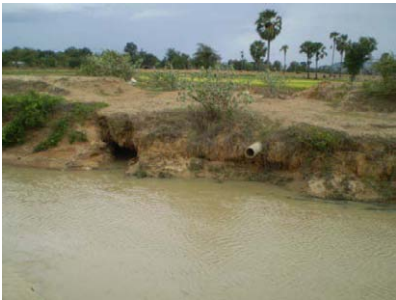
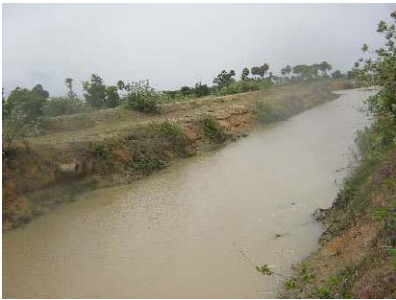
<p style="text-align: center;">Right bank of SMC                      Downstream View</p>

Canal No.: SMC	Proposed Works	Construction of drain inlets		Remarks: (Both side)
Station: 3.00 + 650	Map Ref. SMC-7	Coordinate	X: 0443765 Y: 1264535

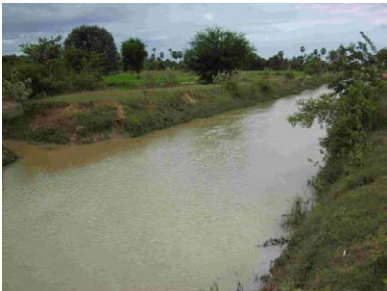
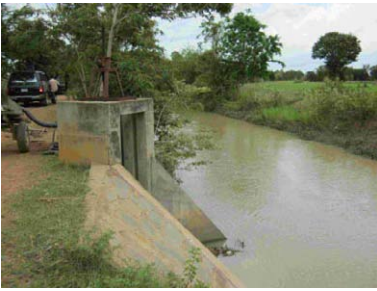
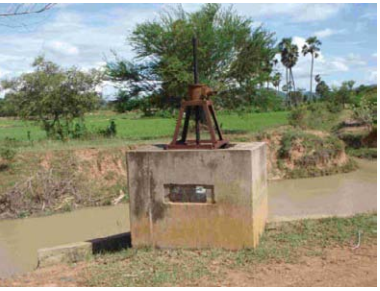
<p style="text-align: center;">Upstream View                      Existing turnout                      Existing turnout</p>

SMC-8	SMC	4.75 km	L/R	Replacement of turnouts	Left side : Replacement of turnout for Koh Té SC-1 (A = 80 ha)
SMC-9	SMC	4.75 km	L/R	Construction of turnouts	Right side : Construction of turnout for Koh Té SC-2 (A = 110 ha)
SMC-10	SC	4.75 km	R	Rehabilitation of Koh Té-1 SC with construction of structures	L = 1 km (A = 80 ha) 3 checks/Turnouts
SMC-11	SC	4.75 km	L	Rehabilitation of Koh Té-2 SC with construction of structures	L = 1.75 km (A = 110 ha) 3 checks/Turnouts
SMC-12	SMC	5 km	L/R	Replacement of check structure	
SMC-13	SMC	5.85 km	L/R	Replacement of turnout and drain inlet	Left side: Turnout for Thnol Bom Bek SC (A = 100 ha) Right side : Construction of drain inlet
SMC-14	SC	5.85 km	L	Rehabilitation of Thnol Bom Bek SC with construction of structures	L = 2.15 km (A = 100 ha) 6 Checks / Turnouts
SMC-15	SMC	6.2 km	-	Replacement of bridge	Removing existing steel bridge and construction of new concrete bridge

Canal No.: SMC	Proposed Works	Replacement of turnouts		Remarks: Left side : Replacement of turnout for Koh Té -1 SC (A = 80 ha)
Station: 4.00 + 750	Map Ref. SMC-8	Coordinate	X: 0444752 Y: 1265073

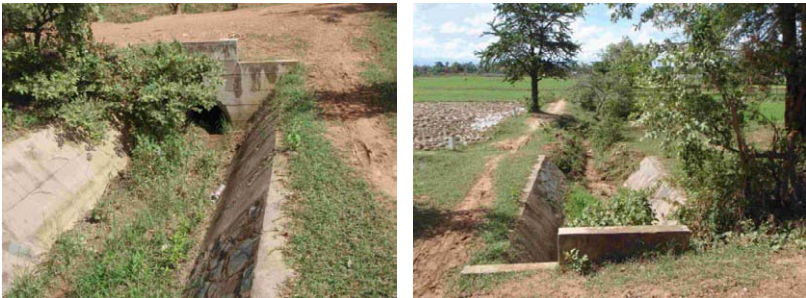
Upstream View at turnout			Upstream of Koh Té-1 secondary canal

Canal No.: SMC	Proposed Works	Rehabilitation of Koh Té-1 SC with construction of structures		Remarks: L = 1 km (A = 80 ha) 3 checks/Turnouts
Station: 4.00 + 750	Map Ref. SMC-10	Coordinate	X: 0444752 Y: 1265073

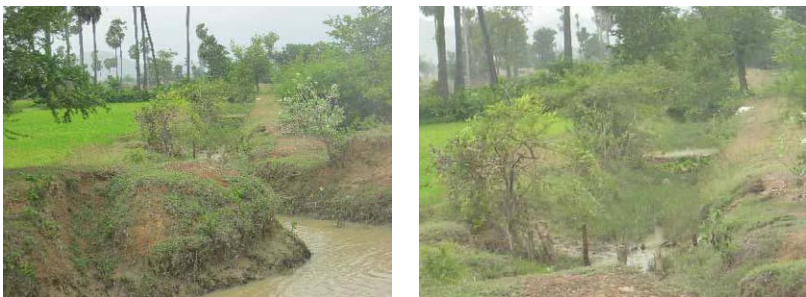
Presentr condition (No structure)			Downstream View

Canal No.: SMC	Proposed Works	Rehabilitation of Koh Té-2 SC with construction of structures		Remarks: L = 1.75 km (A = 110 ha) 3 checks/Turnouts
Station: 4.00 + 750	Map Ref. SMC-11	Coordinate	X: 0444752 Y: 1265073

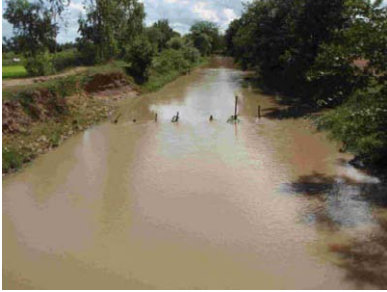
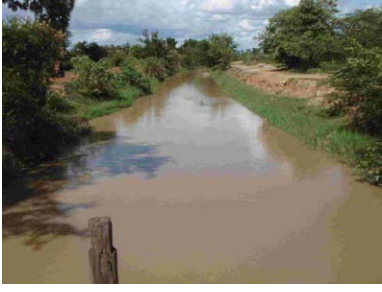
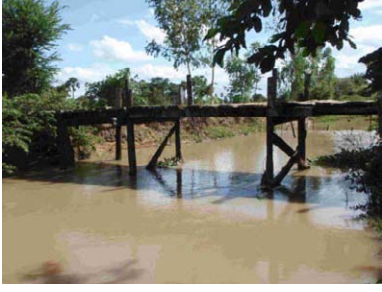
<p style="text-align: center;">Upstream View                      Downstream View                      Existing bridge</p>

Canal No.: SMC	Proposed Works	Construction of check structure		Remarks:
Station: 5.00 + 0.00	Map Ref. SMC-12	Coordinate	X: 0444986 Y: 1265147

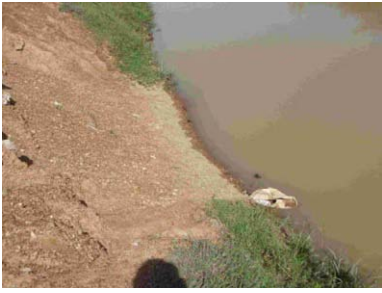
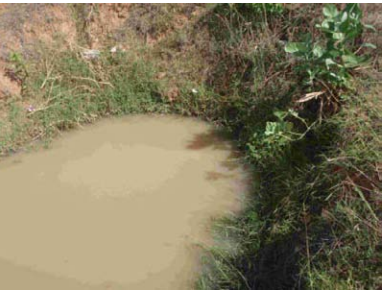
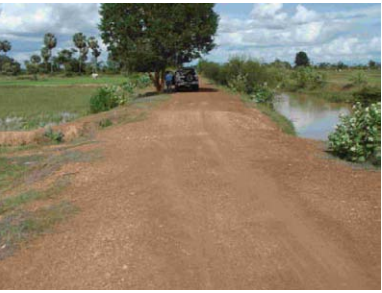
Canal No.: SMC	Proposed Works	Construction of turnout and drain inlet		Remarks: Left side: Turnout for Thnol Bom Bek SC (A = 100 ha) Right side : Construction of drain inlet
Station: 5.00+850	Map Ref. NMC-13	Coordinate	X: 0445815 Y: 1265104

<p style="text-align: center;">Inlet of existing turnout                      Outlet of existing turnout                      Existing turnout</p>

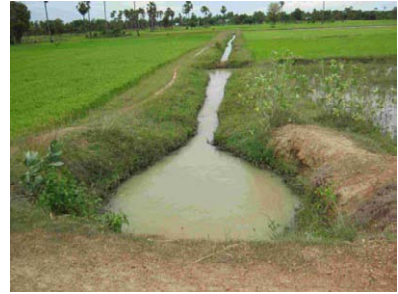
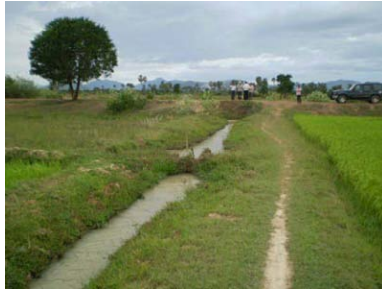
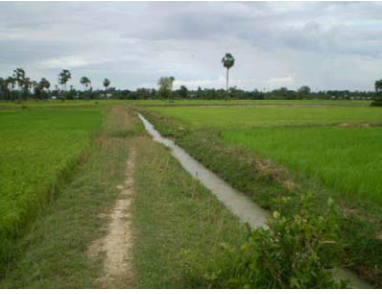
Canal No.: SMC	Proposed Works	Rehabilitation of Thnol Bom Bek SC with construction of structures		Remarks: L = 2.15 km (A = 100 ha) 6 Checks / Turnouts
Station: 5.00 +850	Map Ref. NMC-14	Coordinate	X: 0445815 Y: 1265104

<p style="text-align: center;">Thnol Bom Bek SC just after turnout                      Upstream of Thnol Bom Bek SC                      Downstream View</p>

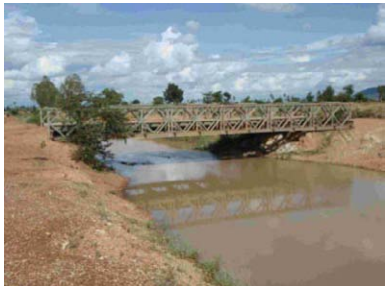
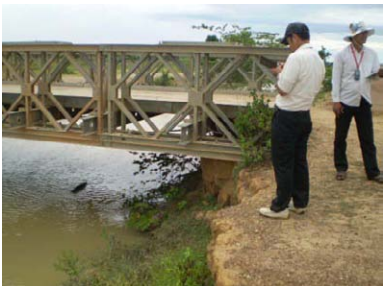
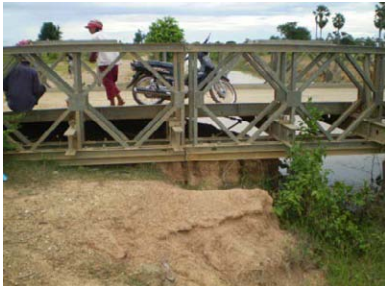
Canal No.: SMC	Proposed Works	Replacement of bridge	Remarks:
Station: 6.00 +200	Map Ref. SMC-15	Coordinate X: 0446159 Y: 1265041	Removing existing steel bridge and construction of new concrete bridge

<p align="center">Upstream View                      Existing bridge                      Existing bridge</p>

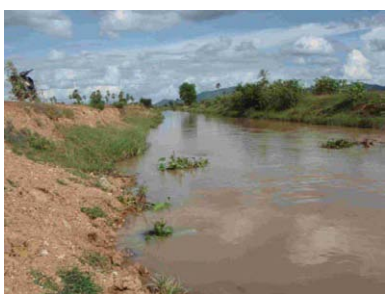
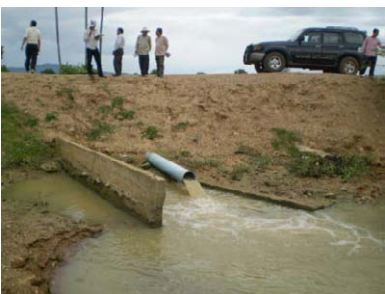
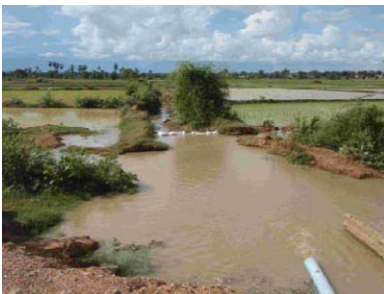
Canal No.: SMC	Proposed Works	Construction of turnout	Remarks:
Station: 6.00+950	Map Ref. SMC-16	Coordinate X: 0446835 Y: 1264797	Turnout for Phum Rong SC (A = 80 ha)

<p align="center">Upsream View (Inlet side in SMC)                      Existing outlet                      Phum Rong SC at existing outlet</p>

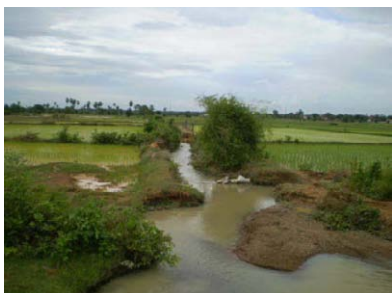
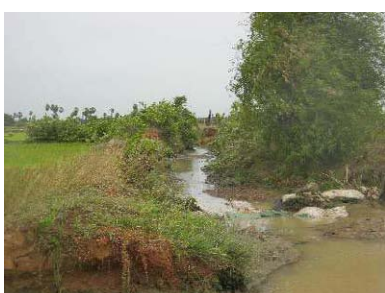
Canal No.: SMC	Proposed Works	Rehabilitation of Phum Rong SC with construction of structures	Remarks:
Station: 6.00+950	Map Ref. SMC-17	Coordinate X: 0446835 Y: 1264797	L = 3km (A = 80 ha) 6 Checks/Turnouts

<p align="center">Existing Phum Rong SC                      Existing Phum Rong SC</p>

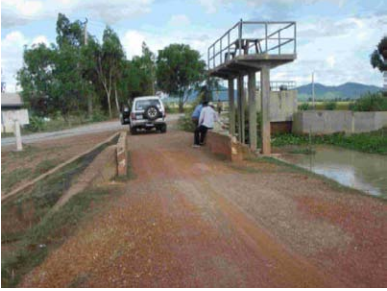
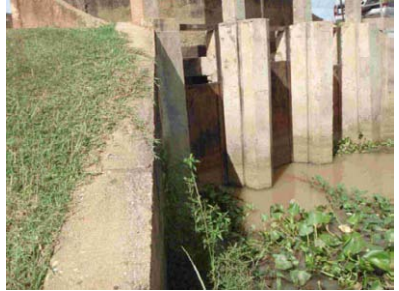
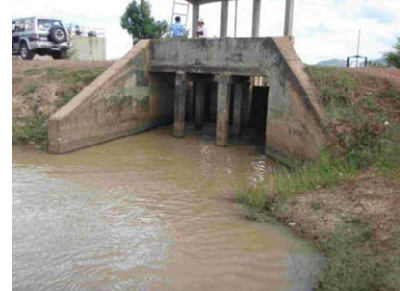
Canal No.: SMC	Proposed Works	Replacement of turnout		Remarks: Replacement of Turnout for Road-110 SC (A = 20 ha)
Station: 7.00+800	Map Ref. SMC-19	Coordinate	X: 0447469 Y: 1264229

<p style="text-align: center;">Existing turnout                      View from Upstream                      View from Downstream</p>

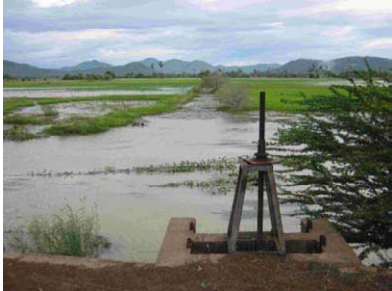
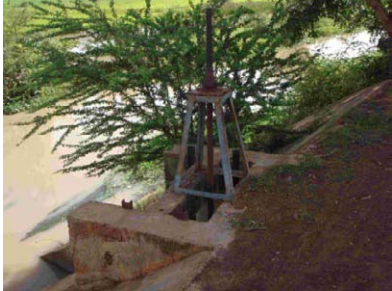
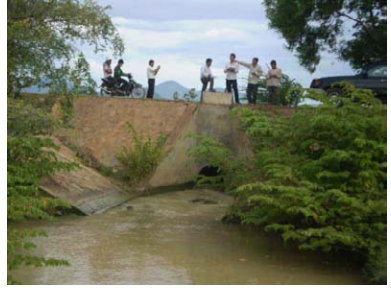
Canal No.: SMC	Proposed Works	Replacement of turnout for Phum Skous-1 SC		Remarks: Turnout for Phum Skous-1 SC (A = 25 ha)
Station: 8.00+400	Map Ref. SMC-20	Coordinate	X: 0447980 Y: 1263876

<p style="text-align: center;">Existing turnout                      Existing turnout (Inlet)                      Existing turnout (Outlet)</p>

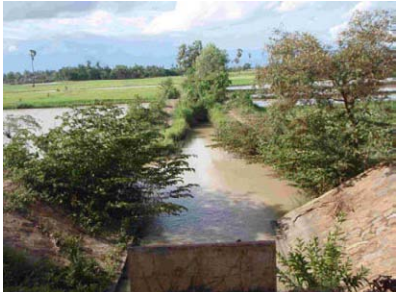
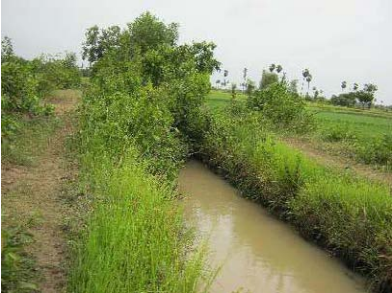
Canal No.: SMC	Proposed Works	Rehabilitation of Phum Skous-1 SC with construction of structures	Remarks: L = 2 km (A = 25 ha) 2 Checks/Turnouts
Station: 8.00+400	Map Ref. SMC-21	Coordinate X: 0447980 Y: 1263876

Existing Phum Skous-1 SC		Existing Phum Skous-1 SC

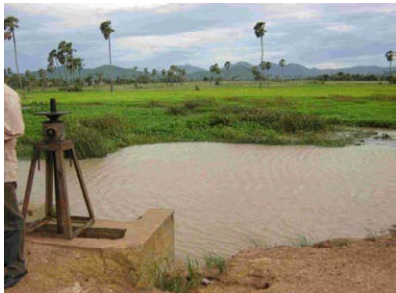
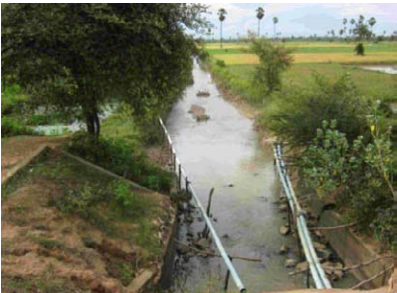
Canal No.: SMC	Proposed Works	Replacement of turnout for Phum Skous-2 SC	Remarks: Turnout for Phum Skous-2 SC (A = 100 ha)
Station: 8.00+700	Map Ref. SMC-22	Coordinate X: 0448274 Y: 1263799

Upstream View		Downstream View

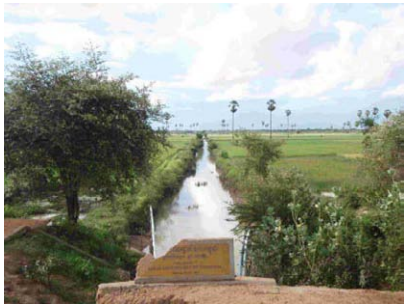
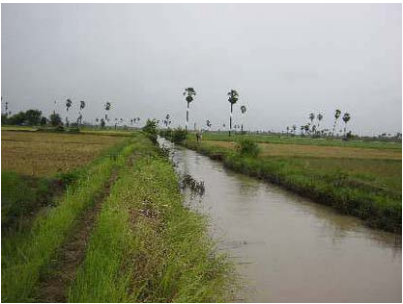
Canal No.: SMC	Proposed Works	Rehabilitating of Phum Skous-2 SC with construction of structures	Remarks: L = 2.8 km (A = 100 ha) 5 Checks/Turnouts and 2 drain inlets
Station: 8.00+700	Map Ref. SMC-23	Coordinate X: 0448274 Y: 1263799

Existing Phum Skous-2 SC (View from turnout)		Existing Phum Skous-2 SC

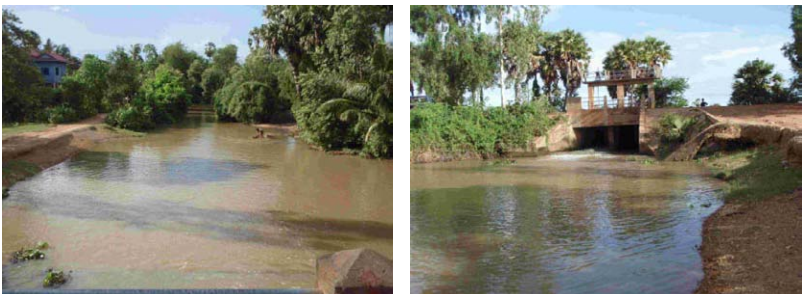
Canal No.: SMC	Proposed Works	Rehabilitation of Bak Thmenh S.C	Remarks: L = 6 km SC in downstream (A = 60 ha)
Station: 9.00+620	Map Ref. SMC-26	Coordinate X: 0448981 Y: 1263728

Downstream view from drainage gate		Turnout (View form Downstream)

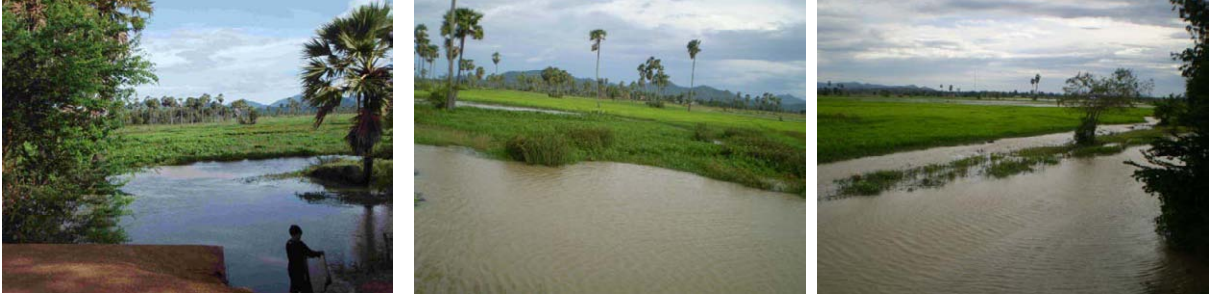
Canal No.: SMC	Proposed Works	Construction of embankment and spillway		Remarks: Construction of embankment and spillway at level crossing reservoir
Station: 9.00+620	Map Ref. SMC-27	Coordinate	X: 0448981 Y: 1263728

Level crossing reservoir		Level crossing reservoir (Upstream view)		Level crossing reservoir (Downstream view)

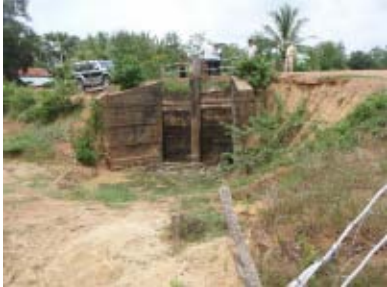
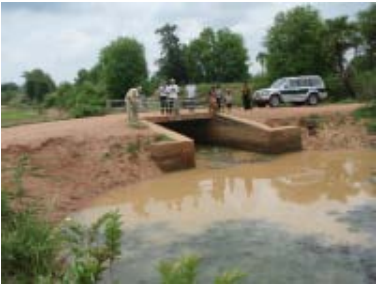
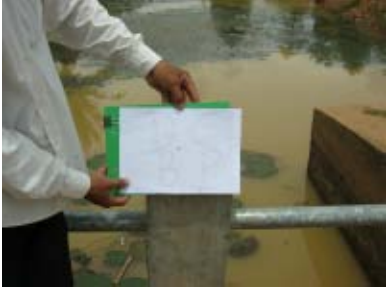
Canal No.: D.C.	Kind of structure(s): Gate	Remarks:
Station: 0.00(B.P.)	Coordinate< Northing: 1229277 Easting: 440717	Check Gate

Up Stream View	Down Stream View	B.P.

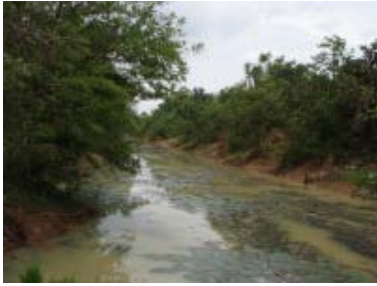
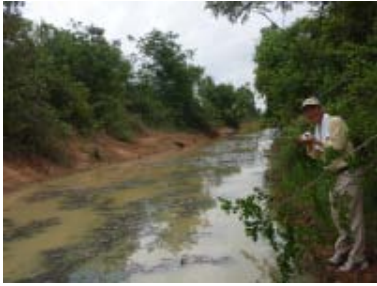
Canal No.: D.C.	Kind of structure(s): Canal	Remarks:
Station: 0.00+410	Coordinate< Northing: 1229045 Easting: 440753	Routine Survey

Up Stream View	Down Stream View

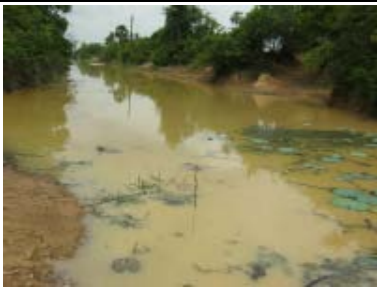
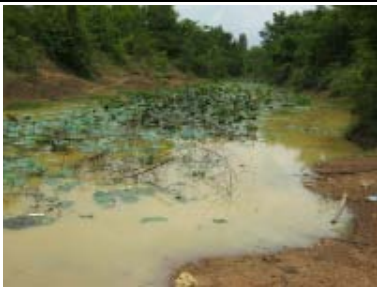
Canal No.: D.C.	Kind of structure(s): Canal	Remarks:
Station: 1.00+390	Coordinate< Northing: 1228585 Easting: 440826	Routine Survey

Up Stream View	Down Stream View

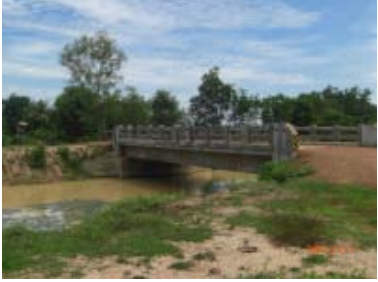
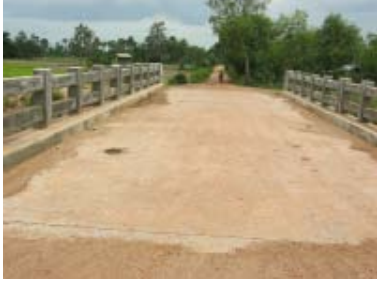
Canal No.: D.C.	Kind of structure(s): Concrete Bridge	Remarks:
Station: 2.00+160	Coordinate< <div style="display: inline-block; vertical-align: middle; margin-left: 10px;">                     Northing: 1227877                      Easting: 440902                 </div>	Tropeang Skear Bridge (Constructed in 2010)

Down Stream View		Structure

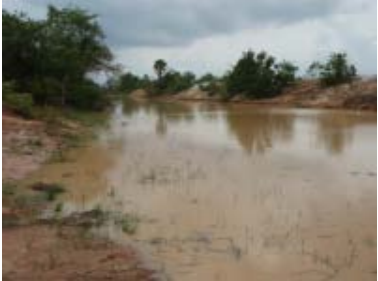
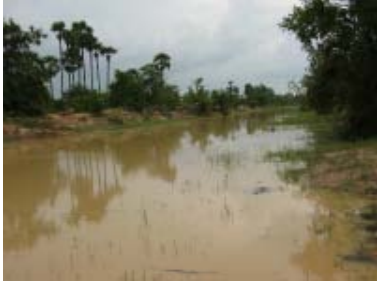
Canal No.: D.C.	Kind of structure(s): Canal	Remarks:
Station: 2.00+680	Coordinate< <div style="display: inline-block; vertical-align: middle; margin-left: 10px;">                     Northing: 1227390                      Easting: 441020                 </div>	Routine Survey

Up Stream View		Down Stream View

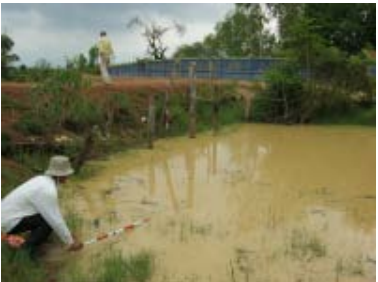
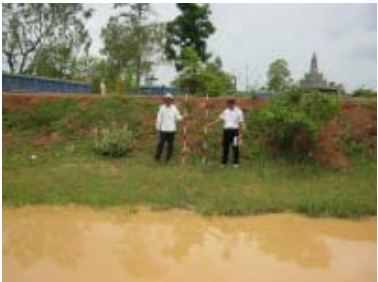
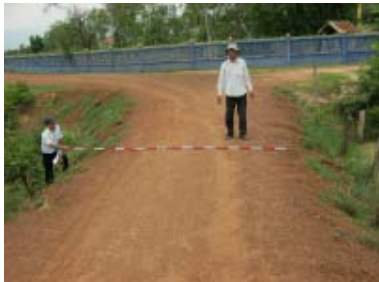
Canal No.: D.C.	Kind of structure(s): Landfill Road	Remarks:
Station: 3.00+180	Coordinate< <div style="display: inline-block; vertical-align: middle; margin-left: 10px;">                     Northing: 1226910                      Easting: 441135                 </div>	Road to Pagoda

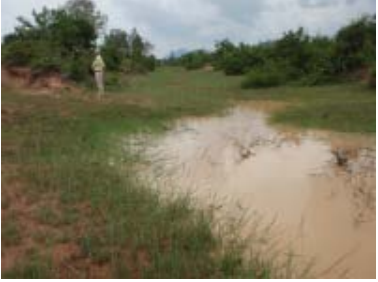
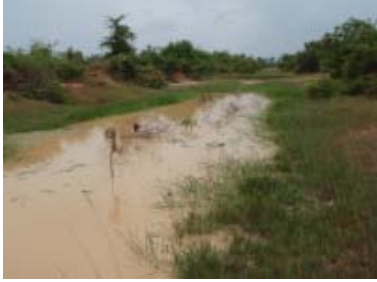
Canal No.: D.C.	Kind of structure(s): Canal	Remarks:
Station: 3.00+680	Coordinate< <div style="display: inline-block; vertical-align: middle; margin-left: 10px;">                     Northing: 1226554                      Easting: 441475                 </div>	Routine Survey

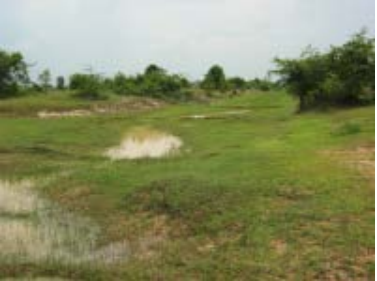
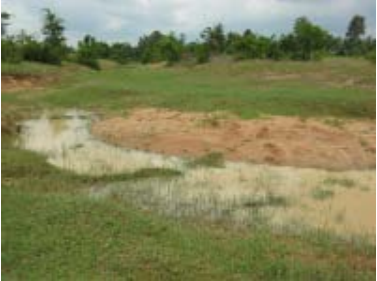
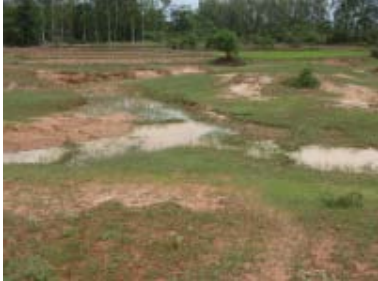
Canal No.: D.C.	Kind of structure(s): Canal	Remarks:
Station: 4.00+180	Coordinate< <div style="display: inline-block; vertical-align: middle; margin-left: 10px;">                     Northing: 1226194                      Easting: 441816                 </div>	Inflow from right bank

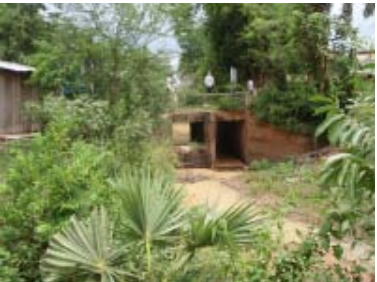
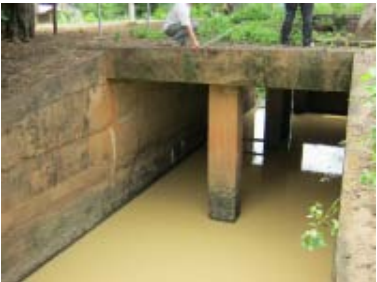
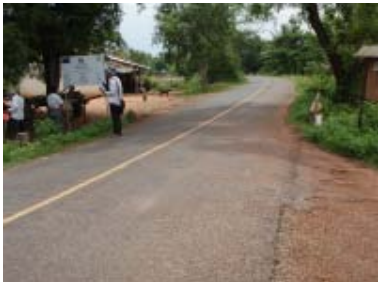
Canal No.: D.C.	Kind of structure(s): Concrete Bridge	Remarks:
Station: 4.00+580	Coordinate< <div style="display: inline-block; vertical-align: middle; margin-left: 10px;">                     Northing: 1225862                      Easting: 442031                 </div>	National Road Crossing D.C.
