*Results of Inventory Survey for  
Proposed Rehabilitation Works in  
Roleang Chrey Headworks Rehabilitation Sub-project*

PREPARATORY SURVEY FOR IRRIGATION AND DRAINAGE  
SYSTEM REHABILITATION AND IMPROVEMENT PROJECT

Japan International Cooperation Agency

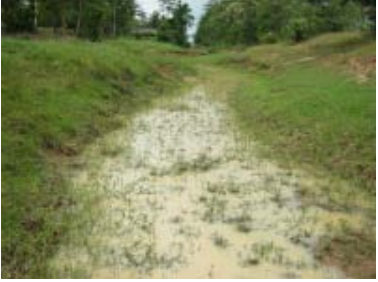
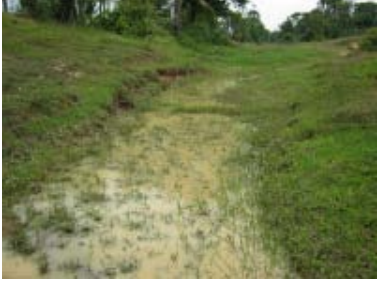
Canal No.: D.C.	Kind of structure(s): Canal	Remarks:
Station: 5.00+220	Coordinate< Northing: 1225476 Easting: 442509	Routine Survey

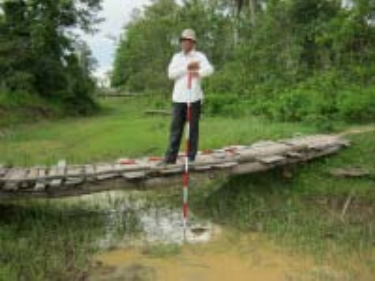
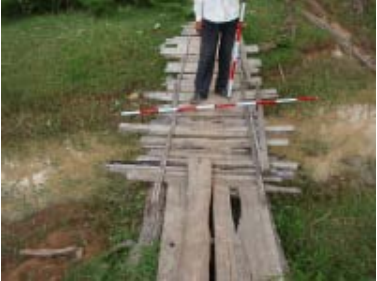
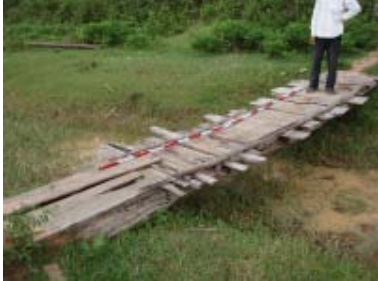
Canal No.: D.C.	Kind of structure(s): Bridge	Remarks:
Station: 5.00+300	Coordinate< Northing: 1225426 Easting: 442559	Private Bridge

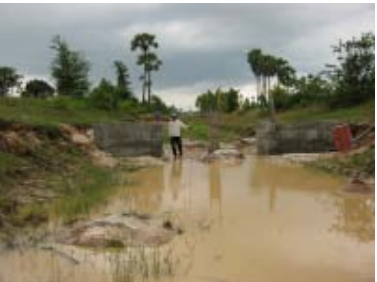
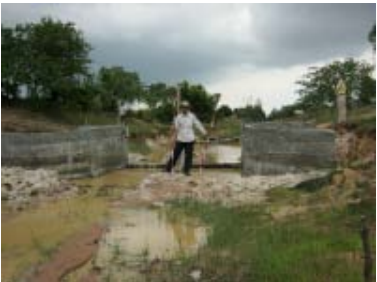
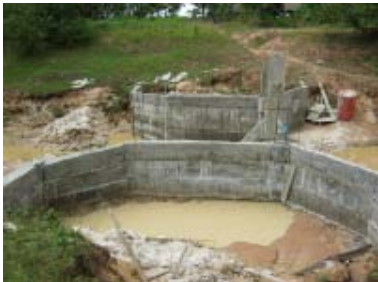
Canal No.: D.C.	Kind of structure(s): Bridge	Remarks:
Station: 5.00+800	Coordinate< Northing: 1225144 Easting: 442963	Private Concrete Bridge under Construction

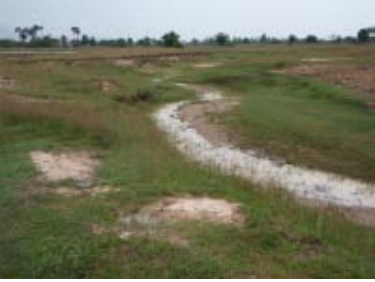
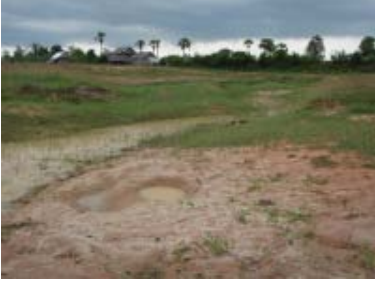
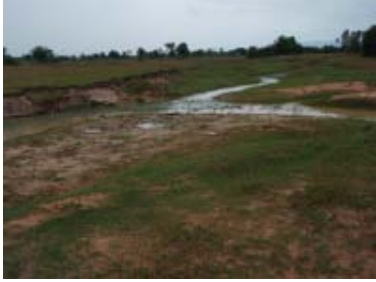
Canal No.: D.C.	Kind of structure(s): Canal	Remarks:
Station: 6.00+950(EP)	Coordinate< <div style="display: inline-block; vertical-align: middle; margin-left: 10px;">                     Northing: 1224841                      Easting: 443316                 </div>	Confluence point of D.C. and Osaray stream

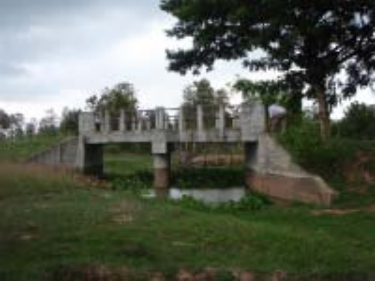
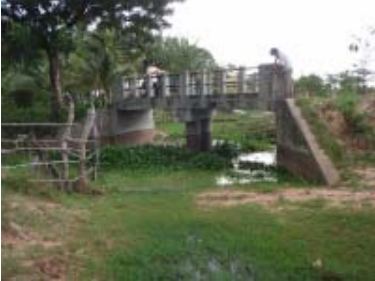
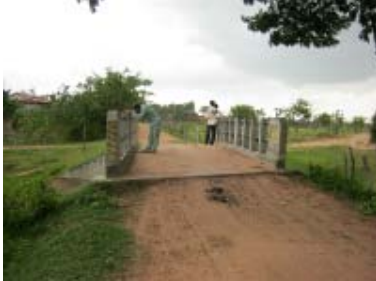
Canal No.: D.C.	Kind of structure(s): Concrete Bridge	Remarks:
Station: 8.00+200	Coordinate< <div style="display: inline-block; vertical-align: middle; margin-left: 10px;">                     Northing: 1223936                      Easting: 444028                 </div>	Constructed in 2000

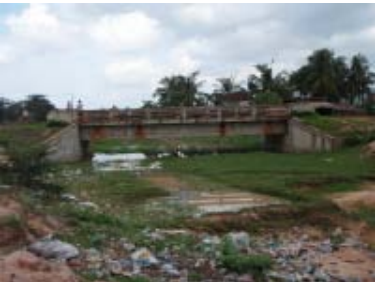
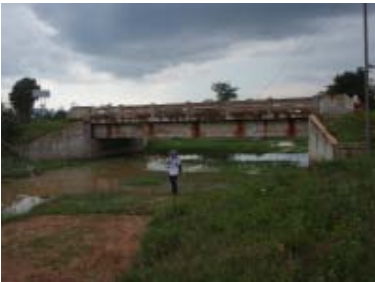
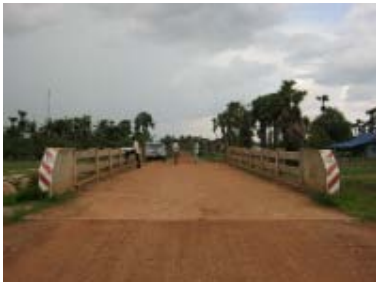
Canal No.: D.C.	Kind of structure(s): Concrete Bridge	Remarks:
Station: 9.00	Coordinate< <div style="display: inline-block; vertical-align: middle; margin-left: 10px;">                     Northing: 1223317                      Easting: 445169                 </div>	Constructed in 2006 ~ 2007

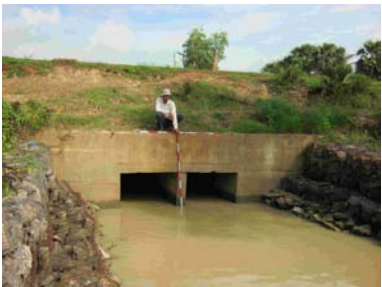
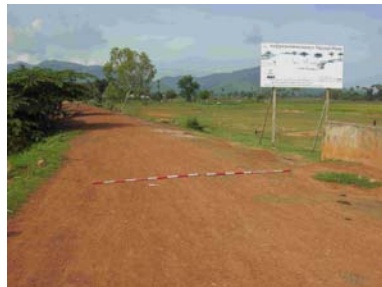
Canal No.: MC33	Kind of structure: Gate (Intake)	Remarks:
Station: 0.00(B.P.)	Coordinate< <div style="display: flex; flex-direction: column; margin-left: 10px;"> <span>Northing: 1223190</span> <span>Easting: 448349</span> </div>	Cross the national road

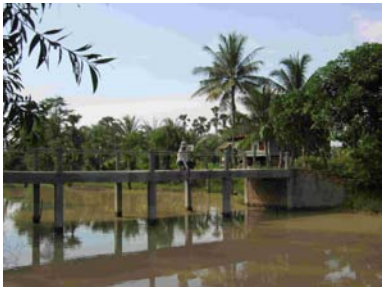
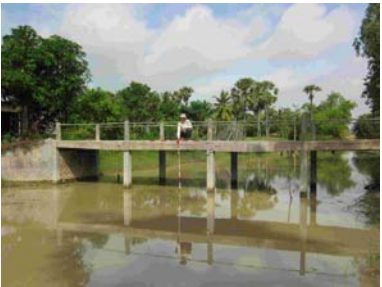
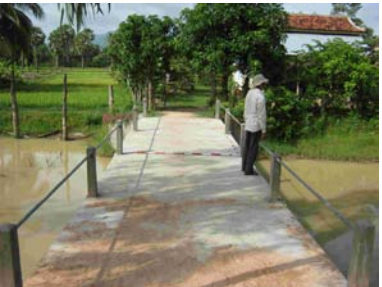
Canal No.: MC33	Kind of structure: Bridge (Private Concrete)	Remarks:
Station: 0.00+240	Coordinate< <div style="display: flex; flex-direction: column; margin-left: 10px;"> <span>Northing: 1223143</span> <span>Easting: 448556</span> </div>	Routine survey

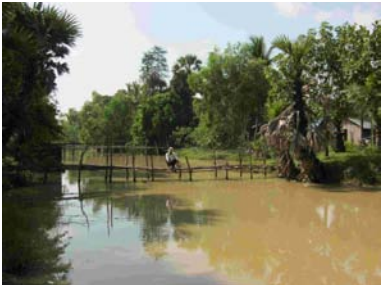
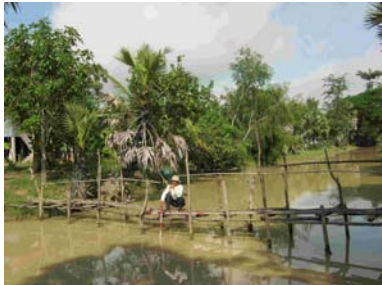
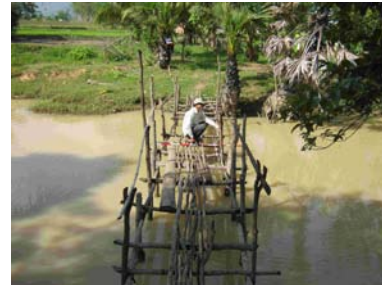
Canal No.: MC33	Kind of structure: Bridge (Private )	Remarks:
Station: 0.00+440	Coordinate< <div style="display: flex; flex-direction: column; margin-left: 10px;"> <span>Northing: 1223111</span> <span>Easting: 448760</span> </div>	Made by wood

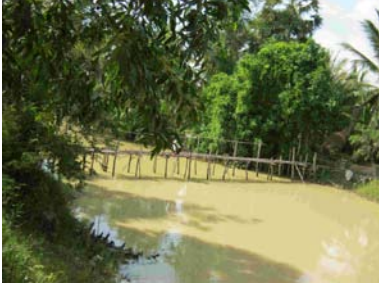
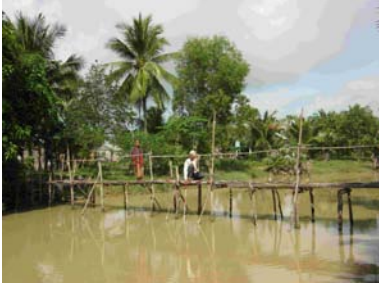
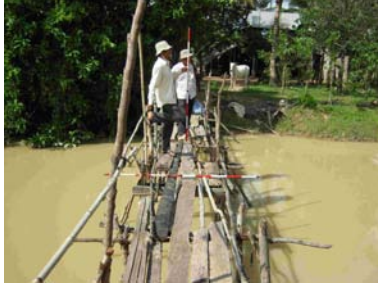
Canal No.: MC33	Kind of structure: Bridge (Private)	Remarks:
Station: 0.00+470	Coordinate< Northing: 1223104 Easting: 448793	Made by wood

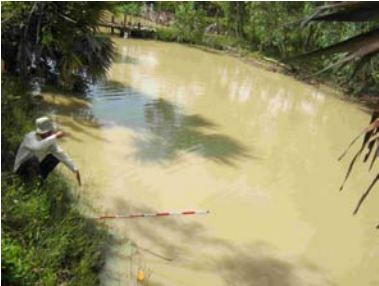
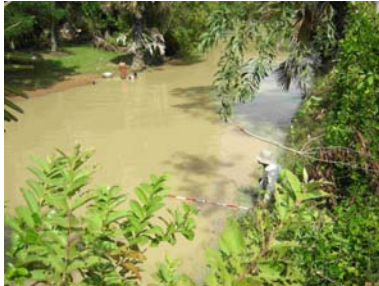
Canal No.: MC33	Kind of structure: Canal	Remarks:
Station: 0.00+500	Coordinate< Northing: 1223097 Easting: 448834	Routine survey Length: 500m

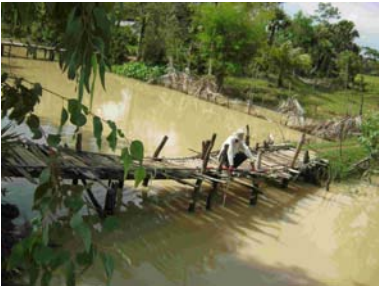
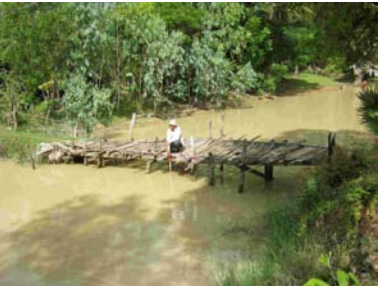
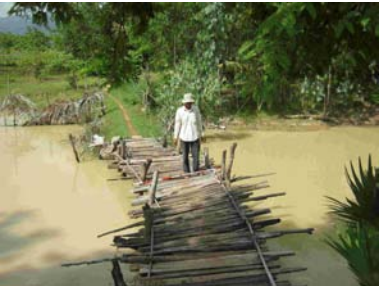
Canal No.: MC33	Kind of structure: Bridge (Private)	Remarks:
Station: 0.00+520	Coordinate< Northing: 1223088 Easting: 448854	Made by wood

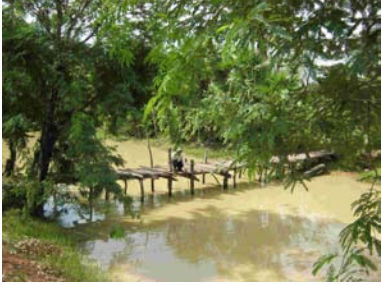
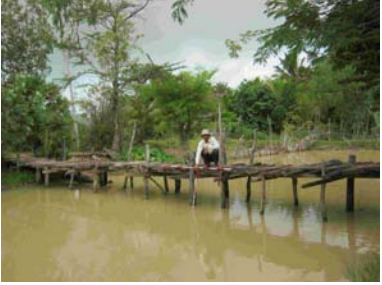
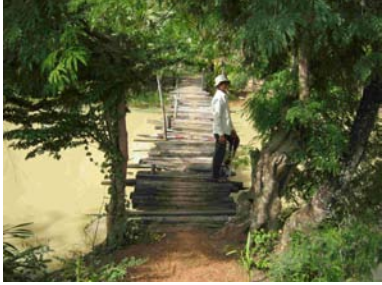
Canal No.: MC33	Kind of structure: Bridge (Private)	Remarks:
Station: 0.00+540	Coordinate< Northing: 1223087 Easting: 448878	Made by wood

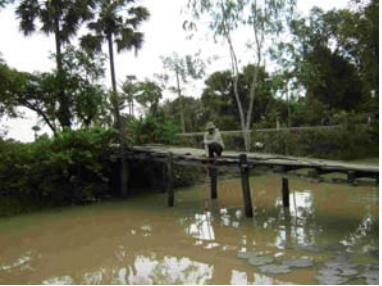
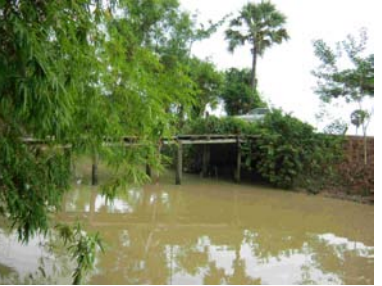
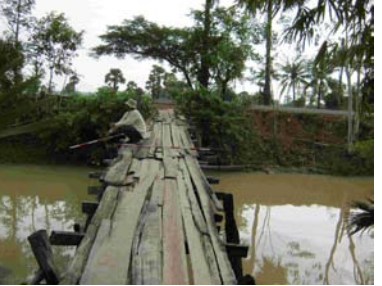
Canal No.: MC33	Kind of structure: Bridge (Private)	Remarks:
Station: 0.00+580	Coordinate< Northing: 1223074 Easting: 448918	Made by wood

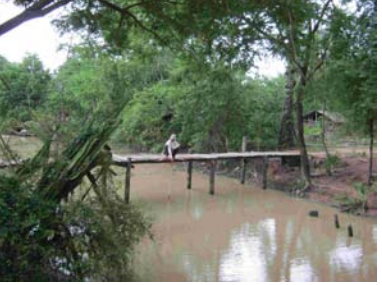
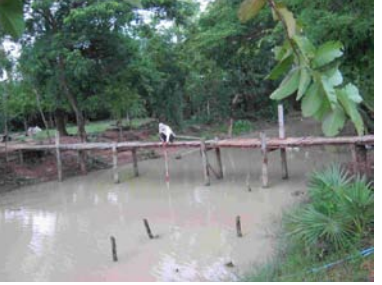
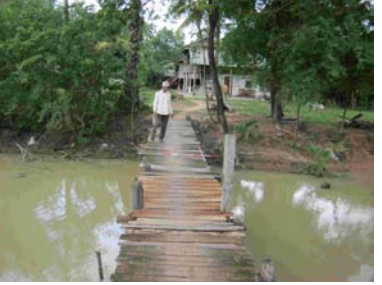
Canal No.: MC33	Kind of structure: Bridge (Private)	Remarks:
Station: 0.00+640	Coordinate< Northing: 1223066 Easting: 448974	Made by wood

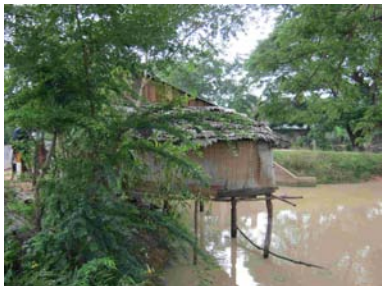
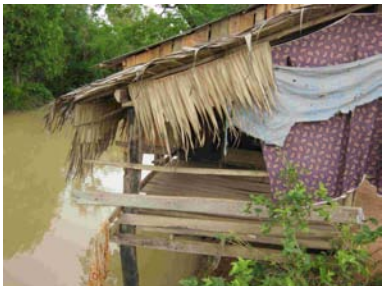
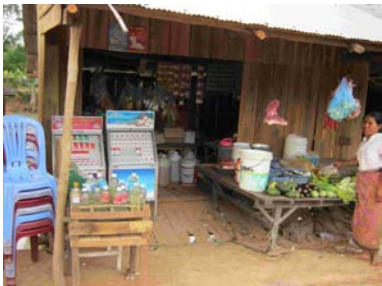
Canal No.: MC33	Kind of structure: House (Double)	Remarks:
Station: 0.00+740	Coordinate< Northing: 1223069 Easting: 449071	Routine survey

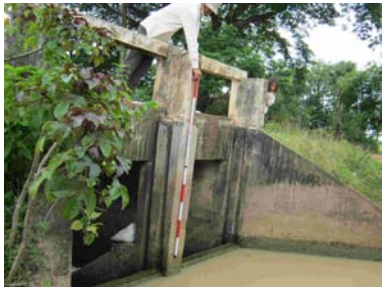
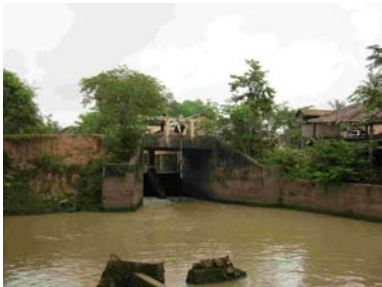
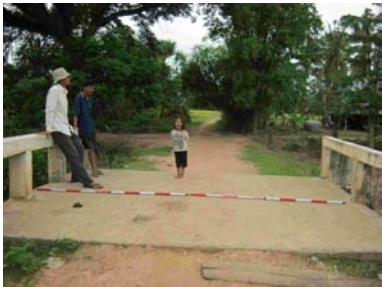
Canal No.: MC33	Kind of structure: Bridge (Private)	Remarks:
Station: 0.00+740	Coordinate< Northing: 1223063 Easting: 449081	There is a groove

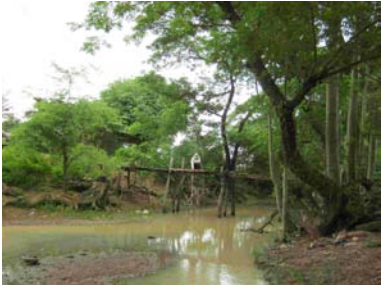
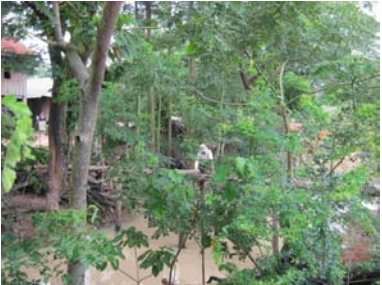
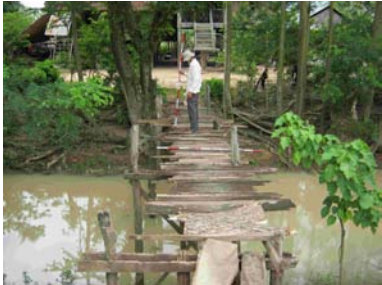
Canal No.: MC33	Kind of structure: Bridge (Private)	Remarks:
Station: 0.00+800	Coordinate< Northing: 1223068 Easting: 449125	Routine survey

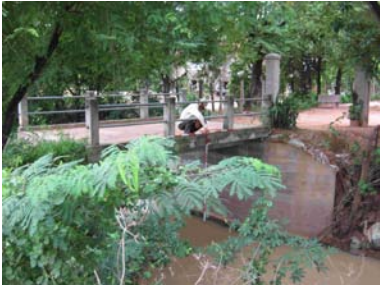
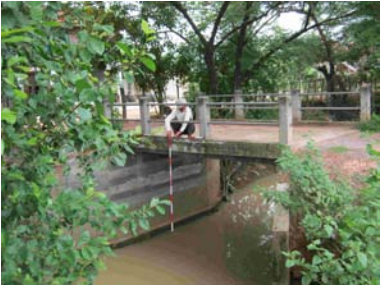
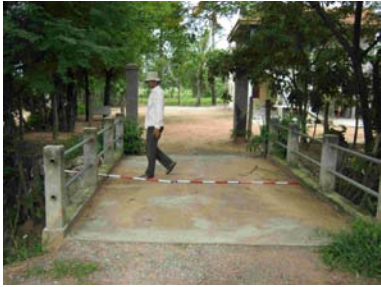
Canal No.: MC33	Kind of structure: Bridge (Private)	Remarks:
Station: 0.00+860	Coordinate< Northing: 1223070 Easting: 449178	Routine survey

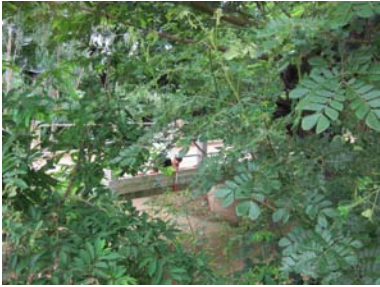
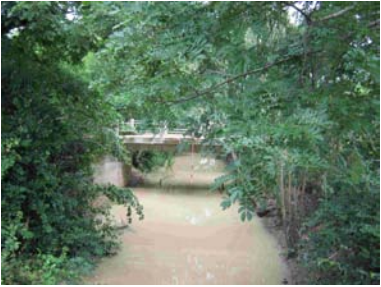
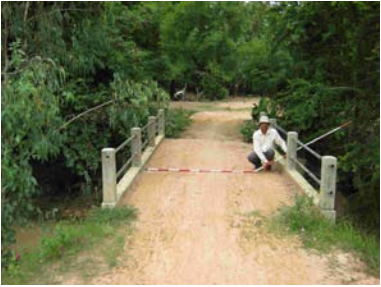
Canal No.: MC33	Kind of structure: Bridge (Private)	Remarks:
Station: 0.00+900	Coordinate< Northing: 1223066 Easting: 449220	Routine survey

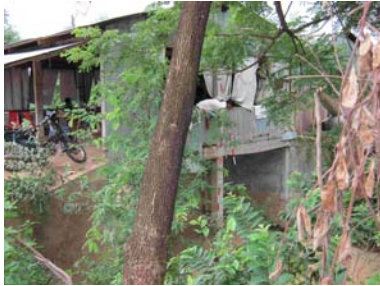
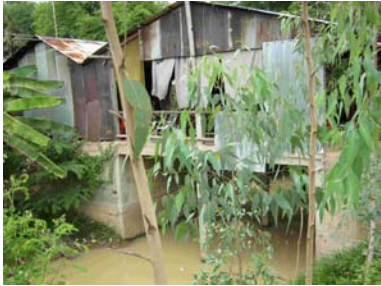
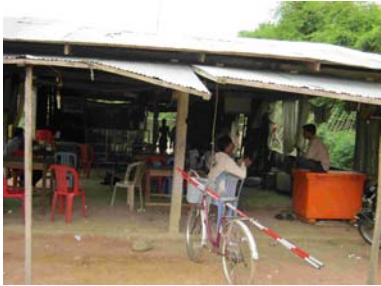
Canal No.: MC33	Kind of structure: Bridge (Private)	Remarks:
Station: 0.00+930	Coordinate< Northing: 1223070 Easting: 449239	There is a house on the bridge

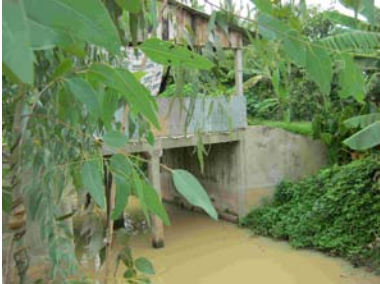
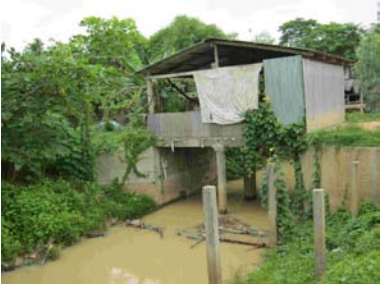
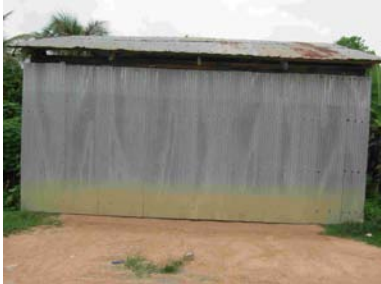
Canal No.: MC33	Kind of structure: Bridge (Private)	Remarks:  There is a house on the bridge
Station: 0.00+960	Coordinate< Northing: 1223069 Easting: 449265

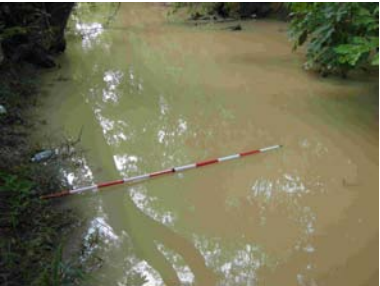
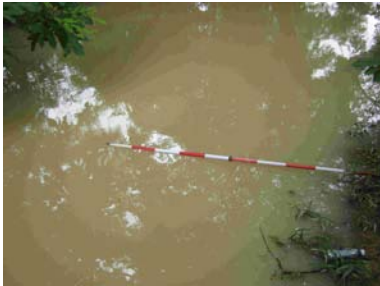
Canal No.: MC33	Kind of structure: Canal	Remarks: Routine survey Length: 1000m
Station: 1.00	Coordinate< Northing: 1223076 Easting: 449313

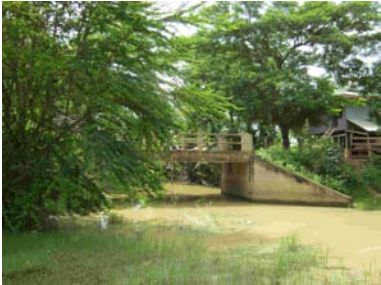
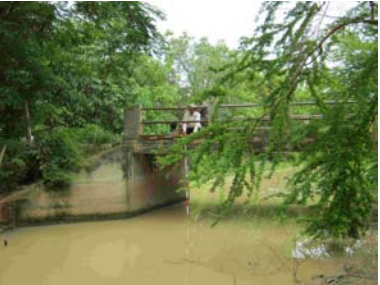
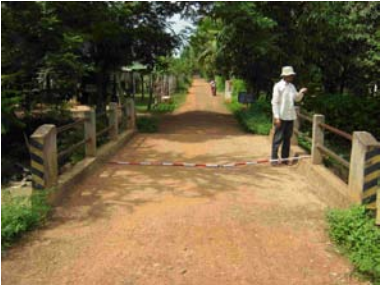
Canal No.: MC33	Kind of structure: Bridge (Private)	Remarks:  Routine survey
Station: 1.00+130	Coordinate< Northing: 1223077 Easting: 449407

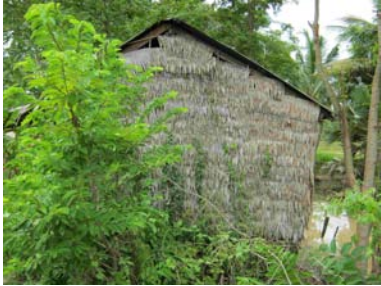
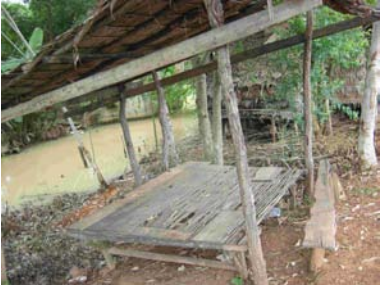
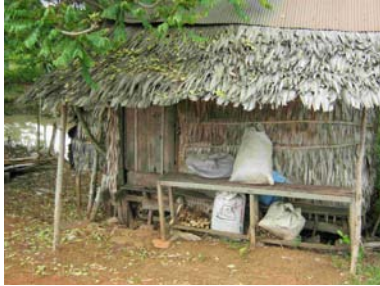
Canal No.: MC33	Kind of structure: House	Remarks:
Station: 1.00+130	Coordinate< Northing: 1223083 Easting: 449416	Routine survey

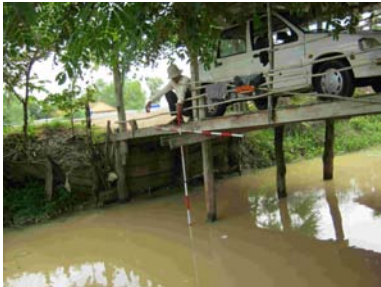
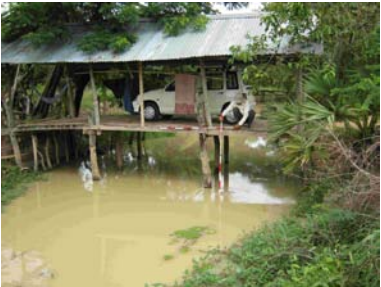
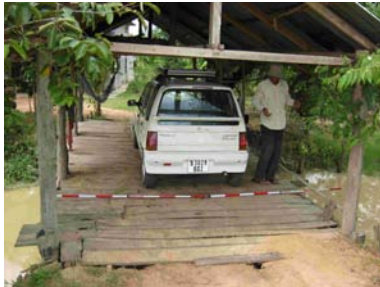
Canal No.: MC33	Kind of structure: Bridge (Private)	Remarks:
Station: 1.00+190	Coordinate< Northing: 1223073 Easting: 449463	Routine survey

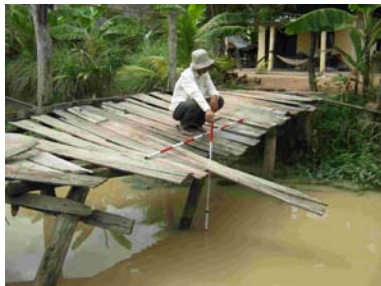
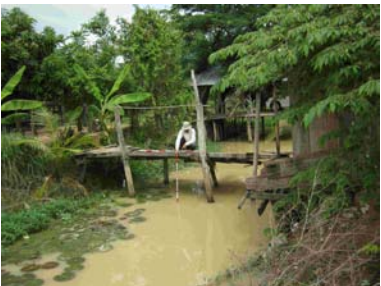
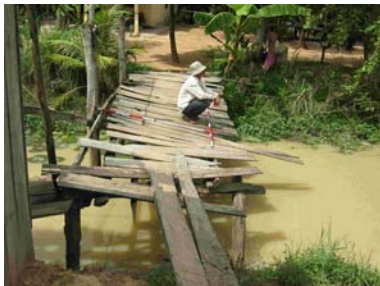
Canal No.: MC33	Kind of structure: Bridge (Private)	Remarks:
Station: 1.00+190	Coordinate< Northing: 1223075 Easting: 449478	There is a house

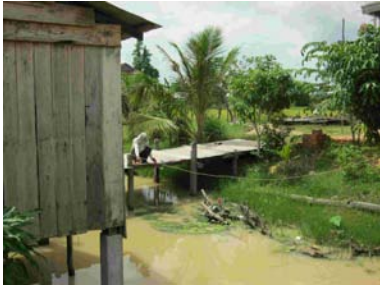
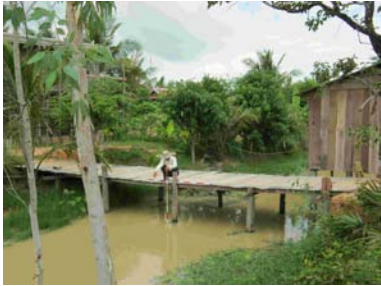
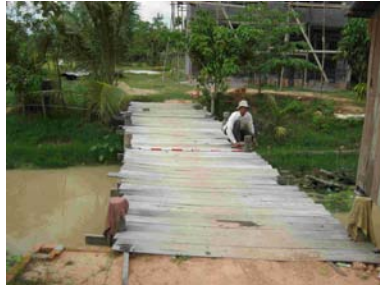
Canal No.: MC33	Kind of structure: Bridge (Private)	Remarks:
Station: 1.00+190	Coordinate< Northing: 1223083 Easting: 449498	There is a house

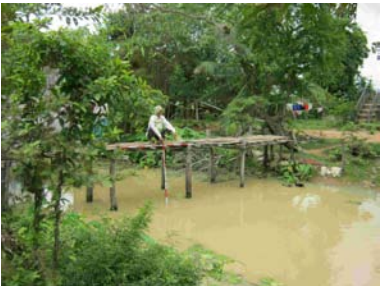
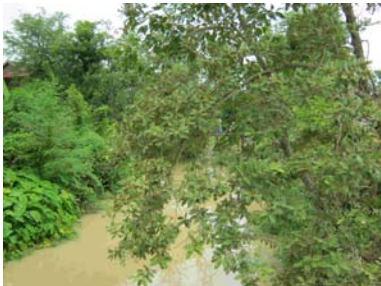
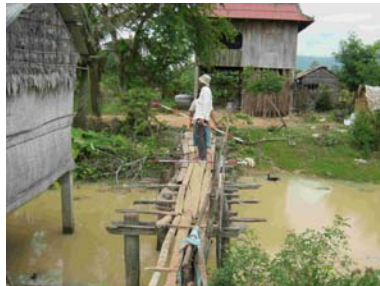
Canal No.: MC33	Kind of structure: Bridge (Private)	Remarks:
Station: 1.00+240	Coordinate< Northing: 1223087 Easting: 449557	There is a house

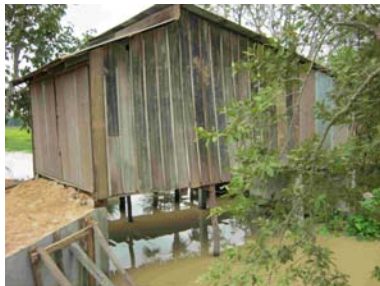
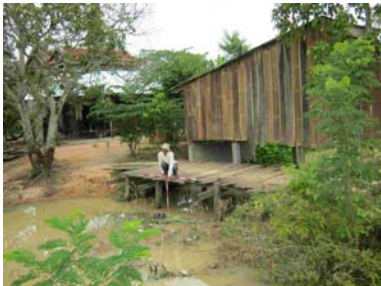
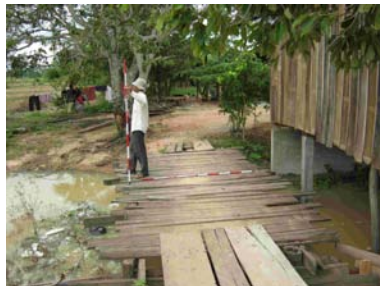
Canal No.: MC33	Kind of structure: Bridge (Private)	Remarks:
Station: 1.00+260	Coordinate< Northing: 1223090 Easting: 449591	There is a house

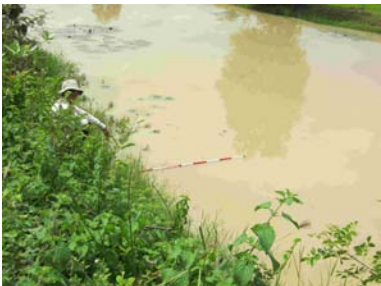
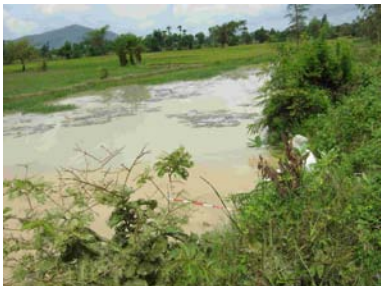
Canal No.: MC33	Kind of structure: Canal	Remarks: Routine survey Length: 1500m
Station: 1.00+500	Coordinate< Northing: 1223100 Easting: 449835	
<div style="display: flex; justify-content: space-around; align-items: center;">

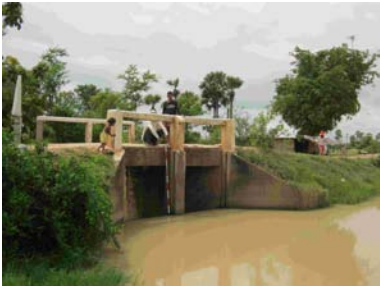
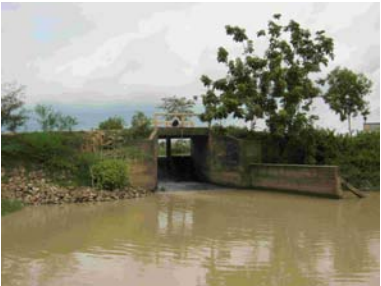
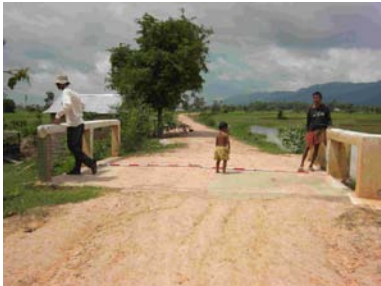
Canal No.: MC33	Kind of structure: Bridge (Ta Mek)	Remarks:  There is a groove
Station: 1.00+660	Coordinate< Northing: 1223096 Easting: 449981	
<div style="display: flex; justify-content: space-around; align-items: center;">

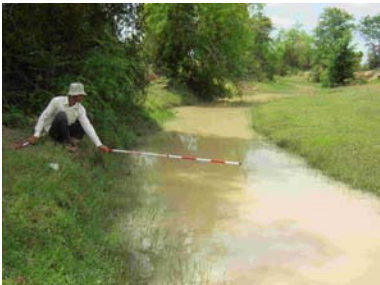
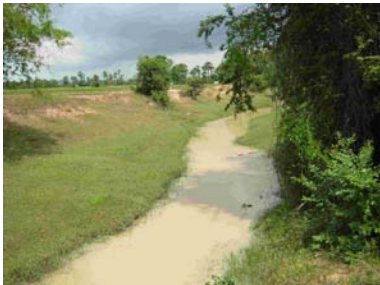
Canal No.: MC33	Kind of structure: Canal	Remarks: Routine survey Length: 2000m
Station: 2.00+20	Coordinate< Northing: 1223101 Easting: 450317	
<div style="display: flex; justify-content: space-around; align-items: center;">

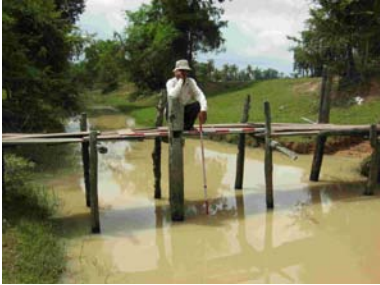
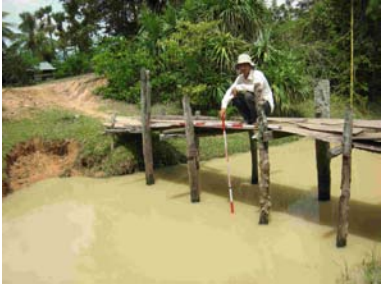
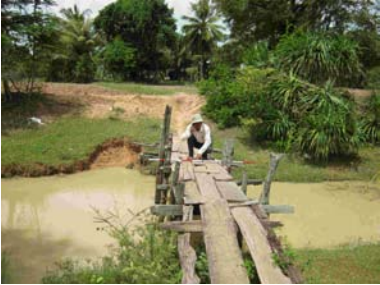
Canal No.: MC33	Kind of structure: Bridge (Private)	Remarks:
Station: 2.00+170	Coordinate< Northing: 1223048 Easting: 450453	Routine survey

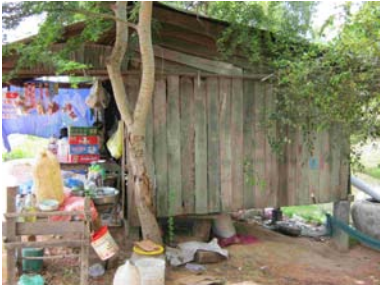
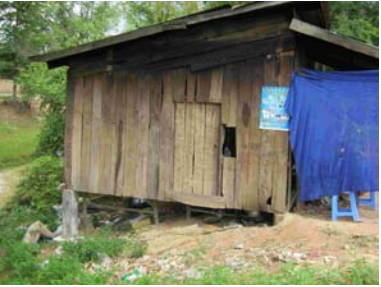
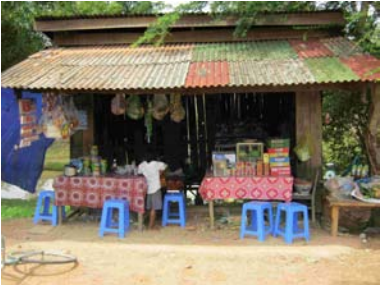
Canal No.: MC33	Kind of structure: House	Remarks:
Station: 2.00+180	Coordinate< Northing: 1223052 Easting: 450465	Routine survey

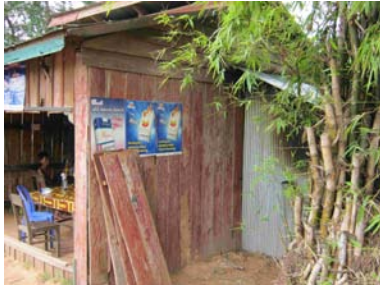
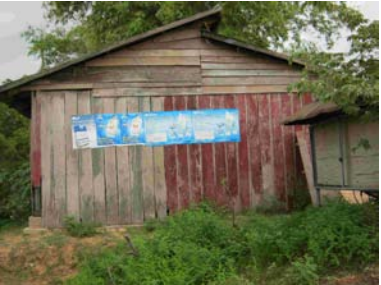
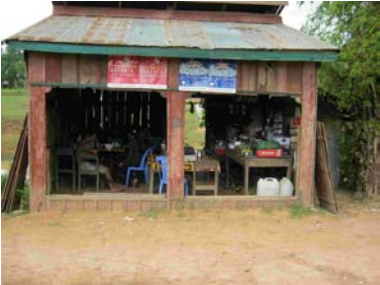
Canal No.: MC33	Kind of structure: House	Remarks:
Station: 2.00+210	Coordinate< Northing: 1223044 Easting: 450500	Routine survey

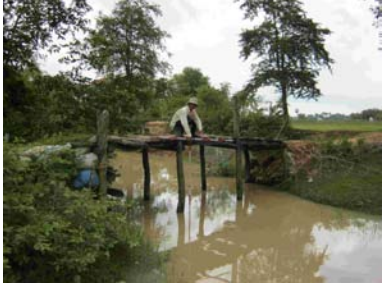
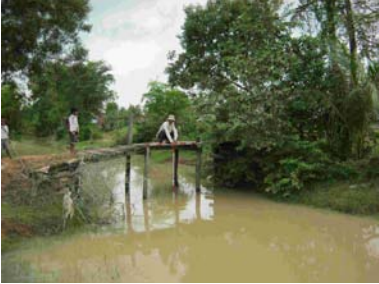
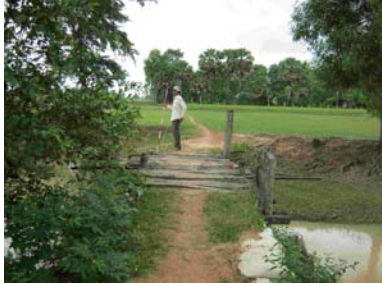
Canal No.: MC33	Kind of structure: Bridge (Private)	Remarks:
Station: 2.00+260	Coordinate< Northing: 1223026 Easting: 450558	There are houses in double

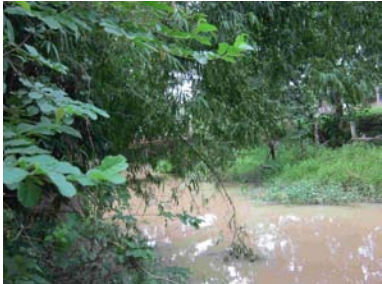
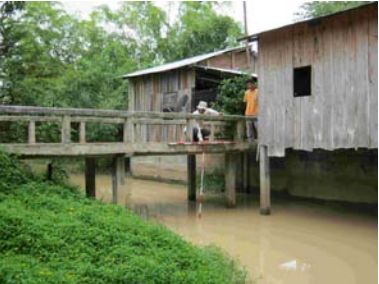
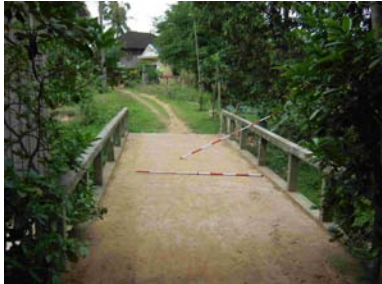
Canal No.: MC33	Kind of structure: Bridge (Private)	Remarks:
Station: 2.00+430	Coordinate< Northing: 1222979 Easting: 450703	There are houses in double

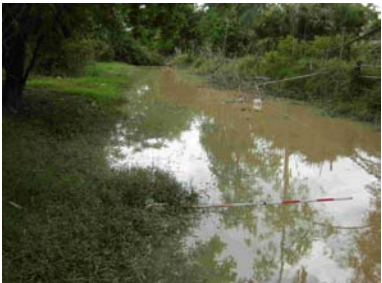
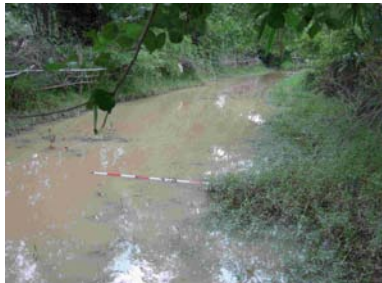
1,260	0449591	1223090	Bridge 17 (Private) & House		Wooden	Private	Storage		Full section of canal used for storage, W= 2 m
1,500	0449835	1223100	Canal Section						Canal section is wide of more than 20 m
1,660	0449981	1223096	Bridge 18 & Groove (Ta Mek)	Regulator-2	Concrete	Public-3	C	C To be replaced	No gate W=4 m 2 m x 1.2 m x 2 nos, flow section is not enough, Old, bridge for Commune road,
2,020	0450317	1223101	Canal Section						Width of water surface is just 3 m,
2,170	0450453	1223048	Bridge 19 (Private)		Wooden	Private			W-1 m
2,180	0450465	1223052	House				Canteen		Within ROW, not on canal
2,210	0450500	1223044	House				Canteen		Within ROW, not on canal
2,260	0450558	1223026	Bridge 20 (Private) & House (Double)		Wooden	Private	Store		Nippa hut nearly broken, W=2 m
2,430	0450703	1222979	Bridge 21 (Private) & House (Double)		Concrete	Private	Store	B	W=2.5m 6 m x 1.8 m
2,530	0450792	1222950	Canal Section						Canal section has been eroded

Canal No.: MC33	Kind of structure: Canal	Remarks: Routine survey Length: 2500m
Station: 2.00+530	Coordinate< Northing: 1222950 Easting: 450792

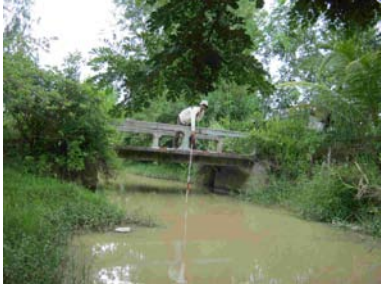
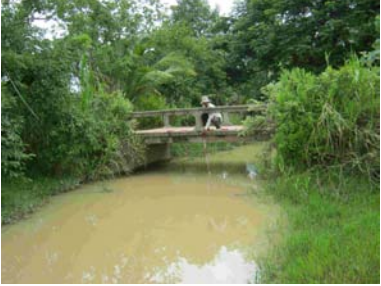
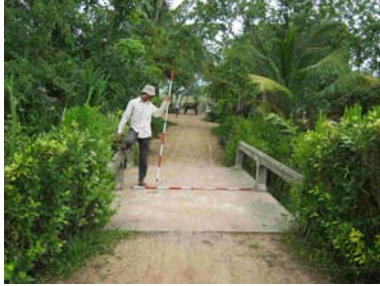
2,610	0450852	1222922	Bridge 22 (Private)		Concrete	Private		B	W=2 m 4.5 m span x 1.8 m high
2,700	0450935	1222904	House		Nippa house	Private	Canteen		Half section of canal used for canteen W=8 m
2,700	0450953	1222896	Bridge 23 (Private) & House (Triple)		Concrete	Private		B	W=2.2 m 4.0 m span x 1.8 m high
2,730	0450995	1222884	House				Shop		Pillars are on canal section
2,730	0451005	1222873	Bridge 24 (Private) & Groove	Regulator-3	Concrete	Public-4	C	C To be replaced	No gate W=4 m 2 m x 1.3 m x 2 nos, flow section is not enough, Old, bridge for Commune road,
2,850	0451096	1222846	Bridge 25 (Private) & House (Double)		Concrete	Private	Shop & Canteen	B	W=2 m 4.5 m x 1.8 m high
3,020	0451202	1222789	Bridge 26 (Private)		Concrete	Private		B	W=2 m 4.5 m x 1.8 m high
3,070	0451247	1222769	House				Storage		Pillars are on canal section
3,090	0451262	1222758	Water Obstruction & Groove (Community)	Regulator-4 for C23				C To be replaced by new one	w/o bridge

Canal No.: MC33	Kind of structure: Bridge (Private)	Remarks:
Station: 2.00+610	Coordinate< <div style="display: flex; flex-direction: column; gap: 5px;"> <span>Northing: 1222922</span> <span>Easting: 450852</span> </div>	Routine survey

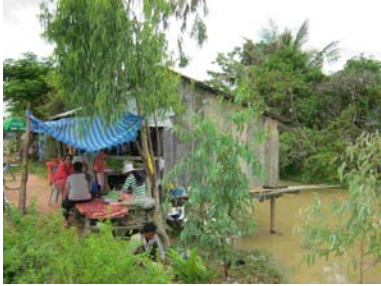
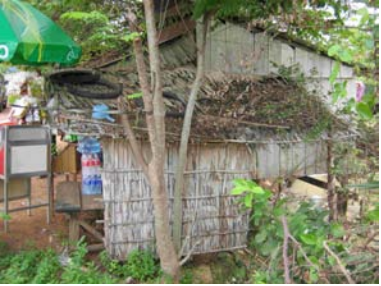
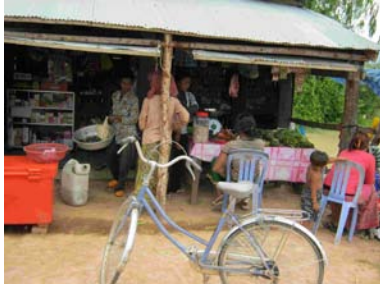
Canal No.: MC33	Kind of structure: House	Remarks:
Station: 2.00+700	Coordinate< <div style="display: flex; flex-direction: column; gap: 5px;"> <span>Northing: 1222904</span> <span>Easting: 450935</span> </div>	Routine survey

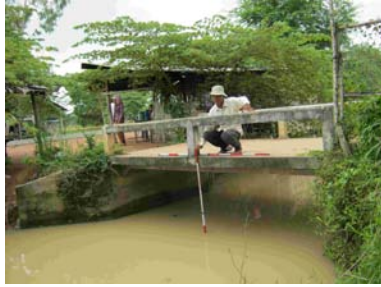
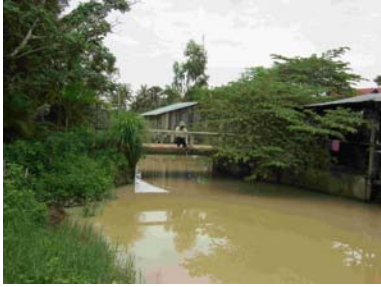
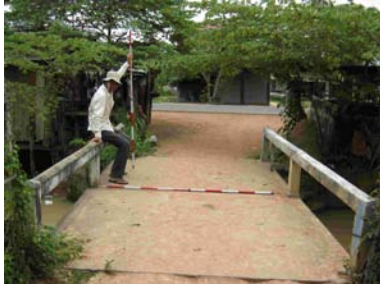
Canal No.: MC33	Kind of structure: Bridge (Private)	Remarks:
Station: 2.00+700	Coordinate< <div style="display: flex; flex-direction: column; gap: 5px;"> <span>Northing: 1222896</span> <span>Easting: 450953</span> </div>	There are houses in triple

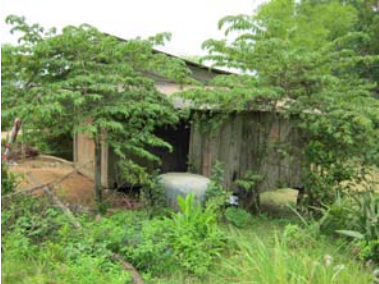
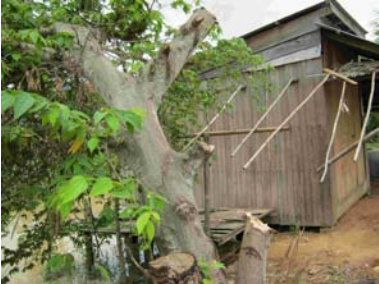
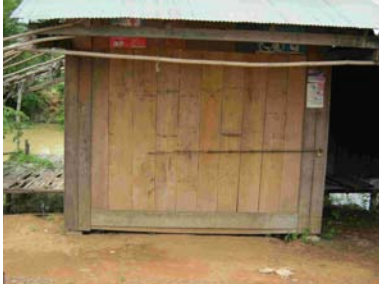
Canal No.: MC33	Kind of structure: House	Remarks:
Station: 2.00+730	Coordinate< Northing: 1222884 Easting: 450995	Routine survey

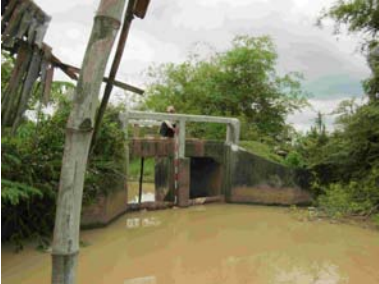
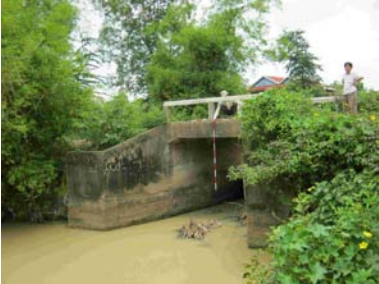
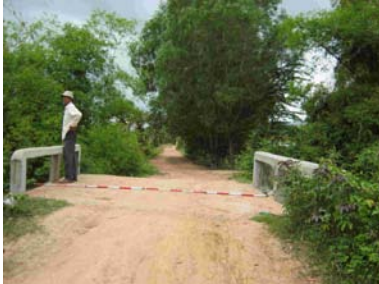
Canal No.: MC33	Kind of structure: Bridge (Private)	Remarks:
Station: 2.00+ 730	Coordinate< Northing: 1222873 Easting: 451005	There is a groove

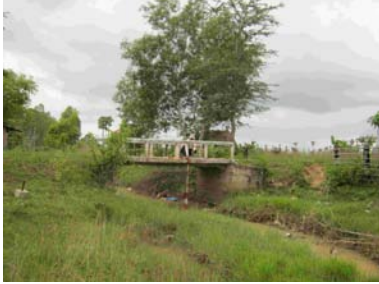
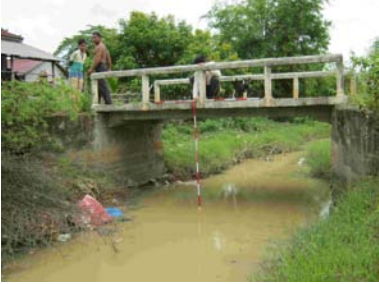
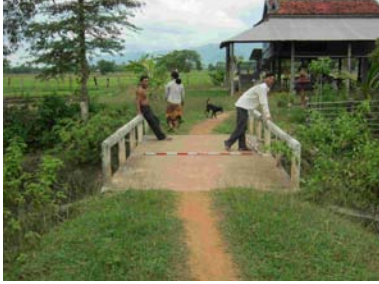
Canal No.: MC33	Kind of structure: Bridge (Private)	Remarks:
Station: 2.00+850	Coordinate< Northing: 1222846 Easting: 451096	There are houses in double

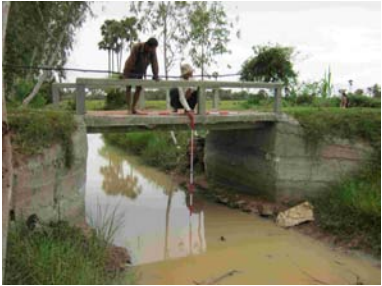
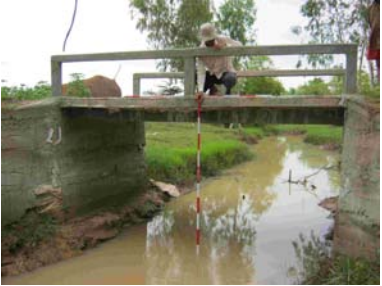
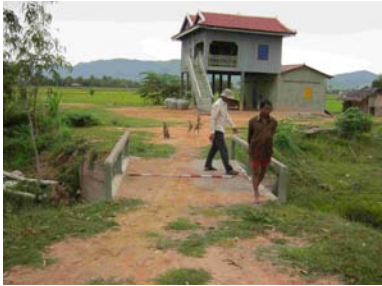
Canal No.: MC33	Kind of structure: Bridge (Private)	Remarks: Routine survey Length: 3000m
Station: 3.00+20	Coordinate< Northing: 1222789 Easting: 451202

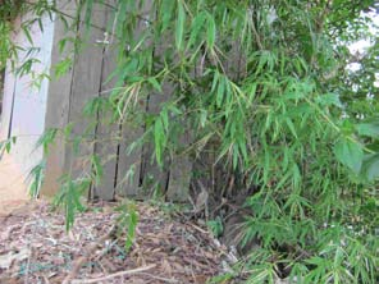
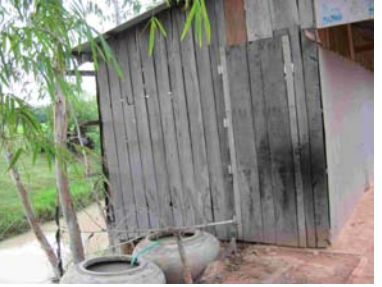
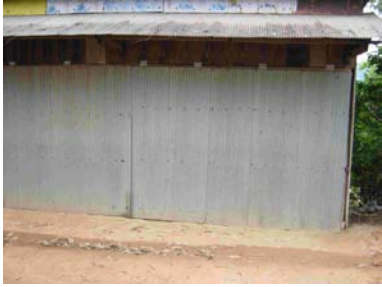
Canal No.: MC33	Kind of structure: House	Remarks: Routine survey
Station: 3.00+70	Coordinate< Northing: 1222769 Easting: 451247

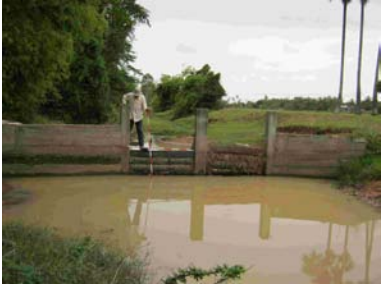
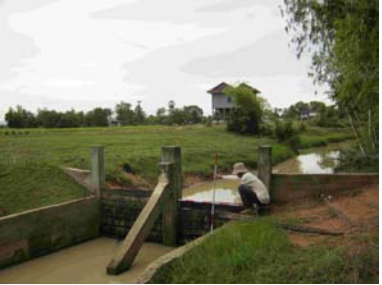
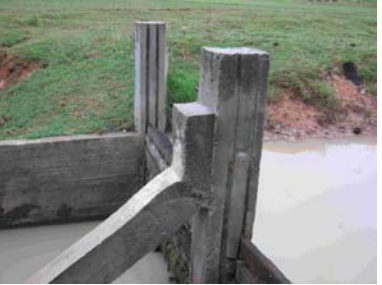
Canal No.: MC33	Kind of structure: Water obstruction (community)	Remarks: There are 3 columns with groove to obstruct the water
Station: 3.00+90	Coordinate< Northing: 1222758 Easting: 451262

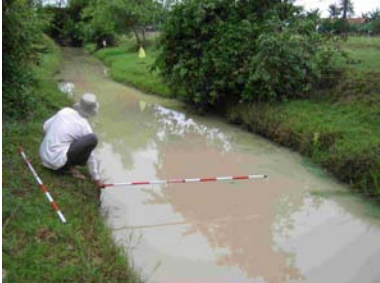
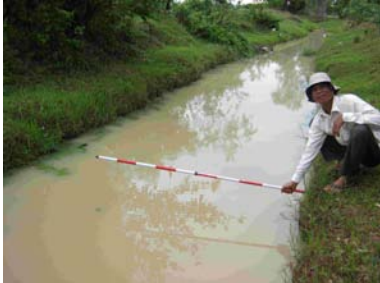
Canal No.: MC33	Kind of structure: Canal	Remarks: Routine survey Length: 3500m
Station: 3.00+530	Coordinate< <div style="display: flex; flex-direction: column; gap: 5px;"> <span>Northing: 1222535</span> <span>Easting: 451590</span> </div>	
<div style="display: flex; justify-content: space-around; align-items: center;">

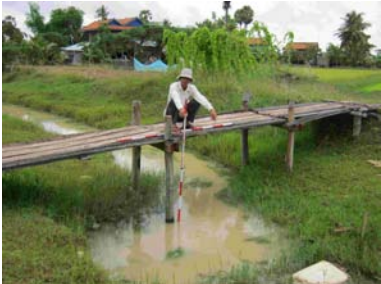
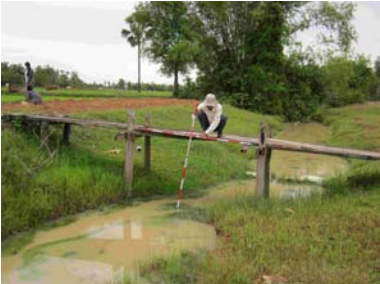
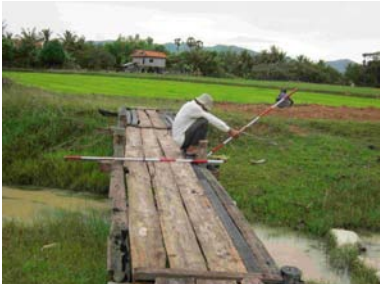
3,530	0451590	1222535	Canal Section						
3,630	0451662	1222484	Bridge 27 (Private Wooden)		Wooden	Private			W=1 m
3,710	0451708	1222445	Bridge 28 (Private Wooden)		Wooden	Private			W=1 m
3,920	0451858	1222344	Bridge 29 (Private Wooden)		Wooden	Private			W=1.5 m
3,950	0451880	1222329	Bridge 30 (Private Wooden)		Wooden	Private			W=1.5 m
4,030	0451949	1222286	House				Temp. hut		Within ROW, not on canal
4,140	0452037	1222215	Bridge 31, Groove & Culvert (Commune)	Regulator-5	Concrete	Public-5	C	C To be replaced	W=4 m 1.8 m x 1.4 m x 2 nos, flow section is not enough, Old, for C-22 without gate,
4,250	0452134	1222150	Bridge 32 (Private)		Wooden	Private			W=0.8 m
4,300	0452164	1222119	Bridge 33 (Private Double)		Concrete	Private		C To be removed	2 nos., W=2.5 m 3 m x 1.6 m (h) x 1 span

Canal No.: MC33	Kind of structure: Wooden Bridge (Private)	Remarks: Routine survey
Station: 3.00+630	Coordinate< <div style="display: flex; flex-direction: column; gap: 5px;"> <span>Northing: 1222484</span> <span>Easting: 451662</span> </div>	
<div style="display: flex; justify-content: space-around; align-items: center;">

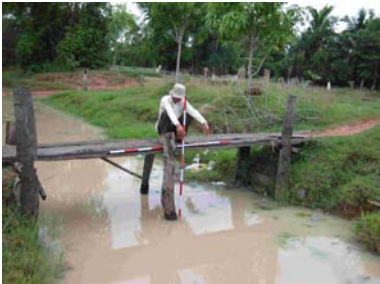
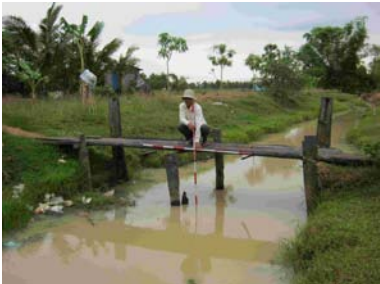
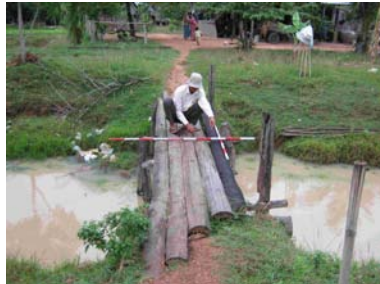
Canal No.: MC33	Kind of structure: Wooden Bridge (Private)	Remarks: Routine survey
Station: 3.00+710	Coordinate< <div style="display: flex; flex-direction: column; gap: 5px;"> <span>Northing: 1222445</span> <span>Easting: 451708</span> </div>	
<div style="display: flex; justify-content: space-around; align-items: center;">

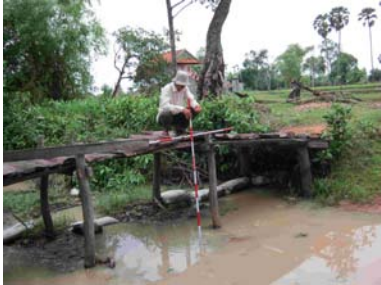
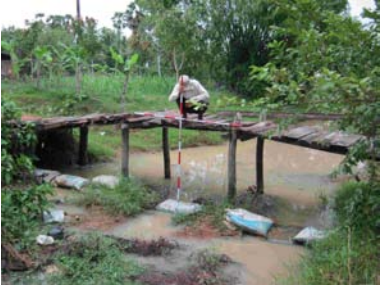
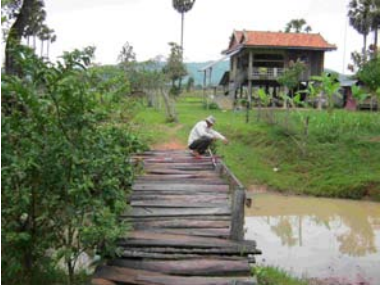
Canal No.: MC33	Kind of structure: Wooden Bridge (Private)	Remarks:
Station: 3.00+920	Coordinate< Northing: 1222344 Easting: 451858	Routine survey

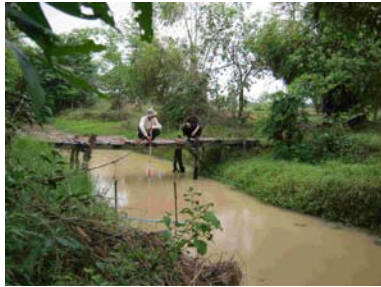
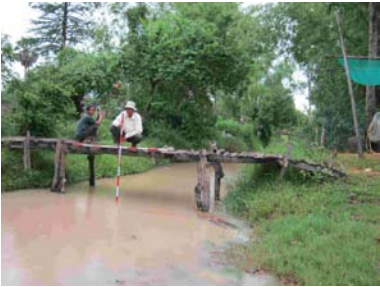
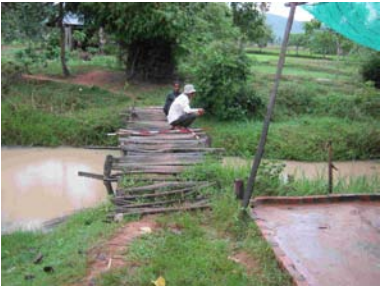
Canal No.: MC33	Kind of structure: House	Remarks:
Station: 4.00+30	Coordinate< Northing: 1222286 Easting: 451949	Routine survey Length: 4000m

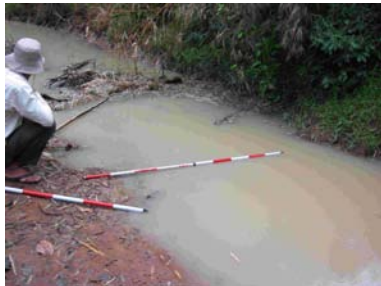
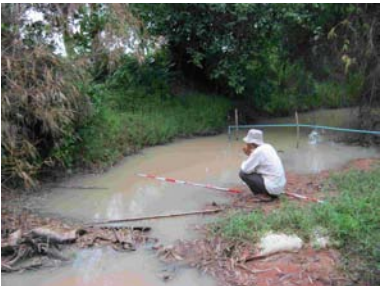
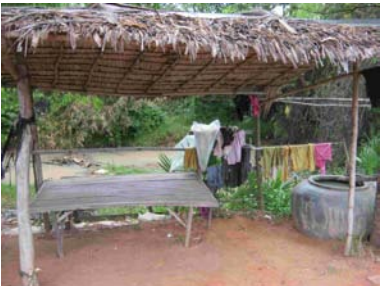
Canal No.: MC33	Kind of structure: Bridge (Commune)	Remarks:
Station: 4.00+140	Coordinate< Northing: 122215 Easting: 452037	There are groove and pipe culvert

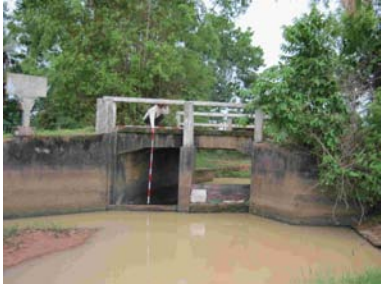
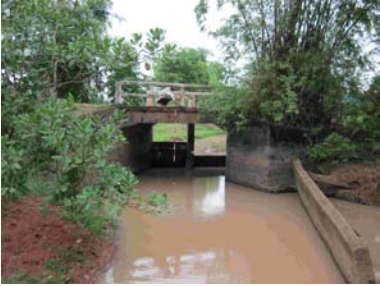
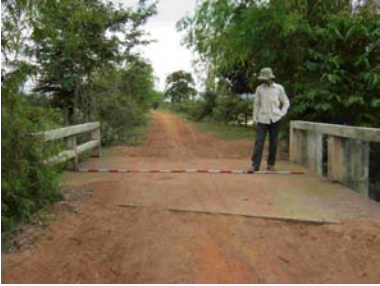
Canal No.: MC33	Kind of structure: Bridge (Private)	Remarks:
Station: 4.00+250	Coordinate< Northing: 1222150 Easting: 452134	Routine survey

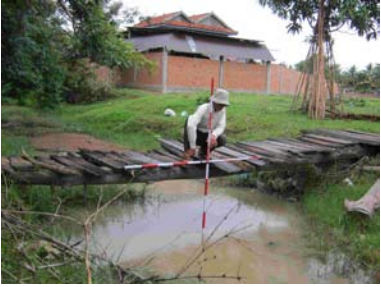
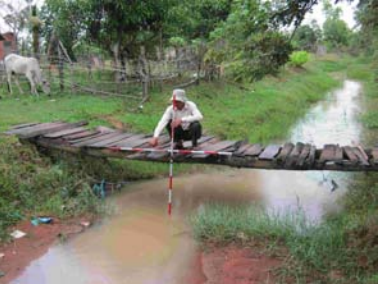
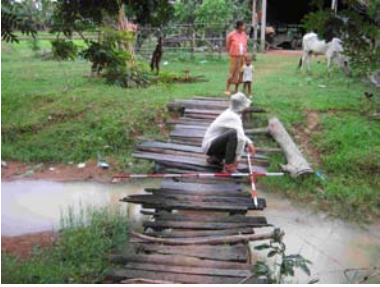
Canal No.: MC33	Kind of structure: Bridge (Private Double)	Remarks:
Station: 4.00+300	Coordinate< Northing: 1222119 Easting: 452164	Routine survey

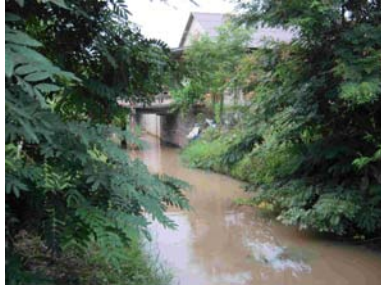
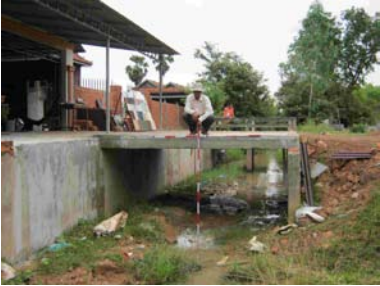
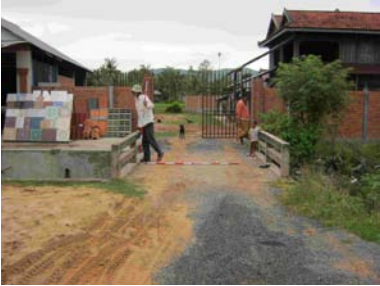
Canal No.: MC33	Kind of structure: Bridge (Private)	Remarks:
Station: 4.00+330	Coordinate< Northing: 1222099 Easting: 452201	There is a house

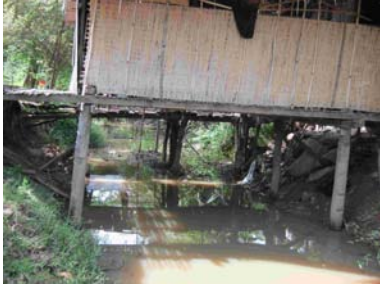
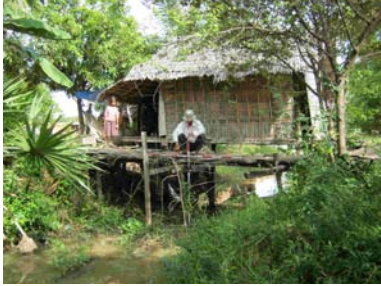
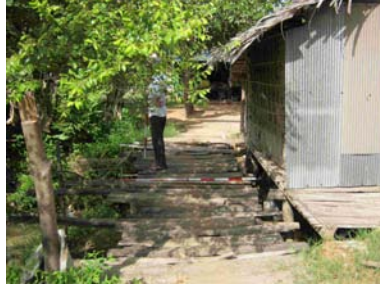
Canal No.: MC33	Kind of structure: House	Remarks:
Station: 4.00+340	Coordinate< Northing: 1222089 Easting: 452219	Routine survey

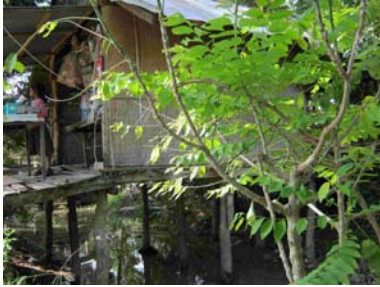
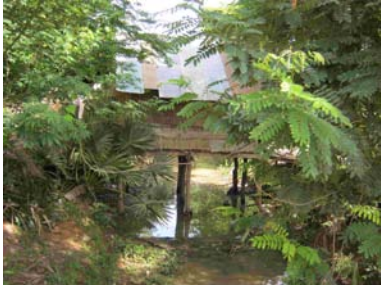
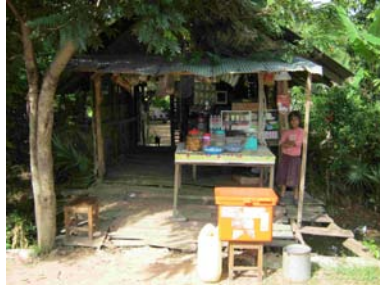
Canal No.: MC33	Kind of structure: Bridge (Private)	Remarks:
Station: 4.00+350	Coordinate< Northing: 1222076 Easting: 452230	There is a house

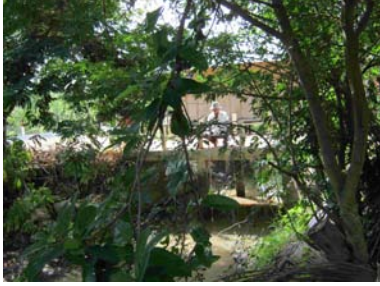
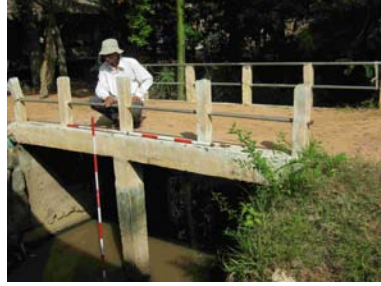
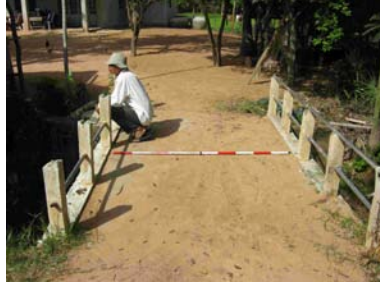
Canal No.: MC33	Kind of structure: Bridge (Private)	Remarks:
Station: 4.00+420	Coordinate< Northing: 1222041 Easting: 452271	Routine survey

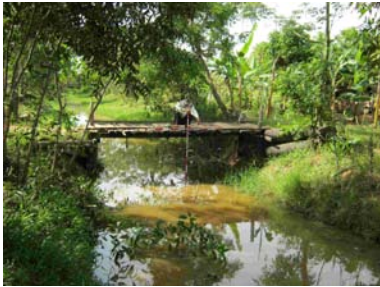
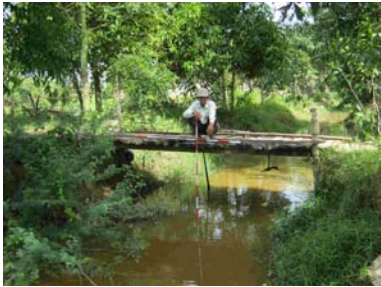
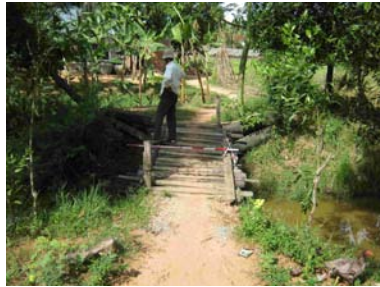
Canal No.: MC33	Kind of structure: Bridge (Private)	Remarks:
Station: 4.00+510	Coordinate< Northing: 1221998 Easting: 452330	There are houses in triple
