*Results of Inventory Survey for  
Proposed Rehabilitation Works in  
Roleang Chrey Headworks Rehabilitation Sub-project*

PREPARATORY SURVEY FOR IRRIGATION AND DRAINAGE  
SYSTEM REHABILITATION AND IMPROVEMENT PROJECT

Japan International Cooperation Agency

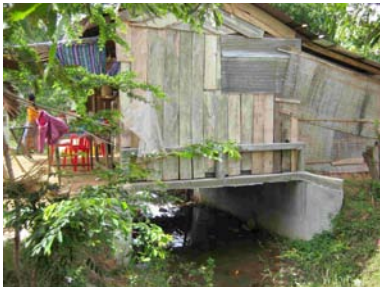
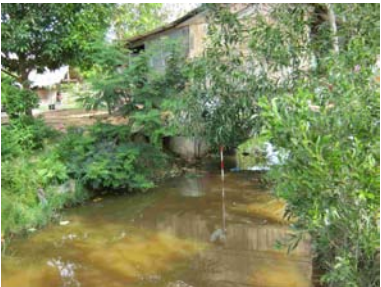
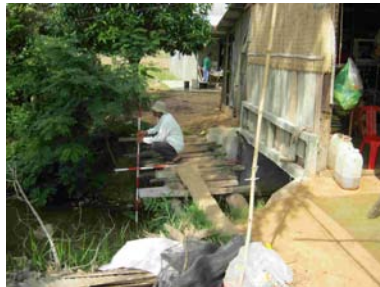
Canal No.: MC33	Kind of structure: Canal	Remarks:
Station: 4.00+530	Coordinate< Northing: 1221979 Easting: 452353	Routine survey Length: 4500m

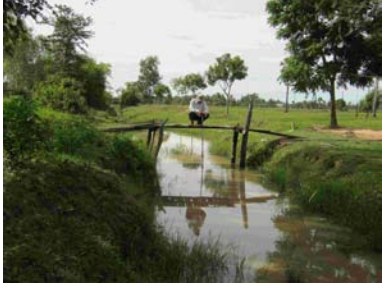
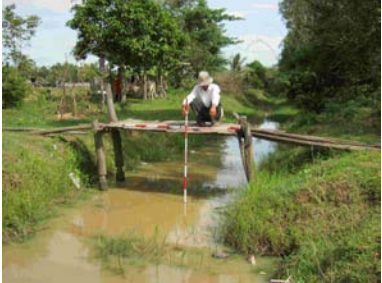
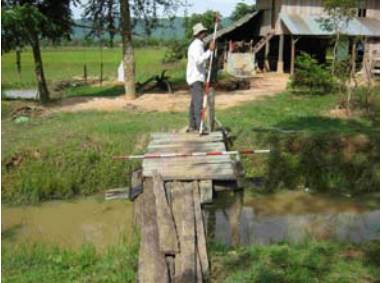
Canal No.: MC33	Kind of structure: Bridge (Private)	Remarks:
Station: 5.00+30	Coordinate< Northing: 1221688 Easting: 452669	Routine survey Length: 5000m

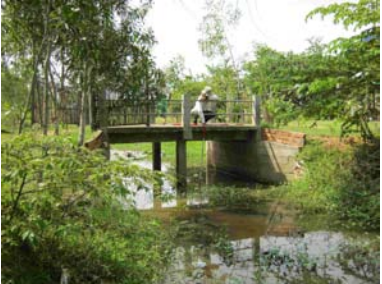
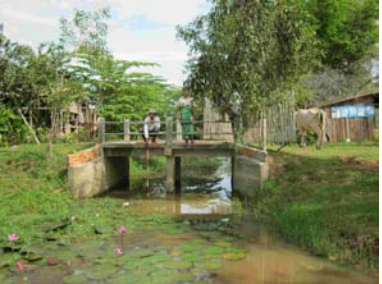
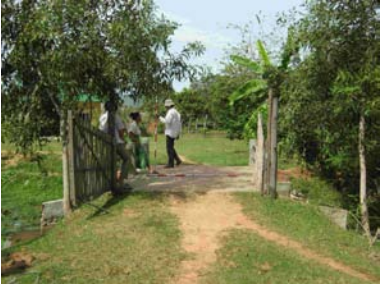
Canal No.: MC33	Kind of structure: Bridge (Private)	Remarks:
Station: 5.00+90	Coordinate< Northing: 1221637 Easting: 452712	Routine survey

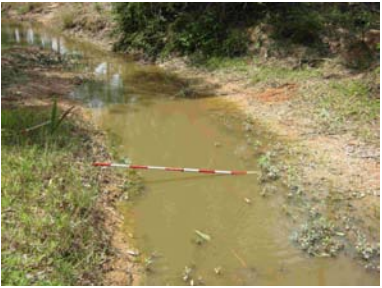
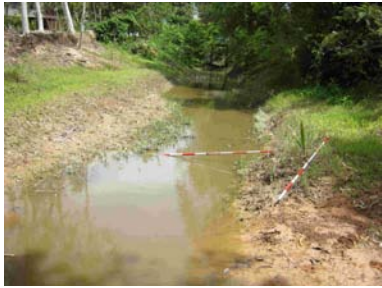
Canal No.: MC33	Kind of structure: Canal	Remarks:
Station: 7.00+80	Coordinate< Northing: 1220496 Easting: 454185	Routine survey

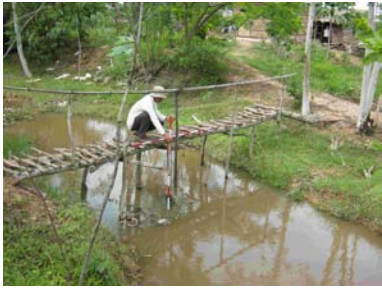
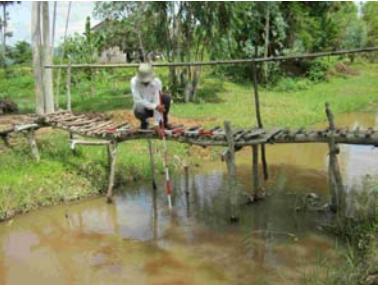
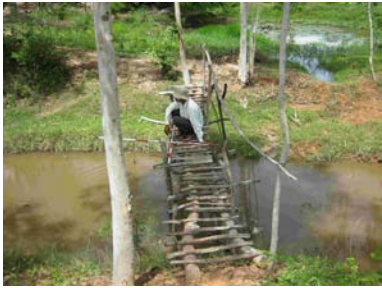
Canal No.: MC33	Kind of structure: Bridge (Private)	Remarks:
Station: 7.00+390	Coordinate< Northing: 1220347 Easting: 454429	Routine survey

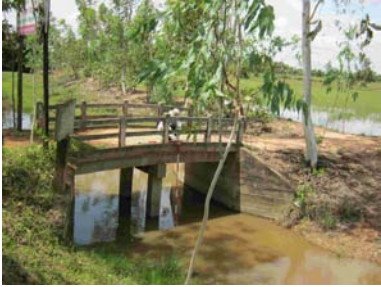
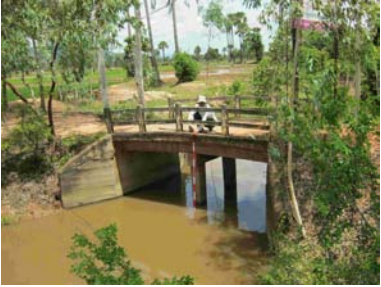
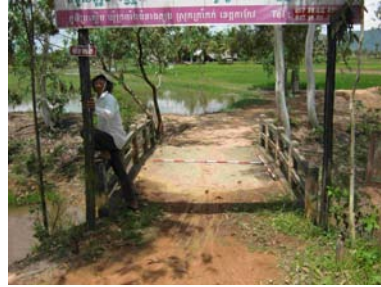
Canal No.: MC33	Kind of structure: Bridge (Private)	Remarks:
Station: 7.00+510	Coordinate< <div style="display: flex; flex-direction: column; margin-left: 10px;"> <span>Northing: 1220272</span> <span>Easting: 454520</span> </div>	Routine survey
<div style="display: flex; justify-content: space-around; align-items: center;">

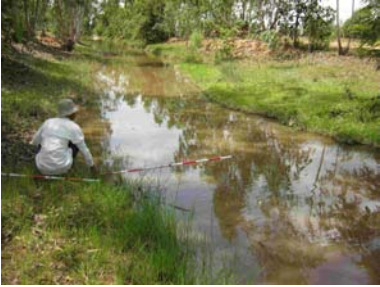
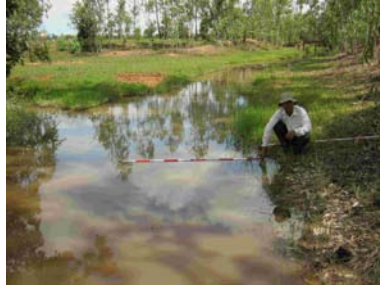
Canal No.: MC33	Kind of structure: Canal	Remarks:
Station: 7.00+580	Coordinate< <div style="display: flex; flex-direction: column; margin-left: 10px;"> <span>Northing: 1220220</span> <span>Easting: 454576</span> </div>	Routine survey Length: 7500m
<div style="display: flex; justify-content: space-around; align-items: center;">

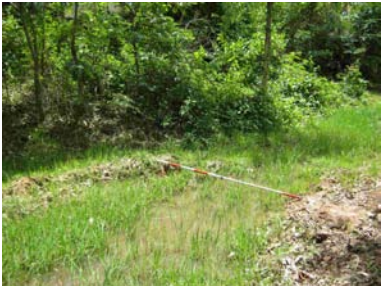
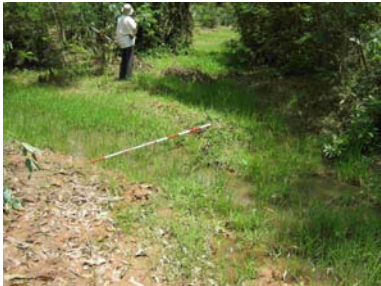
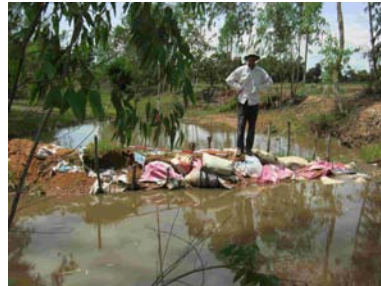
Canal No.: MC33	Kind of structure: Canal	Remarks:
Station: 7.00+730(EP)	Coordinate< <div style="display: flex; flex-direction: column; margin-left: 10px;"> <span>Northing: 1220129</span> <span>Easting: 454696</span> </div>	Routine survey
<div style="display: flex; justify-content: space-around; align-items: center;">

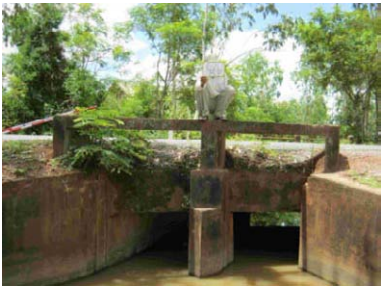
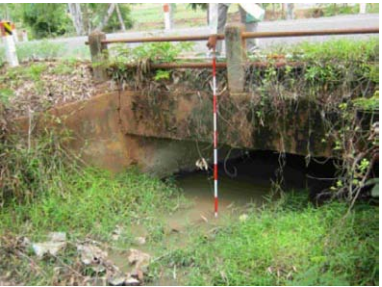
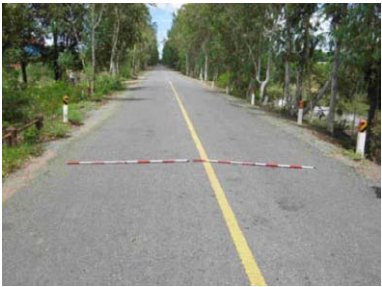
Canal No.: C20	Kind of structure(s): Bridge	Remarks: - Under National Road 130A - There is a Groove
Station: 0.00(B.P.)	Coordinate< Northing: 1220130 Easting: 0454695

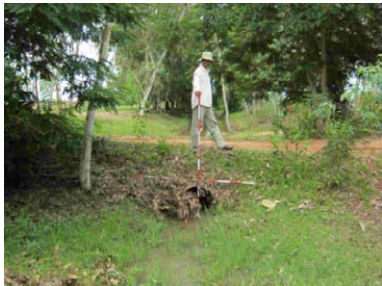
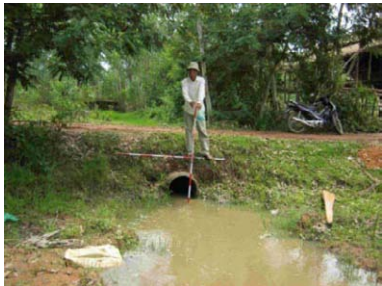
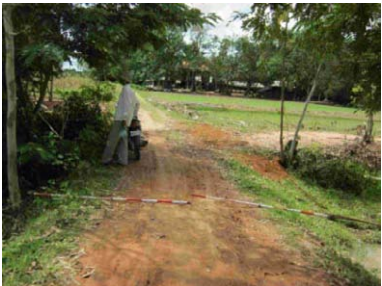
Canal No.: C20	Kind of structure(s): Pipe culvert	Remarks: Routine survey Under village road
Station: 0.00+70	Coordinate< Northing: 1220137 Easting: 0454736

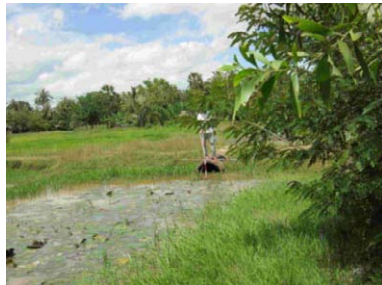
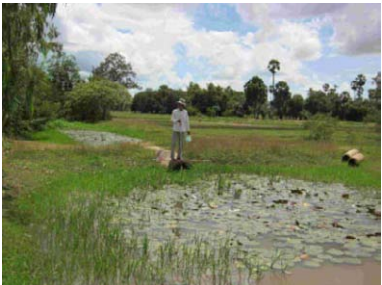
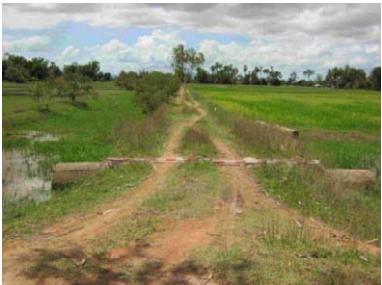
Canal No.: C20	Kind of structure(s): Pipe culvert	Remarks: Routine survey Under cart road
Station: 0.00+360	Coordinate< Northing: 1220136 Easting: 454996

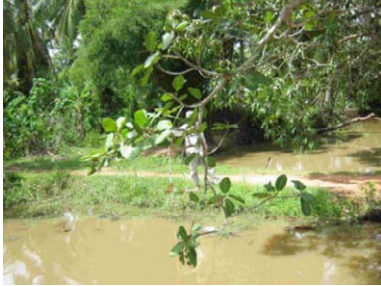
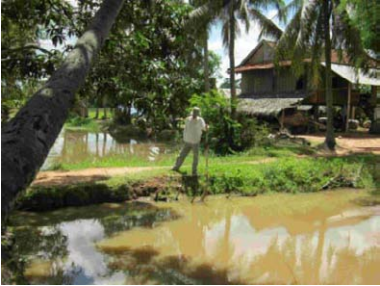
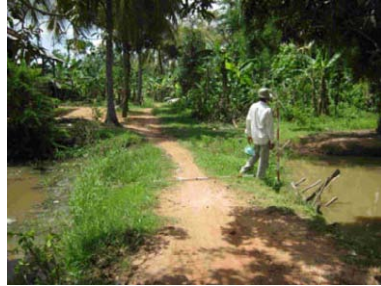
Canal No.: C20	Kind of structure(s): Pipe culvert	Remarks:
Station: 0.00+460	Coordinate< <div style="display: flex; flex-direction: column; gap: 5px;"> <span>Northing: 1220131</span> <span>Easting: 0455100</span> </div>	Routine survey

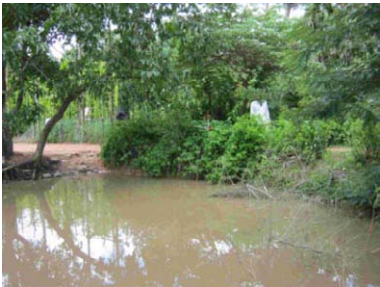
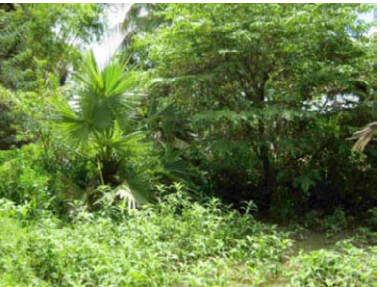
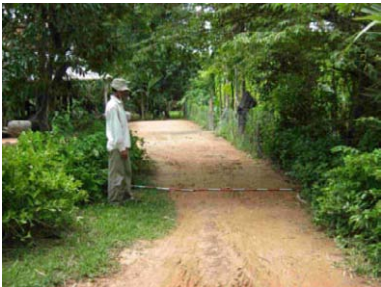
Canal No.: C20	Kind of structure(s): Pipe culvert	Remarks:
Station: 0.00+500	Coordinate< <div style="display: flex; flex-direction: column; gap: 5px;"> <span>Northing: 1220135</span> <span>Easting: 0455133</span> </div>	Routine survey Length: 500m

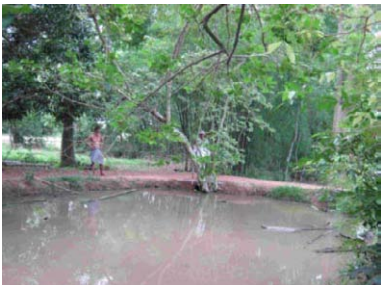
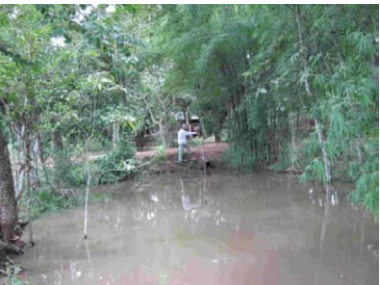
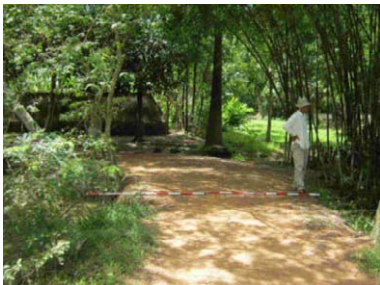
Canal No.: C20	Kind of structure(s): Pipe culvert (Double)	Remarks:
Station: 0.00+570	Coordinate< <div style="display: flex; flex-direction: column; gap: 5px;"> <span>Northing: 1220134</span> <span>Easting: 0455209</span> </div>	Routine survey

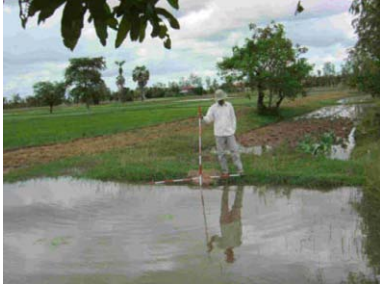
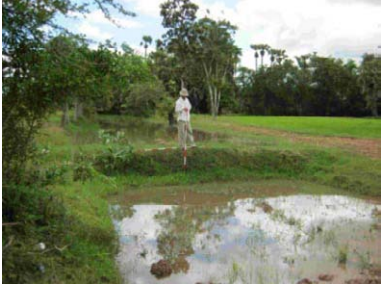
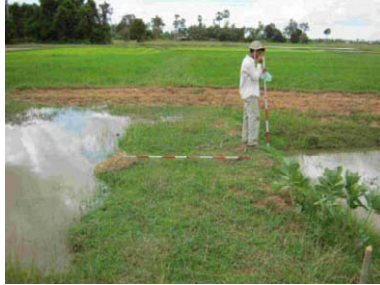
Canal No.: C20	Kind of structure(s): Pipe culvert	Remarks:
Station: 0.00+680	Coordinate< <div style="display: flex; flex-direction: column; gap: 5px;"> <span>Northing: 1220128</span> <span>Easting: 0455323</span> </div>	Routine survey

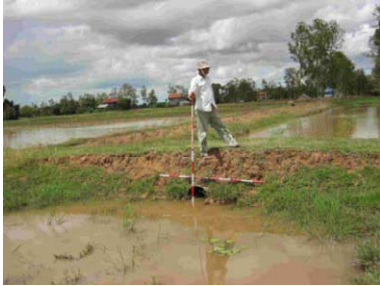
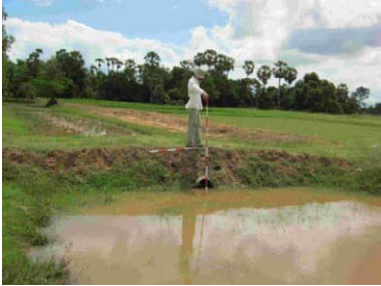
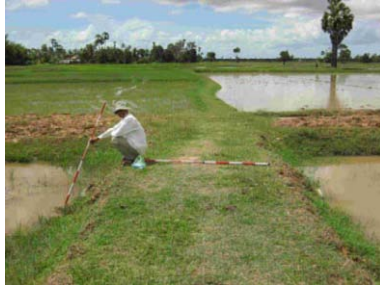
Canal No.: C20	Kind of structure(s): Pipe culvert	Remarks:
Station: 0.00+760	Coordinate< <div style="display: flex; flex-direction: column; gap: 5px;"> <span>Northing: 1220125</span> <span>Easting: 0455408</span> </div>	Routine survey

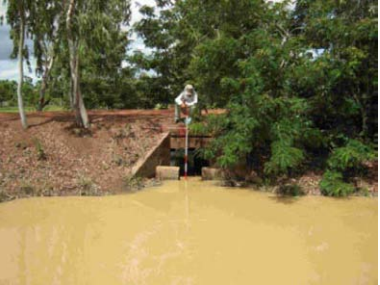
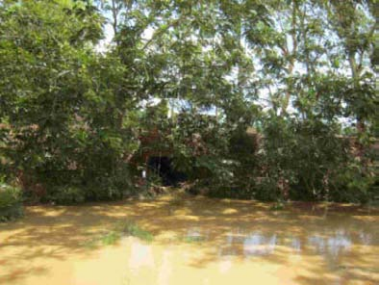
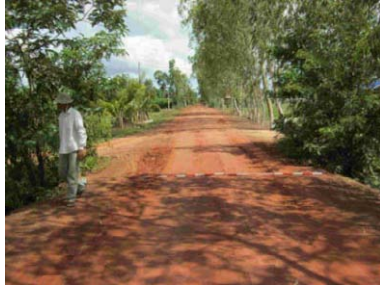
Canal No.: C20	Kind of structure(s): Bridge (Commune)	Remarks:
Station: 1.00	Coordinate< <div style="display: flex; flex-direction: column; gap: 5px;"> <span>Northing: 1220117</span> <span>Easting: 0455642</span> </div>	There is a pipe culvert under the bridge Length: 1000m

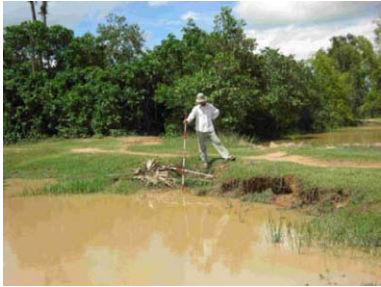
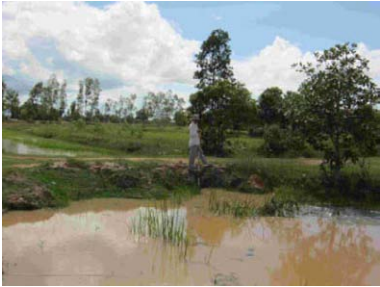
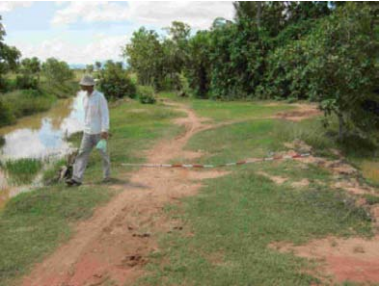
Canal No.: C20	Kind of structure(s): Pipe culvert	Remarks:
Station: 1.00+160	Coordinate< <div style="display: flex; flex-direction: column; margin-left: 10px;"> <span>Northing: 1220124</span> <span>Easting: 0455788</span> </div>	Routine survey

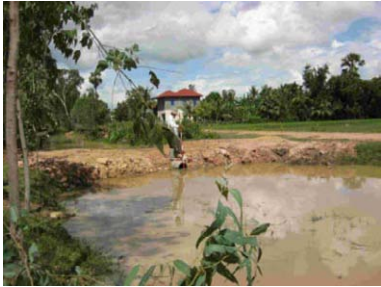
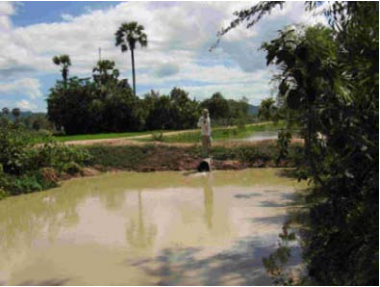
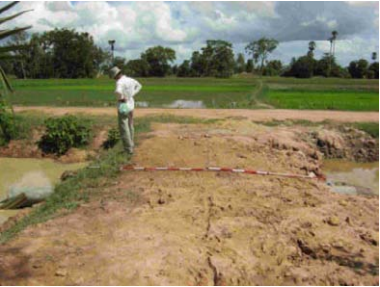
Canal No.: C20	Kind of structure(s): Pipe culvert	Remarks:
Station: 1.00+270	Coordinate< <div style="display: flex; flex-direction: column; margin-left: 10px;"> <span>Northing: 1220119</span> <span>Easting: 0455902</span> </div>	Routine survey

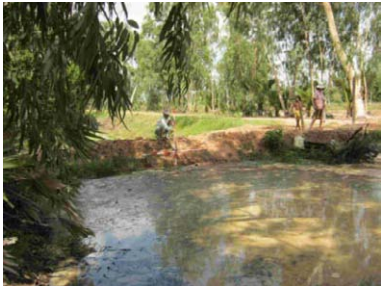
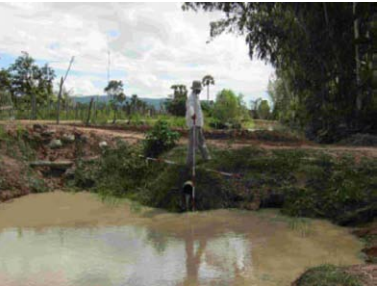
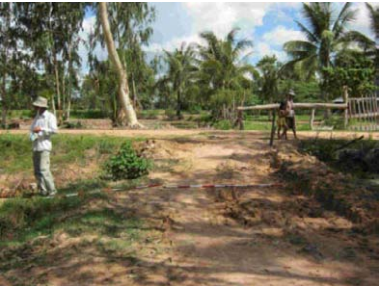
Canal No.: C20	Kind of structure(s): Pipe culvert	Remarks:
Station: 1.00+400	Coordinate< <div style="display: flex; flex-direction: column; margin-left: 10px;"> <span>Northing: 1220119</span> <span>Easting: 0456009</span> </div>	Routine survey

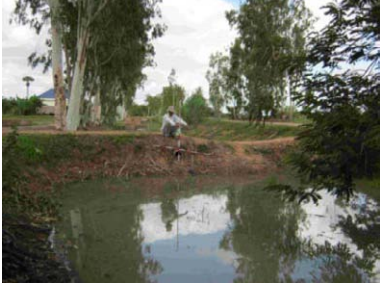
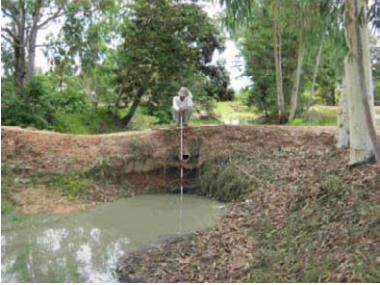
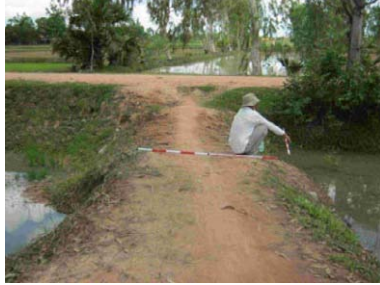
Canal No.: C20	Kind of structure(s): Pipe culvert	Remarks:
Station: 1.00+480	Coordinate< <div style="display: flex; flex-direction: column; margin-left: 10px;"> <span>Northing: 1220117</span> <span>Easting: 0456074</span> </div>	Routine survey
<div style="display: flex; justify-content: space-around;">

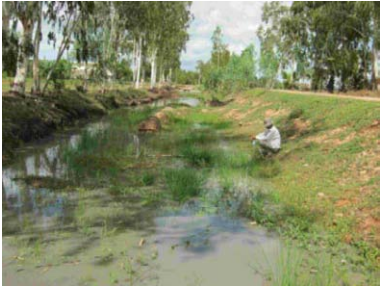
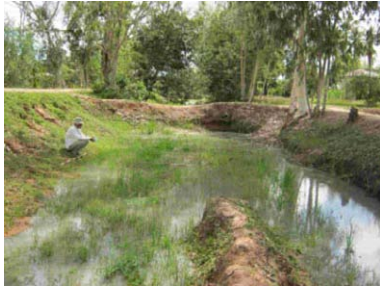
Canal No.: C20	Kind of structure(s): Canal	Remarks:
Station: 1.00+500	Coordinate< <div style="display: flex; flex-direction: column; margin-left: 10px;"> <span>Northing: 1220116</span> <span>Easting: 0456085</span> </div>	Routine survey Length: 1500m
<div style="display: flex; justify-content: space-around;">

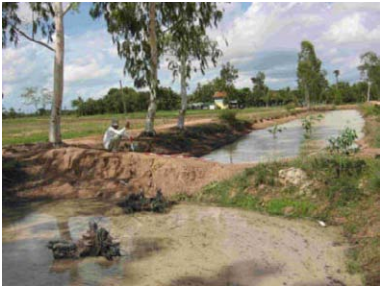
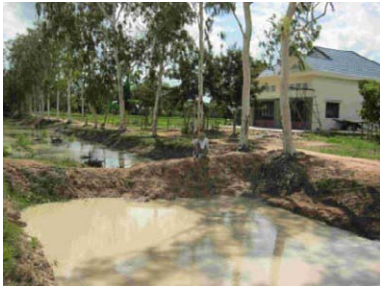
Canal No.: C20	Kind of structure(s): Embankment	Remarks:
Station: 1.00+610	Coordinate< <div style="display: flex; flex-direction: column; margin-left: 10px;"> <span>Northing: 1220116</span> <span>Easting: 0456198</span> </div>	Routine survey
<div style="display: flex; justify-content: space-around;">

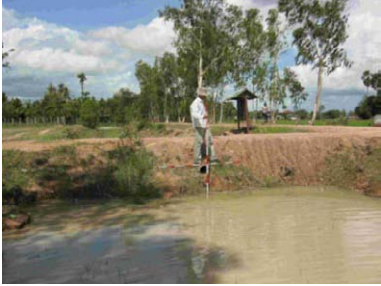
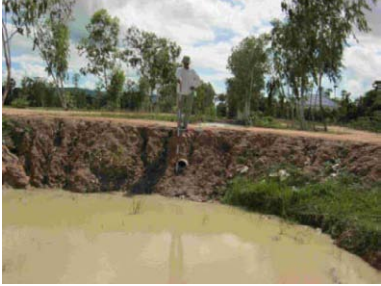
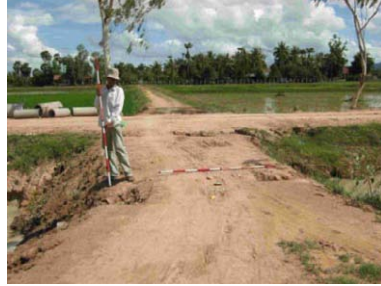
Canal No.: C20	Kind of structure(s): Pipe culvert	Remarks:
Station: 1.00+700	Coordinate< Northing: 1220116 Easting: 0456284	Routine survey

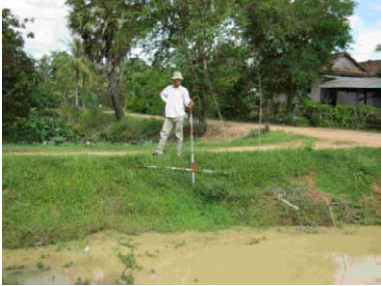
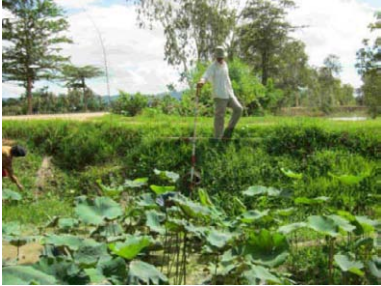
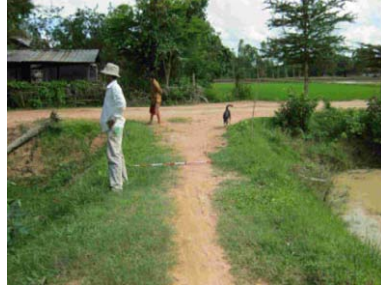
Canal No.: C20	Kind of structure(s): Pipe culvert	Remarks:
Station: 1.00+850	Coordinate< Northing: 1220114 Easting: 0456415	Routine survey

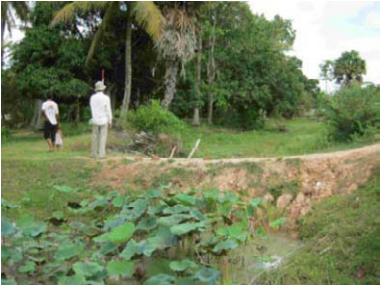
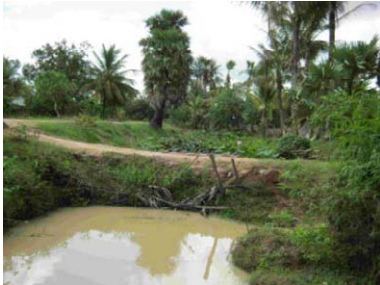
Canal No.: C20	Kind of structure(s): Embankment	Remarks:
Station: 1.00+950	Coordinate< Northing: 1220078 Easting: 0456497	Routine survey

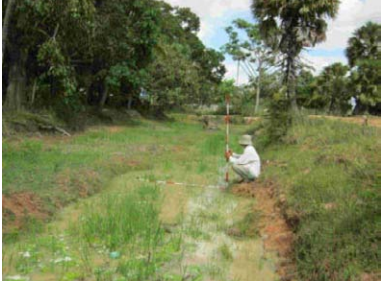
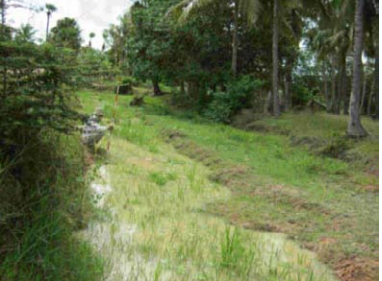
Canal No.: C20	Kind of structure(s): Canal	Remarks: Routine survey Length: 2000m
Station: 2.00	Coordinate< Northing: 1220045 Easting: 0456522

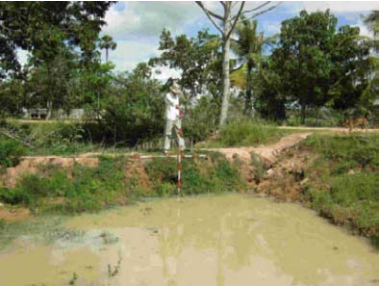
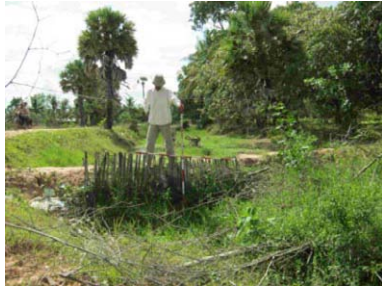
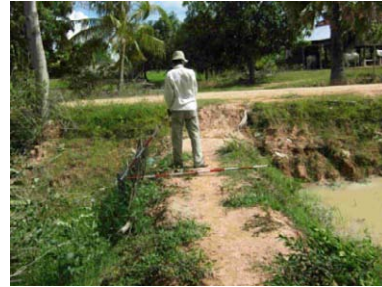
Canal No.: C20	Kind of structure(s): Pipe culvert	Remarks: Routine survey
Station: 2.00+50	Coordinate< Northing: 1220021 Easting: 0456555

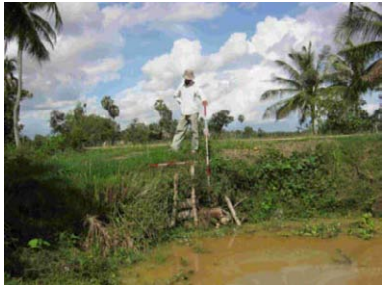
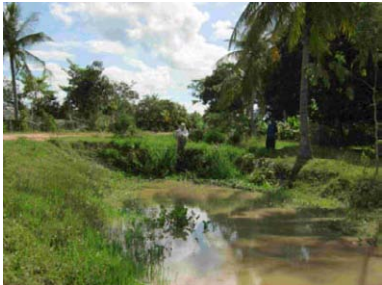
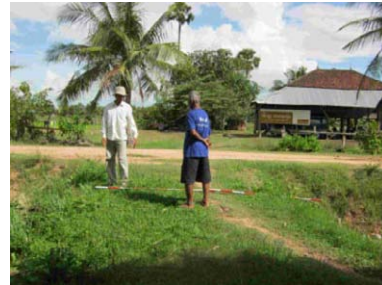
Canal No.: C20	Kind of structure(s): Pipe culvert	Remarks: Routine survey
Station: 2.00+120	Coordinate< Northing: 1220015 Easting: 0456618

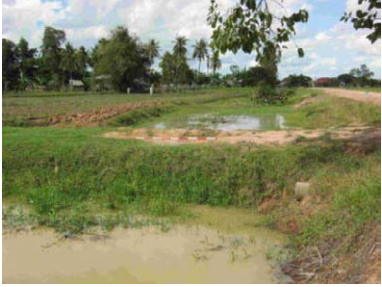
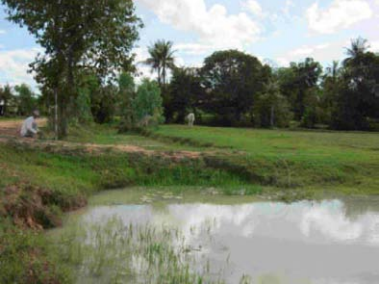
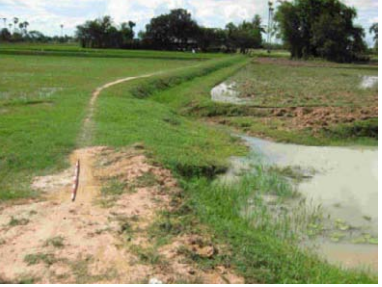
Canal No.: C20	Kind of structure(s): Embankment	Remarks:
Station: 2.00+200	Coordinate< Northing: 1220050 Easting: 0456694	Routine survey

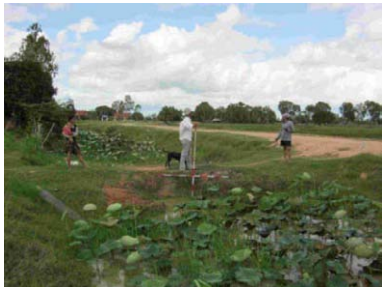
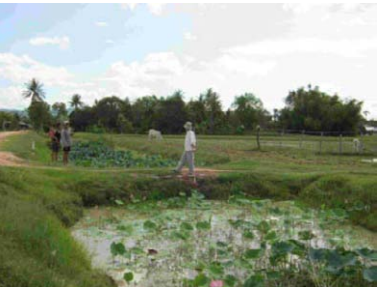
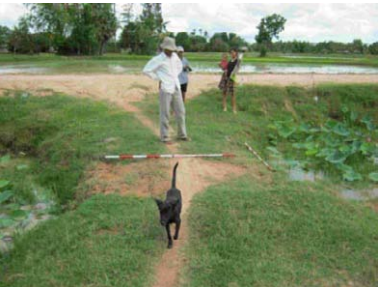
Canal No.: C20	Kind of structure(s): Pipe culvert	Remarks:
Station: 2.00+270	Coordinate< Northing: 1220079 Easting: 0456762	Routine survey

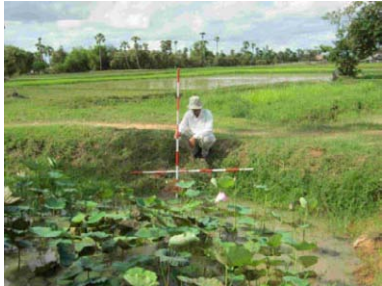
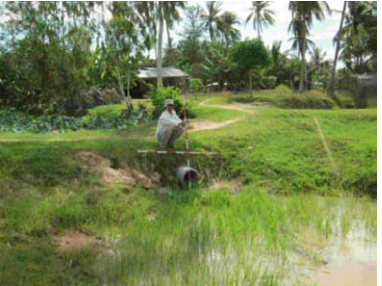
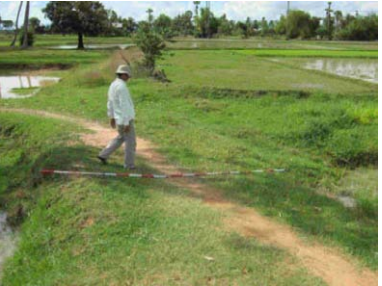
Canal No.: C20	Kind of structure(s): Pipe culvert	Remarks:
Station: 2.00+330	Coordinate< Northing: 1220105 Easting: 0456820	Routine survey

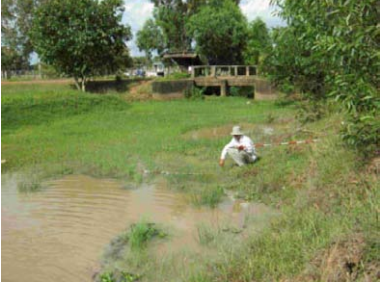
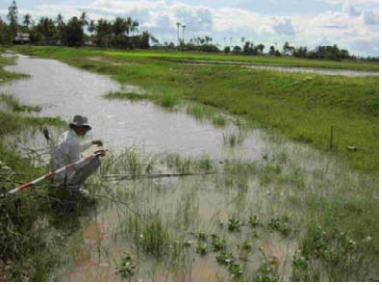
Canal No.: C20	Kind of structure(s): Canal	Remarks: Routine survey Length: 2500m
Station: 2.00+500	Coordinate< Northing: 1220096 Easting: 0456982	
<div style="display: flex; justify-content: space-around; align-items: center;"> <div style="text-align: center;">

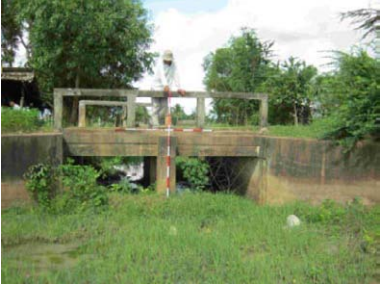
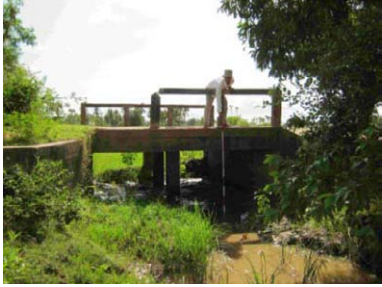
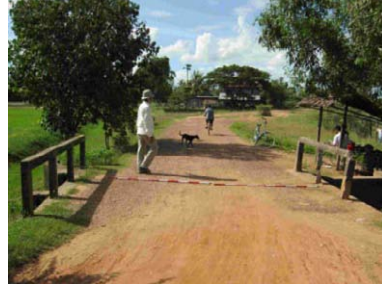
Canal No.: C20	Kind of structure(s): Bridge (Commune)	Remarks: Routine survey There is a Groove
Station: 2.00+520	Coordinate< Northing: 1220106 Easting: 0457008	
<div style="display: flex; justify-content: space-around; align-items: center;"> <div style="text-align: center;">

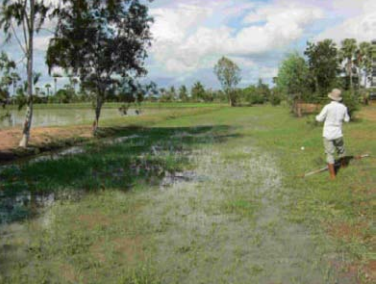
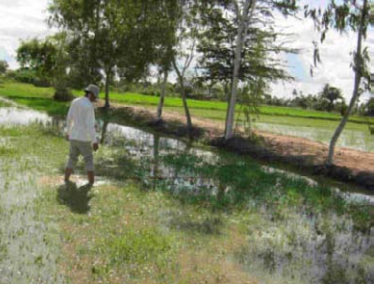
Canal No.: C20	Kind of structure(s): Canal	Remarks: Routine survey Length: 3000m
Station: 3.00	Coordinate< Northing: 1220091 Easting: 0457448	
<div style="display: flex; justify-content: space-around; align-items: center;"> <div style="text-align: center;">

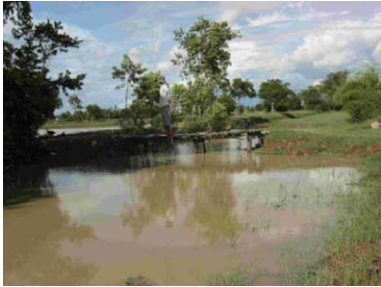
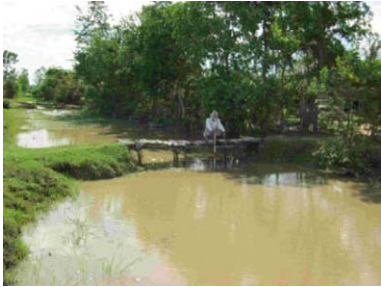
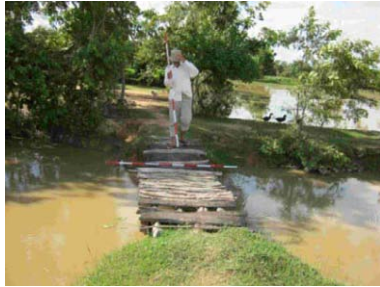
Canal No.: C20	Kind of structure(s): Bridge (Private)	Remarks:
Station: 3.00+240	Coordinate< Northing: 1220093 Easting: 0457676	Routine survey

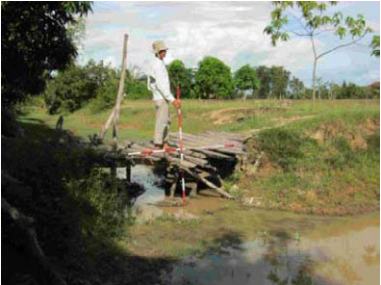
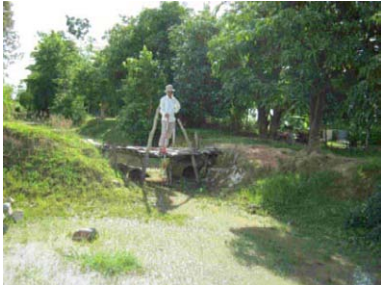
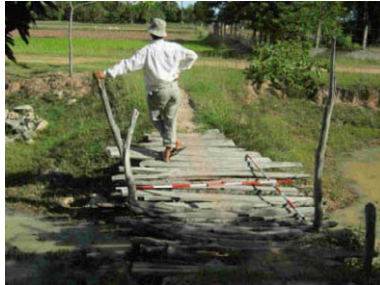
3,500	457916	1220084	Canal section	Use for drainge canal?	D		may be no use for irrigation		
3,550	457939	1220093	Private Bridge 5 & Culvert 19	Wooden bridge of 1 m wide, nealy broken	D		Wooden bridge, house access		
3,640	458021	1220090	Culvert 20 (4 units)	Culvert with four (4) pipes with 0.5 m dia and 4 m long	B	b	on village road		
3,970	458322	1220090	Bridge 6 & Culvert 21 (Triple)	Bridge with 1.4 m span and 2 m width	B	c	house access		
4,010	458363	1220080	Canal section	Canal section remains with water ponding	C	-			
4,210	458544	1220083	Bridge 7 (Private)	Wooden bridge of 1 m wide	C	-	Wooden bridge, house access		
4,370	458691	1220079	Bridge 8 (Private)	Wooden bridge of 1 m wide	C	-	Wooden bridge, house access		
4,460	458775	1220080	Bridge 9 (Private)	Wooden bridge of 1 m wide	C	-	Wooden bridge, house access		
4,510	458825	1220075	0		-	-			
4,520	458838	1220073	House	Shop and canteen, pillars are on canal	-	-	House

Canal No.: C20	Kind of structure(s): Bridge (Private)	Remarks:
Station: 3.00+550	Coordinate< Northing: 1220093 Easting: 0457939	There is a pipe culvert under the bridge

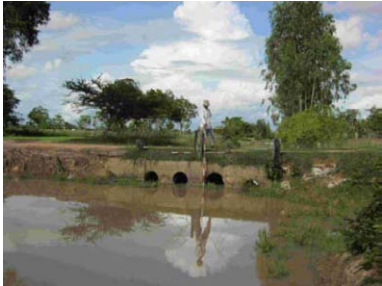
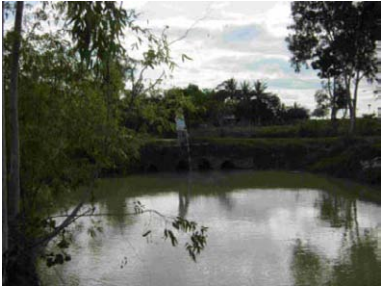
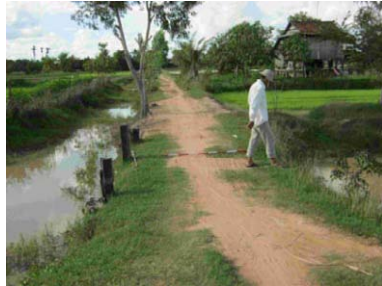
Canal No.: C20	Kind of structure(s): Pipe culvert (4 Units)	Remarks:
Station: 3.00+640	Coordinate< <div style="display: flex; justify-content: space-between; padding: 0 10px;"> <span>Northing: 1220090</span> <span>Easting: 0458021</span> </div>	Routine survey
<div style="display: flex; justify-content: space-around;">

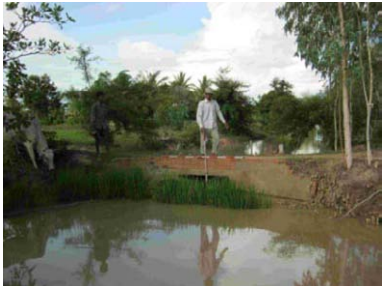
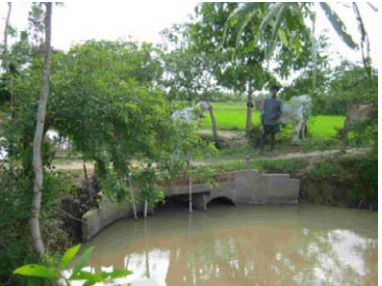
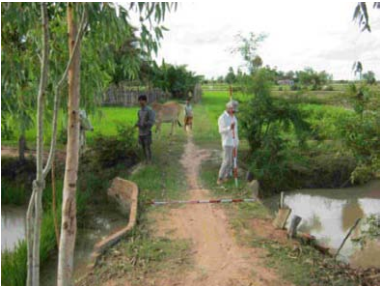
Canal No.: C20	Kind of structure(s): Bridge (Private)	Remarks:
Station: 3.00+970	Coordinate< <div style="display: flex; justify-content: space-between; padding: 0 10px;"> <span>Northing: 1220090</span> <span>Easting: 0458322</span> </div>	There are 3 pipe culverts under the bridge
<div style="display: flex; justify-content: space-around;">

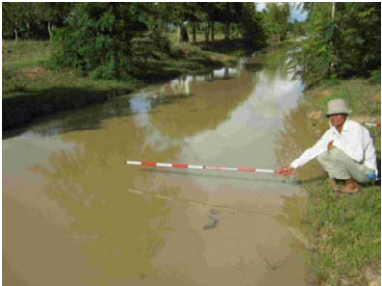
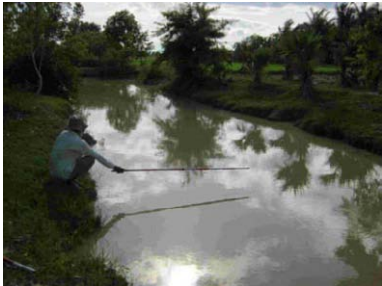
Canal No.: C20	Kind of structure(s): Canal	Remarks:
Station: 4.00+10	Coordinate< <div style="display: flex; justify-content: space-between; padding: 0 10px;"> <span>Northing: 0458363</span> <span>Easting: 1220080</span> </div>	Routine survey Length: 4000m
<div style="display: flex; justify-content: space-around;">

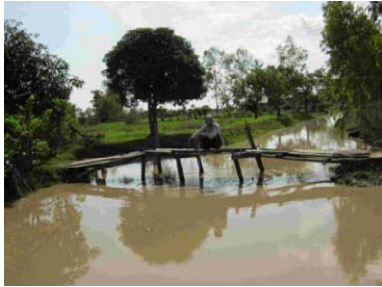
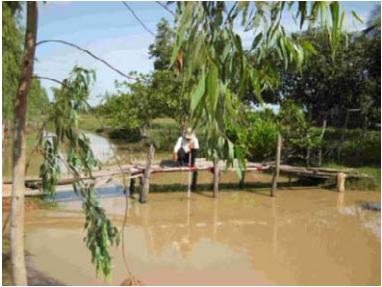
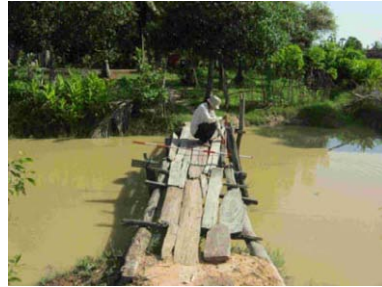
Canal No.: C20	Kind of structure(s): Bridge (Private)	Remarks:
Station: 4.00+210	Coordinate< <div style="display: flex; flex-direction: column; margin-left: 10px;"> <span>Northing: 1220083</span> <span>Easting: 0458544</span> </div>	Routine survey

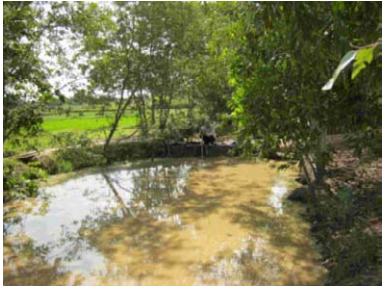
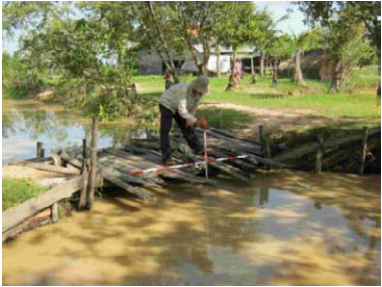
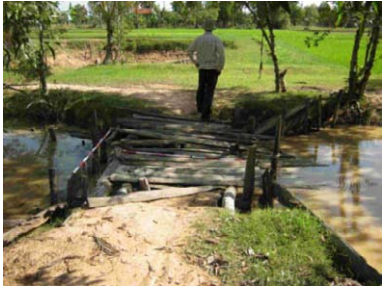
Canal No.: C20	Kind of structure(s): Bridge (Private)	Remarks:
Station: 4.00+370	Coordinate< <div style="display: flex; flex-direction: column; margin-left: 10px;"> <span>Northing: 1220079</span> <span>Easting: 0458691</span> </div>	Routine survey

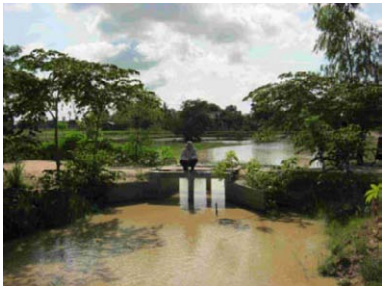
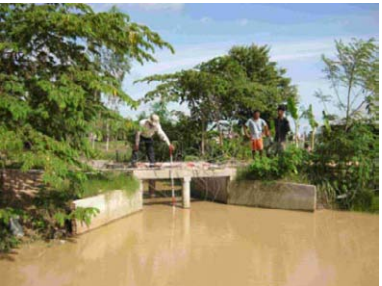
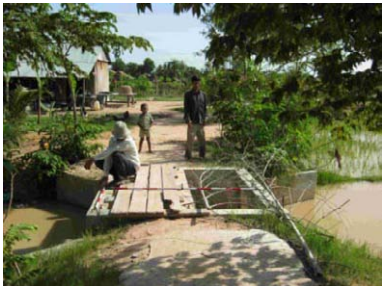
Canal No.: C20	Kind of structure(s): Bridge (Private)	Remarks:
Station: 4.00+460	Coordinate< <div style="display: flex; flex-direction: column; margin-left: 10px;"> <span>Northing: 1220080</span> <span>Easting: 0458775</span> </div>	Routine survey Made by Concrete (incomplete)

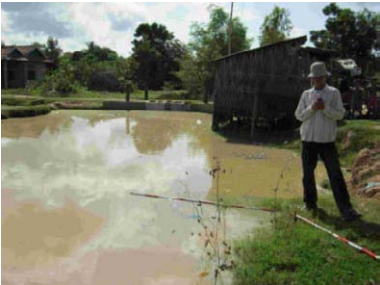
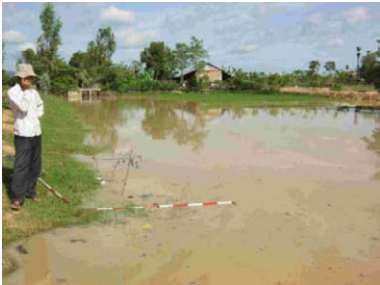
Canal No.: C20	Kind of structure(s): Canal	Remarks: Routine survey Length: 4500m
Station: 4.00+510	Coordinate< <div style="display: flex; flex-direction: column; gap: 5px;"> <span>Northing: 1220075</span> <span>Easting: 0458825</span> </div>	
<div style="display: flex; justify-content: space-around; align-items: center;">

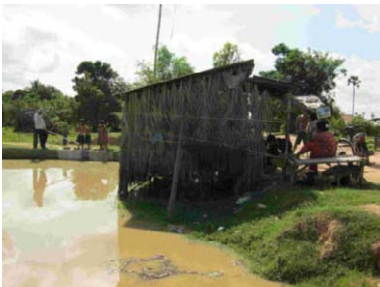
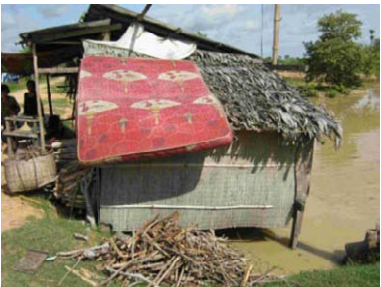
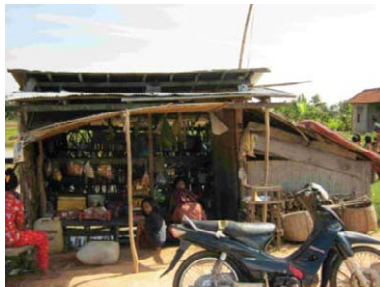
Canal No.: C20	Kind of structure(s): House	Remarks: Routine survey
Station: 4.00+520	Coordinate< <div style="display: flex; flex-direction: column; gap: 5px;"> <span>Northing: 1220073</span> <span>Easting: 0458838</span> </div>	
<div style="display: flex; justify-content: space-around; align-items: center;">

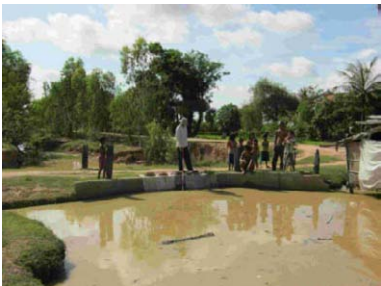
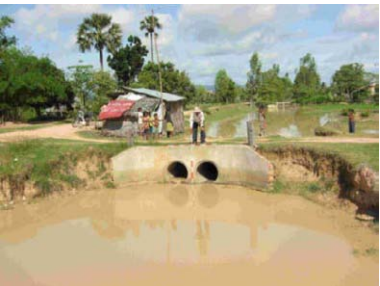
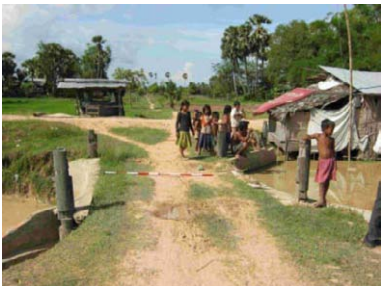
Canal No.: C20	Kind of structure(s): Pipe culvert (Double)	Remarks: Routine survey
Station: 4.00+530	Coordinate< <div style="display: flex; flex-direction: column; gap: 5px;"> <span>Northing: 1220083</span> <span>Easting: 0458844</span> </div>	
<div style="display: flex; justify-content: space-around; align-items: center;">

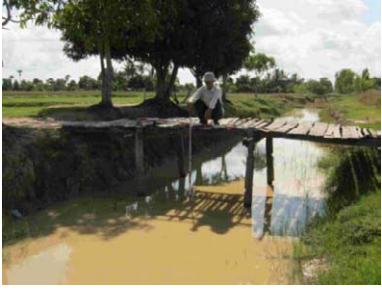
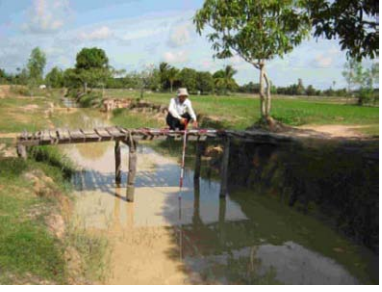
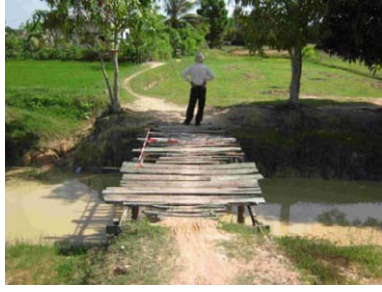
Canal No.: C20	Kind of structure(s): Bridge (Private)	Remarks: Routine survey Length: 5000m
Station: 5.00+10	Coordinate< Northing: 1220078 Easting: 0459278

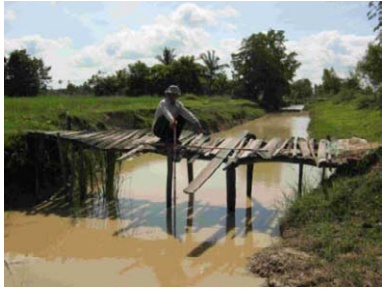
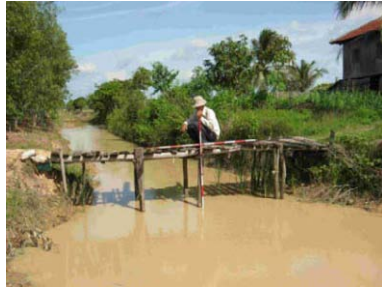
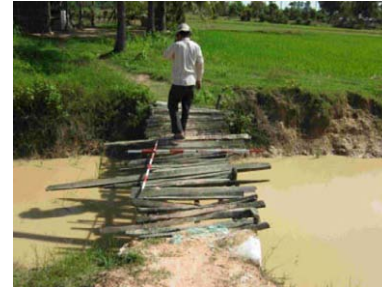
Canal No.: C20	Kind of structure(s): Bridge (Private)	Remarks: Routine survey
Station: 5.00+200	Coordinate< Northing: 1220070 Easting: 0459461

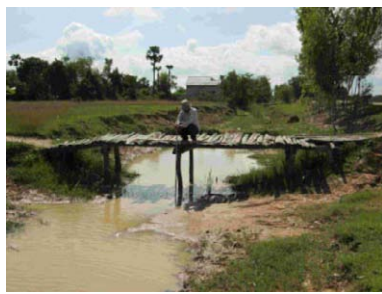
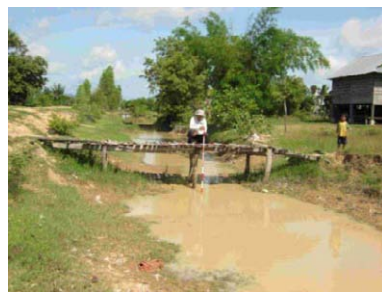
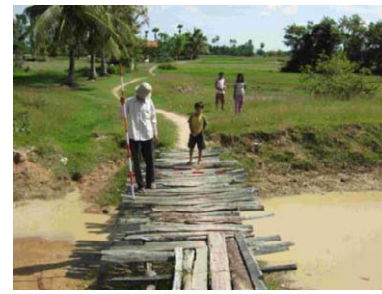
Canal No.: C20	Kind of structure(s): Bridge (Private)	Remarks: Routine survey
Station: 5.00+290	Coordinate< Northing: 1220068 Easting: 0459543

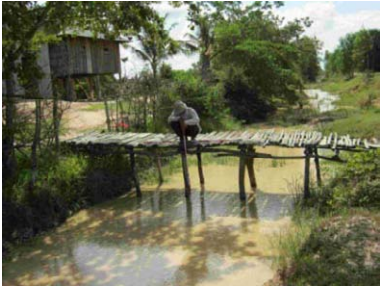
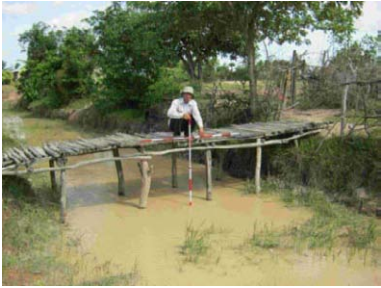
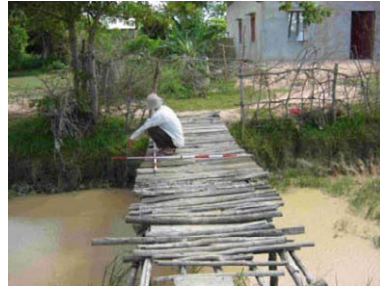
Canal No.: C20	Kind of structure(s): Bridge (Private)	Remarks:
Station: 5.00+380	Coordinate< Northing: 1220071 Easting: 0459637	Routine survey

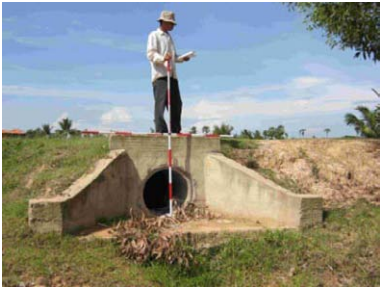
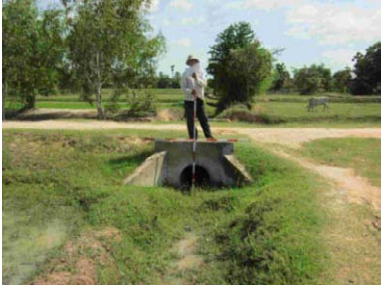
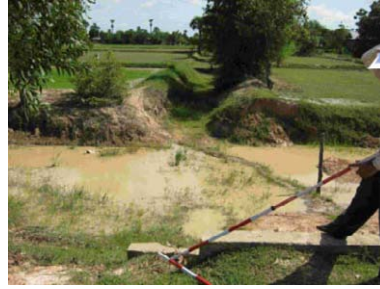
Canal No.: C20	Kind of structure(s): Division structure	Remarks:
Station: 5.00+470	Coordinate< Northing: 1220065 Easting: 0459717	Routine survey There a pipe culvert under the road

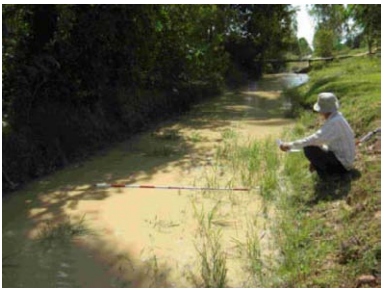
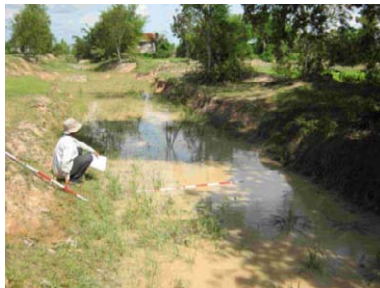
Canal No.: C20	Kind of structure(s): Canal	Remarks:
Station: 5.00+510	Coordinate< Northing: 1220069 Easting: 0459753	Routine survey Length: 5500m

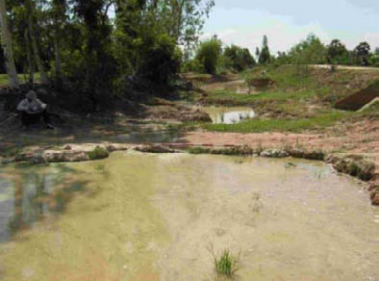
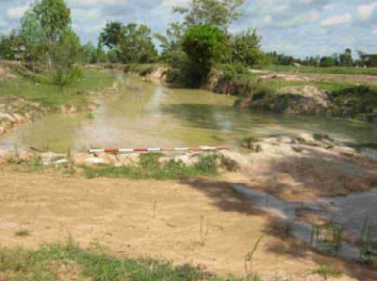
Canal No.: C20	Kind of structure(s): Canal	Remarks:
Station: 5.00+980	Coordinate< Northing: 1220060 Easting: 0460183	Routine survey Length: 6000m

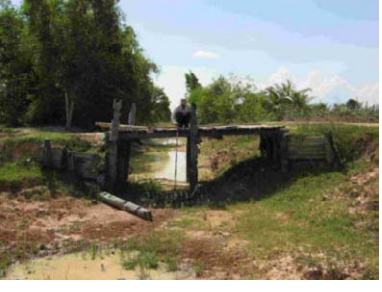
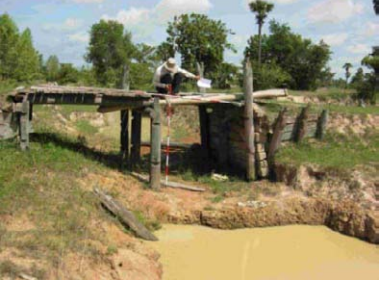
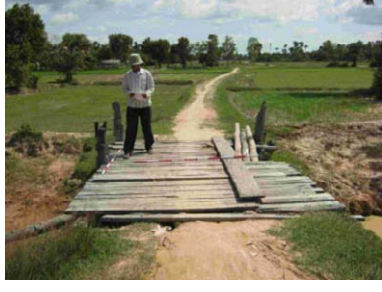
Canal No.: C20	Kind of structure(s): Bridge (Village)	Remarks:
Station: 6.00+220	Coordinate< Northing: 1220061 Easting: 0460399	Routine survey Made by wood

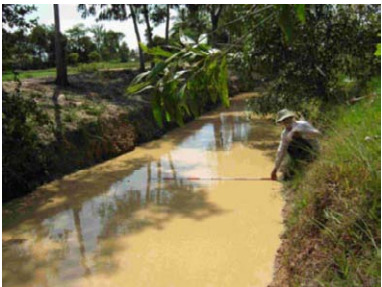
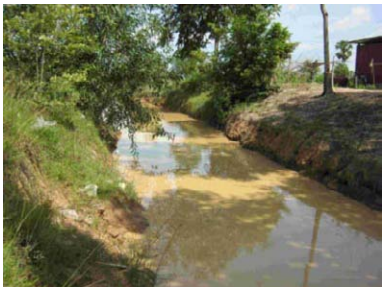
Canal No.: C20	Kind of structure(s): Canal	Remarks: Routine survey Length: 6500m
Station: 6.00+480	Coordinate< <div style="display: flex; flex-direction: column; margin-left: 10px;"> <span>Northing: 1220058</span> <span>Easting: 0460652</span> </div>	
<div style="display: flex; justify-content: space-around; align-items: center;"> <div style="text-align: center;">

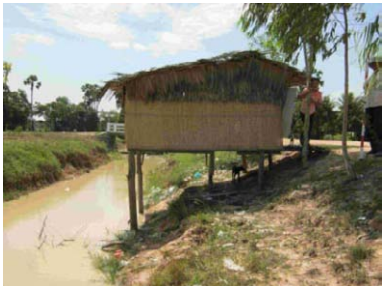
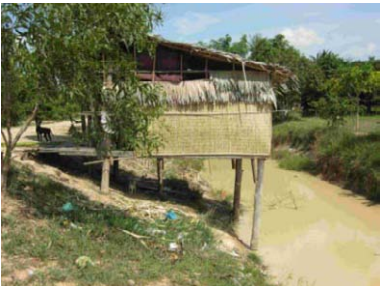
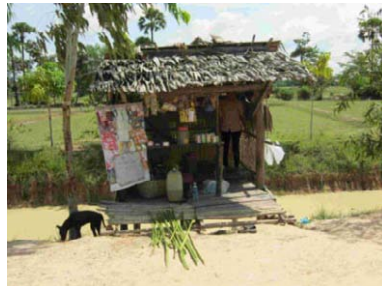
Canal No.: C20	Kind of structure(s): House	Remarks: Routine survey
Station: 6.00+670	Coordinate< <div style="display: flex; flex-direction: column; margin-left: 10px;"> <span>Northing: 1220054</span> <span>Easting: 0460832</span> </div>	
<div style="display: flex; justify-content: space-around; align-items: center;"> <div style="text-align: center;">

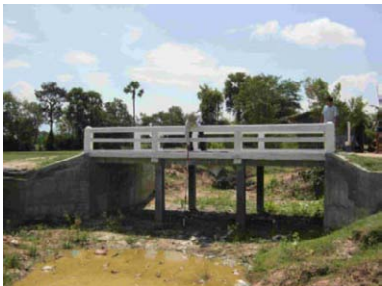
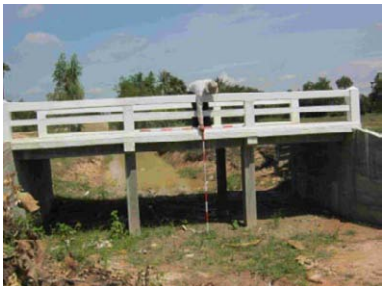
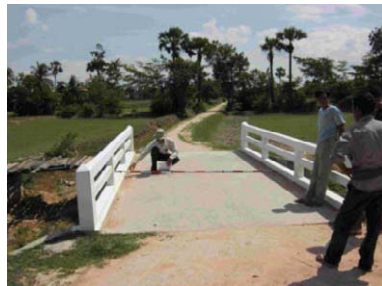
Canal No.: C20	Kind of structure(s): Bridge (Community)	Remarks: Bridge: L= 7m, W= 3m, H= 2m
Station: 6.00+690	Coordinate< <div style="display: flex; flex-direction: column; margin-left: 10px;"> <span>Northing: 1220058</span> <span>Easting: 0460865</span> </div>	
<div style="display: flex; justify-content: space-around; align-items: center;"> <div style="text-align: center;">

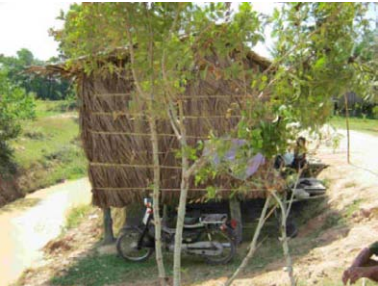
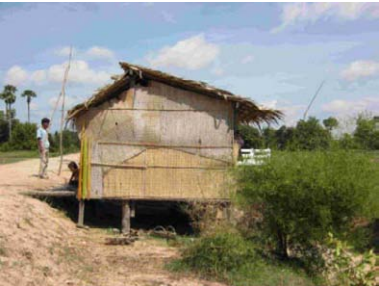
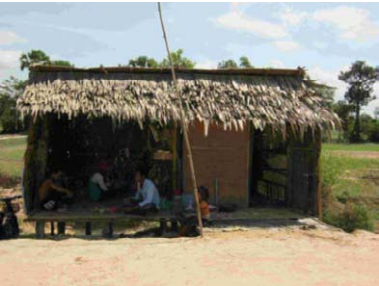
Canal No.: C20	Kind of structure(s): House	Remarks:
Station: 6.00+690	Coordinate< <div style="display: flex; flex-direction: column; margin-left: 10px;"> <span>Northing: 1220053</span> <span>Easting: 0460871</span> </div>	Routine survey
<div style="display: flex; justify-content: space-around;">

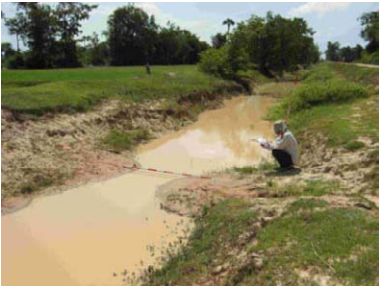
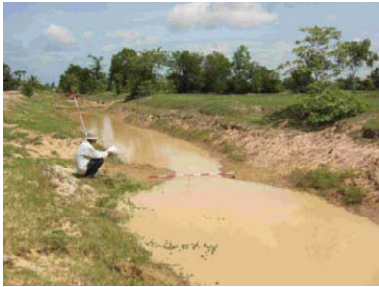
Canal No.: C20	Kind of structure(s): Canal	Remarks:
Station: 6.00+980	Coordinate< <div style="display: flex; flex-direction: column; margin-left: 10px;"> <span>Northing: 1220052</span> <span>Easting: 0461151</span> </div>	Routine survey Length: 7000m
<div style="display: flex; justify-content: space-around;">

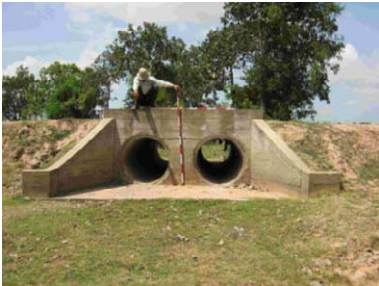
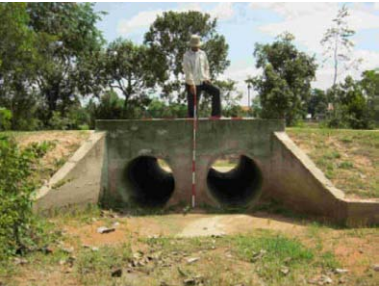
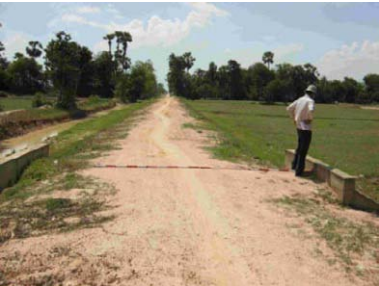
Canal No.: C20	Kind of structure(s): Pipe culvert	Remarks:
Station: 7.00+220	Coordinate< <div style="display: flex; flex-direction: column; margin-left: 10px;"> <span>Northing: 1220048</span> <span>Easting: 0461380</span> </div>	Diameter of pipe culvert = 1 m There is a crossing point
<div style="display: flex; justify-content: space-around;">

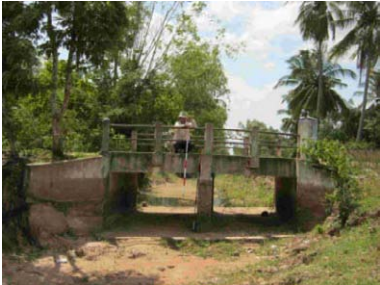
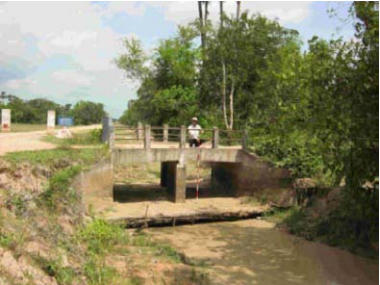
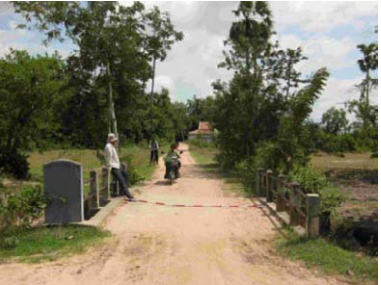
Canal No.: C20	Kind of structure(s): Bridge (Commune)	Remarks: There is a Groove Bridge was built in Pol Pot Regime
Station: 7.00+390	Coordinate< <div style="display: flex; flex-direction: column; margin-left: 10px;"> <span>Northing: 1220049</span> <span>Easting: 0461541</span> </div>	
<div style="display: flex; justify-content: space-around; align-items: center;">
