*Results of Inventory Survey for  
Proposed Rehabilitation Works in  
Roleang Chrey Headworks Rehabilitation Sub-project*

PREPARATORY SURVEY FOR IRRIGATION AND DRAINAGE  
SYSTEM REHABILITATION AND IMPROVEMENT PROJECT

Japan International Cooperation Agency

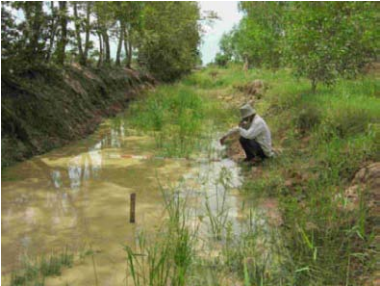
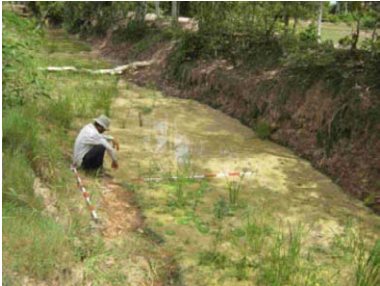
Canal No.: C20	Kind of structure(s): Canal	Remarks: Routine survey Length: 7500m
Station: 7.00+480	Coordinate< <div style="display: flex; flex-direction: column; margin-left: 10px;"> <span>Northing: 1220048</span> <span>Easting: 0461625</span> </div>	
<div style="display: flex; justify-content: space-around; align-items: center;">

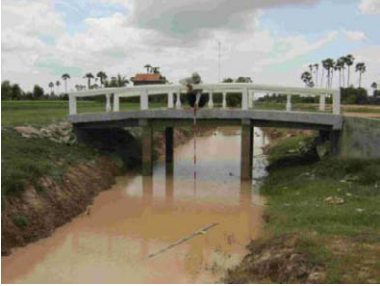
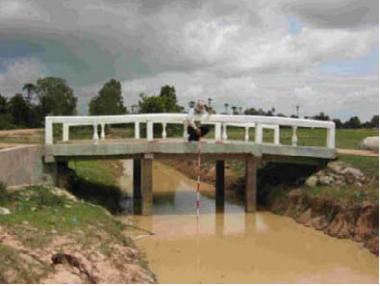
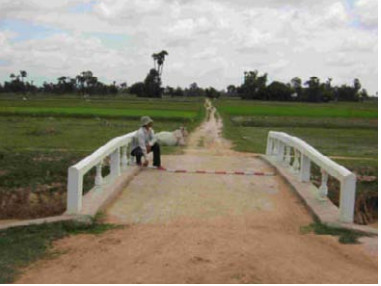
Canal No.: C20	Kind of structure(s): Bridge (Village)	Remarks: Routine survey
Station: 7.00+720	Coordinate< <div style="display: flex; flex-direction: column; margin-left: 10px;"> <span>Northing: 1220045</span> <span>Easting: 0461839</span> </div>	
<div style="display: flex; justify-content: space-around; align-items: center;">

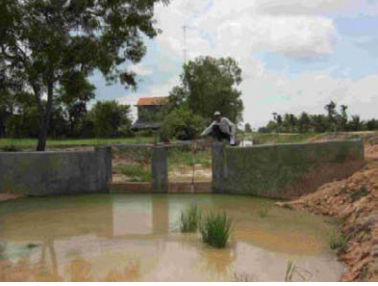
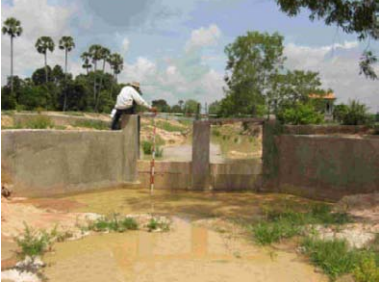
Canal No.: C20	Kind of structure(s): Water Blockade	Remarks: Routine survey Length: 8000m End point of Canal 20
Station: 7.00+930(EP)	Coordinate< Northing: 1220040 Easting: 0462027

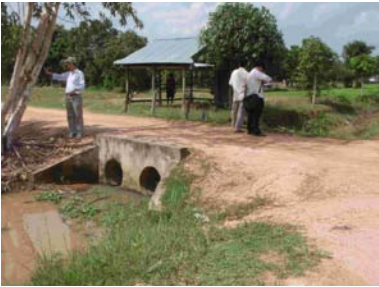
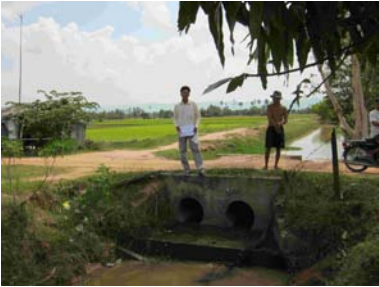
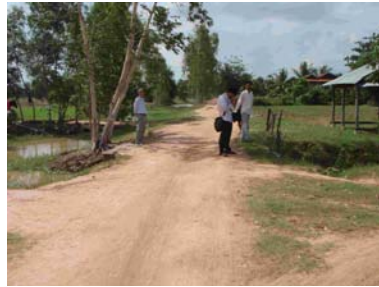
Canal No.: C20S	Kind of structure: Pipe culvert(Double)	Remarks:
Station: 0.00(B.P.)	Coordinate< <div style="display: flex; flex-direction: column; align-items: flex-start;"> <span>Northing: 1219045</span> <span>Easting: 460168</span> </div>	Along the village road

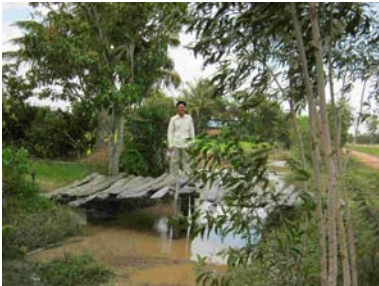
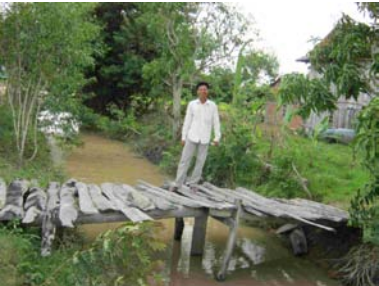
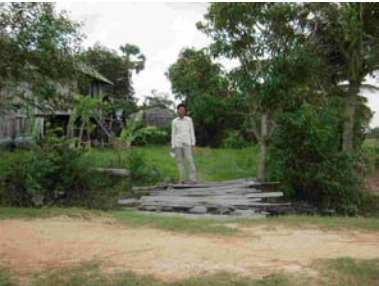
Canal No.: C20S	Kind of structure: Bridge (Private)	Remarks:
Station: 0.00+210	Coordinate< <div style="display: flex; flex-direction: column; align-items: flex-start;"> <span>Northing: 1219055</span> <span>Easting: 460368</span> </div>	Routine survey

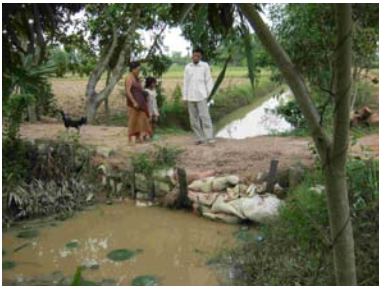
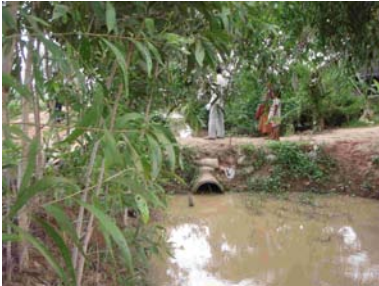
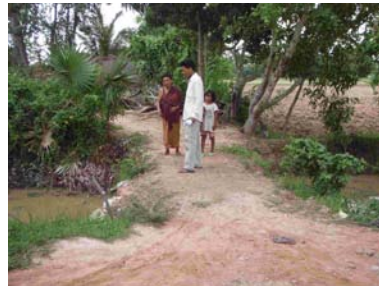
Canal No.: C20S	Kind of structure: Pipe culvert	Remarks:
Station: 0.00+310	Coordinate< <div style="display: flex; flex-direction: column; align-items: flex-start;"> <span>Northing: 1219057</span> <span>Easting: 460458</span> </div>	Routine survey

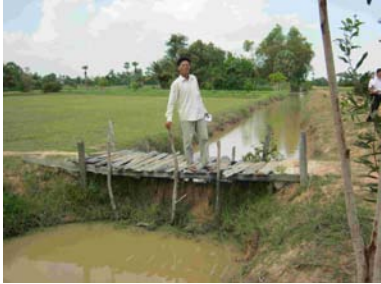
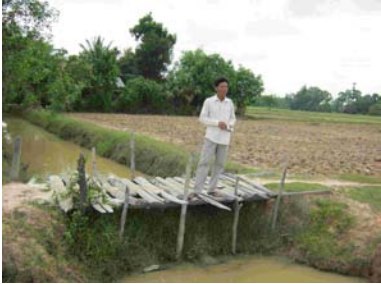
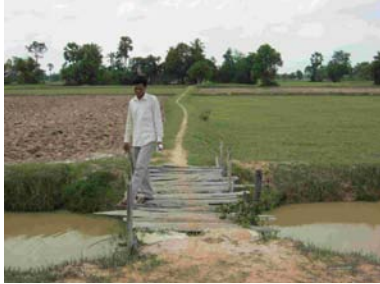
Canal No.: C20S	Kind of structure: Bridge (Private)	Remarks: There is a pipe culvert under the bridge
Station: 0.00+350	Coordinate< <div style="display: flex; flex-direction: column; gap: 5px;"> <span>Northing: 1219058</span> <span>Easting: 460502</span> </div>	
<div style="display: flex; justify-content: space-around;"> <div style="text-align: center;">

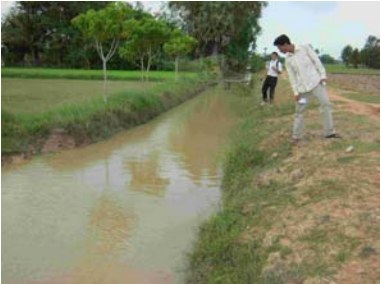
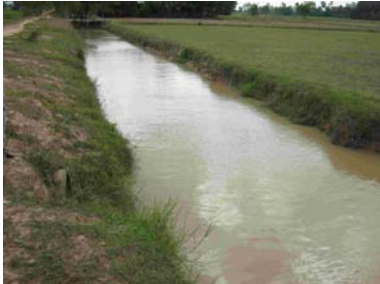
Canal No.: C20S	Kind of structure: Right Bank Culvert	Remarks: Routine survey
Station: 0.00+390	Coordinate< <div style="display: flex; flex-direction: column; gap: 5px;"> <span>Northing: 1219061</span> <span>Easting: 460554</span> </div>	
<div style="display: flex; justify-content: space-around;"> <div style="text-align: center;">

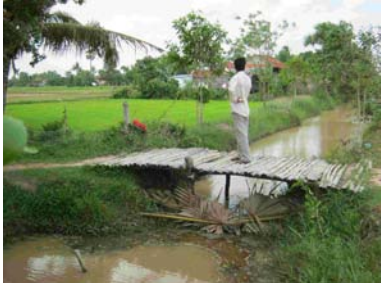
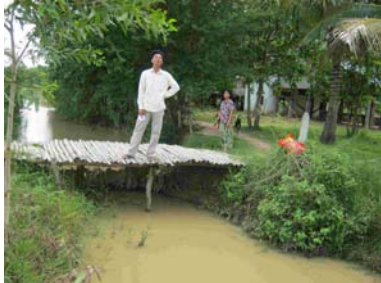
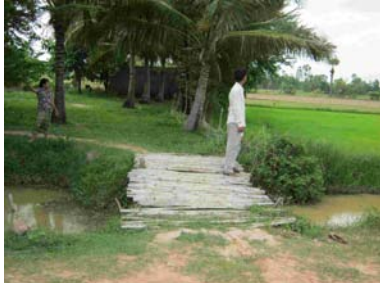
Canal No.: C20S	Kind of structure: Bridge (Private)	Remarks: Routine survey Length: 500m
Station: 0.00+500	Coordinate< <div style="display: flex; flex-direction: column; gap: 5px;"> <span>Northing: 1219066</span> <span>Easting: 460637</span> </div>	
<div style="display: flex; justify-content: space-around;"> <div style="text-align: center;">

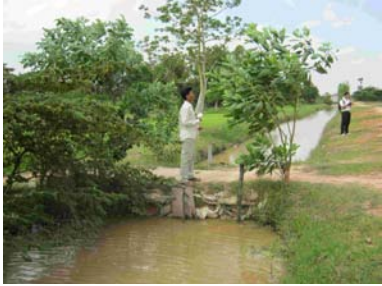
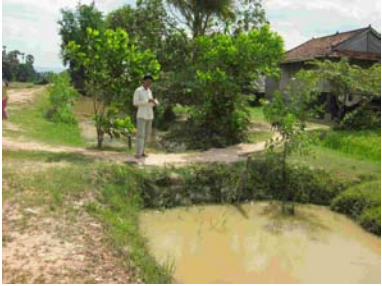
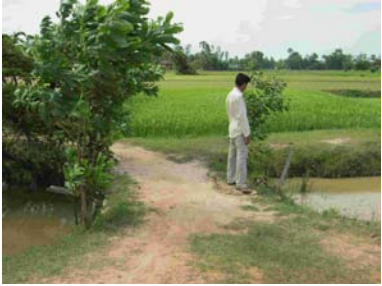
Canal No.: C20S	Kind of structure: Pipe culvert	Remarks:
Station: 0.00+550	Coordinate< <div style="display: flex; flex-direction: column; align-items: flex-start;"> <span>Northing: 1219070</span> <span>Easting: 460698</span> </div>	Routine survey

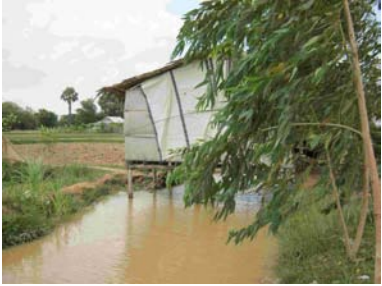
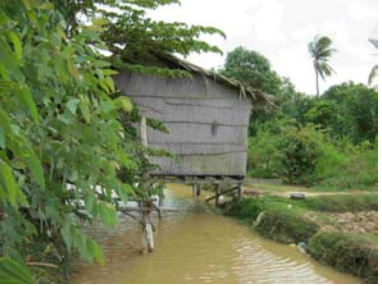
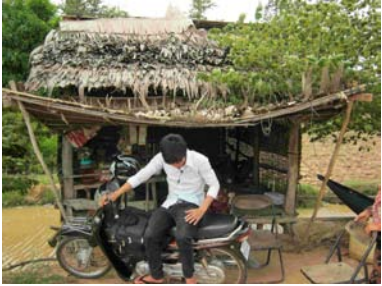
Canal No.: C20S	Kind of structure: House (Cottage)	Remarks:
Station: 0.00+700	Coordinate< <div style="display: flex; flex-direction: column; align-items: flex-start;"> <span>Northing: 1219078</span> <span>Easting: 460838</span> </div>	Routine survey

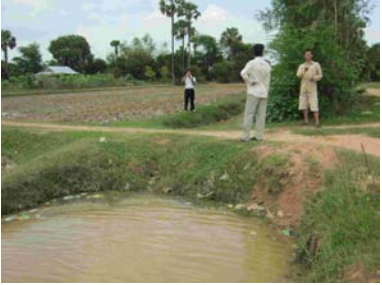
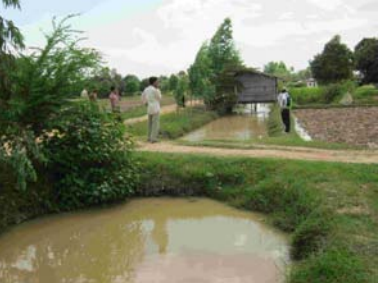
Canal No.: C20S	Kind of structure: Pipe culvert	Remarks:
Station: 0.00+740	Coordinate< <div style="display: flex; flex-direction: column; align-items: flex-start;"> <span>Northing: 1219077</span> <span>Easting: 460862</span> </div>	Routine survey

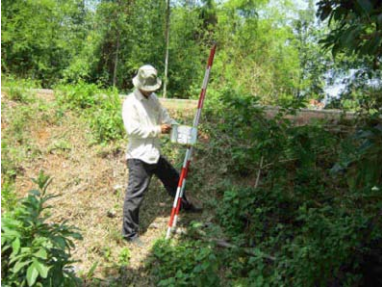
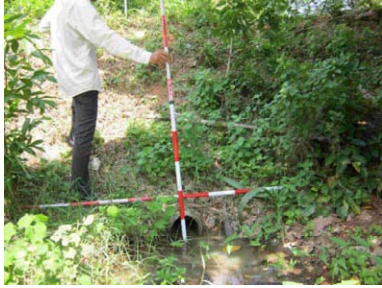
Canal No.: C21	Kind of structure: Pipe culvert	Remarks:  - Cross the national road N° 2
Station: 0.00(B.P.)	Coordinate< <div style="display: inline-block; vertical-align: middle; margin-left: 10px;">                     Northing: 1220976                      Easting: 0453448                 </div>	
<div style="display: flex; justify-content: space-around; align-items: center;"> <div style="text-align: center;">

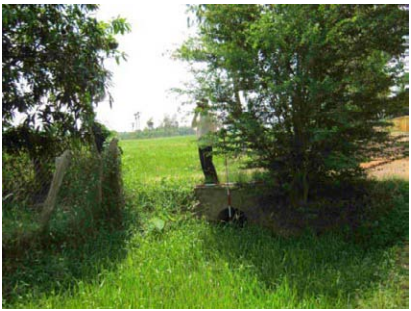
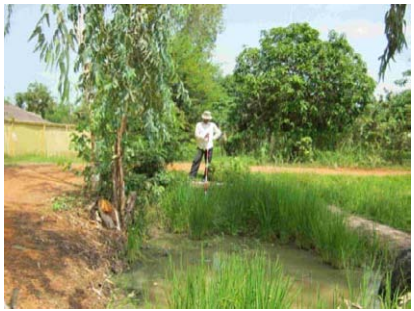
Canal No.: C21	Kind of structure: Pipe culvert	Remarks:  Under commune road
Station: 0.00+220	Coordinate< <div style="display: inline-block; vertical-align: middle; margin-left: 10px;">                     Northing: 1221002                      Easting: 0453609                 </div>	
<div style="display: flex; justify-content: space-around; align-items: center;"> <div style="text-align: center;">

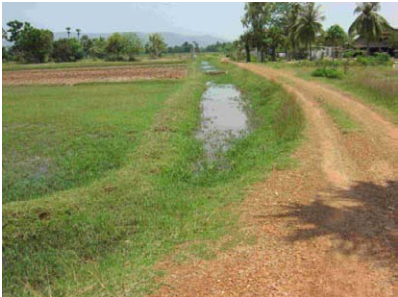
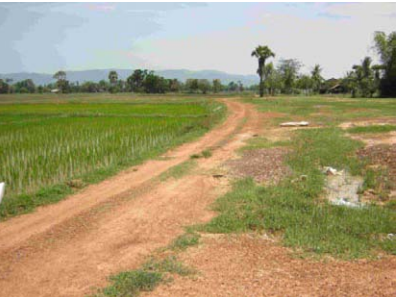
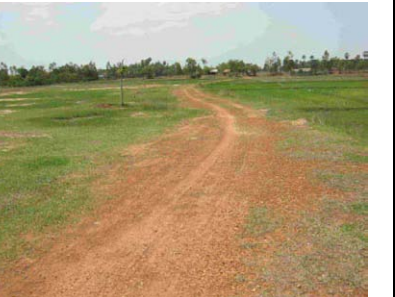
Canal No.: C21	Kind of structure: Pipe culvert	Remarks: - Routine survey - Canal is filled by road soil
Station: 1.00+930	Coordinate< Northing: 1221080 Easting: 0455472	
<div style="display: flex; justify-content: space-around; align-items: center;"> <div style="text-align: center;">

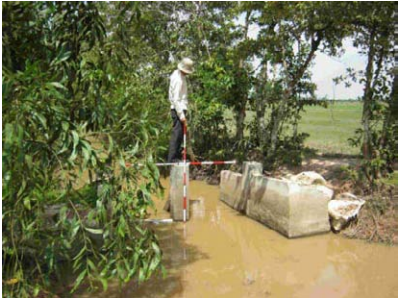
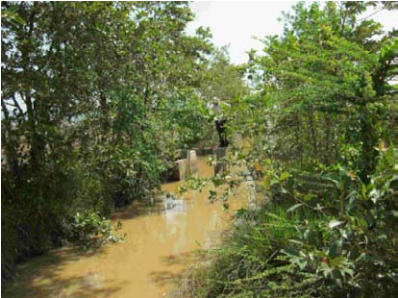
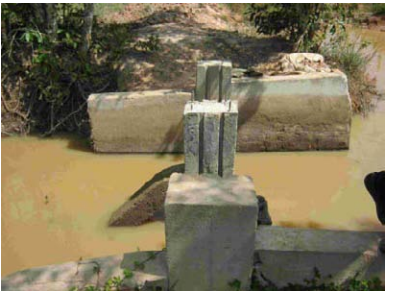
Canal No.: C21	Kind of structure: Check structure	Remarks: - Concrete column used for obstruction of water
Station: 2.00+360	Coordinate< Northing: 1221133 Easting: 0455790

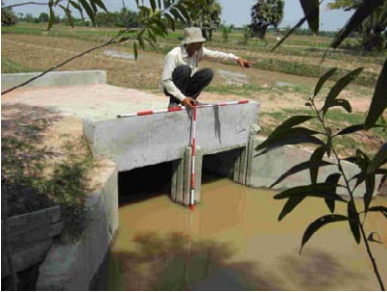
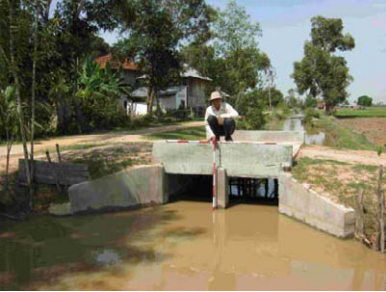
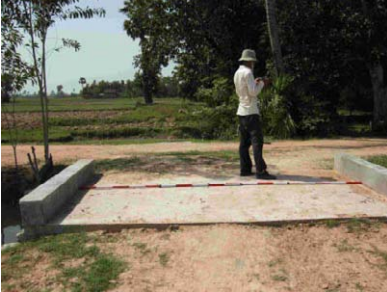
Canal No.: C21	Kind of structure: Bridge (Box culvert)	Remarks: - Under a village road - There is a groove
Station: 2.00+720	Coordinate< Northing: 1221128 Easting: 0456142

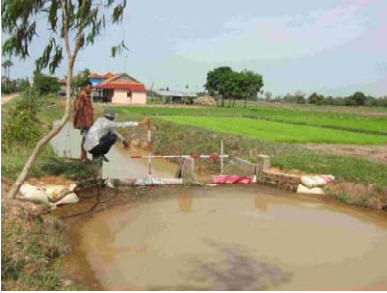
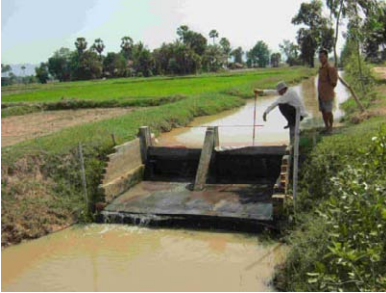
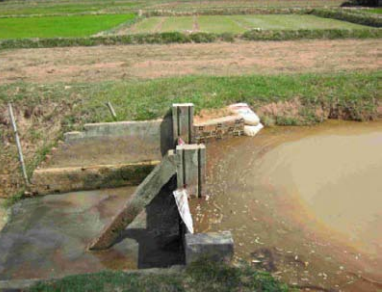
Canal No.: C21	Kind of structure: Water obstruction	Remarks: - Concrete column - Wood and plastic - There are grooves
Station: 2.00+880	Coordinate< Northing: 1221130 Easting: 0456282

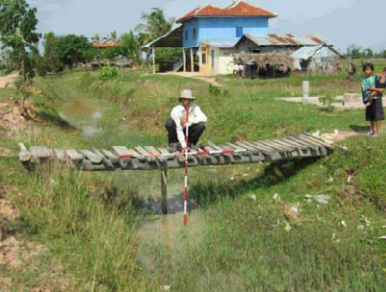
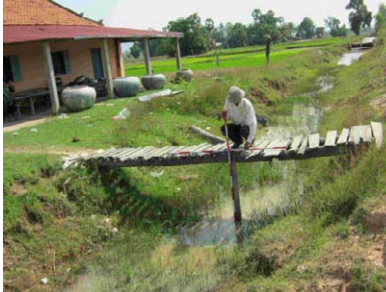
Canal No.: C21	Kind of structure: Wooden Bridge (Private)	Remarks: Routine survey
Station: 2.00+960	Coordinate< Northing: 1221130 Easting: 0456350

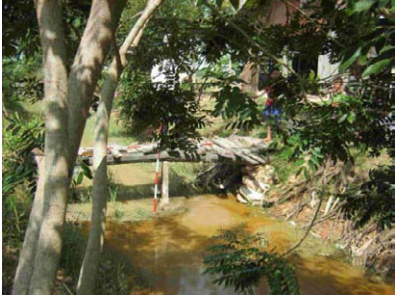
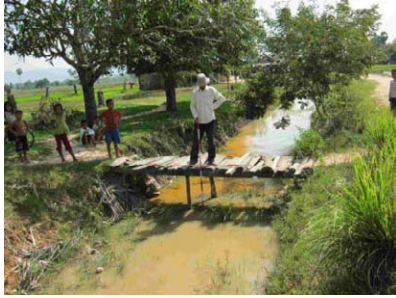
Canal No.: C21	Kind of structure: Wooden Bridge (Private)	Remarks: Routine survey Length: 3000m
Station: 3.00+60	Coordinate< Northing: 1221130 Easting: 0456444	
<div style="display: flex; justify-content: space-around; align-items: center;"> <div style="text-align: center;">

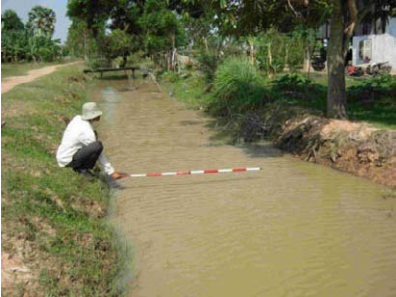
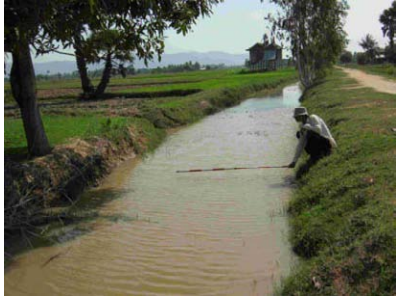
Canal No.: C21	Kind of structure: Canal	Remarks: Routine survey Length: 3500m
Station: 3.00+560	Coordinate< Northing: 1221129 Easting: 0456914	
<div style="display: flex; justify-content: space-around; align-items: center;"> <div style="text-align: center;">

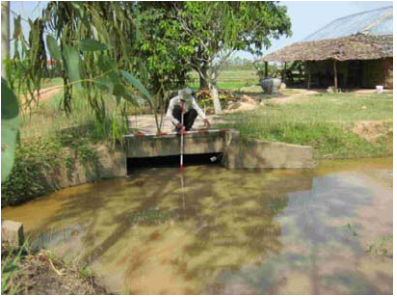
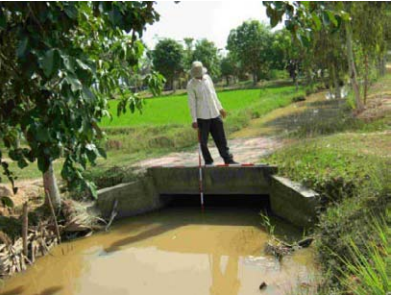
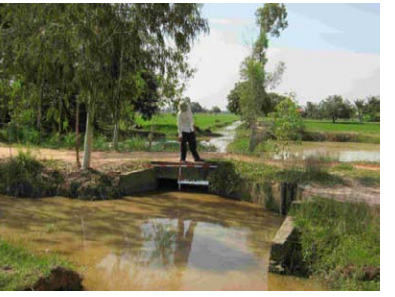
Canal No.: C21	Kind of structure: Bridge	Remarks: There is a groove which is box culvert
Station: 3.00+660	Coordinate< Northing: 1221128 Easting: 0457020	
<div style="display: flex; justify-content: space-around; align-items: center;"> <div style="text-align: center;">

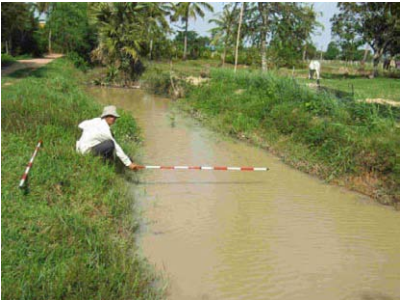
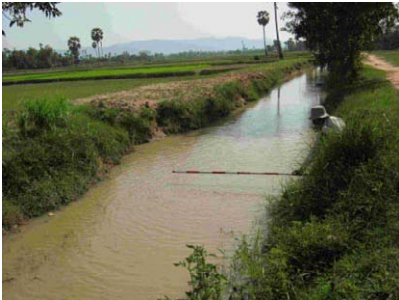
Canal No.: C21	Kind of structure: Canal	Remarks:
Station: 4.00+60	Coordinate< Northing: 1221130 Easting: 0457390	Routine survey Length: 4000m

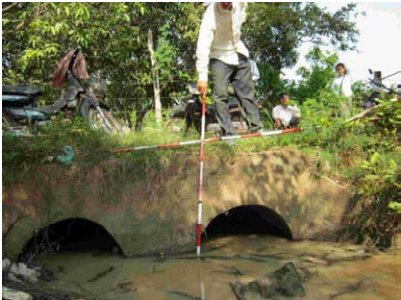
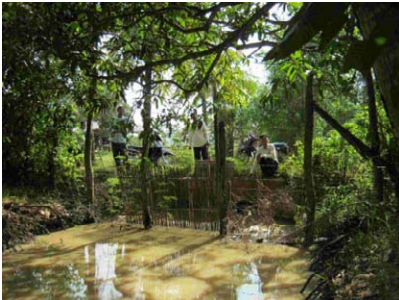
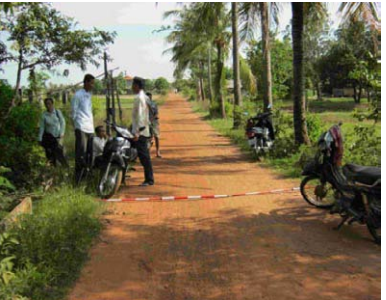
Canal No.: C21	Kind of structure: Pipe culvert (Double)	Remarks:
Station: 4.00+130	Coordinate< Northing: 1221124 Easting: 0457445	Routine survey Under commune road

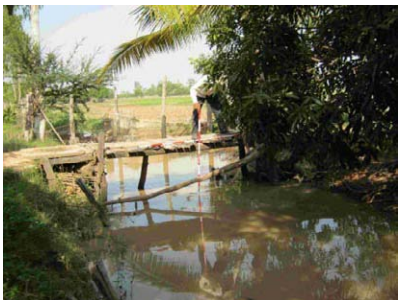
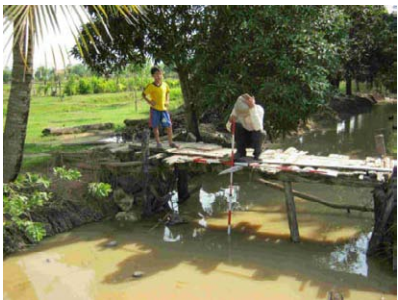
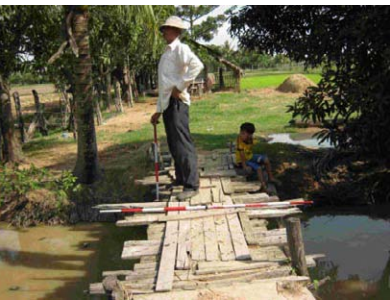
Canal No.: C21	Kind of structure: Wooden Bridge (Private)	Remarks:
Station: 4.00+210	Coordinate< Northing: 1221126 Easting: 0457519	Routine survey

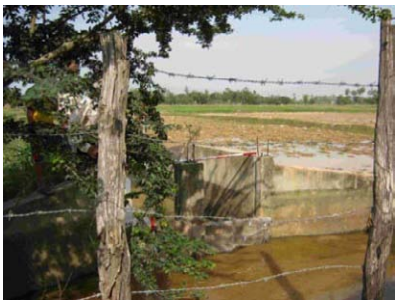
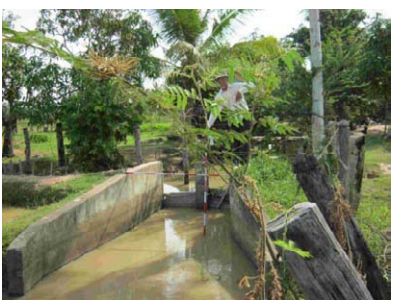
Canal No.: C21	Kind of structure: Water obstruction structure	Remarks:
Station: 4.00+220	Coordinate< Northing: 1221124 Easting: 0457526	Routine survey

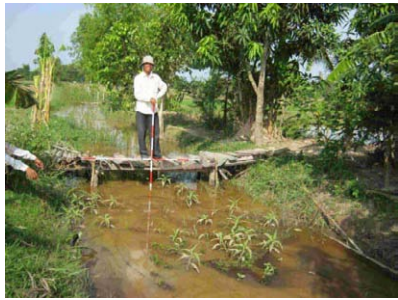
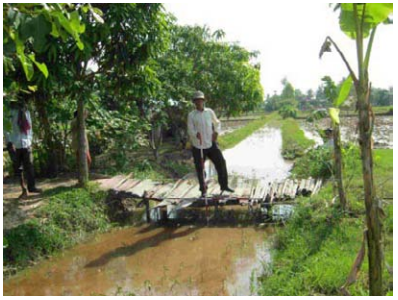
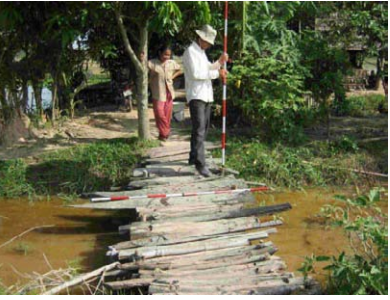
Canal No.: C21	Kind of structure: Wooden Bridge (Private)	Remarks:
Station: 4.00+390	Coordinate< Northing: 1221124 Easting: 0457704	Routine survey

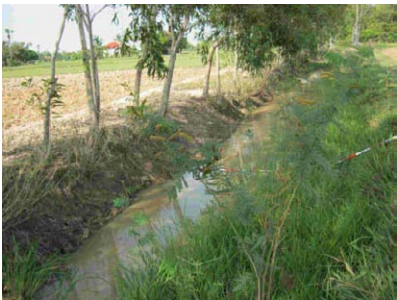
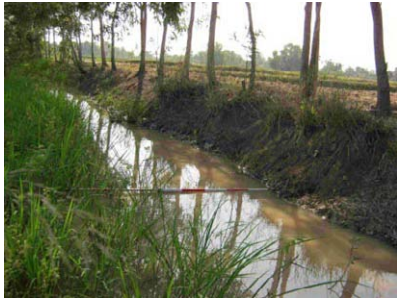
Canal No.: C21	Kind of structure: Canal	Remarks: Routine survey Length: 4500m
Station: 4.00+560	Coordinate< Northing: 1221121 Easting: 0457862	
<div style="display: flex; justify-content: space-around; align-items: center;"> <div style="text-align: center;">

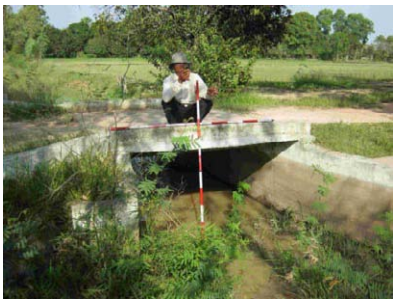
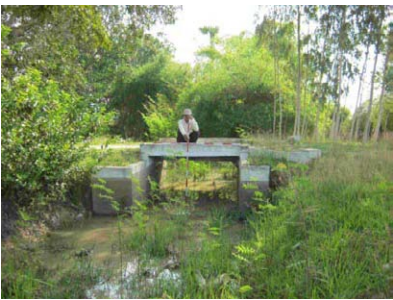
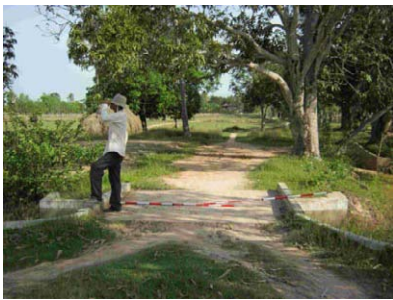
Canal No.: C21	Kind of structure: Bridge	Remarks: - Routine survey - Under a village road
Station: 4.00+770	Coordinate< Northing: 1221124 Easting: 0458044	
<div style="display: flex; justify-content: space-around; align-items: center;"> <div style="text-align: center;">

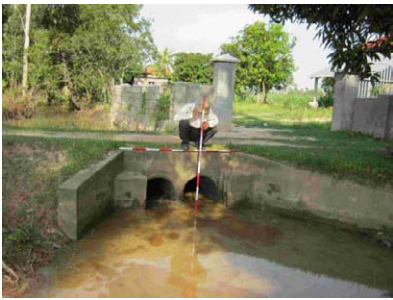
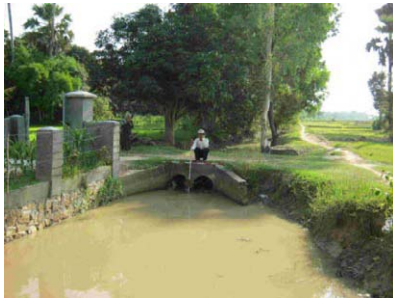
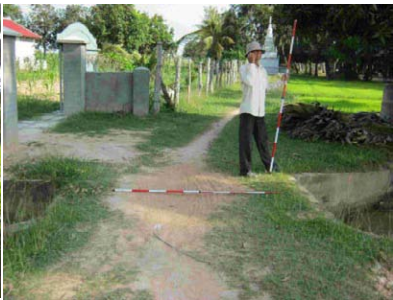
Canal No.: C21	Kind of structure: Bridge (Double culvert)	Remarks: Under house entrance road
Station: 4.00+970	Coordinate< Northing: 1221123 Easting: 0458230	
<div style="display: flex; justify-content: space-around; align-items: center;"> <div style="text-align: center;">

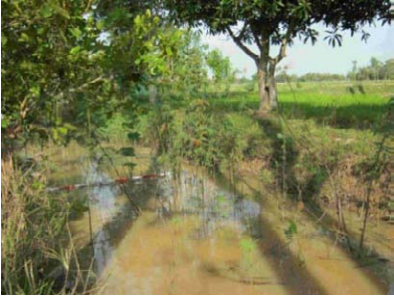
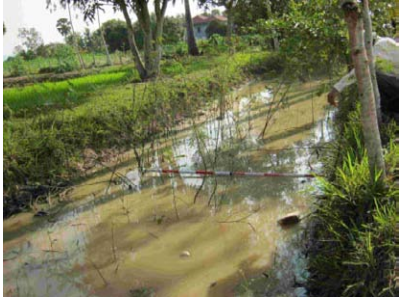
Canal No.: C21	Kind of structure: Canal	Remarks: Routine survey Length: 5000m
Station: 5.00+60	Coordinate< Northing: 1221126 Easting: 0458339	
<div style="display: flex; justify-content: space-around; align-items: center;"> <div style="text-align: center;">

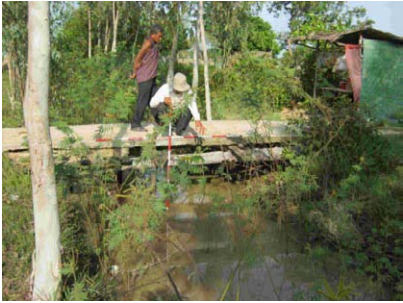
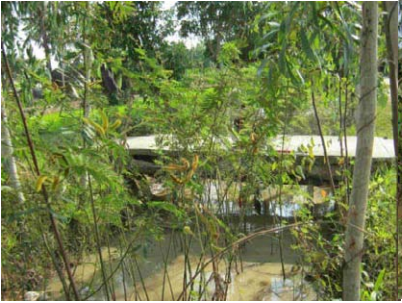
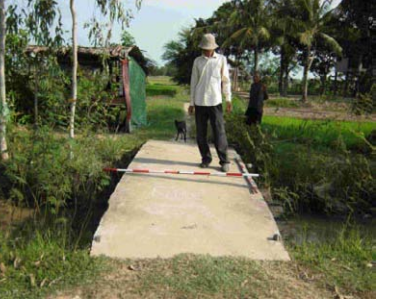
#REF!	458361	1221124	Bridge 10 (Private)	Concrete bridge of 1.8 m wide	B	b	House access
#REF!	458505	1221126	Water Blockade	Temporary Regulator with plastick sheet and planks	D	-	Tempo regulator to be replaced proper structure

Canal No.: C21	Kind of structure: Bridge (Private)	Remarks: Routine survey
Station: 5.00+80	Coordinate< Northing: 1221124 Easting: 0458361	
<div style="display: flex; justify-content: space-around; align-items: center;"> <div style="text-align: center;">

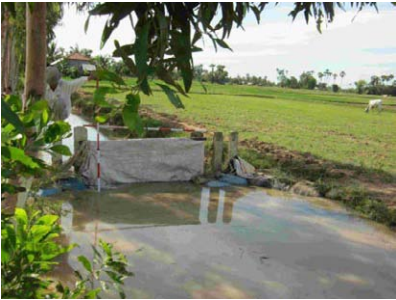
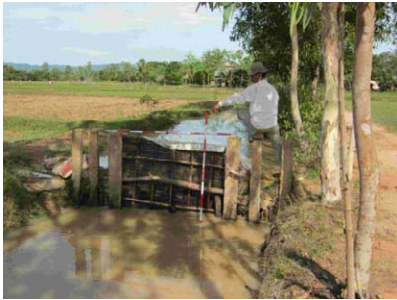
Canal No.: C21	Kind of structure: Water blockade	Remarks: - Concrete column with plastic
Station: 5.00+230	Coordinate< Northing: 1221126 Easting: 0458505	
<div style="display: flex; justify-content: space-around; align-items: center;"> <div style="text-align: center;">

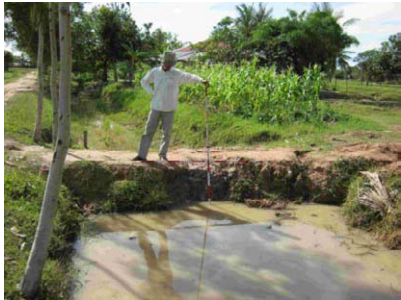
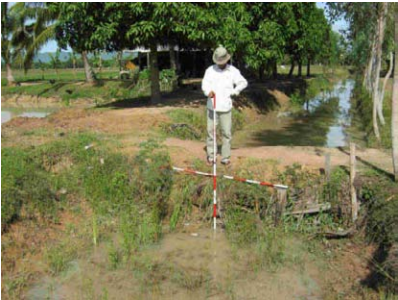
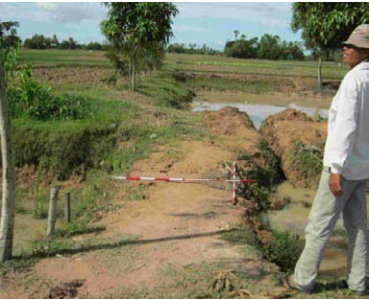
Canal No.: C21	Kind of structure: Embankment	Remarks:
Station: 5.00+380	Coordinate< <div style="display: flex; flex-direction: column; align-items: flex-start;"> <span>Northing: 1221126</span> <span>Easting: 0458642</span> </div>	- Embankment is soil

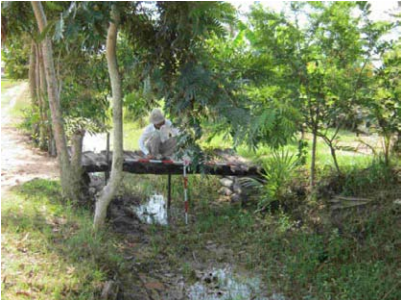
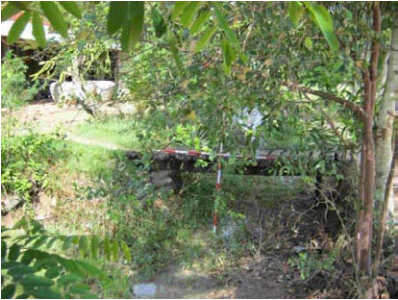
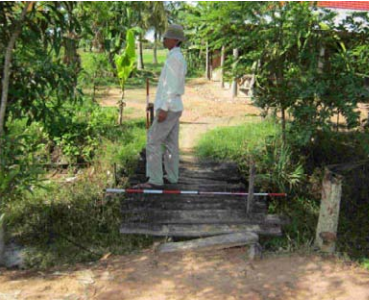
Canal No.: C21	Kind of structure: Wooden Bridge (Private)	Remarks:
Station: 5.00+420	Coordinate< <div style="display: flex; flex-direction: column; align-items: flex-start;"> <span>Northing: 1221124</span> <span>Easting: 0458682</span> </div>	Routine survey

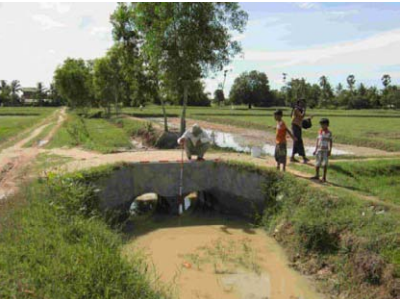
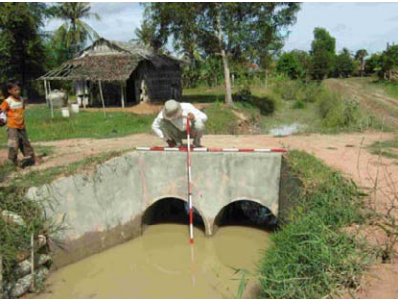
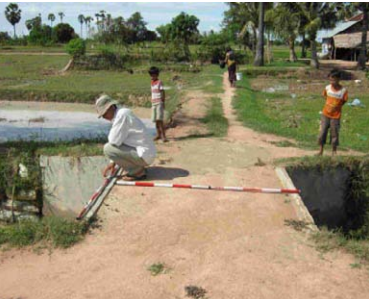
Canal No.: C21	Kind of structure: Pipe culvert (Double)	Remarks:
Station: 5.00+500	Coordinate< <div style="display: flex; flex-direction: column; align-items: flex-start;"> <span>Northing: 1221124</span> <span>Easting: 0458771</span> </div>	<ul style="list-style-type: none"> <li>- Routine survey</li> <li>- Under a village road</li> </ul>

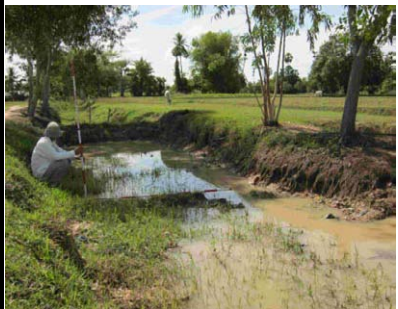
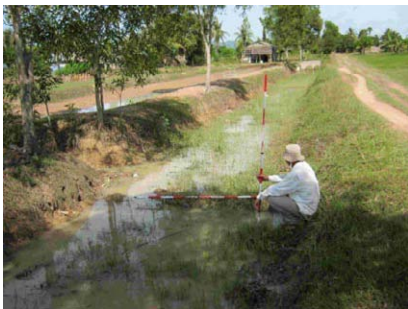
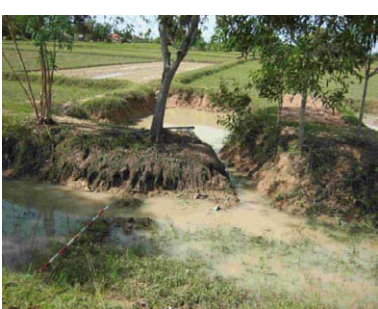
Canal No.: C21	Kind of structure: Canal	Remarks: - A groove takes water to fields - Length: 5500m
Station: 5.00+560	Coordinate< Northing: 1221127 Easting: 0458821

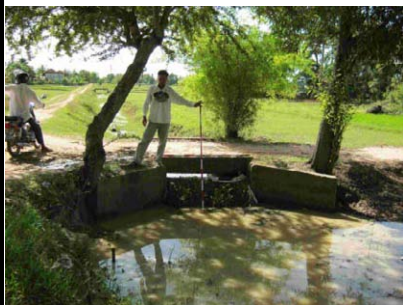
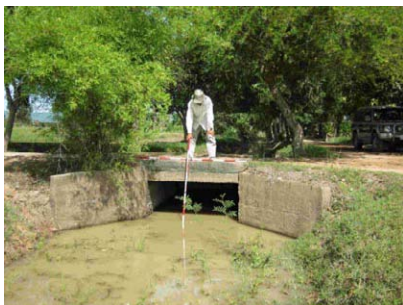
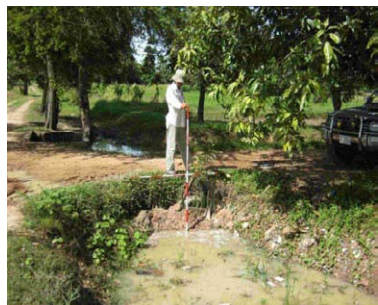
Canal No.: C21	Kind of structure: Bridge	Remarks: - Under a village road - There is a groove
Station: 5.00+780	Coordinate< Northing: 1221124 Easting: 0459034

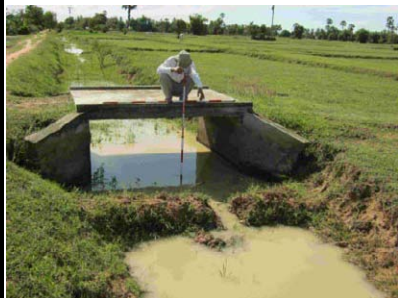
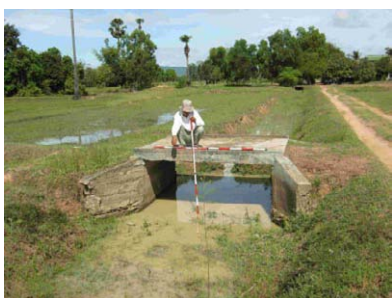
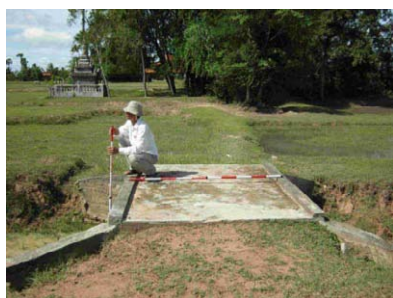
Canal No.: C21	Kind of structure: Bridge (Private)	Remarks:  Under a carte road
Station: 5.00+870	Coordinate< Northing: 1221125 Easting: 0459119

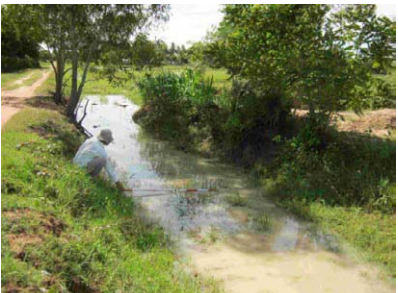
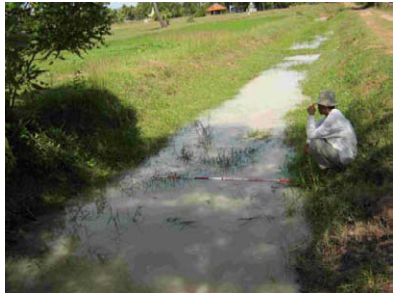
Canal No.: C21	Kind of structure: Canal	Remarks: Routine survey Length: 6000m
Station: 6.00+60	Coordinate< Northing: 1221127 Easting: 0459304	
<div style="display: flex; justify-content: space-around; align-items: center;"> <div style="text-align: center;">

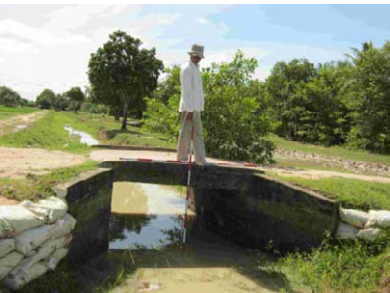
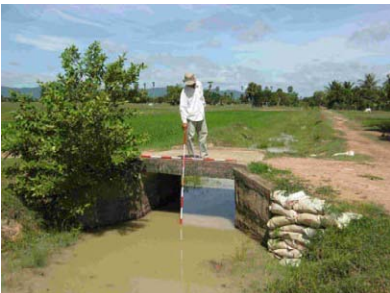
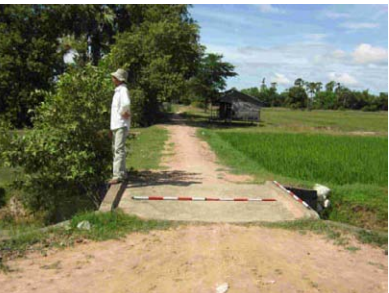
Canal No.: C21	Kind of structure: Bridge (Private)	Remarks: Routine survey
Station: 6.00+280	Coordinate< Northing: 1221124 Easting: 0459521	
<div style="display: flex; justify-content: space-around; align-items: center;"> <div style="text-align: center;">

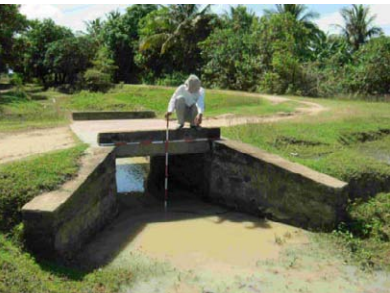
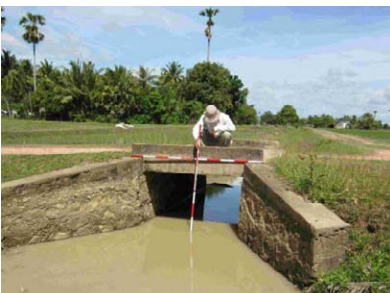
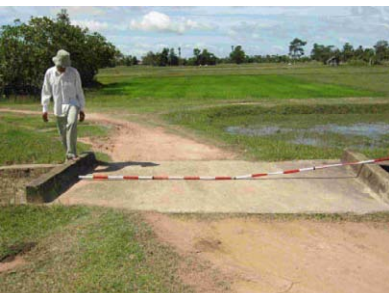
Canal No.: C21	Kind of structure: Bridge (Brasac Organization)	Remarks: Under a village road
Station: 6.00+490	Coordinate< Northing: 1221123 Easting: 0459733	
<div style="display: flex; justify-content: space-around; align-items: center;"> <div style="text-align: center;">

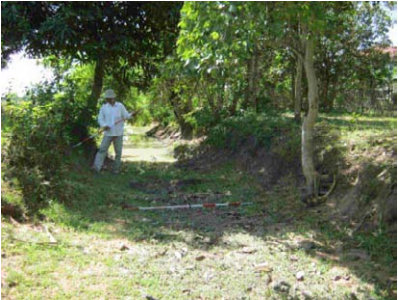
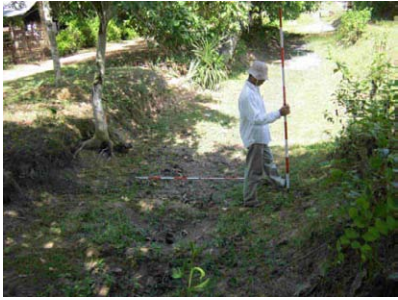
Canal No.: C21	Kind of structure: Canal	Remarks: Routine survey Length: 6500m
Station: 6.00+560	Coordinate< <div style="display: flex; flex-direction: column; gap: 5px;"> <span>Northing: 1221126</span> <span>Easting: 0459809</span> </div>	
<div style="display: flex; justify-content: space-around; align-items: center;"> <div style="text-align: center;">

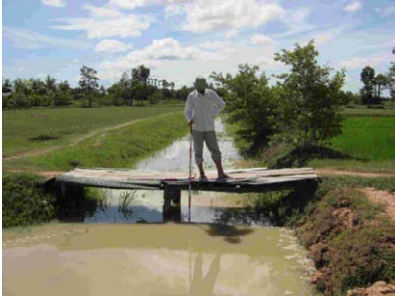
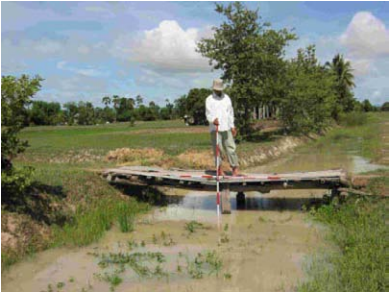
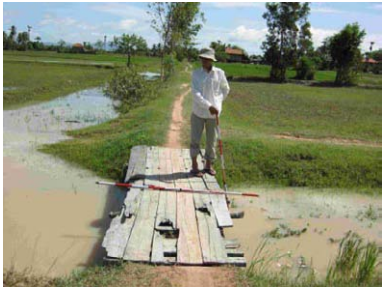
Canal No.: C21	Kind of structure: Wooden Bridge (Private)	Remarks: - Routine survey - There is a secondary canal
Station: 6.00+970	Coordinate< <div style="display: flex; flex-direction: column; gap: 5px;"> <span>Northing: 1221116</span> <span>Easting: 0460214</span> </div>	
<div style="display: flex; justify-content: space-around; align-items: center;"> <div style="text-align: center;">

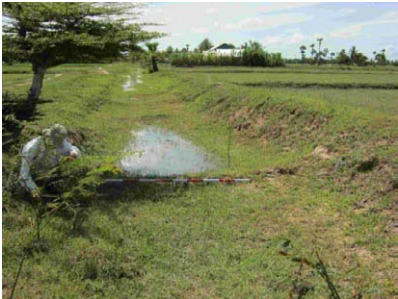
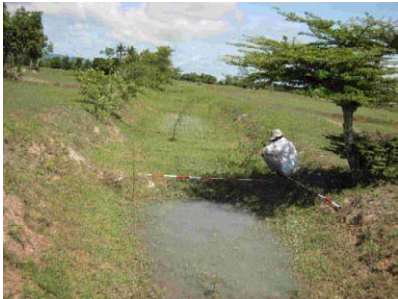
Canal No.: C21	Kind of structure: Canal	Remarks: Routine survey Length: 7000m
Station: 7.00+70	Coordinate< <div style="display: flex; flex-direction: column; gap: 5px;"> <span>Northing: 1221121</span> <span>Easting: 0460308</span> </div>	
<div style="display: flex; justify-content: space-around; align-items: center;"> <div style="text-align: center;">

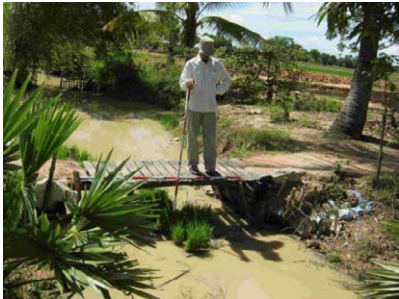
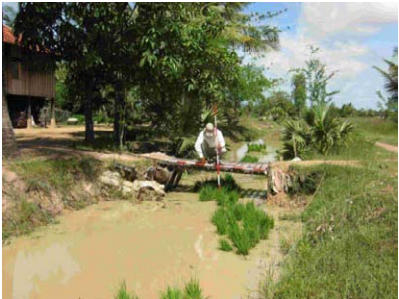
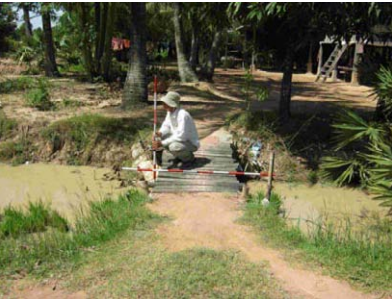
Canal No.: C21	Kind of structure: Wooden Bridge (Private)	Remarks:
Station: 7.00+530	Coordinate< Northing: 1221120 Easting: 0460746	Under house entrance road

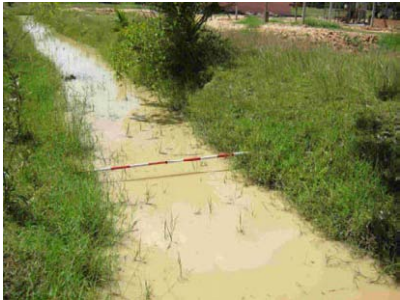
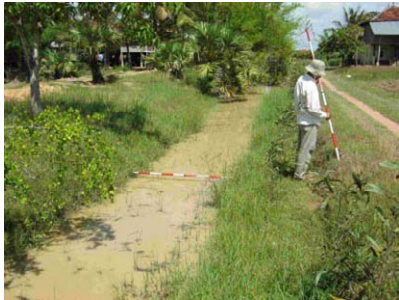
Canal No.: C21	Kind of structure: Canal	Remarks:
Station: 7.00+570	Coordinate< Northing: 1221119 Easting: 0460790	Routine survey Length: 7500m

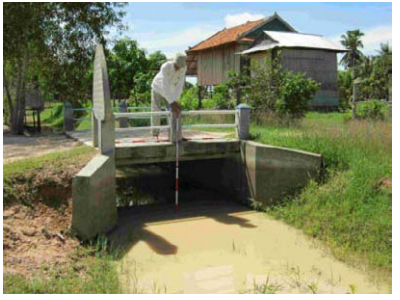
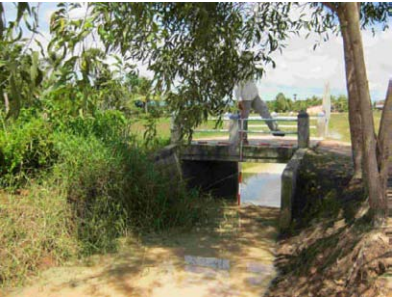
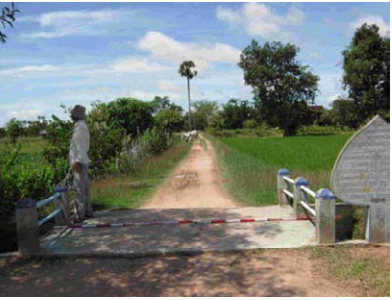
Canal No.: C21	Kind of structure: Bridge (Commune)	Remarks:
Station: 7.00+810	Coordinate< Northing: 1221115 Easting: 0461020	Under a village road

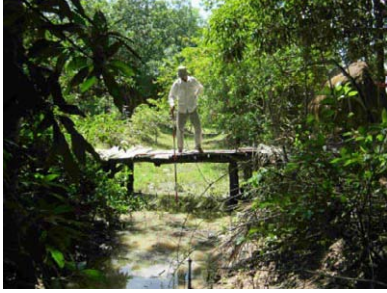
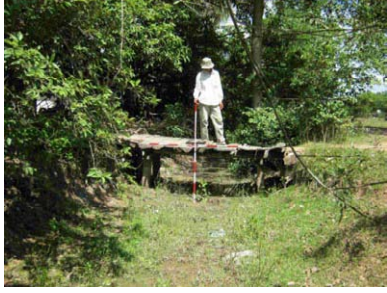
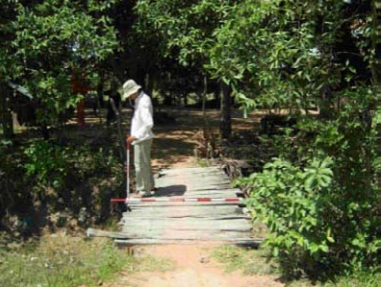
Canal No.: C21	Kind of structure: Wooden Bridge (Private)	Remarks:
Station: 7.00+950	Coordinate< Northing: 1221117 Easting: 0461166	Under house entrance road

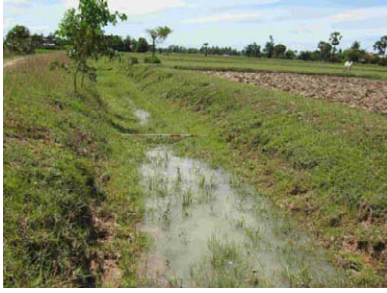
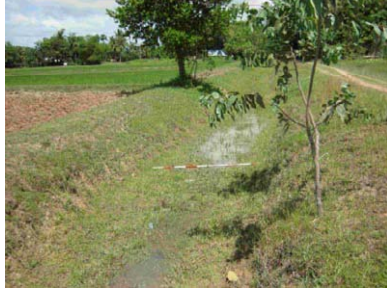
Canal No.: C21	Kind of structure: Canal	Remarks:
Station: 8.00+70	Coordinate< Northing: 1221114 Easting: 0461284	Routine survey Length: 8000m

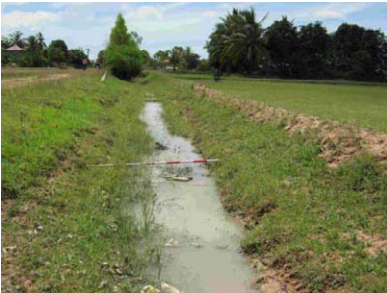
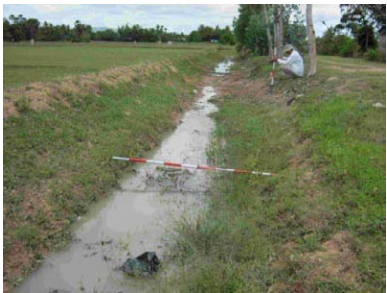
Canal No.: C21	Kind of structure: Canal	Remarks:
Station: 8+280(E.P)	Coordinate< Northing: 1221112 Easting: 0461500	Routine survey

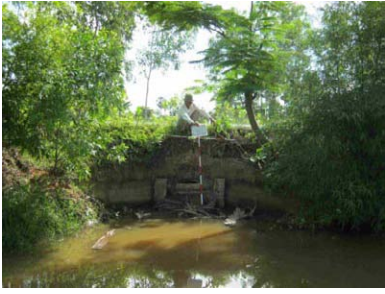
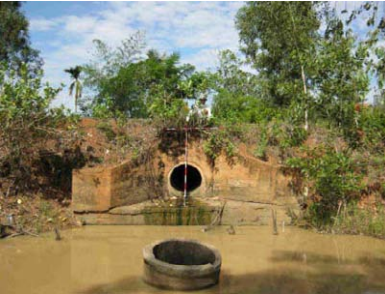
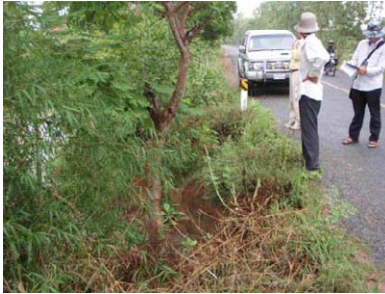
Canal No.: C22	Kind of structure(s): Pipe culvert	Remarks: - Groove - Under national road N0 2
Station: 0.00(B.P.)	Coordinate< Northing: 1222016 Easting: 0452306

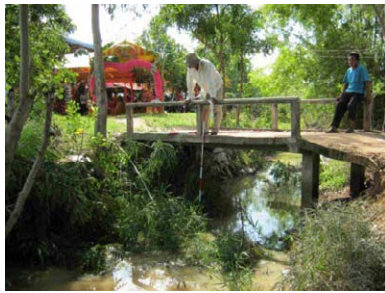
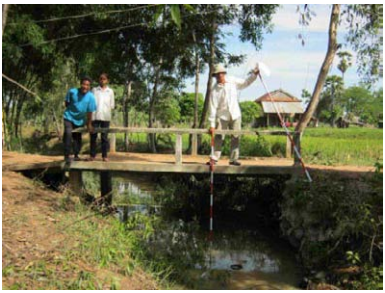
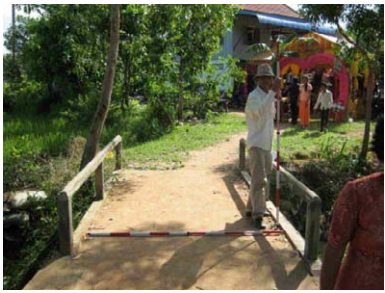
Canal No.: C22	Kind of structure(s): Bridge (Concrete)	Remarks: Under house entrance road
Station: 0.00+50	Coordinate< Northing: 1222025 Easting: 0452367

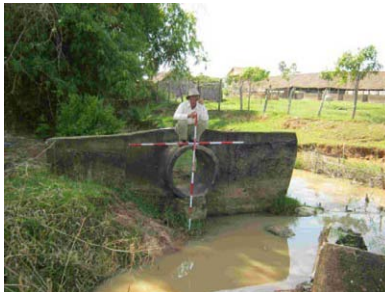
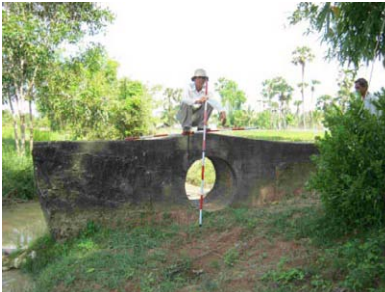
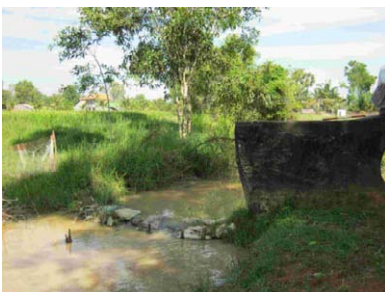
Canal No.: C22	Kind of structure(s): Pipe culvert	Remarks: - Totally broken - Water flows out of culvert
Station: 0.00+230	Coordinate< Northing: 1222032 Easting: 0452534

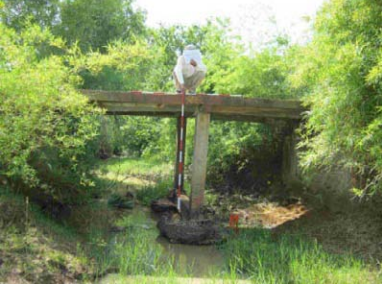
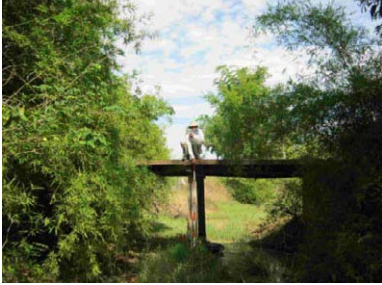
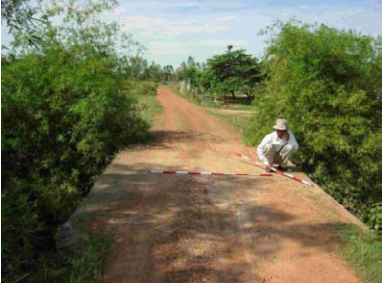
Canal No.: C22	Kind of structure(s): Concrete bridge	Remarks: Under commune road
Station: 0.00+340	Coordinate< Northing: 1222036 Easting: 0452635

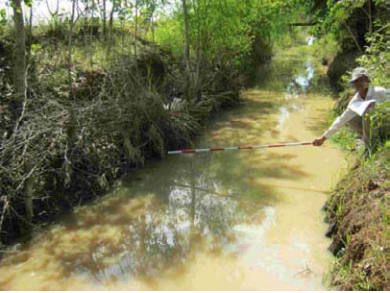
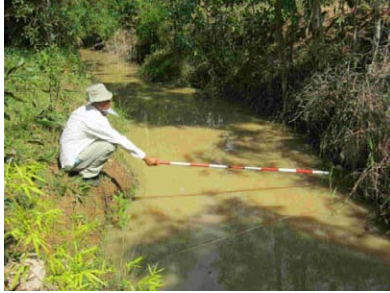
Canal No.: C22	Kind of structure(s): Canal	Remarks: Routine survey Length: 500m
Station: 0.00+620	Coordinate< Northing: 1222030 Easting: 0452758

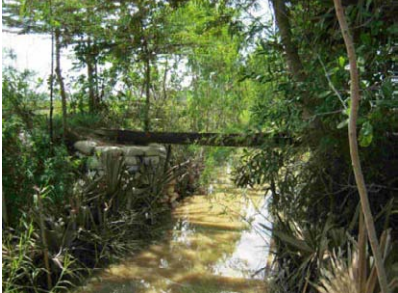
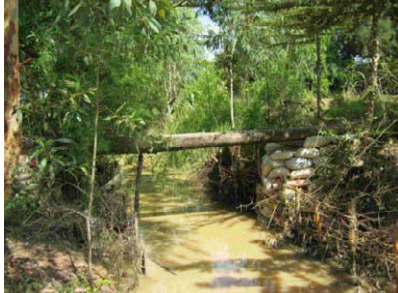
Canal No.: C22	Kind of structure(s): Crossing pipe	Remarks: Routine survey
Station: 0.00+650	Coordinate< Northing: 1222036 Easting: 0452793

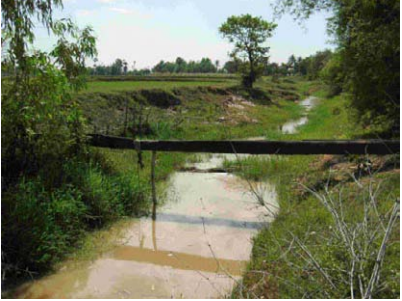
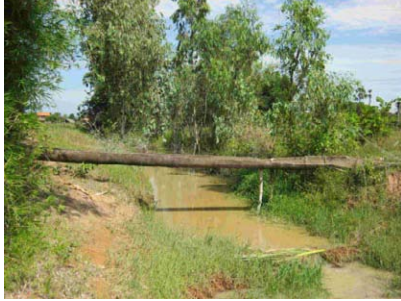
Canal No.: C22	Kind of structure(s): Crossing Pipe	Remarks: - Made by wood (palm tree)
Station: 0.00+720	Coordinate< Northing: 1222036 Easting: 0452860

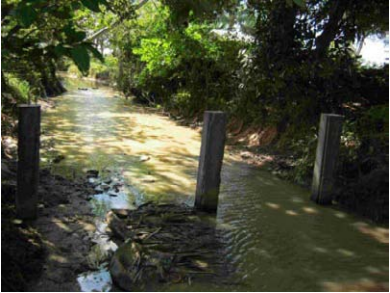
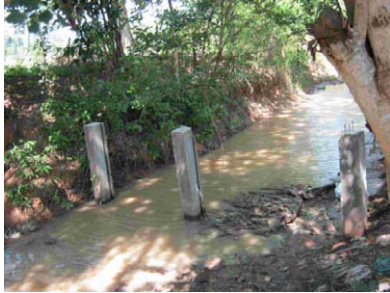
Canal No.: C22	Kind of structure(s): Future bridge	Remarks: - Routine survey - Concrete column
Station: 0.00+990	Coordinate< Northing: 1222050 Easting: 0453118

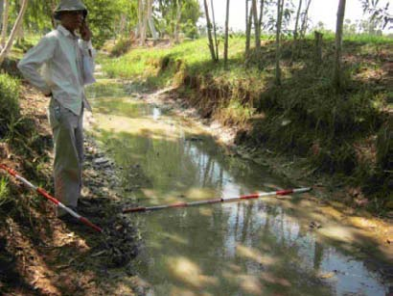
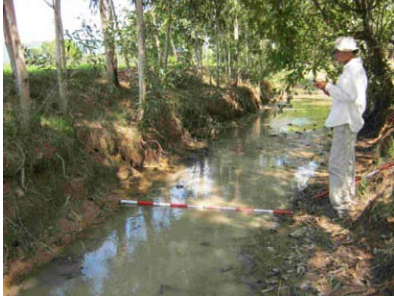
Canal No.: C22	Kind of structure(s): Canal	Remarks: Routine survey Length: 1000m
Station: 1.00+120	Coordinate< Northing: 1222049 Easting: 0453240

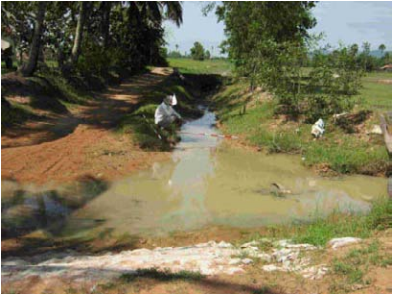
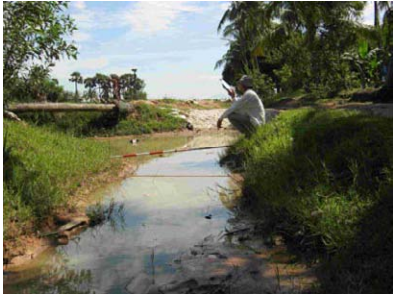
Canal No.: C22	Kind of structure(s): Tertiary crossing point	Remarks:
Station: 1.00+240	Coordinate< Northing: 1222051 Easting: 0453366	Routine survey
<div style="display: flex; justify-content: space-around; align-items: center;"> <div style="text-align: center;">

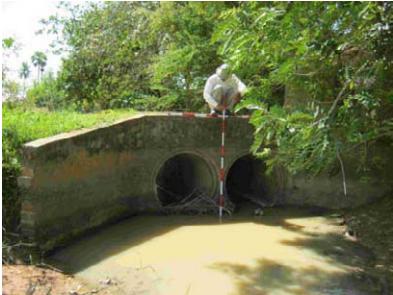
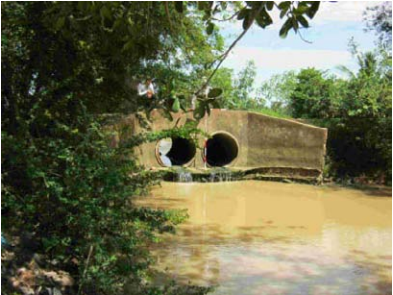
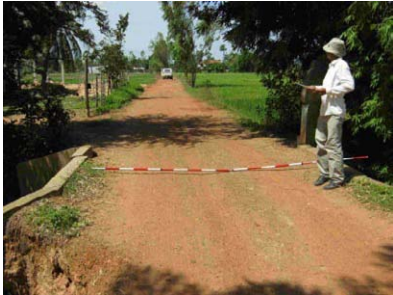
Canal No.: C22	Kind of structure(s): Pipe culvert (Double)	Remarks:
Station: 1.00+500	Coordinate< Northing: 1222045 Easting: 0453598	Under commune road
<div style="display: flex; justify-content: space-around; align-items: center;"> <div style="text-align: center;">
