*Results of Inventory Survey for  
Proposed Rehabilitation Works in  
Roleang Chrey Headworks Rehabilitation Sub-project*

PREPARATORY SURVEY FOR IRRIGATION AND DRAINAGE  
SYSTEM REHABILITATION AND IMPROVEMENT PROJECT

Japan International Cooperation Agency

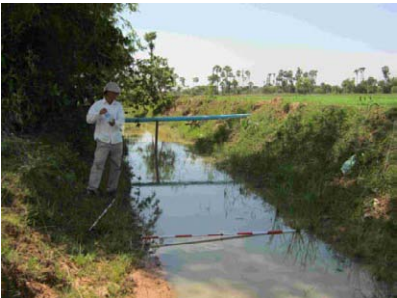
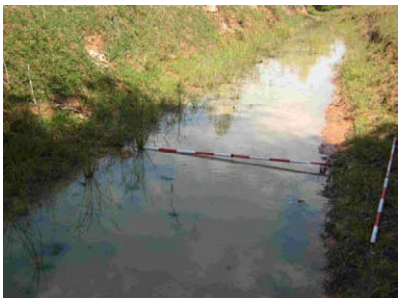
Canal No.: C22	Kind of structure(s): Canal	Remarks:
Station: 1.00+630	Coordinate< Northing: 1222046 Easting: 0453717	Routine survey Length: 1500m
<div style="display: flex; justify-content: space-around; align-items: center;"> <div style="text-align: center;">

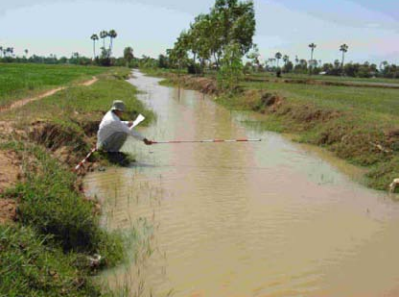
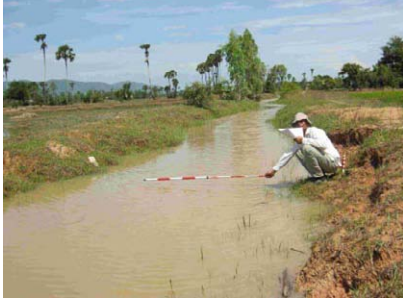
Canal No.: C22	Kind of structure(s): Canal	Remarks: Routine survey Length: 2000m
Station: 2.00+140	Coordinate< Northing: 1222039 Easting: 0454183	
<div style="display: flex; justify-content: space-around; align-items: center;">

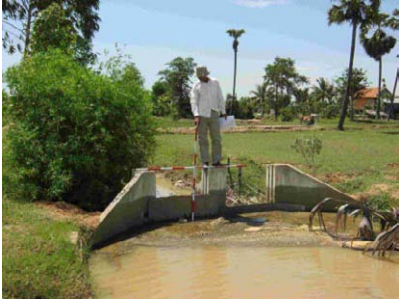
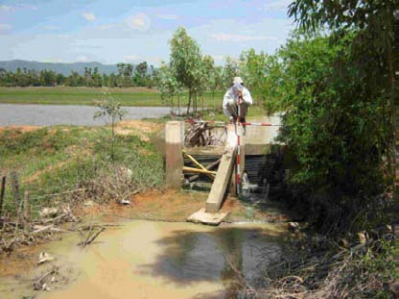
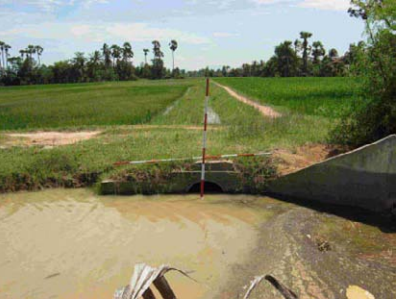
Canal No.: C22	Kind of structure(s): Blockade	Remarks: - Groove takes water into secondary canal
Station: 2.00+420	Coordinate< Northing: 1222026 Easting: 0454450	
<div style="display: flex; justify-content: space-around; align-items: center;">

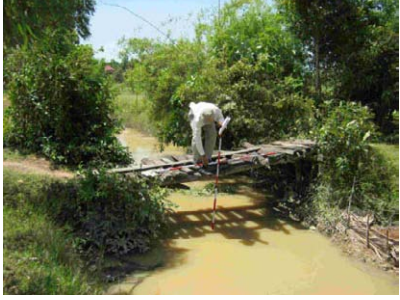
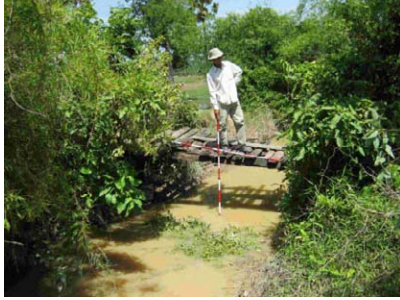
Canal No.: C22	Kind of structure(s): Wooden Bridge	Remarks: - Made by wood
Station: 2.00+510	Coordinate< Northing: 1222024 Easting: 0454530	
<div style="display: flex; justify-content: space-around; align-items: center;">

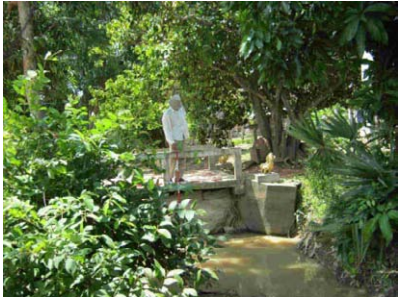
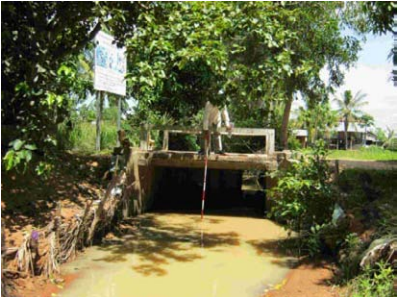
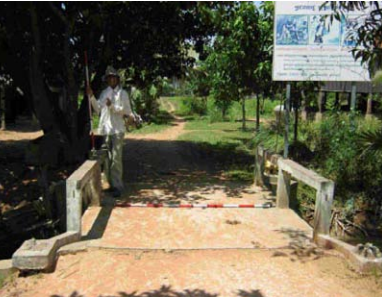
Canal No.: C22	Kind of structure(s): Concrete Bridge	Remarks: - Under village road - Length: 2500m
Station: 2.00+650	Coordinate< Northing: 1222023 Easting: 0454677

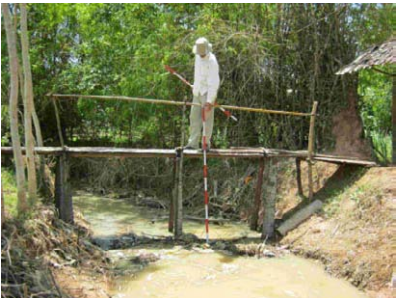
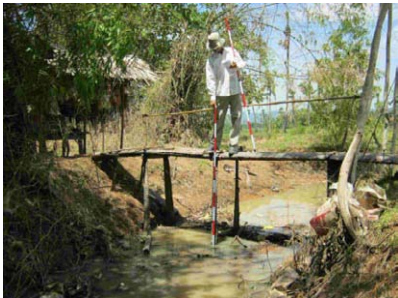
Canal No.: C22	Kind of structure(s): Bridge (Wooden)	Remarks: - Made by wood
Station: 2.00+900	Coordinate< Northing: 1222015 Easting: 0454916

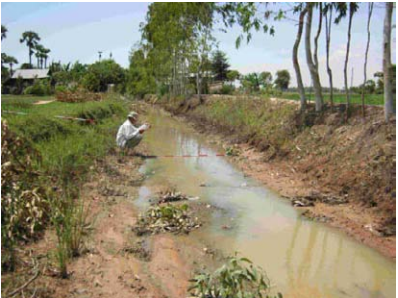
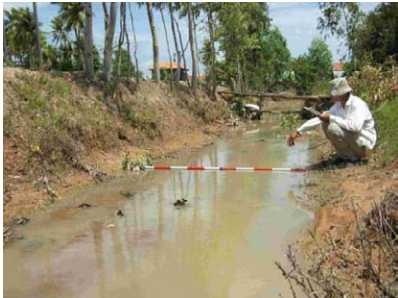
Canal No.: C22	Kind of structure(s): Canal	Remarks: Routine survey Length: 3000m
Station: 3.00+150	Coordinate< Northing: 1222009 Easting: 0455077

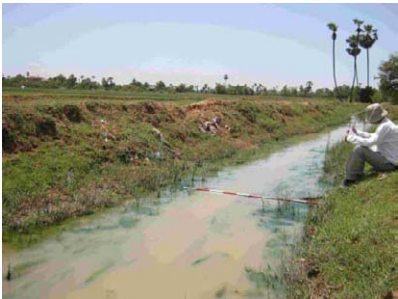
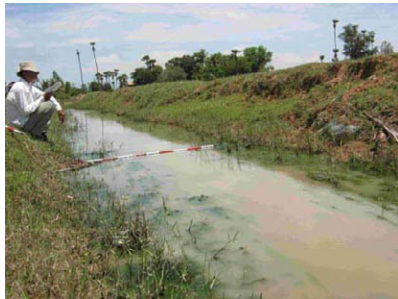
Canal No.: C22	Kind of structure(s): Canal	Remarks: Routine survey Length: 3500m
Station: 3.00+680	Coordinate< Northing: 1221989 Easting: 0455524	
<div style="display: flex; justify-content: space-around; align-items: center;"> <div style="text-align: center;">

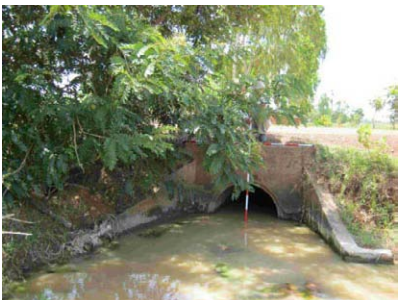
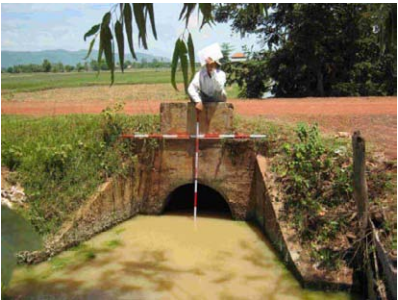
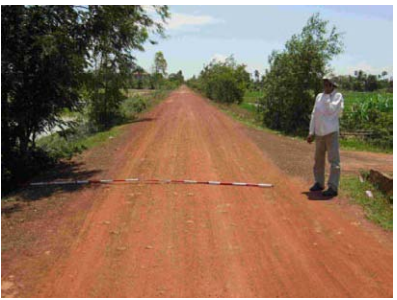
Canal No.: C22	Kind of structure(s): Pipe culvert (Commune)	Remarks: - Under commune road
Station: 3.00+950	Coordinate< Northing: 1221982 Easting: 0455782	
<div style="display: flex; justify-content: space-around; align-items: center;"> <div style="text-align: center;">

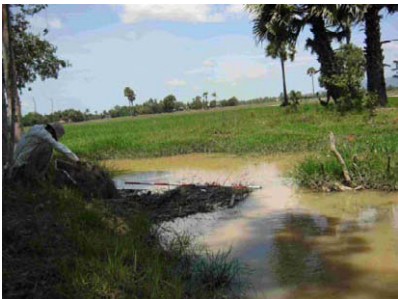
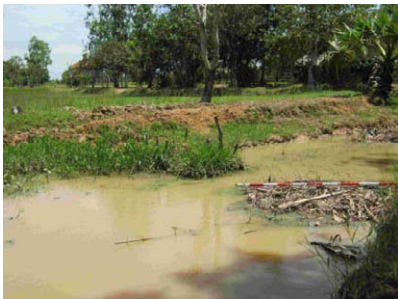
Canal No.: C22	Kind of structure(s): Canal	Remarks: Routine survey Length: 4000m
Station: 4.00+190	Coordinate< Northing: 1221961 Easting: 0455996	
<div style="display: flex; justify-content: space-around; align-items: center;"> <div style="text-align: center;">

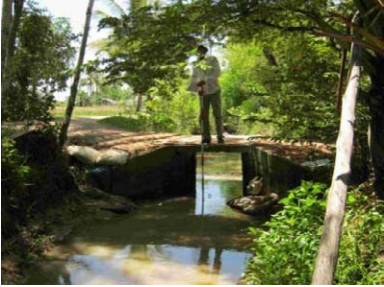
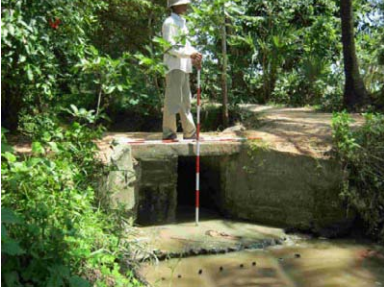
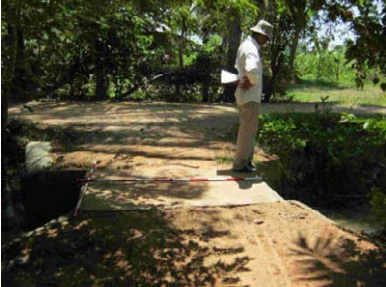
Canal No.: C22	Kind of structure(s): Bridge	Remarks: - Under house entrance road - There is a groove
Station: 4.00+500	Coordinate< Northing: 1221938 Easting: 0456299

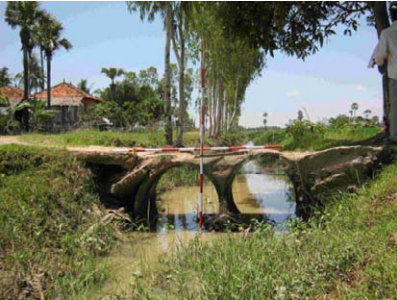
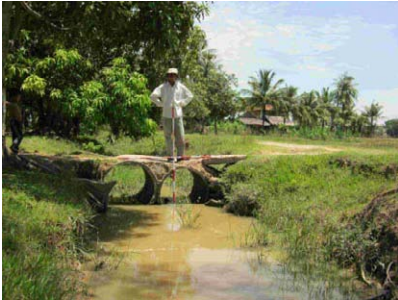
Canal No.: C22	Kind of structure(s): Pipe culvert (Double)	Remarks: Routine survey
Station: 4.00+570	Coordinate< Northing: 1221939 Easting: 0456361

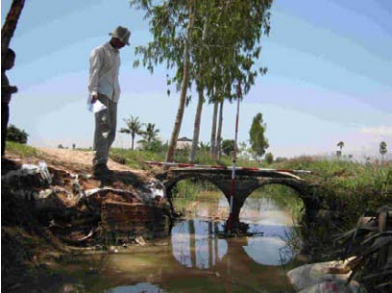
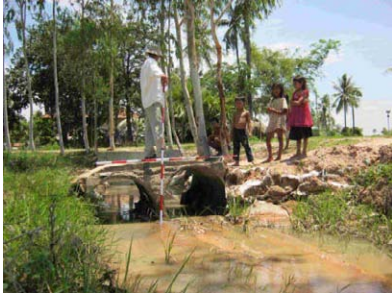
Canal No.: C22	Kind of structure(s): Pipe culvert (Double)	Remarks: Routine survey Length: 4500m
Station: 4.00+690	Coordinate< Northing: 1221960 Easting: 0456457

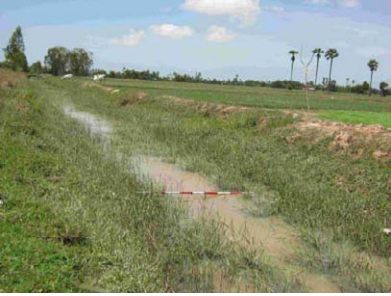
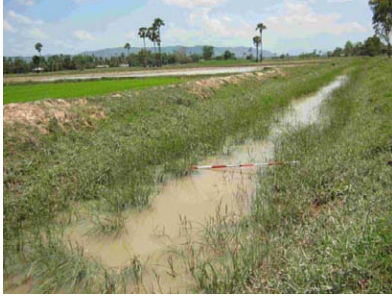
Canal No.: C22	Kind of structure(s): Canal	Remarks: Routine survey Length: 5000m
Station: 5.00+190	Coordinate< Northing: 1221946 Easting: 0456913	
<div style="display: flex; justify-content: space-around; align-items: center;"> <div style="text-align: center;">

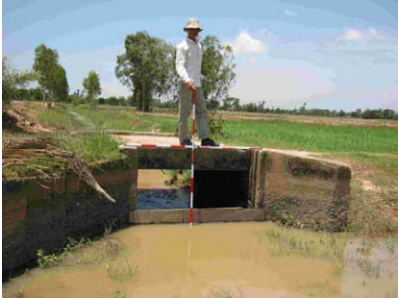
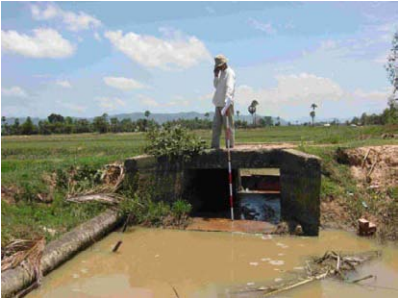
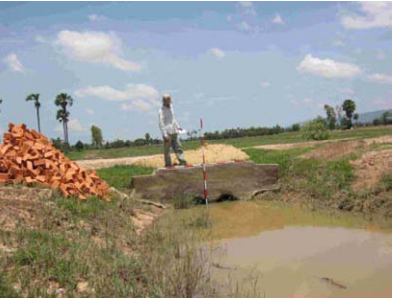
Canal No.: C22	Kind of structure(s): Concrete Bridge	Remarks: - Groove (Double pipe culvert)
Station: 5.00+320	Coordinate< Northing: 1221935 Easting: 0457033	
<div style="display: flex; justify-content: space-around; align-items: center;"> <div style="text-align: center;">

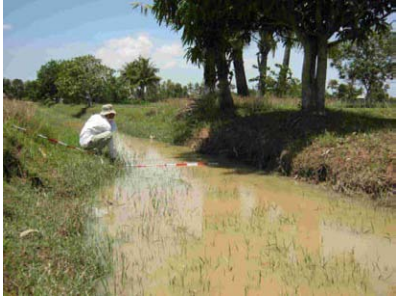
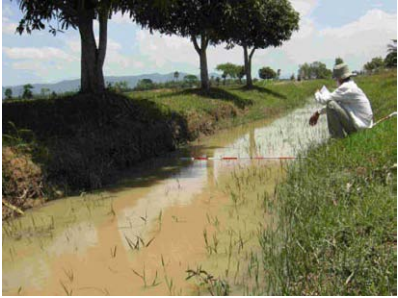
Canal No.: C22	Kind of structure(s): Canal	Remarks: Routine survey Length: 5500m
Station: 5.00+690	Coordinate< Northing: 1221924 Easting: 0457373	
<div style="display: flex; justify-content: space-around; align-items: center;"> <div style="text-align: center;">

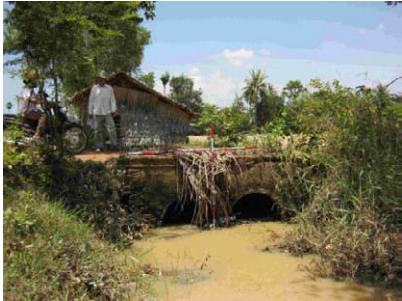
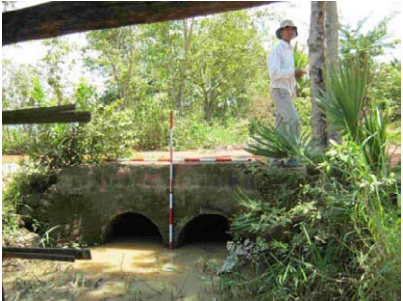
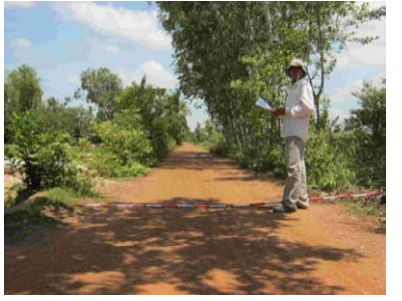
Canal No.: C22	Kind of structure(s): Pipe culvert (Double)	Remarks: Routine survey Under commune road
Station: 5.00+990	Coordinate< Northing: 1221914 Easting: 0457652

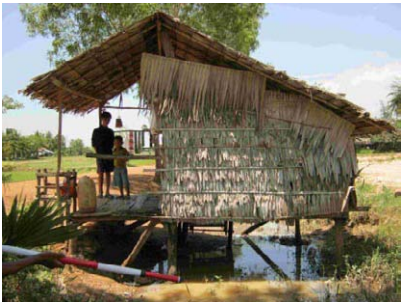
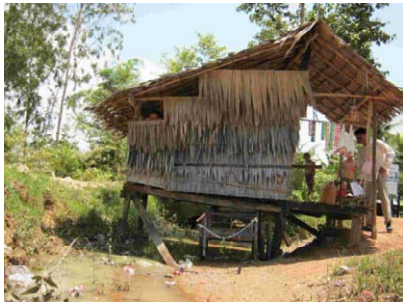
Canal No.: C22	Kind of structure(s): House (Cottage)	Remarks: Routine survey
Station: 5.00+990	Coordinate< Northing: 1221911 Easting: 0457658

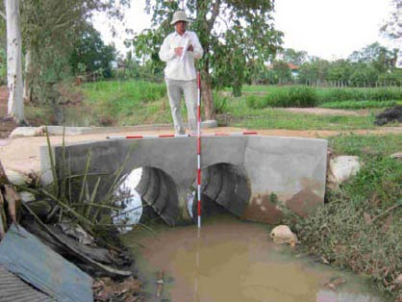
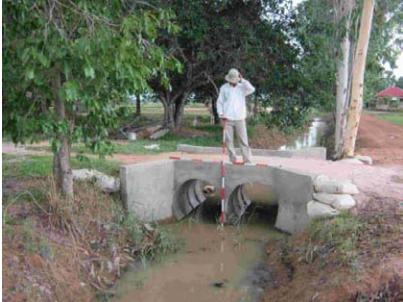
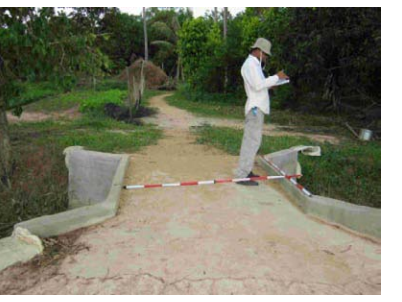
Canal No.: C22	Kind of structure(s): Pipe culvert (Double)	Remarks: - Under village road
Station: 6.00+90	Coordinate< Northing: 1221908 Easting: 0457755

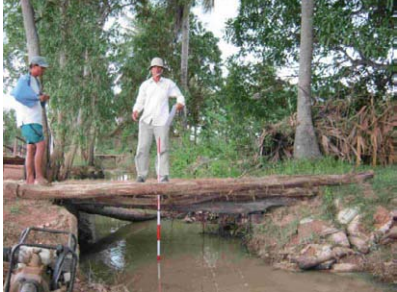
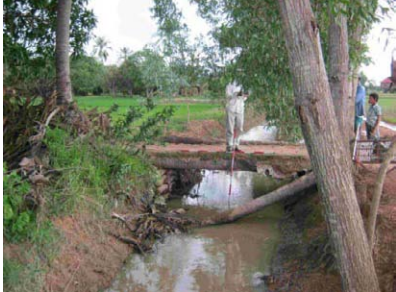
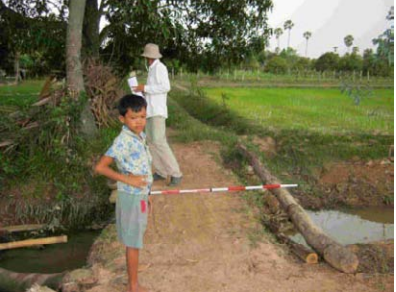
Canal No.: C22	Kind of structure(s): Wooden Bridge	Remarks: - Under a small bicycle road - Length: 6000m
Station: 6.00+170	Coordinate< Northing: 1221908 Easting: 0457838

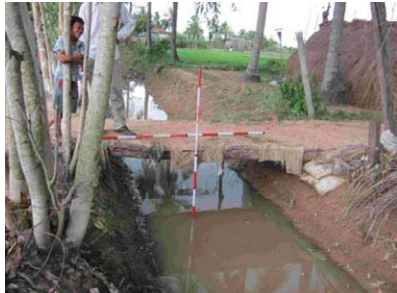
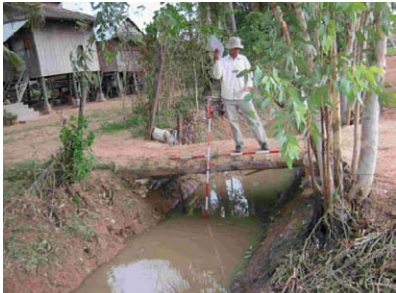
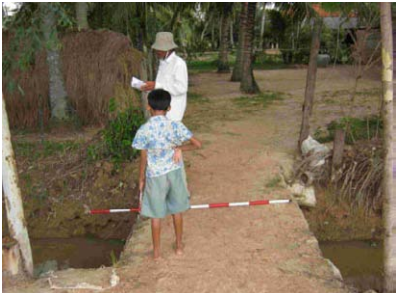
Canal No.: C22	Kind of structure(s): Bridge	Remarks: Under house entrance road
Station: 6.00+210	Coordinate< Northing: 1221906 Easting: 0457878

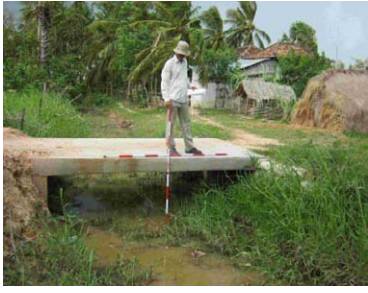
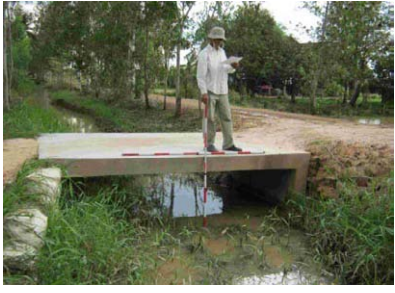
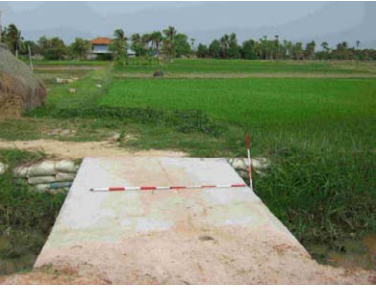
Canal No.: C22	Kind of structure(s): Bridge (Private)	Remarks: Under small bicycle road
Station: 6.00+320	Coordinate< Northing: 1221898 Easting: 0457985

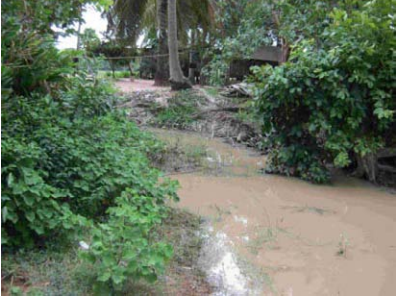
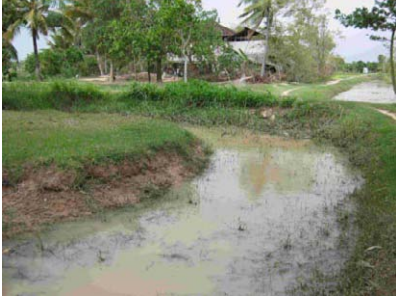
Canal No.: C22	Kind of structure(s): Turning point	Remarks: Routine survey
Station: 6.00+370	Coordinate< Northing: 1221883 Easting: 0458040	
<div style="display: flex; justify-content: space-around; align-items: center;"> <div style="text-align: center;">

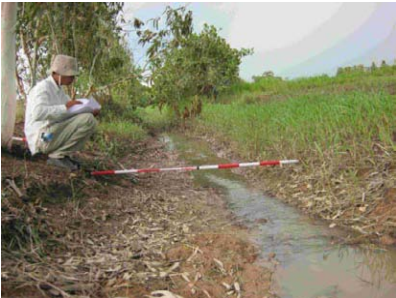
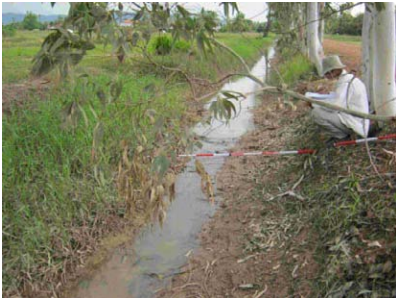
Canal No.: C22	Kind of structure(s): Canal	Remarks: Routine survey Length: 6500m
Station: 6.00+670	Coordinate< Northing: 1221907 Easting: 0458295	
<div style="display: flex; justify-content: space-around; align-items: center;"> <div style="text-align: center;">

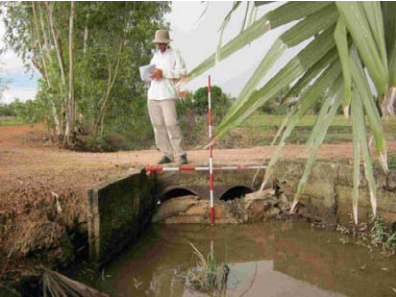
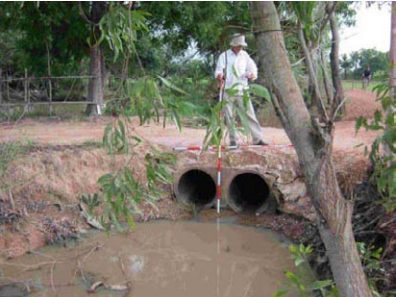
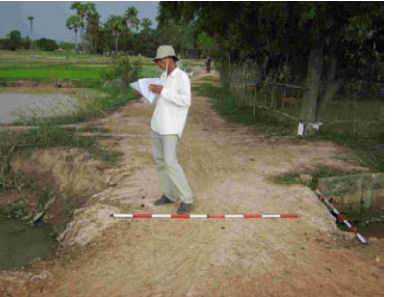
Canal No.: C22	Kind of structure(s): Pipe culvert (Double)	Remarks: Under a village road
Station: 7.00+50	Coordinate< Northing: 1221887 Easting: 0458644	
<div style="display: flex; justify-content: space-around; align-items: center;"> <div style="text-align: center;">

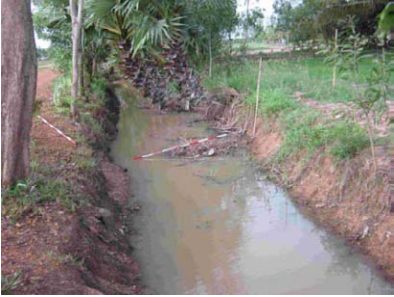
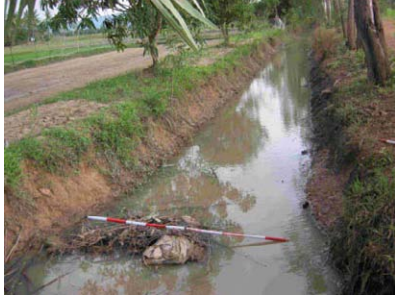
Canal No.: C22	Kind of structure(s): Canal	Remarks: Routine survey Length: 7000m
Station: 7.00+170	Coordinate< Northing: 1221889 Easting: 0458759	
<div style="display: flex; justify-content: space-around; align-items: center;"> <div style="text-align: center;">

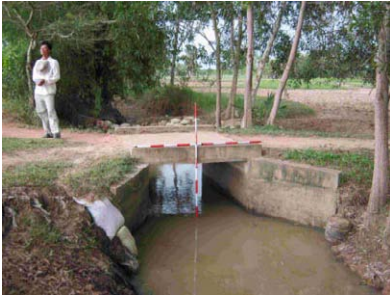
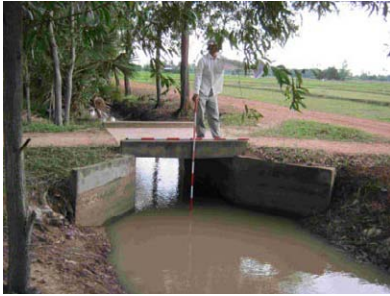
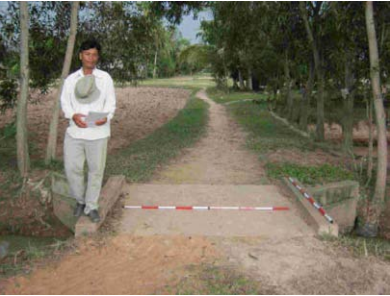
Canal No.: C22	Kind of structure(s): Bridge	Remarks: - Box culvert - Under a small road
Station: 7.00+200	Coordinate< Northing: 1221887 Easting: 0458803	
<div style="display: flex; justify-content: space-around; align-items: center;"> <div style="text-align: center;">

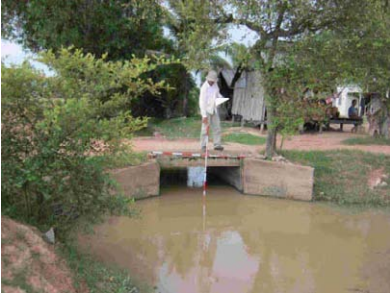
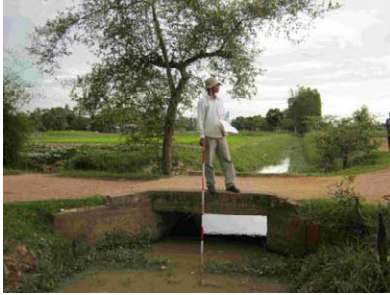
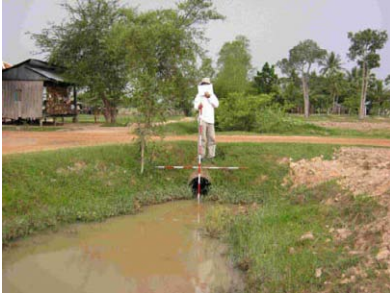
Canal No.: C22	Kind of structure(s): Bridge	Remarks: - Under a village road - Groove (pipe culvert) take water to secondary canal
Station: 7.00+440	Coordinate< Northing: 1221887 Easting: 0459033	
<div style="display: flex; justify-content: space-around; align-items: center;"> <div style="text-align: center;">

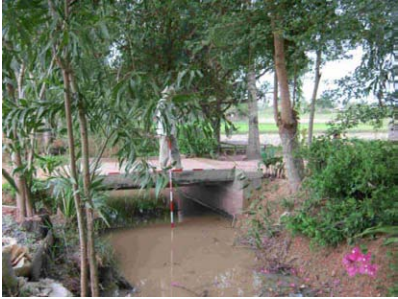
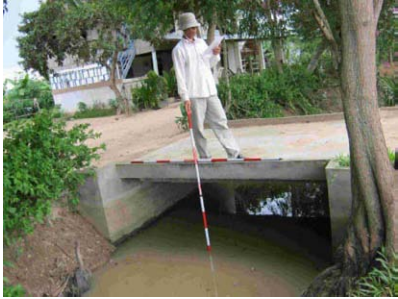
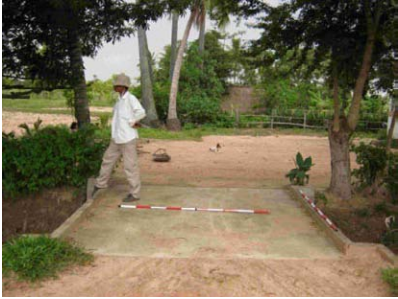
Canal No.: C22	Kind of structure(s): Bridge	Remarks: Under village road Length: 7500m
Station: 7.00+680	Coordinate< Northing: 1221890 Easting: 0459254

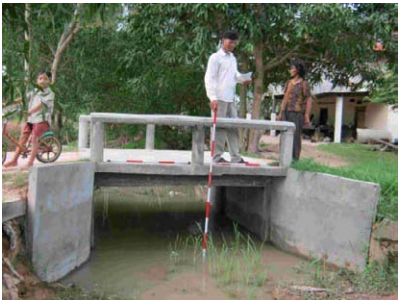
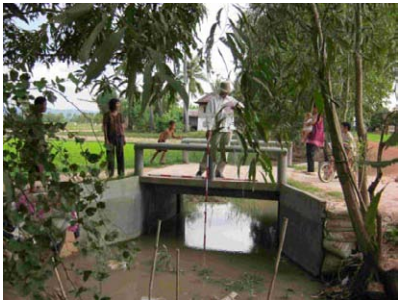
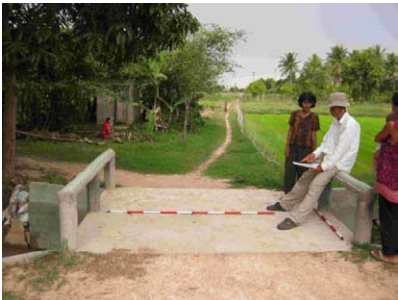
Canal No.: C22	Kind of structure(s): Bridge (Private)	Remarks: Under small village road
Station: 7.00+730	Coordinate< Northing: 1221886 Easting: 0459301

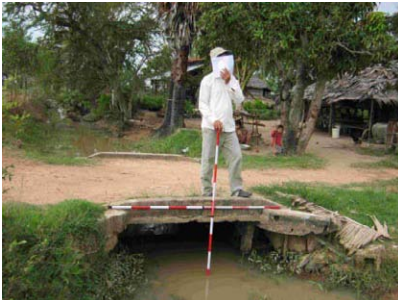
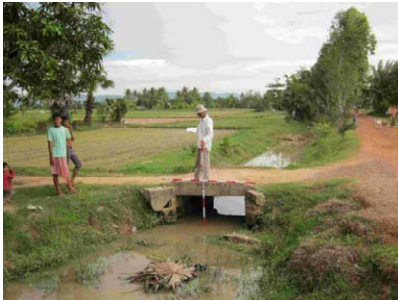
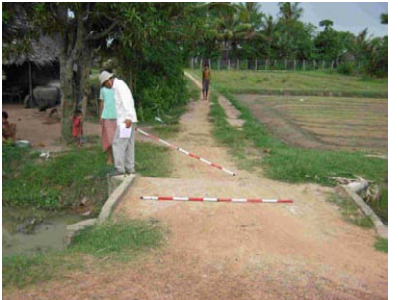
Canal No.: C22	Kind of structure(s): Bridge (Village)	Remarks: Under small village road
Station: 7.00+930	Coordinate< Northing: 1221886 Easting: 0459490

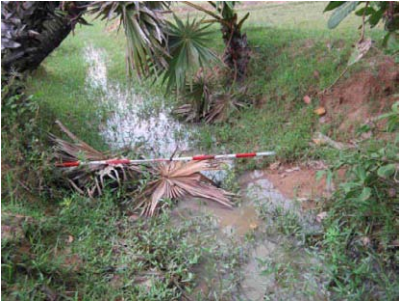
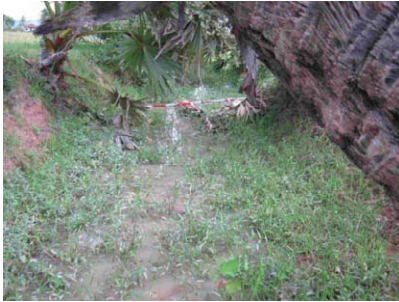
Canal No.: C22	Kind of structure(s): Canal	Remarks: Routine survey Length: 8000m
Station: 8.00+200	Coordinate< Northing: 1221887 Easting: 0459754

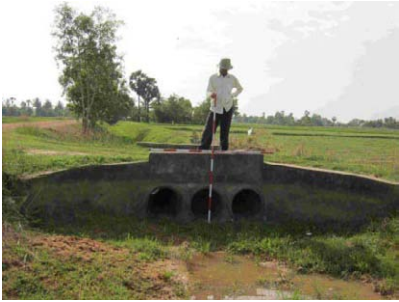
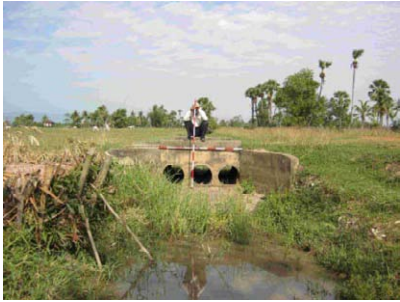
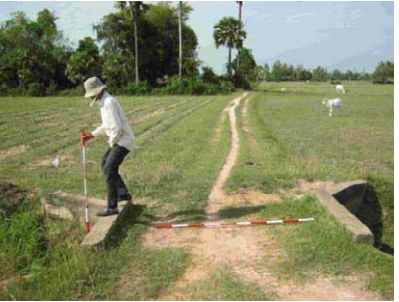
Canal No.: C22	Kind of structure(s): Pipe culvert (Triple)	Remarks: Under a small carte road
Station: 8.00+210	Coordinate< Northing: 1221887 Easting: 0459852

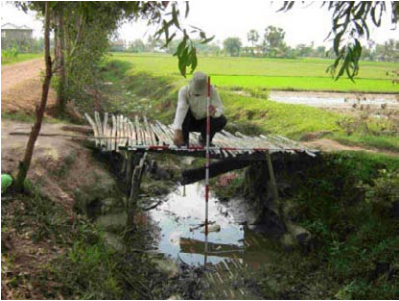
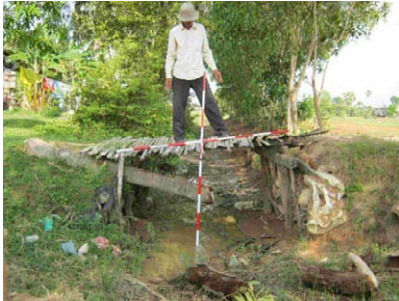
Canal No.: C22	Kind of structure(s): Wooden Bridge (Private)	Remarks: Routine survey
Station: 8.00+360	Coordinate< Northing: 1221891 Easting: 0459998

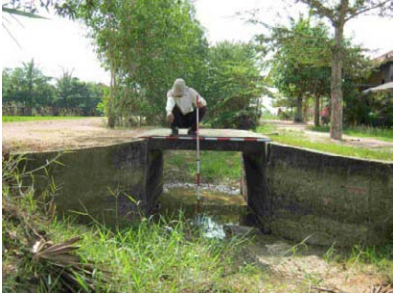
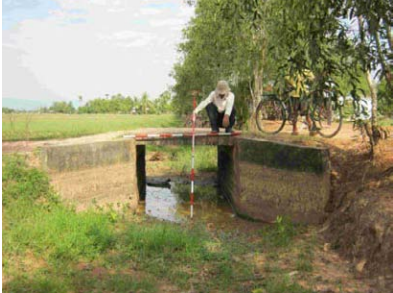
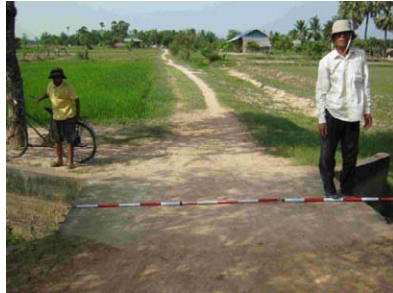
Canal No.: C22	Kind of structure(s): Bridge (Private)	Remarks: Under small bicycle road Length: 8500m
Station: 8.00+610	Coordinate< Northing: 1221889 Easting: 0460221

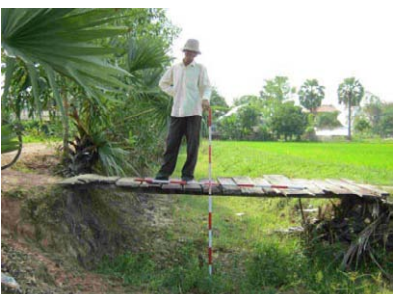
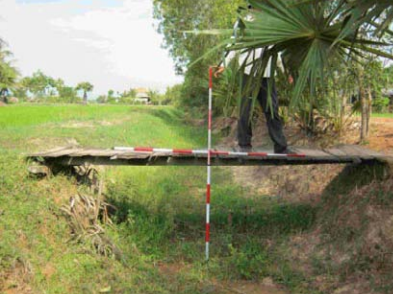
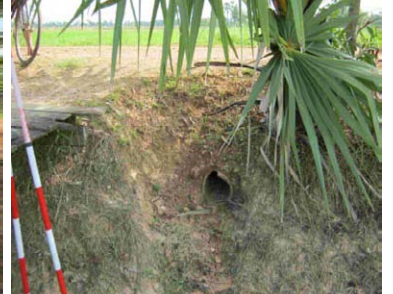
Canal No.: C22	Kind of structure(s): Bridge (Private)	Remarks: Routine survey
Station: 8.00+810	Coordinate< Northing: 1221889 Easting: 0460405

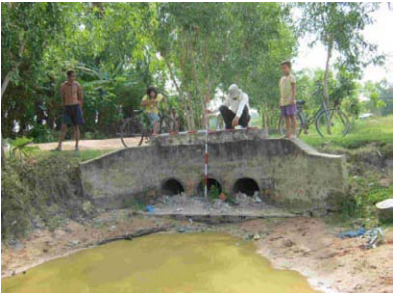
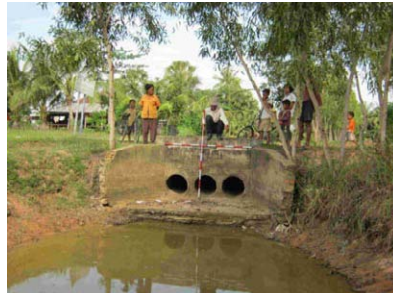
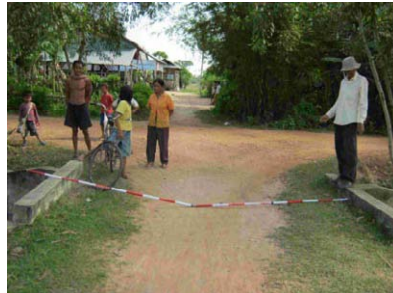
Sta.	E	N	Structure	Condition	Evaluation*	Flow Capacity	Remarks
9,010	460591	1221880	Culvert 11 (Triple)	Three pipes of 0.5 m dia each, 3 m long	C	c	on village road
9,110	460679	1221893	Canal section	Canal section remain with bottom width of 2 m	C		
9,180	460749	1221891	Culvert 12 (Private)	Wooden bridge of 2 m wide	D	-	House access
9,250	460822	1221893	Tertially Crossing Point				
9,410	460976	1221892	Culvert 13 (Double)	Two pipes of 0.7 m dia each and 2.8 m long	C	b	on village road
9,550	461114	1221898	Bridge 19 (private)	Wooden bridge of 1 m wide	D	-	Wooden bridge, house access
9,650	461199	1221897	Culvert-14 (private)	2 m span and 2.5 m wide with grooves for planks	B	b	House access
9,690	461237	1221900	Canal section	Canal section remain with bottom width of 2 m	B		
9,980	461517	1221900	E.P (Bridge 19)	1.8 m span and 3 m wide with grooves for planks	B		House access

Canal No.: C22	Kind of structure(s): Pipe culvert (Triple)	Remarks: Under a village road
Station: 9.00+10	Coordinate< Northing: 1221880 Easting: 0460591

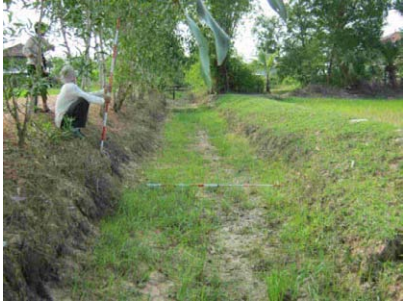
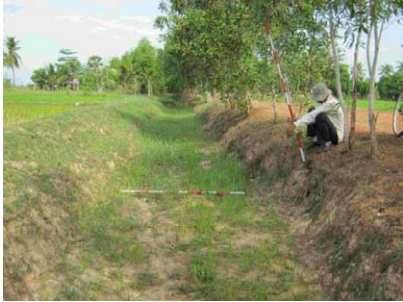
Canal No.: C22	Kind of structure(s): Canal	Remarks: Routine survey Length: 9000m
Station: 9.00+110	Coordinate< Northing: 1221893 Easting: 0460679	
<div style="display: flex; justify-content: space-around; align-items: center;"> <div style="text-align: center;">

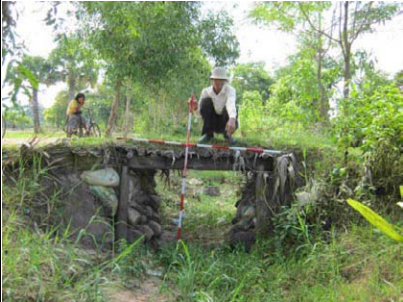
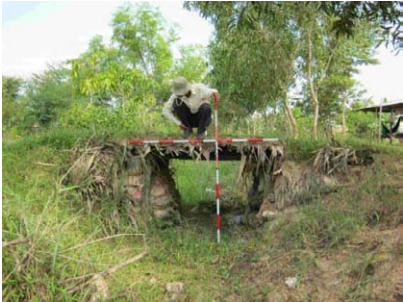
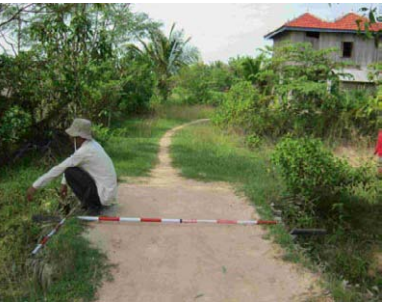
Canal No.: C22	Kind of structure(s): Bridge (Private)	Remarks: - Routine survey - Under house entrance road
Station: 9.00+180	Coordinate< Northing: 1221891 Easting: 0460749	
<div style="display: flex; justify-content: space-around; align-items: center;"> <div style="text-align: center;">

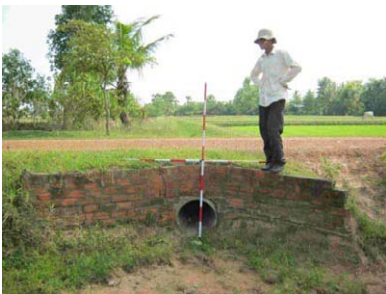
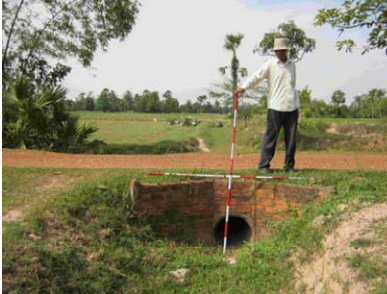
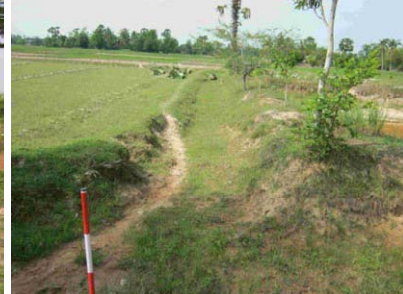
Canal No.: C22	Kind of structure(s): Pipe culvert	Remarks: Routine survey Tertiary crossing
Station: 9.00+250	Coordinate< Northing: 1221893 Easting: 0460822	
<div style="display: flex; justify-content: space-around; align-items: center;"> <div style="text-align: center;">

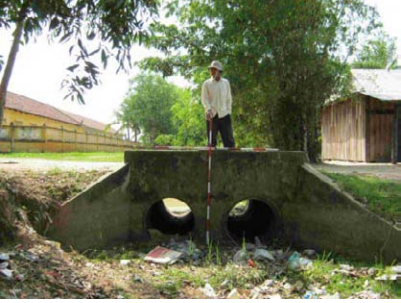
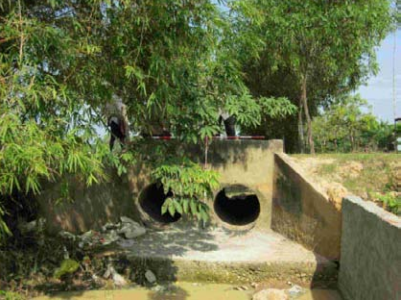
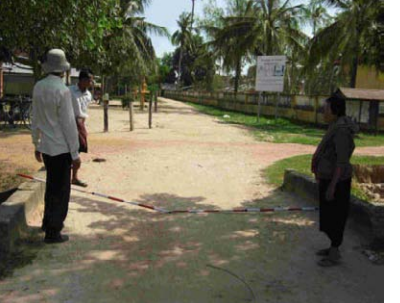
Canal No.: C22	Kind of structure(s): Pipe culvert (Double)	Remarks: Under commune road
Station: 9.00+410	Coordinate< Northing: 1221892 Easting: 0460976

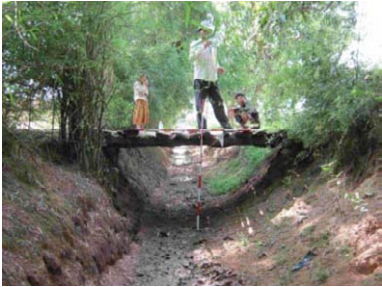
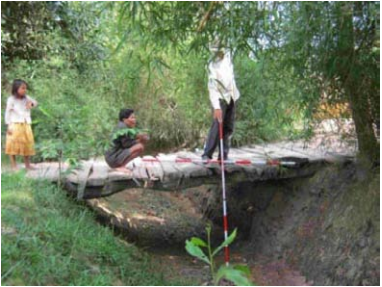
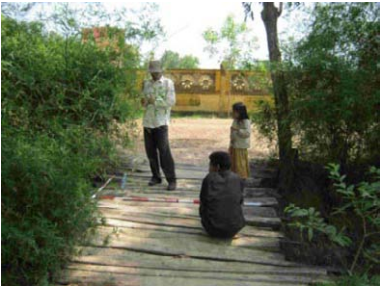
Canal No.: C22	Kind of structure(s): Bridge (Private)	Remarks: - Routine survey - Made by wood
Station: 9.00+550	Coordinate< Northing: 1221898 Easting: 0461114

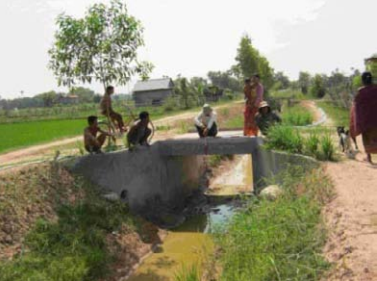
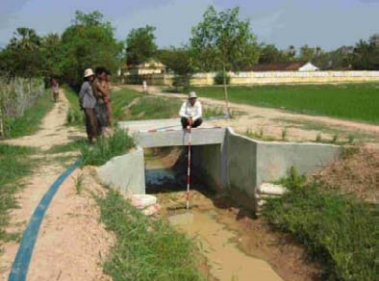
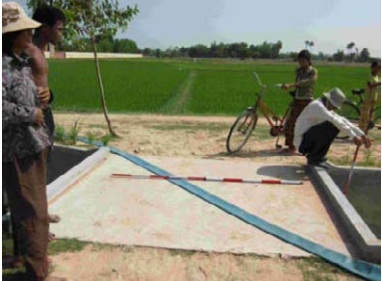
Canal No.: C22	Kind of structure(s): Bridge (Private)	Remarks: Routine survey
Station: 9.00+650	Coordinate< Northing: 1221897 Easting: 0461199

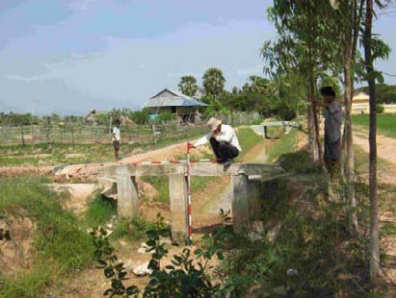
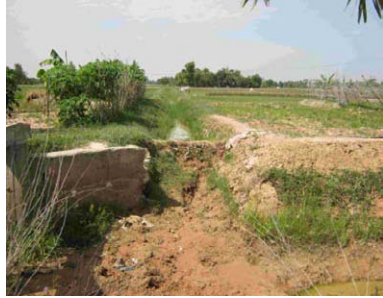
Canal No.: C22	Kind of structure(s): Check structure	Remarks: - Totally broken - Groove takes water into secondary canal, Length: 9500m
Station: 9.00+690	Coordinate< Northing: 1221900 Easting: 0461237

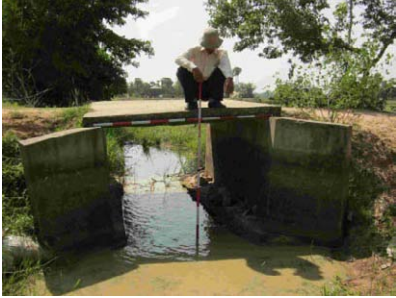
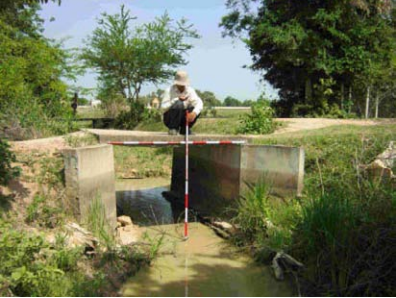
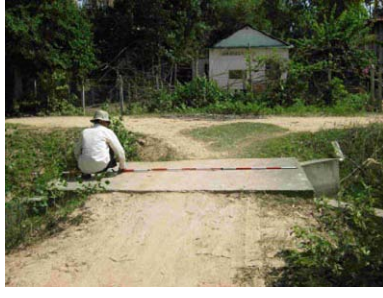
Canal No.: C22	Kind of structure(s): Bridge	Remarks: Under small village road (E.P.)
Station: 9.00+980(EP)	Coordinate< Northing: 1221900 Easting: 0461517

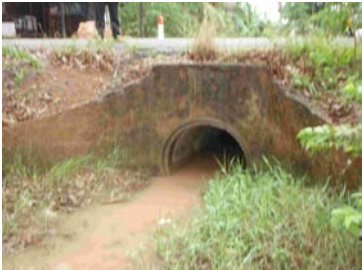
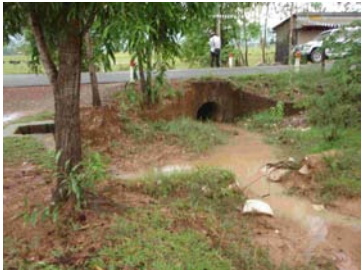
Canal No.: C23	Kind of structure: Pipe culvert	Remarks: Under National Road 130A
Station: 0.00(B.P.)	Coordinate< <div style="display: flex; justify-content: space-between; padding: 0 5px;"> <span>Northing: 1222762</span> <span>Easting: 451255</span> </div>	
<div style="display: flex; justify-content: space-around; align-items: center;">

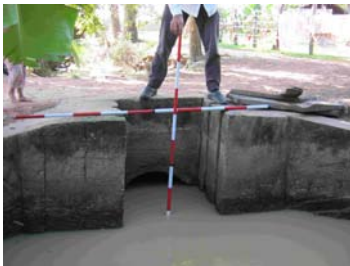
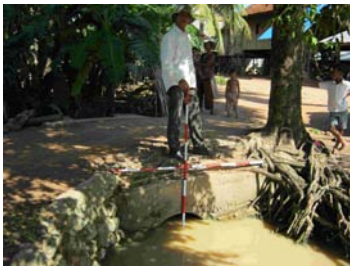
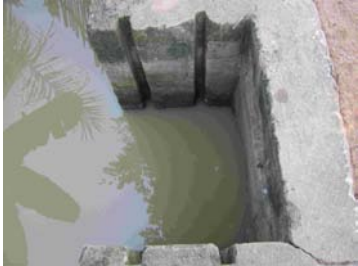
Canal No.: C23	Kind of structure: Pipe culvert	Remarks: Under house entrance road
Station: 0.00+40	Coordinate< <div style="display: flex; justify-content: space-between; padding: 0 5px;"> <span>Northing: 1222801</span> <span>Easting: 451274</span> </div>	
<div style="display: flex; justify-content: space-around; align-items: center;">

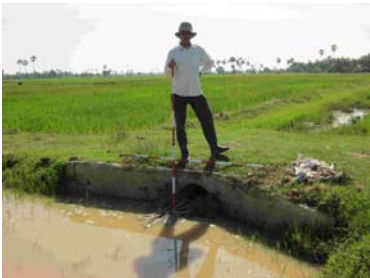
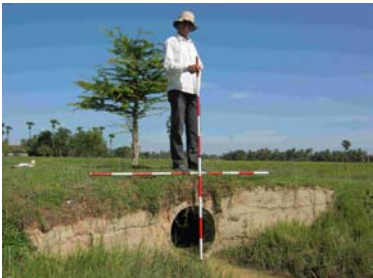
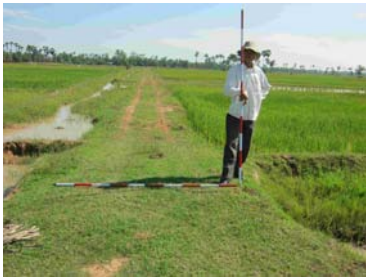
Canal No.: C23	Kind of structure: Pipe culvert	Remarks: Pipe culvert under carte road
Station: 0.00+290	Coordinate< <div style="display: flex; justify-content: space-between; padding: 0 5px;"> <span>Northing: 1222792</span> <span>Easting: 451513</span> </div>	
<div style="display: flex; justify-content: space-around; align-items: center;">

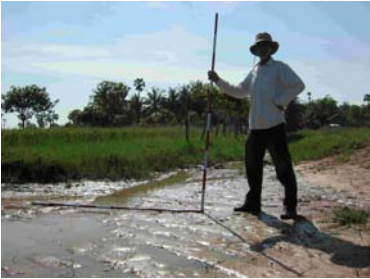
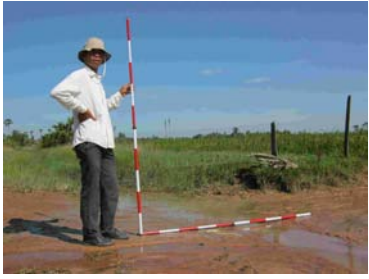
Canal No.: C23	Kind of structure: Dry canal	Remarks: Dry canal Length: 500m
Station: 0.00+500	Coordinate< <div style="display: inline-block; vertical-align: middle; margin-left: 10px;">                     Northing: 1222779                      Easting: 451715                 </div>	
<div style="display: flex; justify-content: space-around; align-items: center;"> <div style="text-align: center;">

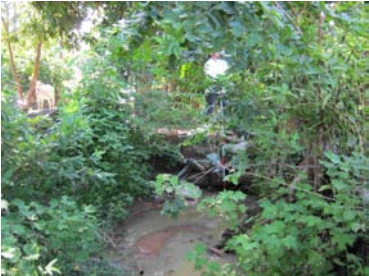
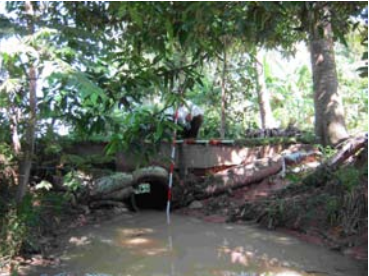
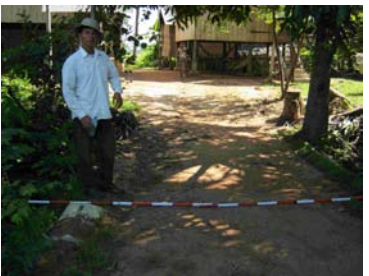
640	451859	1222776	Culvert 6	Culvert of 50 cm dia with 3.6 m long for house access, condition is rather in good condition	C	c	Private house access
670	451902	1222774	Culvert 7	Culvert of 50 cm dia with 3.6 m long for house access, condition is rather in good condition	B	c	Private house access
740	451948	1222809	Culvert 8	Culvert of 50 cm dia with 3 m long for house access, condition is rather in good condition	C	c	Private house access
770	451974	1222813	Culvert 9	Culvert of 50 cm dia with 3.6 m long for house access, condition is rather in good condition	C	c	Private house access
780	451992	1222814	Culvert 10	Culvert of 50 cm dia with 2.5 m long for house access, condition is rather in good condition	C	c	Private house access
850	452056	1222811	Culvert 11	Culvert of 30 cm dia with 2.5 m long for house access, condition is rather in good condition	D	c	Private house access
930	452108	1222774	Earth Check	Canal section is obstructed by earth embankment	D		Temporary measure

Canal No.: C23	Kind of structure: Pipe culvert	Remarks:
Station: 0.00+640	Coordinate< <div style="display: flex; flex-direction: column; align-items: flex-start;"> <span>Northing: 1222776</span> <span>Easting: 451859</span> </div>	Under house entrance road

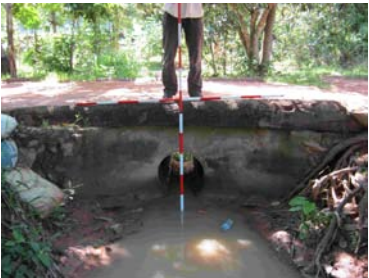
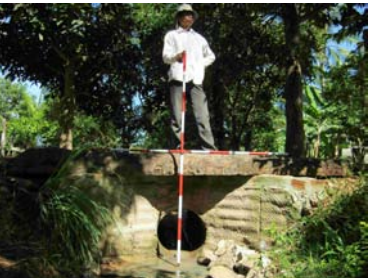
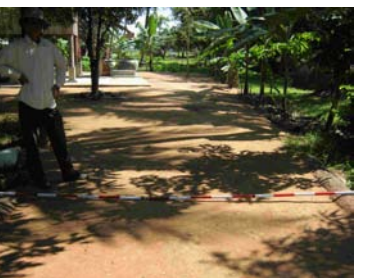
Canal No.: C23	Kind of structure: Pipe culvert	Remarks:
Station: 0.00+670	Coordinate< <div style="display: flex; flex-direction: column; align-items: flex-start;"> <span>Northing: 1222774</span> <span>Easting: 451902</span> </div>	Under house entrance road

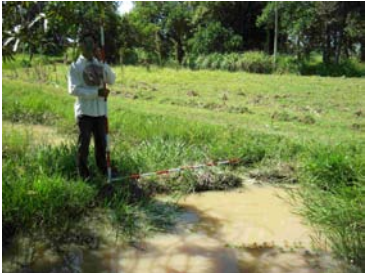
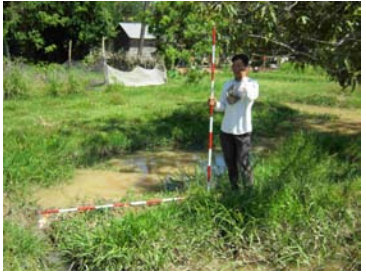
Canal No.: C23	Kind of structure: Earth Check	Remarks: Earth check cross C23
Station: 0.00+930	Coordinate< <div style="display: flex; justify-content: space-between; padding: 0 5px;"> <span>Northing: 1222774</span> <span>Easting: 452108</span> </div>

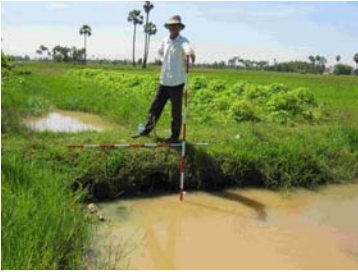
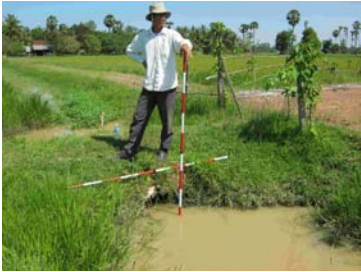
Canal No.: C23	Kind of structure: Pipe culvert	Remarks:
Station: 1.00+100	Coordinate< <div style="display: inline-block; vertical-align: middle; margin-left: 10px;">                     Northing: 1222777                      Easting: 452237                 </div>	Routine survey
<div style="display: flex; justify-content: space-around; align-items: center;"> <div style="text-align: center;">

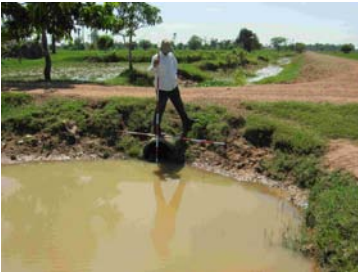
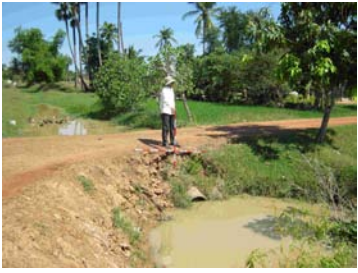
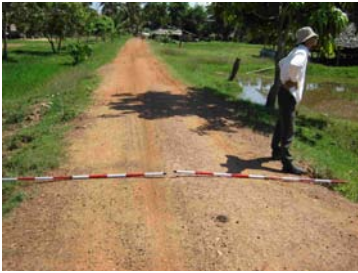
Canal No.: C23	Kind of structure: Pipe culvert	Remarks:
Station: 1.00+420	Coordinate< <div style="display: inline-block; vertical-align: middle; margin-left: 10px;">                     Northing: 1222780                      Easting: 452538                 </div>	Under commune road (laterite road)
<div style="display: flex; justify-content: space-around; align-items: center;"> <div style="text-align: center;">

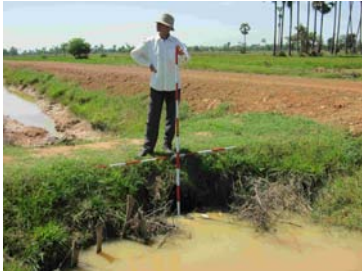
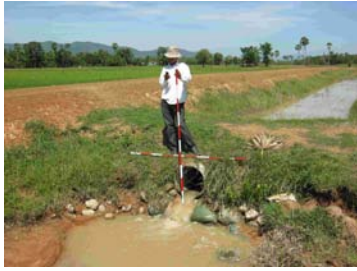
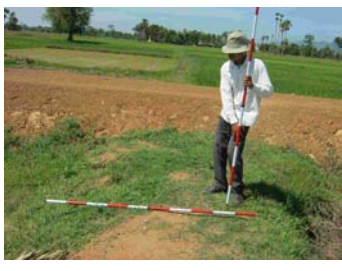
Canal No.: C23	Kind of structure: Pipe culvert	Remarks:
Station: 1.00+470	Coordinate< <div style="display: flex; justify-content: space-between; padding: 0 5px;"> <span>Northing: 1222777</span> <span>Easting: 452649</span> </div>	Along commune road

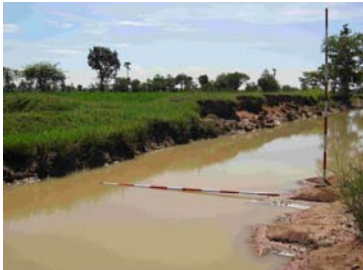
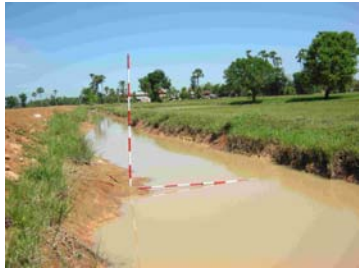
Canal No.: C23	Kind of structure: Canal	Remarks:
Station: 1.00+500	Coordinate< <div style="display: flex; justify-content: space-between; padding: 0 5px;"> <span>Northing: 1222773</span> <span>Easting: 452749</span> </div>	Big erosion Length : 1500m

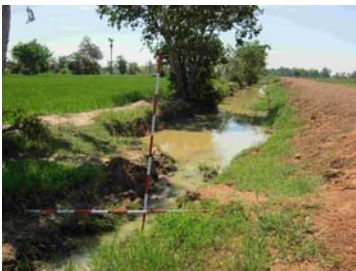
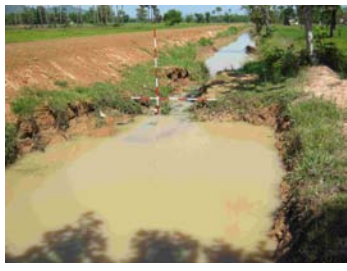
Canal No.: C23	Kind of structure: Embankment	Remarks:
Station: 1.00+580	Coordinate< <div style="display: flex; justify-content: space-between; padding: 0 5px;"> <span>Northing: 1222774</span> <span>Easting: 452830</span> </div>	Routine survey

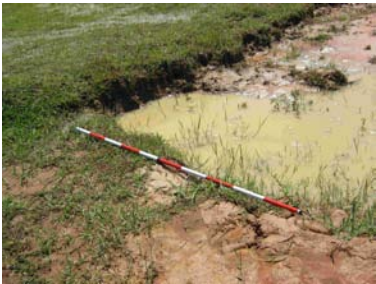
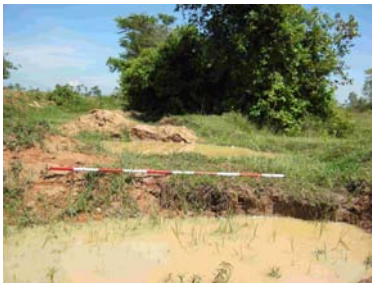
Canal No.: C23	Kind of structure: Canal	Remarks:
Station: 2.00+10	Coordinate< <div style="display: inline-block; vertical-align: middle; margin-left: 10px;">                     Northing: 1222779                      Easting: 453242                 </div>	Routine survey Length: 2000m

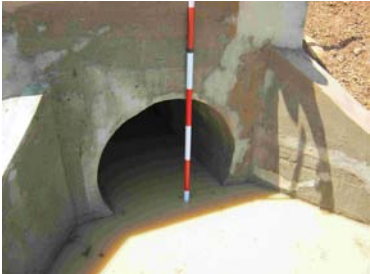
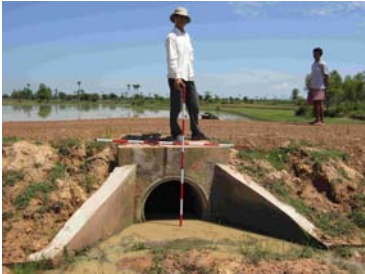
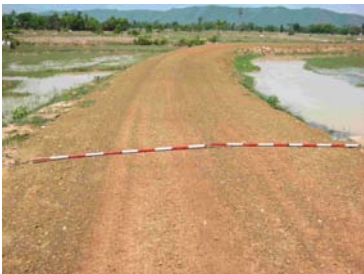
Canal No.: C23	Kind of structure: Pipe culvert	Remarks:
Station: 2.00+130	Coordinate< <div style="display: inline-block; vertical-align: middle; margin-left: 10px;">                     Northing: 1222806                      Easting: 453350                 </div>	Under commune road

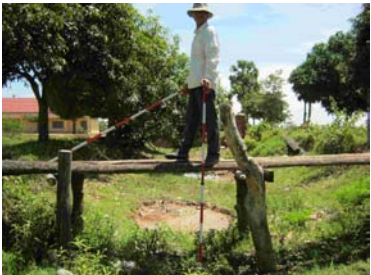
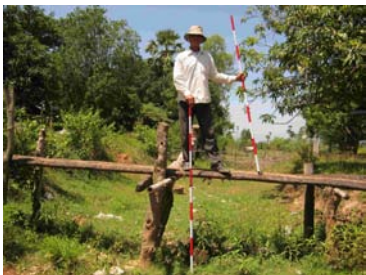
Canal No.: C23	Kind of structure: Bridge	Remarks:
Station: 2.00+460	Coordinate< <div style="display: inline-block; vertical-align: middle; margin-left: 10px;">                     Northing: 1222792                      Easting: 453610                 </div>	Routine survey Wooden bridge

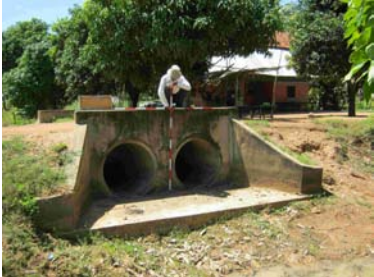
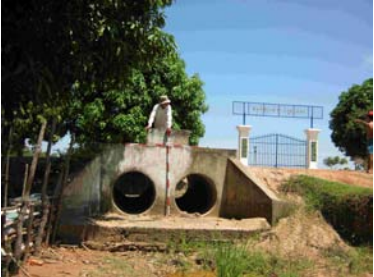
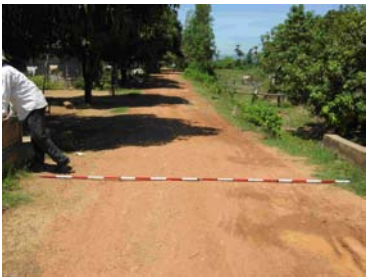
Canal No.: C23	Kind of structure: Pipe culvert (Double)	Remarks:
Station: 2.00+490	Coordinate< <div style="display: flex; justify-content: space-between; padding: 0 5px;"> <span>Northing: 1222818</span> <span>Easting: 453619</span> </div>	Under commune road

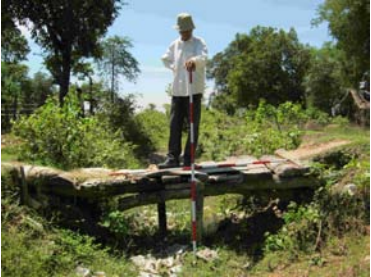
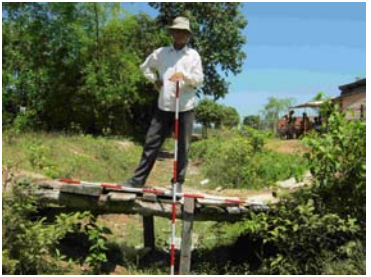
Canal No.: C23	Kind of structure: Wooden Bridge	Remarks:
Station: 2.00+590	Coordinate< <div style="display: flex; justify-content: space-between; padding: 0 5px;"> <span>Northing: 1222805</span> <span>Easting: 453714</span> </div>	Routine survey

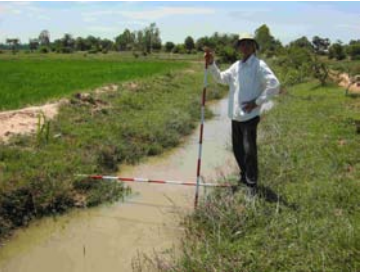
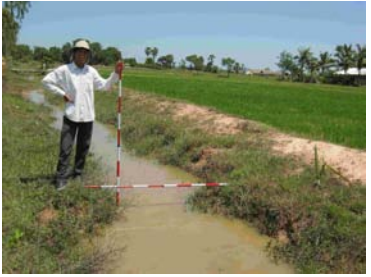
Canal No.: C23	Kind of structure: Canal	Remarks:
Station: 2.00+990	Coordinate< <div style="display: flex; justify-content: space-between; padding: 0 5px;"> <span>Northing: 1222794</span> <span>Easting: 454081</span> </div>	Routine survey Length: 3000m
