*Results of Inventory Survey for  
Proposed Rehabilitation Works in  
Roleang Chrey Headworks Rehabilitation Sub-project*

PREPARATORY SURVEY FOR IRRIGATION AND DRAINAGE  
SYSTEM REHABILITATION AND IMPROVEMENT PROJECT

Japan International Cooperation Agency

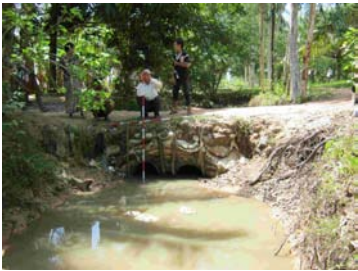
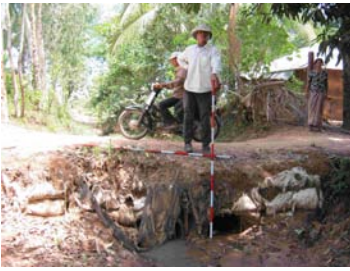
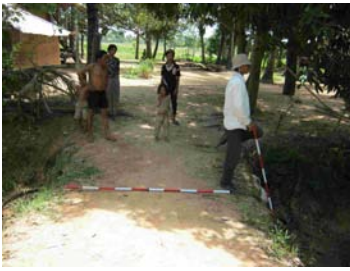
Sta.	E	N	Structure	Condition	Evaluation*	Flow Capacity	Remarks
3,260	454357	1222806	Culvert 18 (Double)	Double pipe culvert, 0.4 m dia, for house access; no riprap protection at inlet and outlet	B	c	Private house access
3,290	454375	1222806	Culvert 19	Culvert of 60 cm dia with 2 m long for house access, no protection for inlet and outlet	B	c	Private house access
3,300	454395	1222806	Culvert 20 (Double)	Double pipe culvert, 0.4 m dia, for house access; no riprap protection at inlet and outlet	B	c	Private house access
3,510	454595	1222811	Canal section	Canal section remains as canal, but not used, bottom width is 4 m and canal height is 1 m	B		
3,940	455011	1222822	Culvert 21	Culvert of 60 cm dia with 4 m long for village road, no inlet and outlet structure	B	c	Culvert on public road
4,010	455089	1222824	Canal section	Canal section remains as canal: rain water is ponded	B		
4,140	455214	1222828	Culvert (22)	Culvert of 50 cm dia with 2 m long for house access, no protection for inlet and outlet	B	c	Private house access Road along the canal seems be well maintained and functional

Canal No.: C23	Kind of structure: Pipe culvert (Double)	Remarks: Under house entrance road
Station: 3.00+260	Coordinate< Northing: 1222806 Easting: 454357

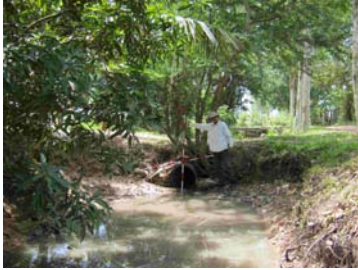
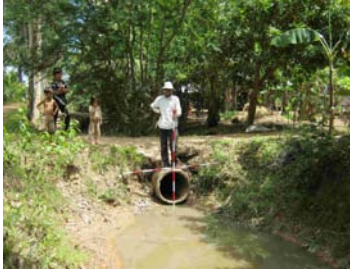
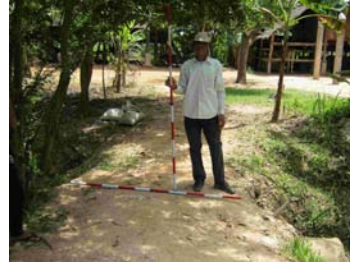
Canal No.: C23	Kind of structure: Pipe culvert	Remarks: Under house entrance road
Station: 3.00+290	Coordinate< Northing: 1222806 Easting: 454375

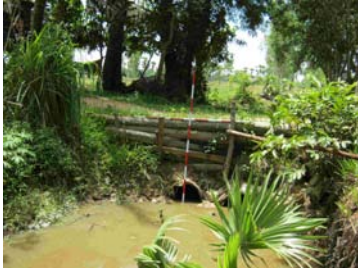
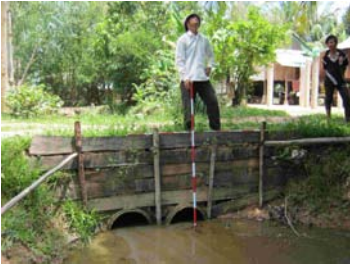
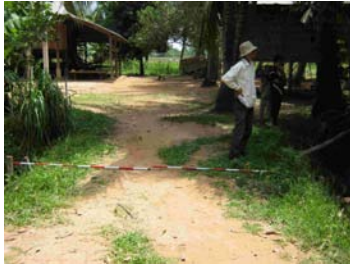
Canal No.: C23	Kind of structure: Pipe culvert (Double)	Remarks: Under house entrance road
Station: 3.00+300	Coordinate< Northing: 1222806 Easting: 454395

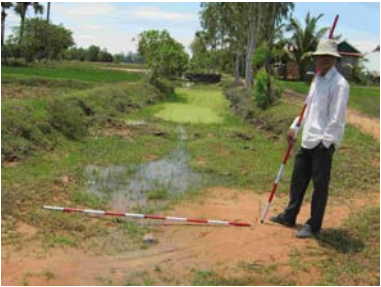
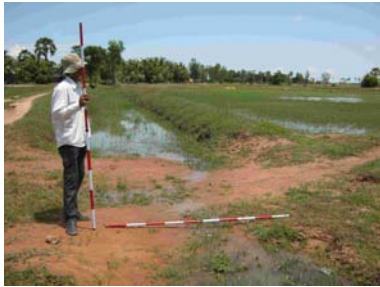
Canal No.: C23	Kind of structure: Pipe culvert	Remarks: Under small village road
Station: 3.00+510	Coordinate< <div style="display: flex; justify-content: space-between; padding: 0 10px;"> <span>Northing: 1222811</span> <span>Easting: 454595</span> </div>

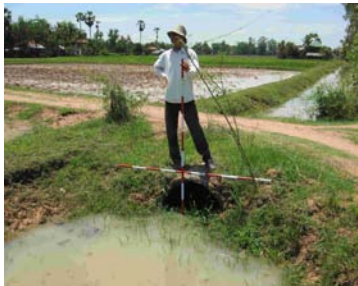
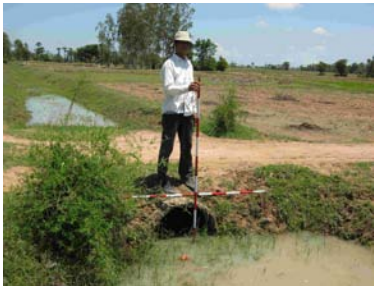
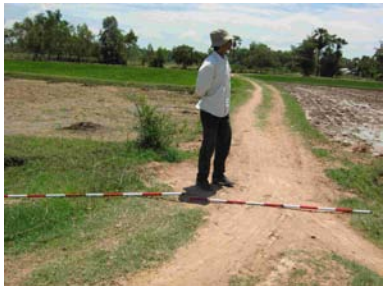
Canal No.: C23	Kind of structure: Pipe culvert	Remarks: Routine survey	
Station: 3.00+940	Coordinate< <div style="display: flex; justify-content: space-between; padding: 0 10px;"> <span>Northing: 1222822</span> <span>Easting: 455011</span> </div>

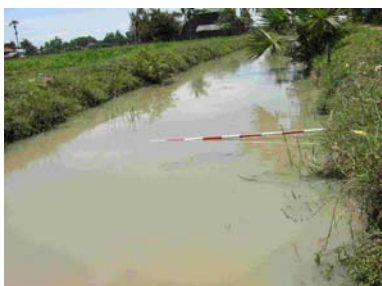
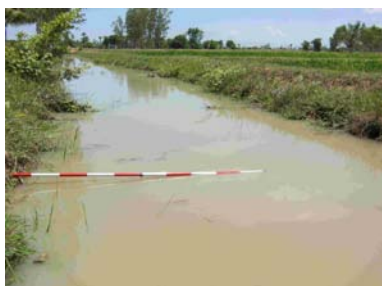
Canal No.: C23	Kind of structure: Canal	Remarks: Routine survey Length: 4000m
Station: 4.00+10	Coordinate< <div style="display: flex; justify-content: space-between; padding: 0 10px;"> <span>Northing: 1222824</span> <span>Easting: 455089</span> </div>

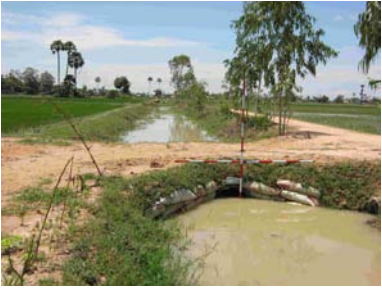
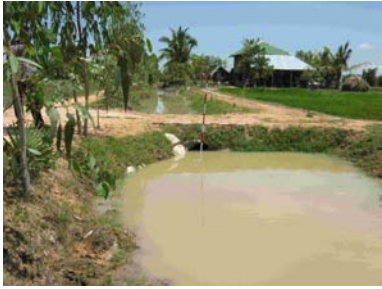
Canal No.: C23	Kind of structure: Bridge (Commune)	Remarks: Under commune road
Station: 4.00+140	Coordinate< <div style="display: flex; flex-direction: column; gap: 5px;"> <span>Northing: 1222828</span> <span>Easting: 455214</span> </div>	
<div style="display: flex; justify-content: space-around; align-items: center;"> <div style="text-align: center;">

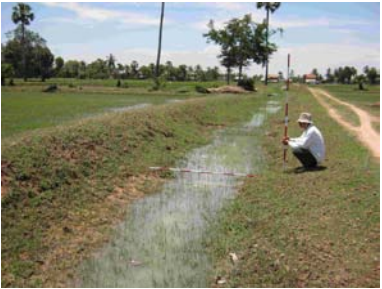
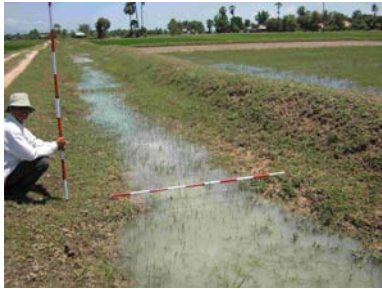
Canal No.: C23	Kind of structure: Canal	Remarks: Routine survey Length : 4500m
Station: 4.00+440	Coordinate< <div style="display: flex; flex-direction: column; gap: 5px;"> <span>Northing: 1222834</span> <span>Easting: 455529</span> </div>	
<div style="display: flex; justify-content: space-around; align-items: center;"> <div style="text-align: center;">

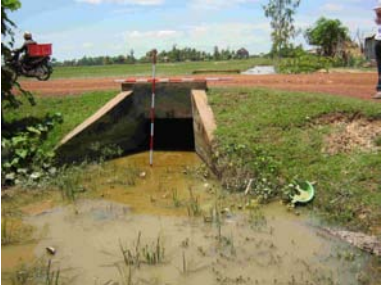
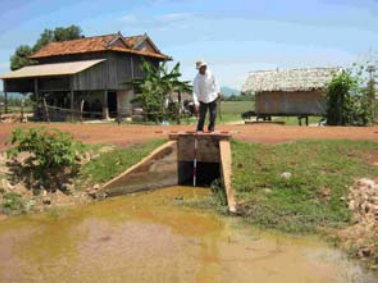
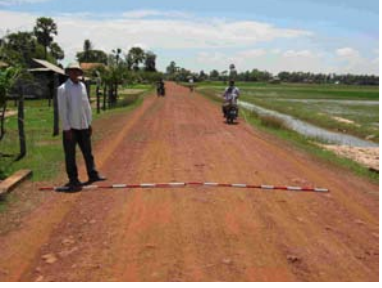
Canal No.: C23	Kind of structure: Bridge (Commune)	Remarks: Under commune road
Station: 4.00+780	Coordinate< <div style="display: flex; flex-direction: column; gap: 5px;"> <span>Northing: 1222842</span> <span>Easting: 455851</span> </div>	
<div style="display: flex; justify-content: space-around; align-items: center;"> <div style="text-align: center;">

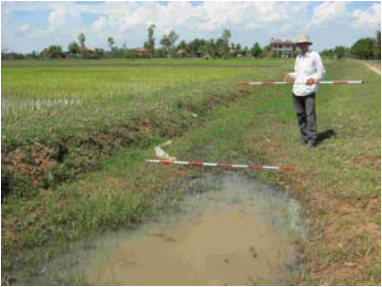
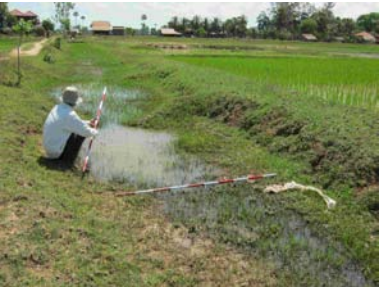
Canal No.: C23	Kind of structure: Canal	Remarks: Routine survey Length : 5000m
Station: 5.00	Coordinate< Northing: 1222845 Easting: 456002

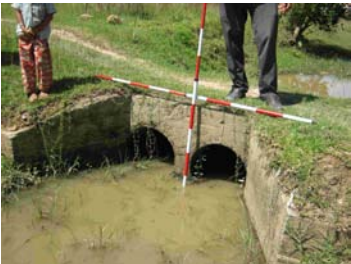
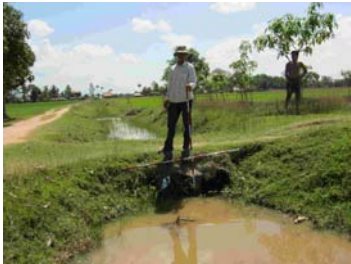
Canal No.: C23	Kind of structure: Pipe culvert (Double)	Remarks: Routine survey
Station: 5.00+160	Coordinate< Northing: 1222851 Easting: 456172

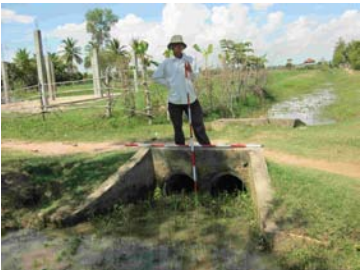
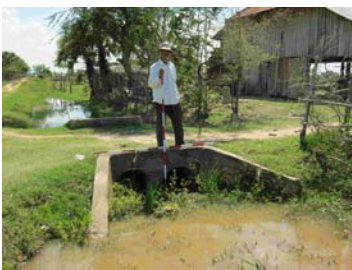
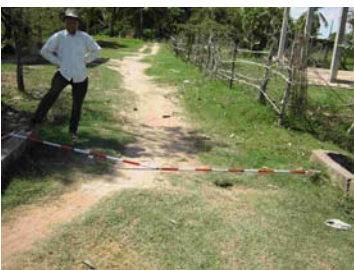
Canal No.: C23	Kind of structure: Pipe culvert (Double)	Remarks: Under village road
Station: 5.00+330	Coordinate< Northing: 1222857 Easting: 456326

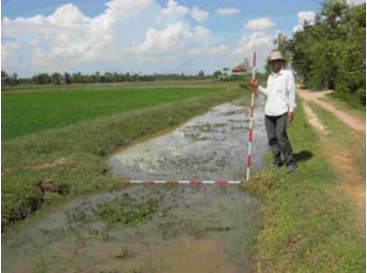
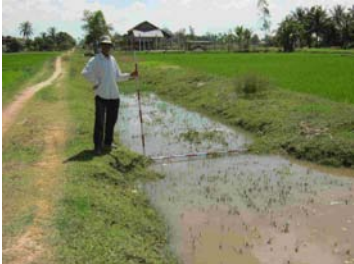
Canal No.: C23	Kind of structure: Canal	Remarks: Length : 5500m
Station: 5.00+400	Coordinate< <div style="display: flex; flex-direction: column; gap: 5px;"> <span>Northing: 1222853</span> <span>Easting: 456398</span> </div>	
<div style="display: flex; justify-content: space-around; align-items: center;"> <div style="text-align: center;">

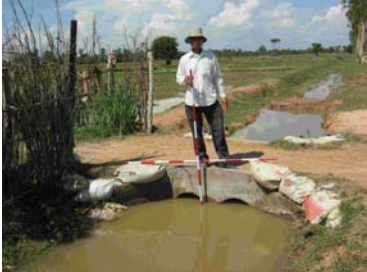
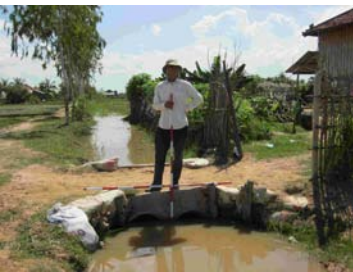
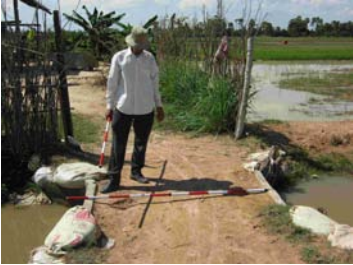
Canal No.: C23	Kind of structure: Pipe culvert (Double)	Remarks: Under house entrance road
Station: 5.00+590	Coordinate< <div style="display: flex; flex-direction: column; gap: 5px;"> <span>Northing: 1222860</span> <span>Easting: 456577</span> </div>	
<div style="display: flex; justify-content: space-around; align-items: center;"> <div style="text-align: center;">

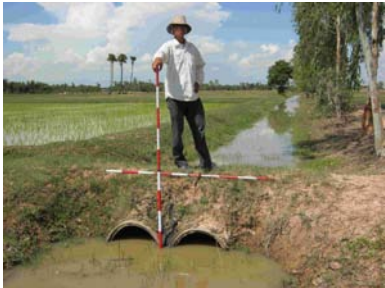
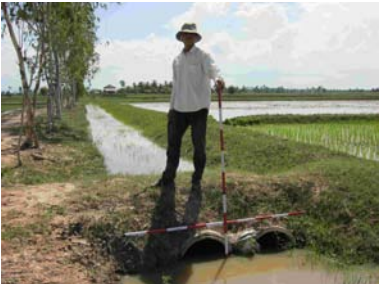
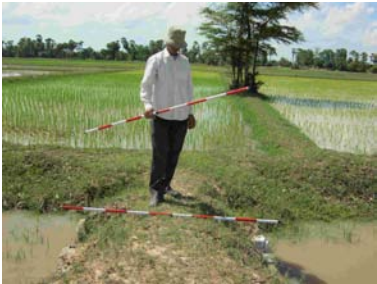
Canal No.: C23	Kind of structure: Pipe culvert (Double)	Remarks: Routine survey
Station: 5.00+820	Coordinate< <div style="display: flex; flex-direction: column; gap: 5px;"> <span>Northing: 1222865</span> <span>Easting: 456806</span> </div>	
<div style="display: flex; justify-content: space-around; align-items: center;"> <div style="text-align: center;">

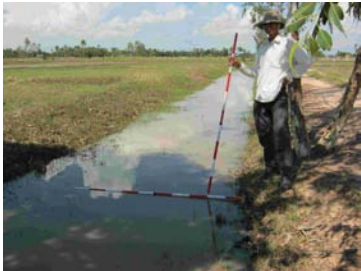
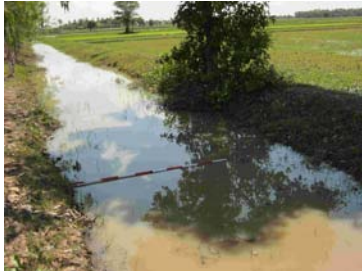
Canal No.: C23	Kind of structure: Canal	Remarks:
Station: 5.00+910	Coordinate< <div style="display: inline-block; vertical-align: middle; margin-left: 10px;">                     Northing: 1222867                      Easting: 456891                 </div>	Routine survey

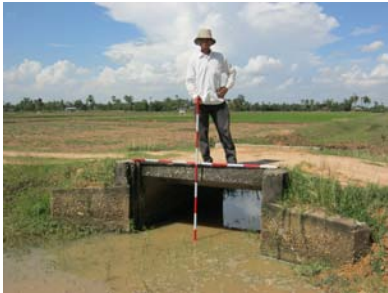
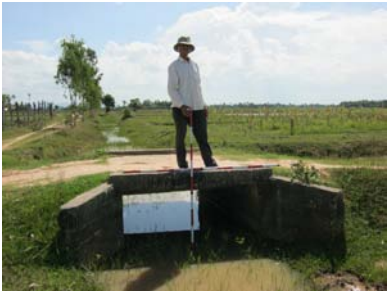
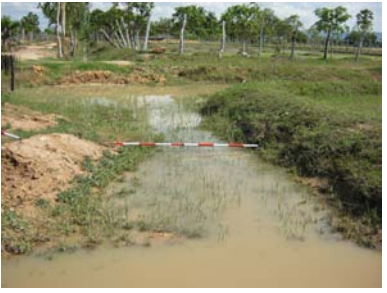
Canal No.: C23	Kind of structure: Bridge & groove	Remarks:
Station: 6.00+70	Coordinate< <div style="display: inline-block; vertical-align: middle; margin-left: 10px;">                     Northing: 1222872                      Easting: 457046                 </div>	Bridge is under village road

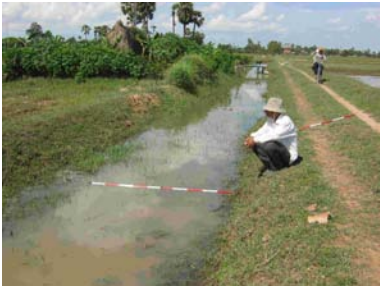
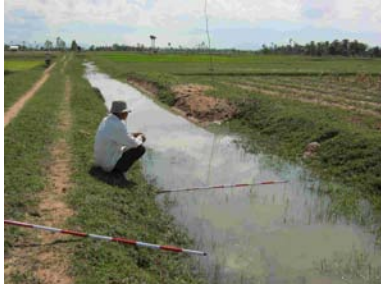
Canal No.: C23	Kind of structure: Canal	Remarks:
Station: 6.00+410	Coordinate< <div style="display: inline-block; vertical-align: middle; margin-left: 10px;">                     Northing: 1222882                      Easting: 457373                 </div>	Length of canal : 6500m

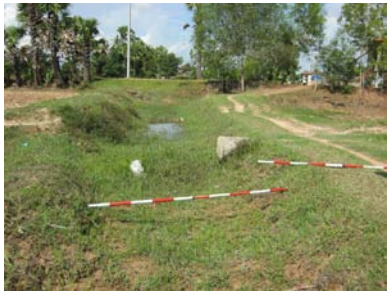
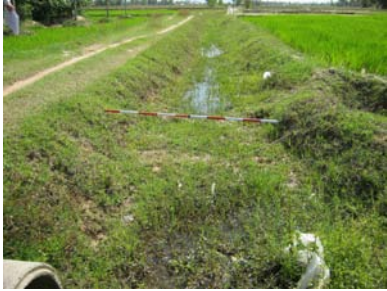
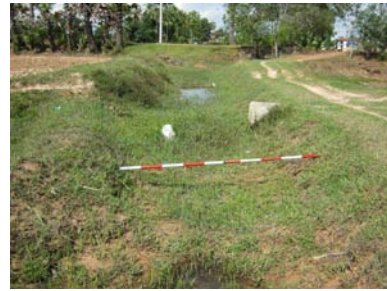
Canal No.: C23	Kind of structure: Canal	Remarks: Length : 7000m
Station: 6.00+910	Coordinate< <div style="display: flex; flex-direction: column; gap: 5px;"> <span>Northing: 1222899</span> <span>Easting: 457857</span> </div>

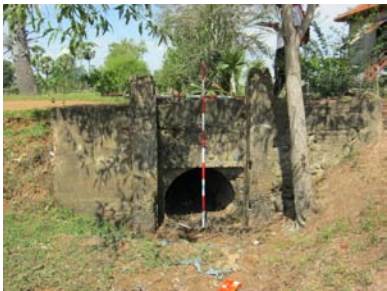
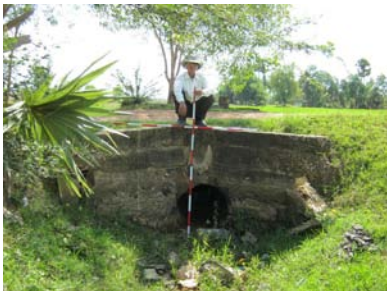
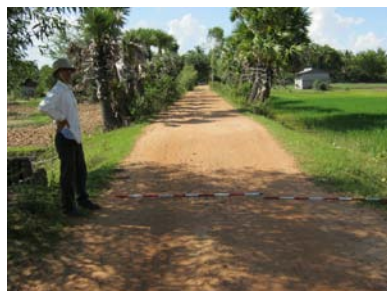
Canal No.: C23	Kind of structure: Bridge	Remarks: Under commune road
Station: 6.00+940	Coordinate< <div style="display: flex; flex-direction: column; gap: 5px;"> <span>Northing: 1222898</span> <span>Easting: 457883</span> </div>

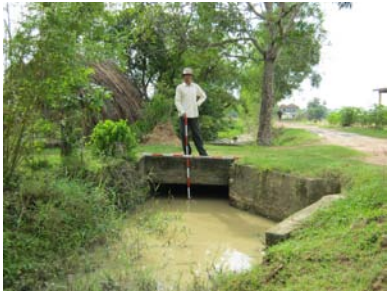
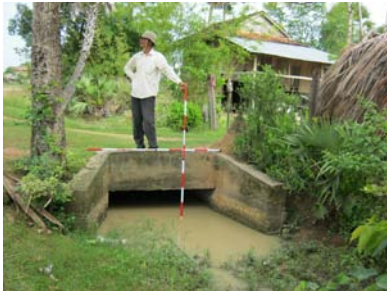
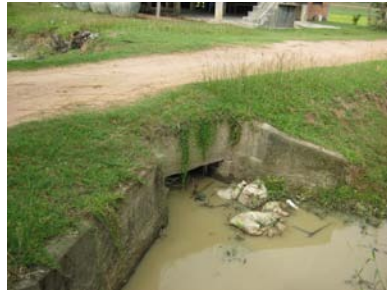
7,150	458052	1222873	Bridge 7 & Groove	Bridge of 3.8 m wide and 1.8 m span for private access Intake structure for tertiary canal exists		b	Private access Regulating structure with turnout
7,440	4583309	1222832	Canal section	Canal section remains as canal, mainly for evacuating excess water: bottom width is about 2 m	B		No road for cart is found along the canal
7,570	458429	1222816	Culvert 27	Culvert of 60 cm dia with 1.6 m long for house access, no protection for inlet and outlet	C	c	Private house access
7,590	458449	1222812	Culvert 28 (Double)	Two pipes with 50 cm dia, 2.8 m long for house access, no protection for inlet and outlet; wingwall is made by bricks	B	c	Private house access

Canal No.: C23	Kind of structure: Bridge & groove	Remarks: Under house entrance road Groove : water flow into pond
Station: 7.00+150	Coordinate< <div style="display: flex; flex-direction: column; gap: 5px;"> <span>Northing: 1222873</span> <span>Easting: 458052</span> </div>

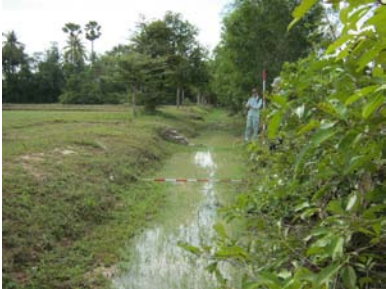
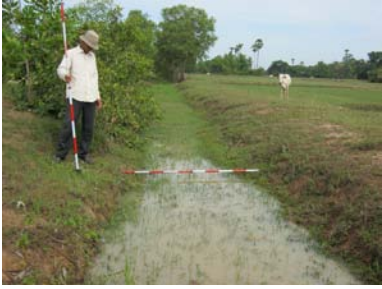
Up Stream View		Down Stream View

Canal No.: C23	Kind of structure: Canal	Remarks:
Station: 7.00+440	Coordinate< <div style="display: flex; flex-direction: column; gap: 5px;"> <span>Northing: 1222832</span> <span>Easting: 458309</span> </div>	Routine survey Length : 7500m

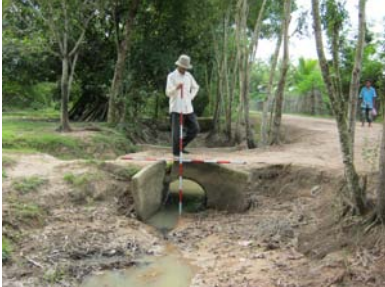
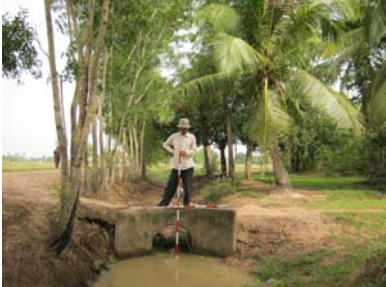
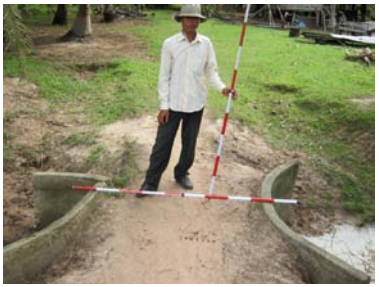
Up Stream View		Down Stream View

Canal No.: C23	Kind of structure: Pipe Culvert	Remarks:
Station: 7.00+570	Coordinate< <div style="display: flex; flex-direction: column; gap: 5px;"> <span>Northing: 1222816</span> <span>Easting: 458429</span> </div>	Under house entrance road

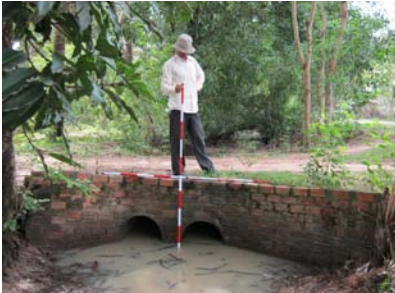
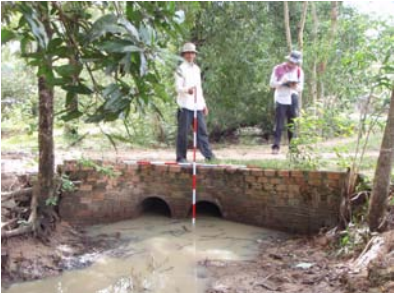
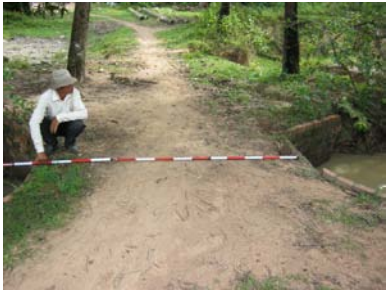
Up Stream View		Down Stream View

Canal No.: C23	Kind of structure: Pipe Culvert (Double)	Remarks:
Station: 7.00+590	Coordinate< <div style="display: flex; flex-direction: column; gap: 5px;"> <span>Northing: 1222812</span> <span>Easting: 458449</span> </div>	Under house entrance road

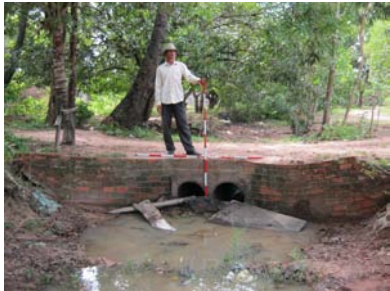
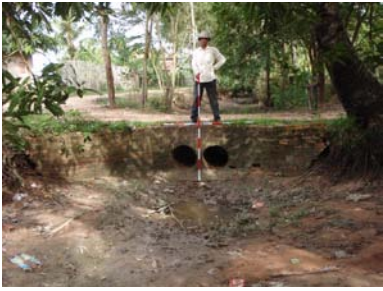
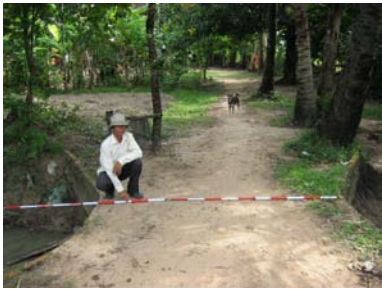
Up Stream View	Down Stream View	Side View

Canal No.: C23	Kind of structure: Pipe Culvert (Double)	Remarks: Under house entrance road
Station: 7.00+660	Coordinate< <div style="display: flex; flex-direction: column; gap: 5px;"> <span>Northing: 1222798</span> <span>Easting: 458508</span> </div>

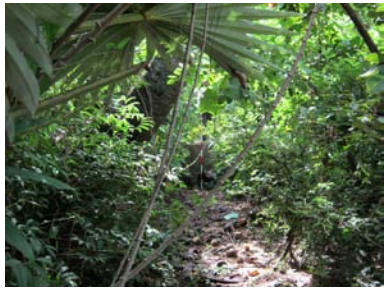
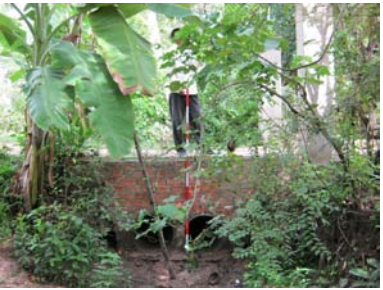
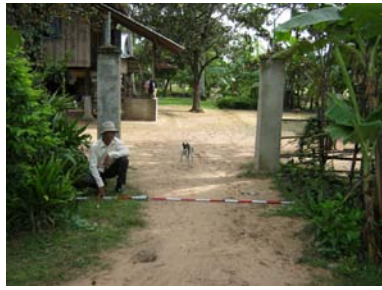
Up Stream View	Down Stream View	Side View

Canal No.: C23	Kind of structure: Pipe Culvert (Double)	Remarks: Routine survey Under house entrance road
Station: 7.00+720	Coordinate< <div style="display: flex; flex-direction: column; gap: 5px;"> <span>Northing: 1222784</span> <span>Easting: 458569</span> </div>

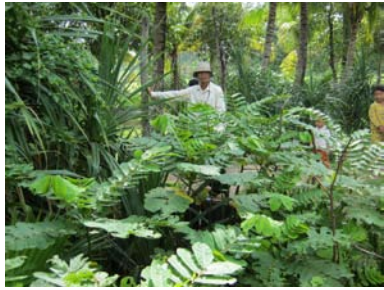
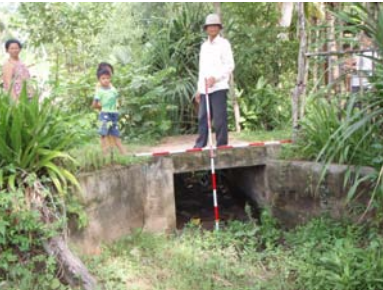
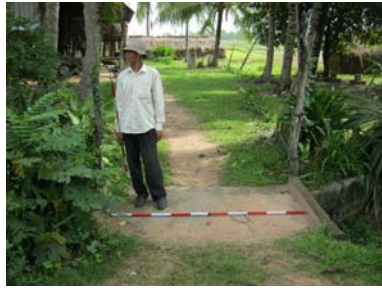
Up Stream View	Down Stream View	Side View

Canal No.: C23	Kind of structure: Bridge (Box culvert)	Remarks: Under house entrance road
Station: 7.00+820	Coordinate< <div style="display: flex; flex-direction: column; gap: 5px;"> <span>Northing: 1222774</span> <span>Easting: 458652</span> </div>

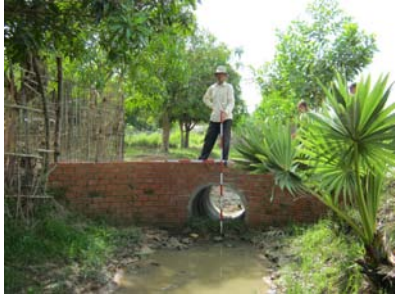
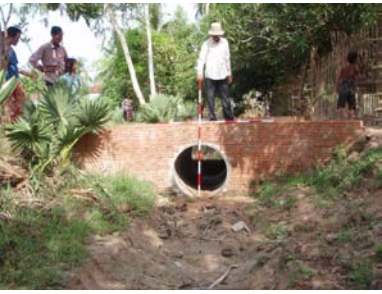
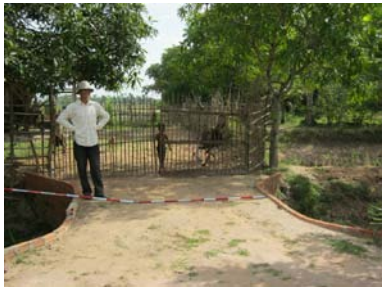
Up Stream View	Down Stream View	Side View

Canal No.: C23	Kind of structure: Pipe culvert	Remarks:
Station: 7.00+970	Coordinate< <div style="display: flex; justify-content: space-between; padding: 0 5px;"> <span>Northing: 1222774</span> <span>Easting: 458778</span> </div>	Under house entrance road Diameter of pipe : 1m

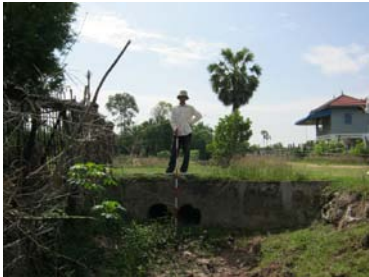
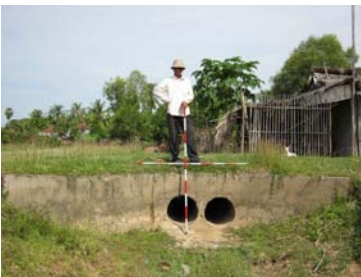
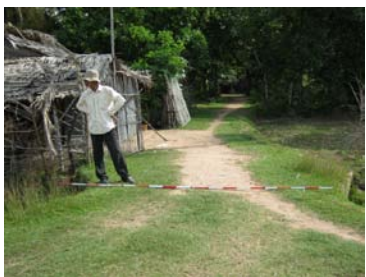
Up Stream View	Down Stream View	Side View

Canal No.: C23	Kind of structure: Pipe culvert (Double)	Remarks:
Station: 8.00+20	Coordinate< <div style="display: flex; justify-content: space-between; padding: 0 5px;"> <span>Northing: 1222769</span> <span>Easting: 458829</span> </div>	Under house entrance road

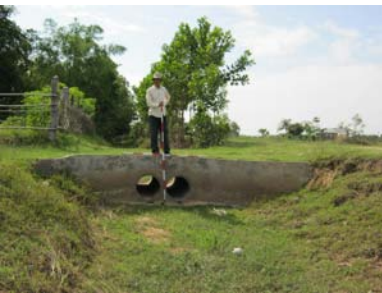
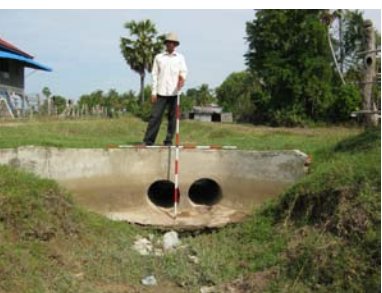
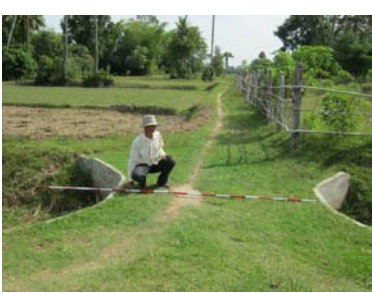
Up Stream View	Down Stream View	Side View

Canal No.: C23	Kind of structure: Pipe culvert (Double)	Remarks:
Station: 8.00+100	Coordinate< <div style="display: flex; justify-content: space-between; padding: 0 5px;"> <span>Northing: 1222760</span> <span>Easting: 458904</span> </div>	Under small bicycle road There is a groove (to pond)

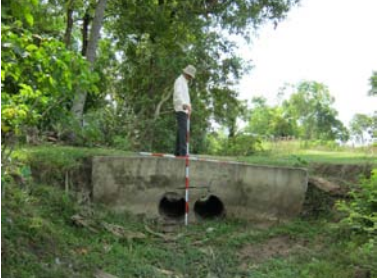
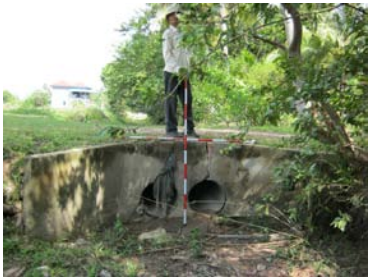
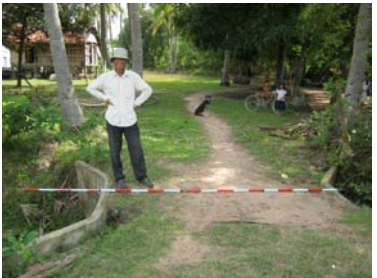
</div> <div style="display: flex; justify-content: space-around; margin-top: 10px;"> <span>Up Stream View</span> <span>Down Stream View</span> <span>Side View</span> </div>

Canal No.: C23	Kind of structure: Pipe culvert (Double)	Remarks: Under house entrance road
Station: 8.00+180	Coordinate< <div style="display: flex; flex-direction: column; gap: 5px;"> <span>Northing: 1222758</span> <span>Easting: 458978</span> </div>	
<div style="display: flex; justify-content: space-around;">

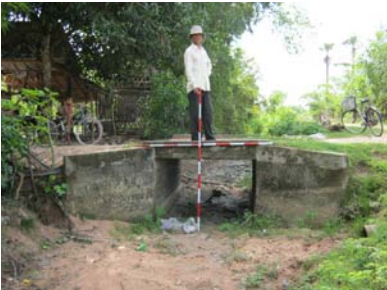
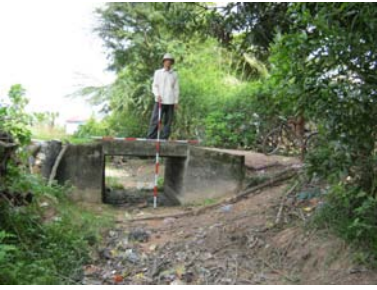
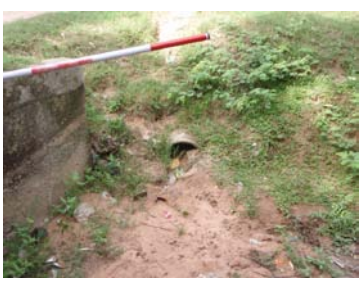
</div> <div style="display: flex; justify-content: space-around; margin-top: 10px;"> <span>Up Stream View</span> <span>Down Stream View</span> <span>Structure</span> </div>

Canal No.: C23	Kind of structure: Bridge (Private)	Remarks: Under house entrance road A groove (to secondary canal)
Station: 8.00+250	Coordinate< <div style="display: flex; flex-direction: column; gap: 5px;"> <span>Northing: 1222753</span> <span>Easting: 459038</span> </div>	
<div style="display: flex; justify-content: space-around;">

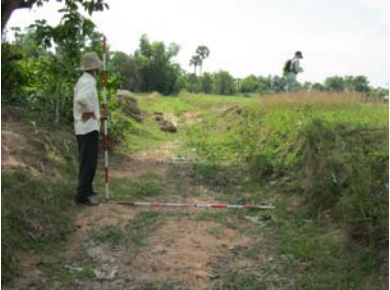
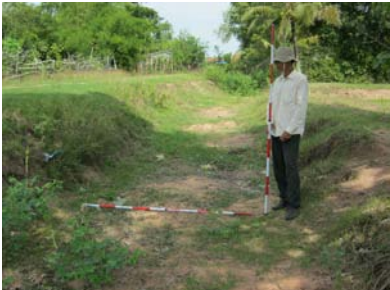
</div> <div style="display: flex; justify-content: space-around; margin-top: 10px;"> <span>Up Stream View</span> <span>Down Stream View</span> </div>

Canal No.: C23	Kind of structure: Canal	Remarks: Length : 8500m
Station: 8.00+320	Coordinate< <div style="display: flex; flex-direction: column; gap: 5px;"> <span>Northing: 1222743</span> <span>Easting: 459115</span> </div>	
<div style="display: flex; justify-content: space-around;">

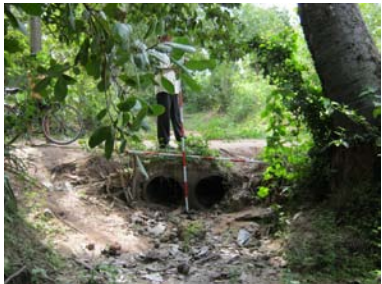
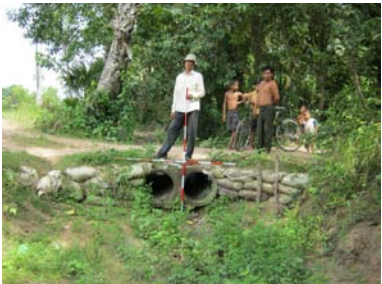
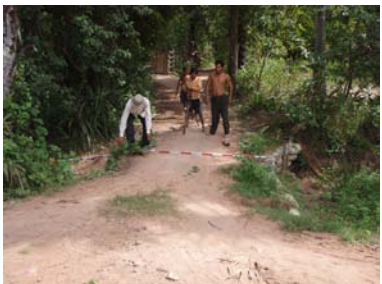
Up Stream View	Down Stream View	Side View

Canal No.: C23	Kind of structure: Pipe culvert (Double)	Remarks: Under village road
Station: 8.00+540	Coordinate< <div style="display: flex; flex-direction: column; gap: 5px;"> <span>Northing: 1222728</span> <span>Easting: 459315</span> </div>

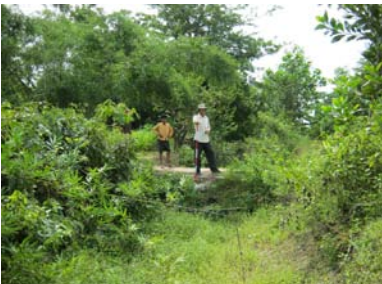
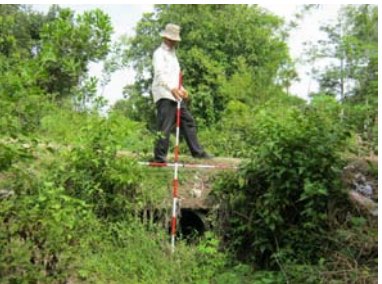
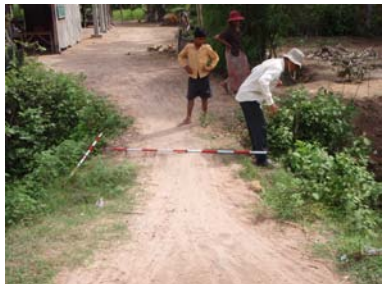
Up Stream View	Down Stream View	Side View

Canal No.: C23	Kind of structure: Pipe culvert (Double)	Remarks: Under house entrance road
Station: 8.00+630	Coordinate< <div style="display: flex; flex-direction: column; gap: 5px;"> <span>Northing: 1222721</span> <span>Easting: 459392</span> </div>

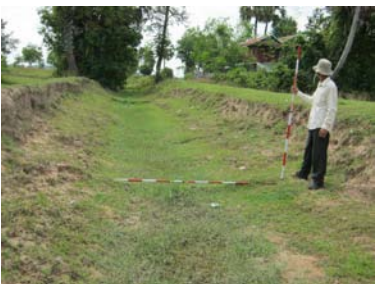
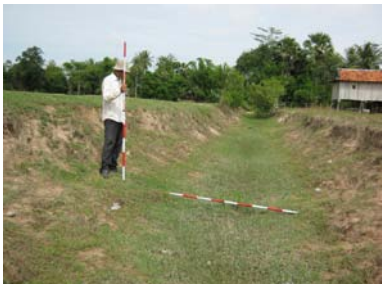
Canal No.: C23	Kind of structure: Canal	Remarks: Routine survey Length : 9000m
Station: 8.00+820	Coordinate< <div style="display: flex; flex-direction: column; gap: 5px;"> <span>Northing: 1222705</span> <span>Easting: 459565</span> </div>

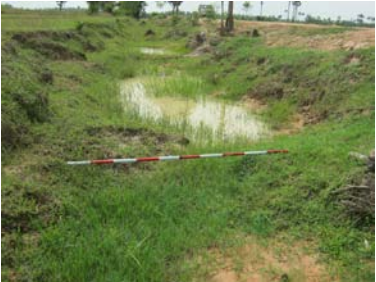
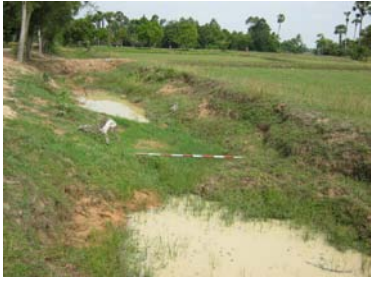
Canal No.: C23	Kind of structure: Canal	Remarks:
Station: 9.00+70	Coordinate< <div style="display: flex; justify-content: space-between; padding: 0 10px;"> <span>Northing: 1222684</span> <span>Easting: 459794</span> </div>	Routine survey Length : 9250m

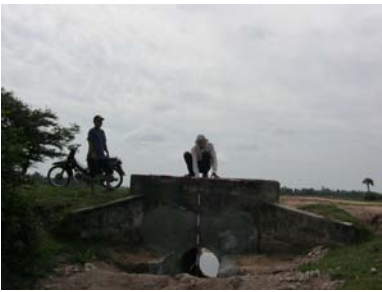
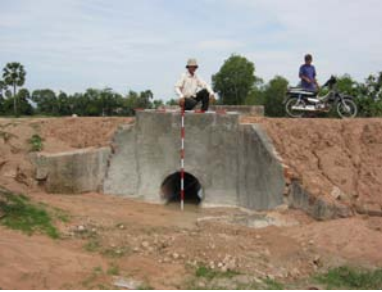
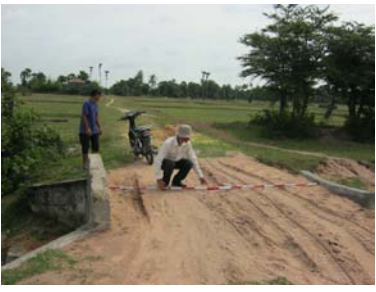
Canal No.: C23	Kind of structure: Pipe culvert	Remarks:
Station: 9.00+220	Coordinate< <div style="display: flex; justify-content: space-between; padding: 0 10px;"> <span>Northing: 1222677</span> <span>Easting: 459943</span> </div>	Under bicycle road

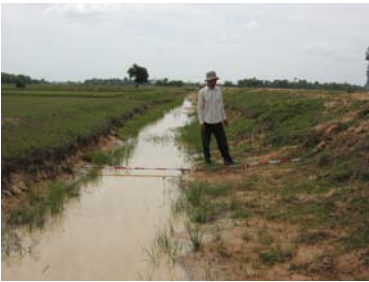
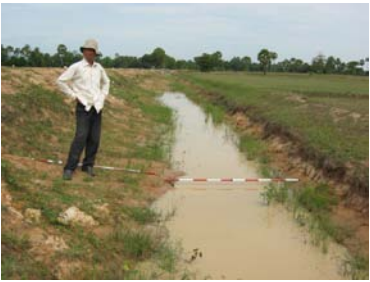
Canal No.: C23	Kind of structure: Canal	Remarks:
Station: 9.00+370	Coordinate< <div style="display: flex; justify-content: space-between; padding: 0 10px;"> <span>Northing: 1222667</span> <span>Easting: 460093</span> </div>	Routine survey Length :9750m

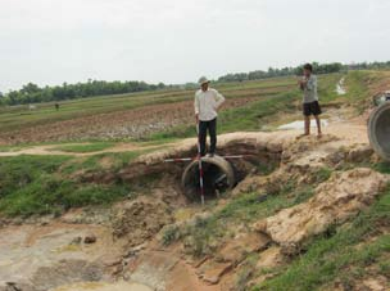
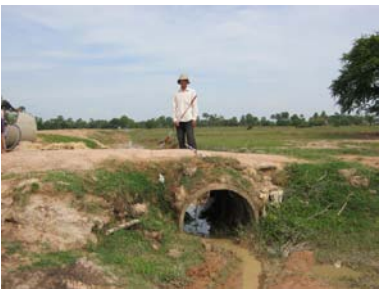
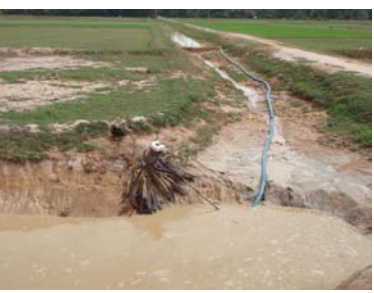
Canal No.: C23	Kind of structure: Pipe culvert	Remarks:
Station: 9.00+510	Coordinate< <div style="display: flex; justify-content: space-between; padding: 0 10px;"> <span>Northing: 1222667</span> <span>Easting: 460239</span> </div>	Routine survey Pipe for Pumping up

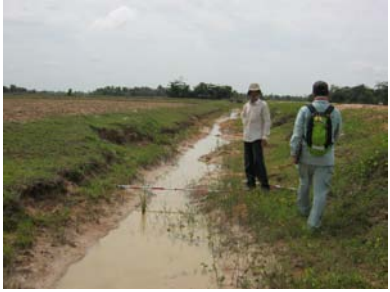
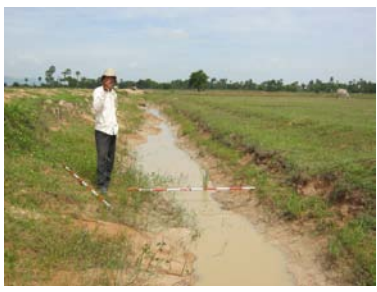
Canal No.: C23	Kind of structure: Canal	Remarks:
Station: 9.00+630	Coordinate< <div style="display: flex; justify-content: space-between; padding: 0 10px;"> <span>Northing: 1222659</span> <span>Easting: 460350</span> </div>	Routine survey Length : 10,000m

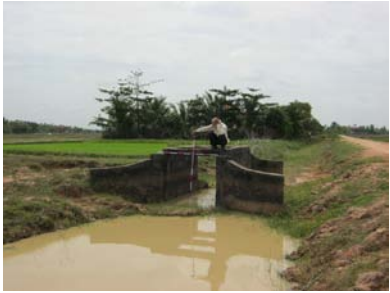
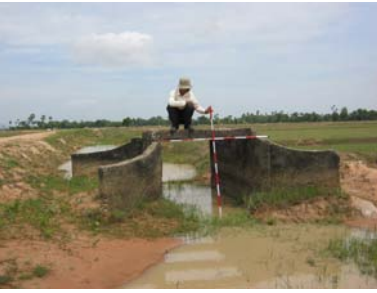
Canal No.: C23	Kind of structure: Bridge (Unused)	Remarks:
Station: 9.00+760	Coordinate< <div style="display: flex; justify-content: space-between; padding: 0 10px;"> <span>Northing: 1222660</span> <span>Easting: 460486</span> </div>	There is a groove

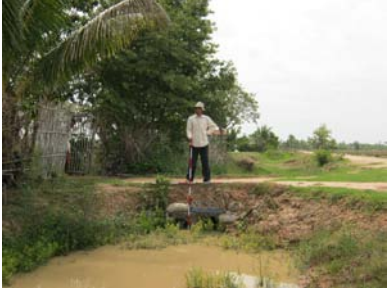
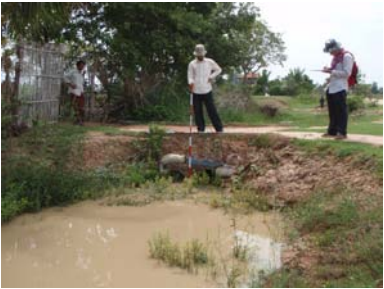
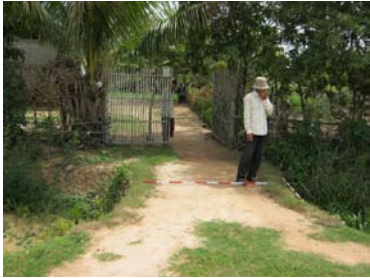
Canal No.: C23	Kind of structure: Pipe culvert (Double)	Remarks: Under house entrance road
Station: 9.00+830	Coordinate< <div style="display: flex; flex-direction: column; gap: 5px;"> <span>Northing: 1222666</span> <span>Easting: 460563</span> </div>

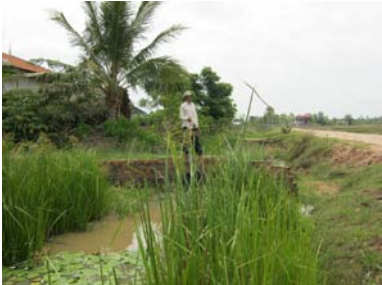
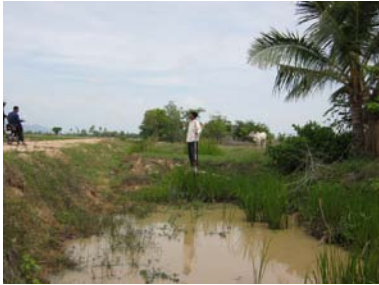
Canal No.: C23	Kind of structure: Pipe culvert	Remarks: Routine survey
Station: 9.00+930	Coordinate< <div style="display: flex; flex-direction: column; gap: 5px;"> <span>Northing: 1222666</span> <span>Easting: 460650</span> </div>

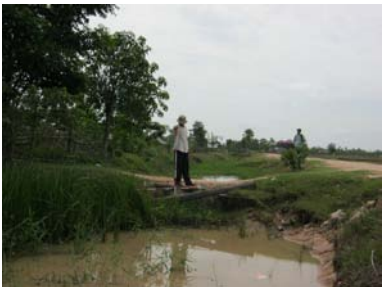
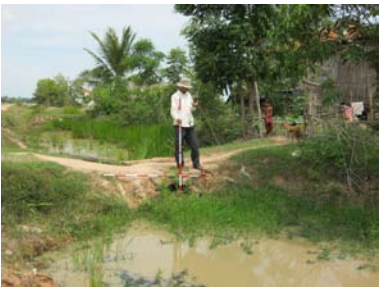
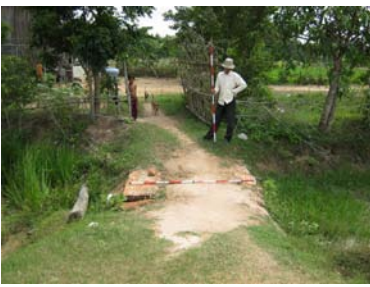
Canal No.: C23	Kind of structure: Pipe culvert	Remarks: Under house entrance road
Station: 9.00+970	Coordinate< <div style="display: flex; flex-direction: column; gap: 5px;"> <span>Northing: 1222663</span> <span>Easting: 460677</span> </div>

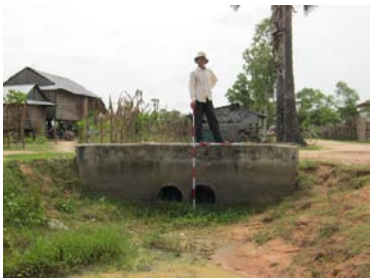
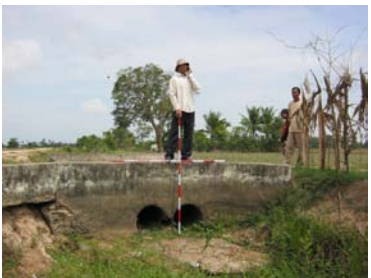
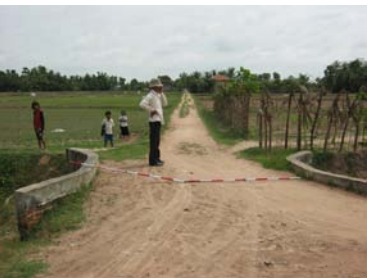
Canal No.: C23	Kind of structure: Pipe culvert (Double)	Remarks: Under village road
Station: 10.00+140	Coordinate< <div style="display: flex; flex-direction: column; gap: 5px;"> <span>Northing: 1222668</span> <span>Easting: 460854</span> </div>

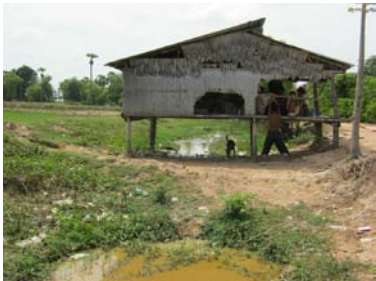
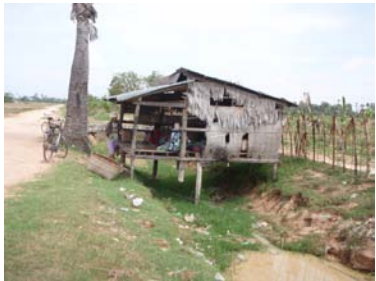
9,830	460563	1222666	Culvert 39 (Double)	Two pipes with 30 cm dia, 2 m long for house access, no protection for inlet and outlet; wingwall is made by sand bags	C	c	Private house access
9,930	460650	1222666	Culvert 40	Culvert of 50 cm dia with 2.5 m long for farm access, upstream wall is made by brick but no protection for inlet and outlet	D	c	Broken
9,970	460677	1222663	Culvert 41	Culvert of 40 cm dia with 2 m long for farm access, upstream wall is made by brick but no protection for inlet and outlet	C	c	Nealy broken
10,140	460854	1222668	Culvert 42 (Double)	Two pipes with 50 cm dia, 3.6 m long for village road, no protection for inlet and outlet; wingwall is made by hollow blocks with plastering	B	c	Public access
10,200	460921	1222667	House	Nipa hut on the canal, meeting space (?)	D		To be removed

Canal No.: C23	Kind of structure: House	Remarks: House is under canal
Station: 10.00+200	Coordinate< <div style="display: flex; flex-direction: column; gap: 5px;"> <span>Northing: 1222667</span> <span>Easting: 460921</span> </div>

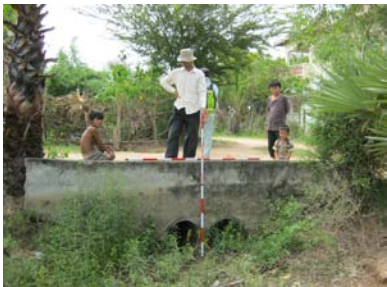
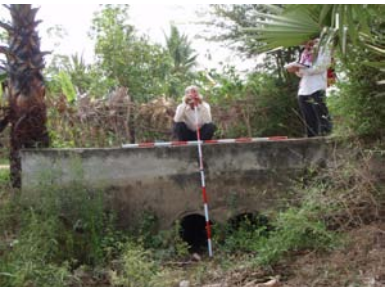
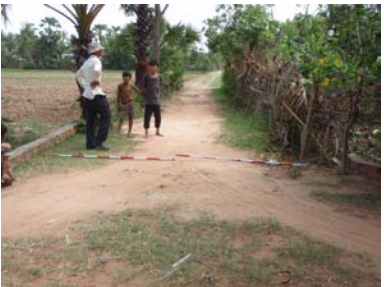
Sta.	E	N	Structure	Condition	Evaluation*	Flow Capacity	Remarks
10,300	461009	1222671	Culvert 43 (Double)	Two pipes with 50 cm dia, 4.5 m long for village road, no protection for inlet and outlet; wingwall is made by hollow blocks with plastering		c	Public access
10,470	461176	1222674	Canal section	Canal section remains as canal, mainly for evacuating excess water: bottom width is about 2 m	B		
10,670	461373	1222680	Culvert 44	Culvert of 50 cm dia with 2.5 m long for farm access, upstream wall is made by brick but no protection for inlet and outlet	B	c	House access
10,700	461409	1222680	Double Culvert 45	Two pipes with 60 cm dia, 1.5 m long	B	c	Public access
10,830	461544	1222682	EP

Canal No.: C23	Kind of structure: Pipe culvert (Double)	Remarks: Routine survey Under village road
Station: 10.00+300	Coordinate< <div style="display: flex; flex-direction: column; gap: 5px;"> <span>Northing: 1222671</span> <span>Easting: 461009</span> </div>

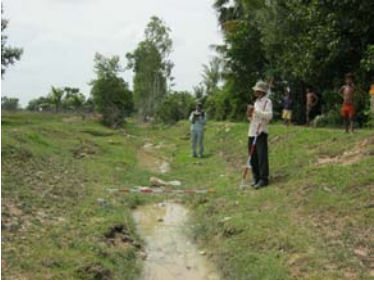
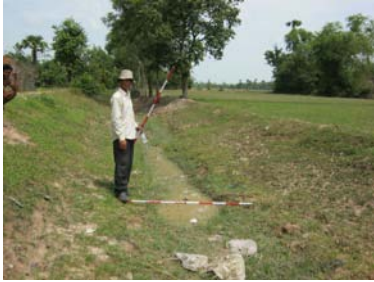
Canal No.: C23	Kind of structure: Canal	Remarks: Routine survey Length : 10,500m
Station: 10.00+470	Coordinate< <div style="display: flex; justify-content: space-between; padding: 0 10px;"> <span>Northing: 1222674</span> <span>Easting: 461176</span> </div>

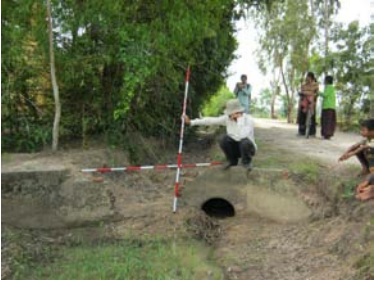
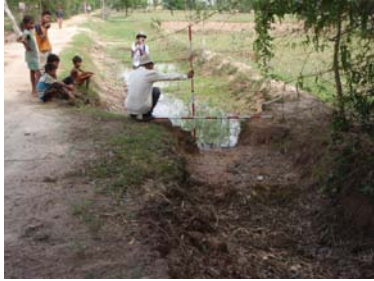
Canal No.: C23	Kind of structure: Pipe culvert	Remarks: All pipe culverts are broken
Station: 10.00+670	Coordinate< <div style="display: flex; justify-content: space-between; padding: 0 10px;"> <span>Northing: 1222680</span> <span>Easting: 461373</span> </div>

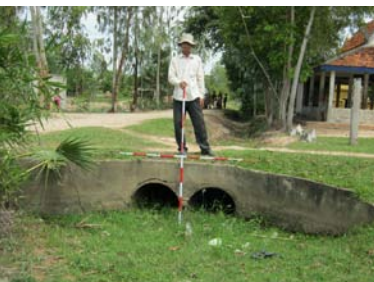
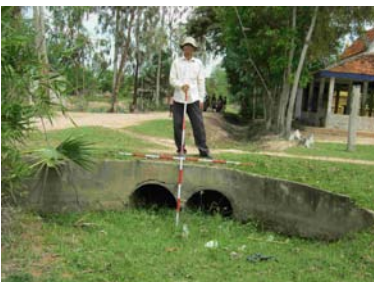
Canal No.: C23	Kind of structure: Pipe culvert (Double)	Remarks: Under village road
Station: 10.00+700	Coordinate< <div style="display: flex; justify-content: space-between; padding: 0 10px;"> <span>Northing: 1222680</span> <span>Easting: 461409</span> </div>

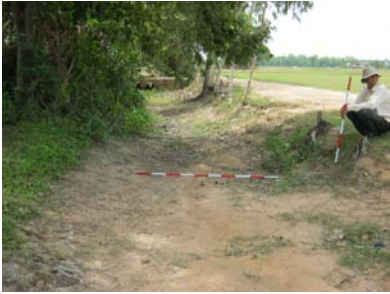
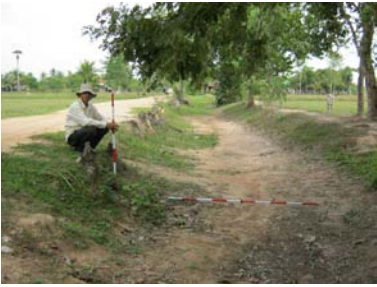
Canal No.: C23	Kind of structure: Canal	Remarks:
Station: 10.00+830 (EP)	Coordinate< Northing: 1222682 Easting: 461544	Routine survey End Point of canal

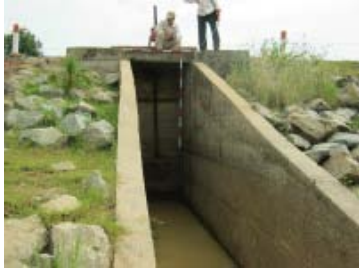
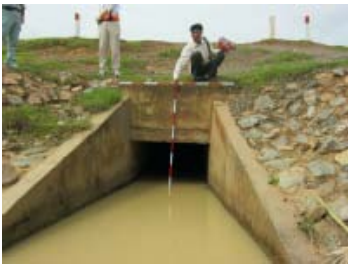
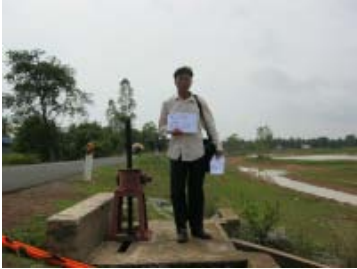
Up Stream View	Down Stream View	B.P.

Canal No.: C24	Kind of structure(s): Gate	Remarks: Intake Gate
Station: 0.00(B.P.)	Coordinate< Northing: 1223268 Easting: 447987

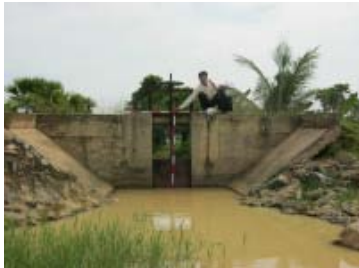
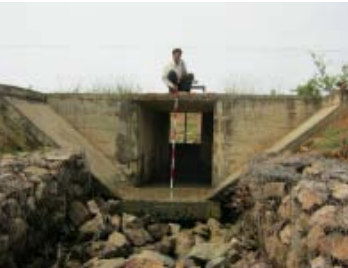
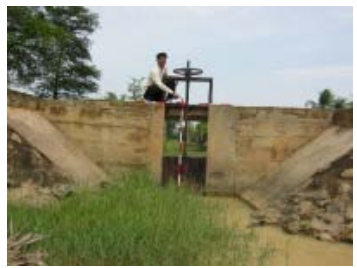
Up Stream View	Down Stream View	Inflow Gate

Canal No.: C24	Kind of structure(s): Gate	Remarks: Inflow from Left(westward) Gate
Station: 0.00+50	Coordinate< Northing: 1223308 Easting: 447998

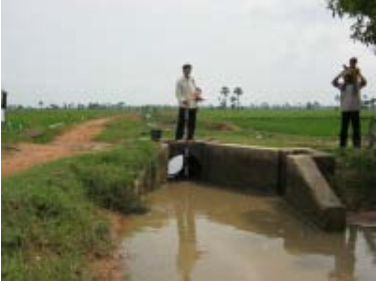
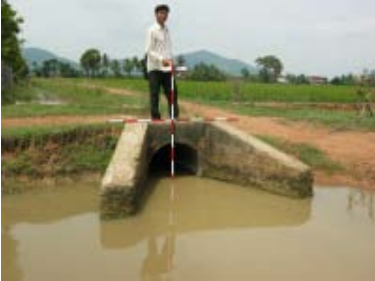
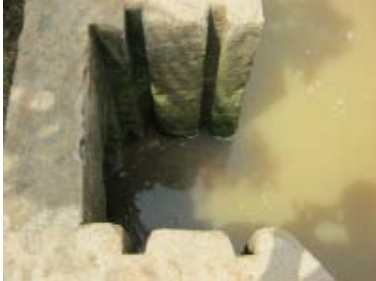
Up Stream View	Down Stream View	Groove (Right Bank)

Canal No.: C24	Kind of structure(s): Pipe Culvert	Remarks: In/Out-flow from both bank
Station: 0.00+420	Coordinate< Northing: 1223581 Easting: 448015

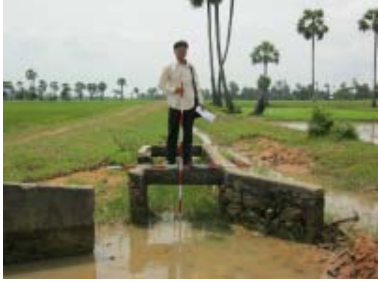
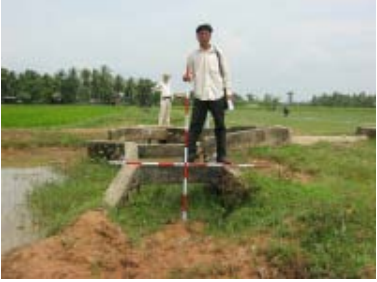
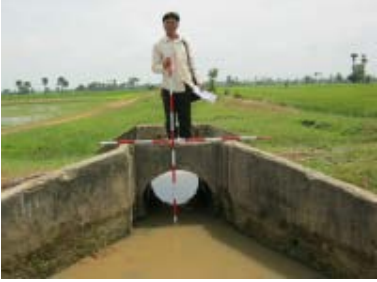
Up Stream View	Down Stream View	Northward Pipe Culvert

Canal No.: C24	Kind of structure(s): Pipe Culvert	Remarks: Canal turning point (Direction change from North to East)
Station: 0.00+810	Coordinate< Northing: 1223888 Easting: 448029

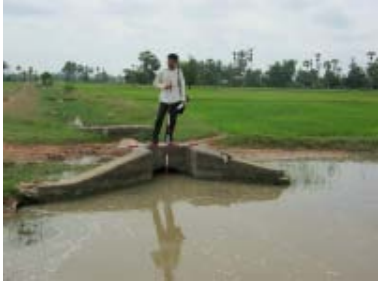
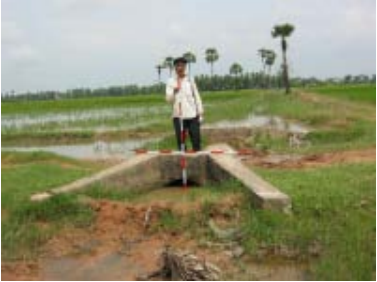
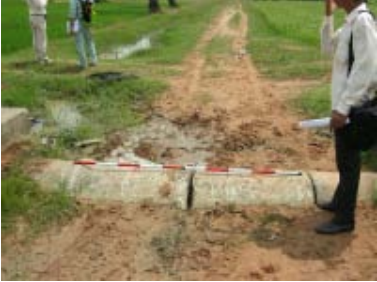
Up Stream View	Down Stream View	Side View

Canal No.: C24	Kind of structure(s): Pipe Culvert	Remarks: - Pipe culvert with groove - Routine survey
Station: 1.00	Coordinate< Northing: 1223883 Easting: 448015

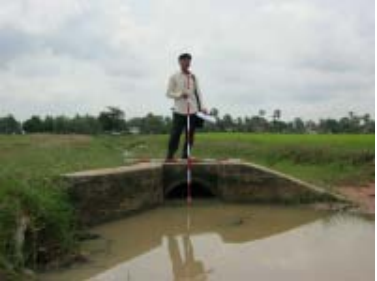
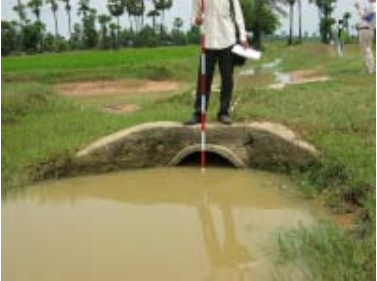
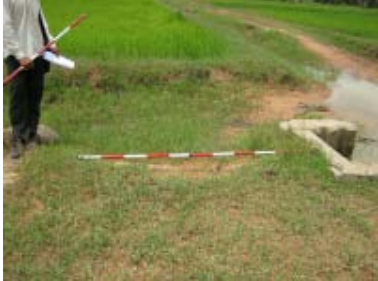
Up Stream View	Down Stream View	Side View

Canal No.: C24	Kind of structure(s): Pipe Culver	Remarks: - Pipe culvert with groove - In/Out flow from/to left bank
Station: 1.00 + 590	Coordinate< Northing: 1223886 Easting: 448783

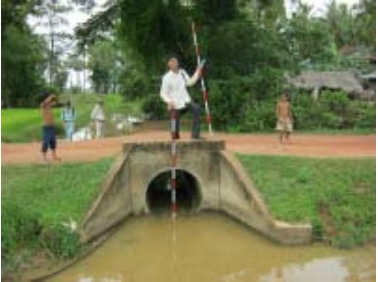
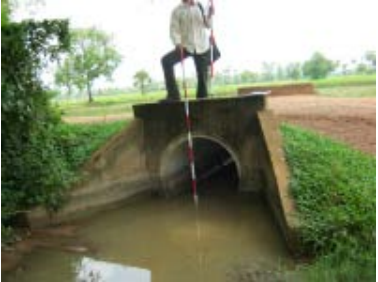
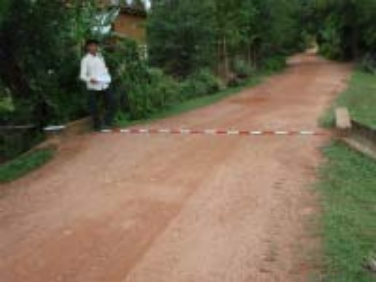
Up Stream View	Down Stream View	Side View

Canal No.: C24	Kind of structure(s): Pipe Culver	Remarks: Pipe culvert under commune road
Station: 1.00 + 940	Coordinate< Northing: 1223931 Easting: 449073

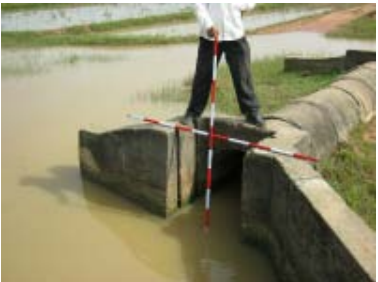
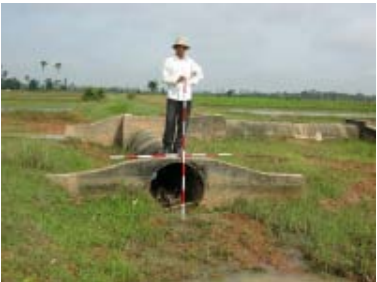
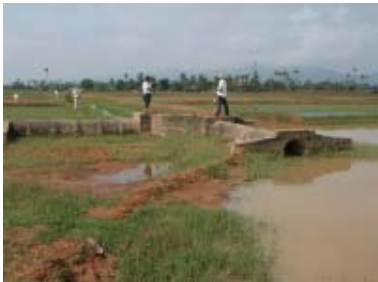
Canal No.: C24	Kind of structure(s): Division structure	Remarks: Routine survey Structure without almost function
Station: 4.00	Coordinate< Northing: 1223859 Easting: 451021

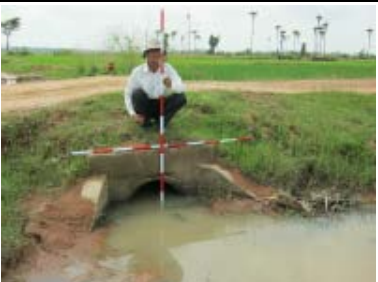
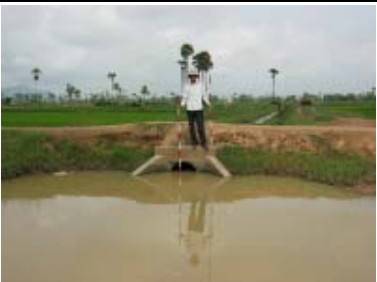
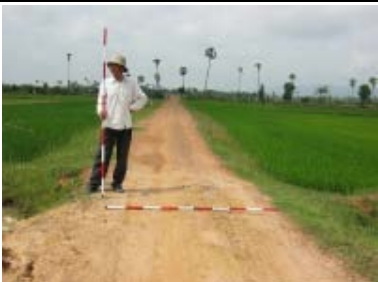
Canal No.: C24	Kind of structure(s): Pipe Culvert	Remarks: Routine survey
Station: 5.00+500	Coordinate< Northing: 1223827 Easting: 452484

Up Stream View	Down Stream View	Side View (Crossover Road)
