*Results of Inventory Survey for  
Proposed Rehabilitation Works in  
Roleang Chrey Headworks Rehabilitation Sub-project*

PREPARATORY SURVEY FOR IRRIGATION AND DRAINAGE  
SYSTEM REHABILITATION AND IMPROVEMENT PROJECT

Japan International Cooperation Agency

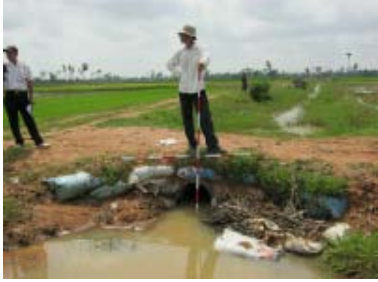
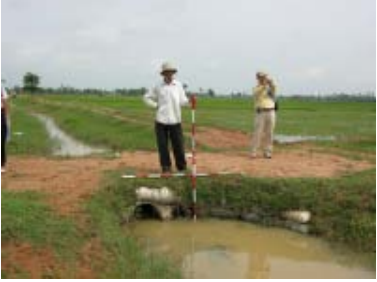
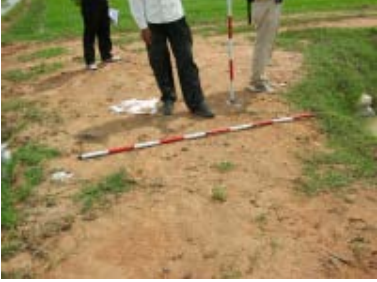
Canal No.: C24	Kind of structure(s): Pipe Culvert	Remarks:
Station: 5.00+720	Coordinate< Northing: 1223822 Easting: 452701

Up Stream View	Down Stream View	Side View

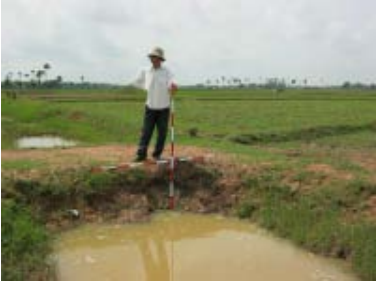
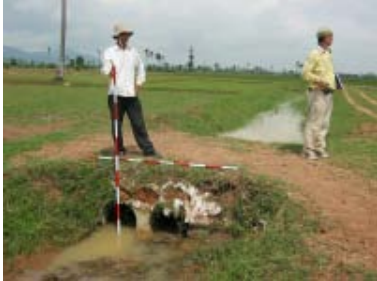
Canal No.: C24	Kind of structure(s): Pipe Culvert	Remarks: Double Pipe culvert
Station: 6.00	Coordinate< Northing: 1223820 Easting: 453002

Up Stream View	Down Stream View

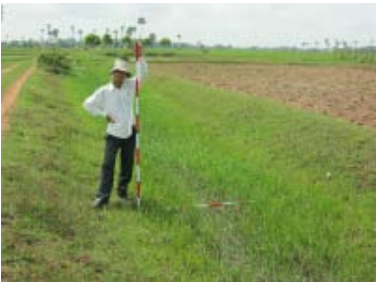
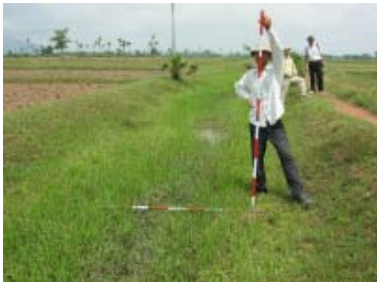
Canal No.: C24	Kind of structure(s): Canal	Remarks: E.P.
Station: 6.00+50(EP)	Coordinate< Northing: 1223818 Easting: 453058

Sta.	E	N	Structure	Condition	Evaluation	Flow Capacity	Remarks
6,050	453058	1223818	E.P.	Canal section is remained, but no irrigation water reached to this point	C

Up Stream View	Down Stream View

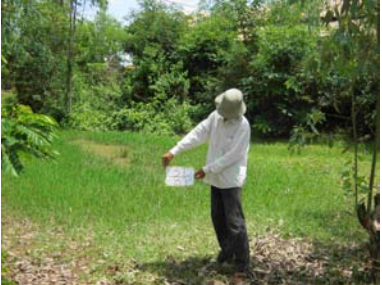
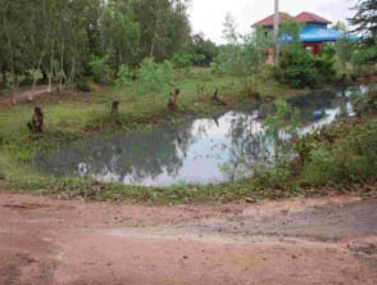
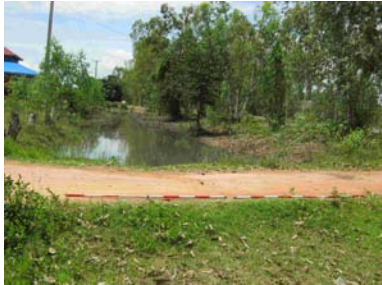
Canal No.: 3D	Kind of structure: Canal	Remarks: - Cross the National Road 130A
Station: 0.00(B.P.)	Coordinate< Northing: 1220131 Easting: 454726

Up Stream View	Down Stream View	Structure

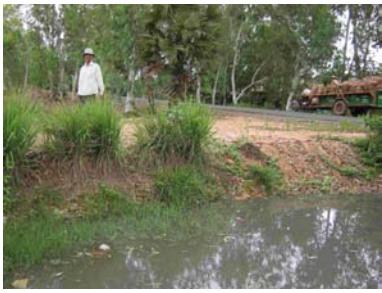
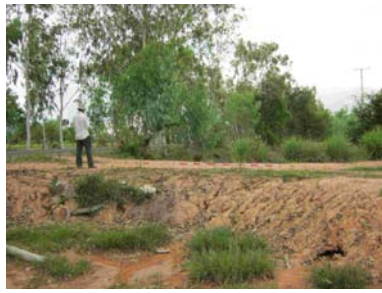
Canal No.: 3D	Kind of structure: Embankment	Remarks: Routine survey
Station: 0.00+80	Coordinate< Northing: 1220081 Easting: 454803

Up Stream View	Down Stream View

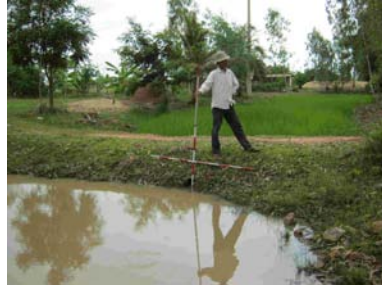
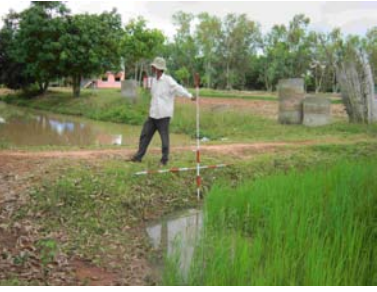
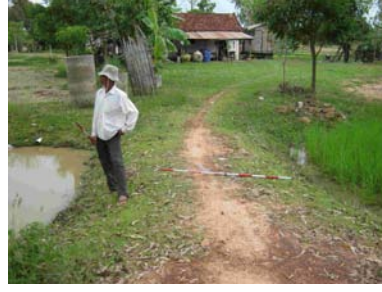
Canal No.: 3D	Kind of structure: Pipe culvert	Remarks: Routine survey
Station: 0.00+160	Coordinate< Northing: 1220047 Easting: 454848

Up Stream View	Down Stream View	Side View

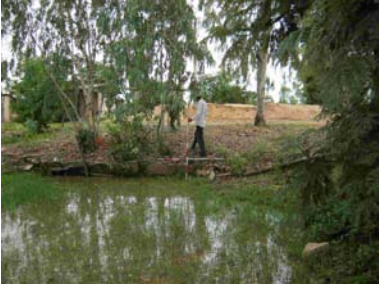
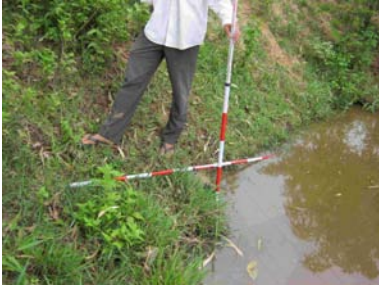
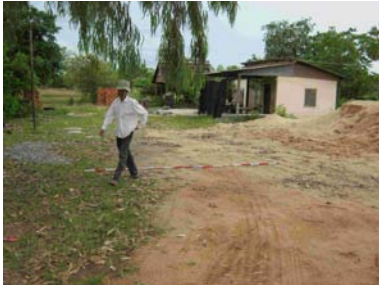
Canal No.: 3D	Kind of structure: Pipe culvert	Remarks:
Station: 0.00+240	Coordinate< Northing: 1220008 Easting: 454906	Routine survey

Up Stream View	Down Stream View	Side View

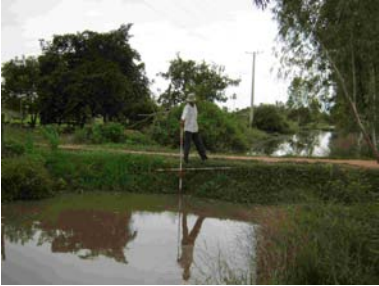
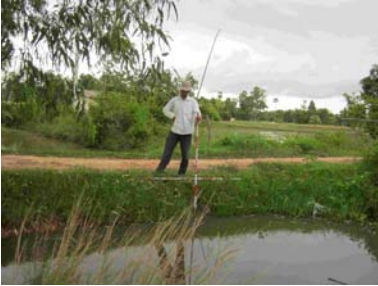
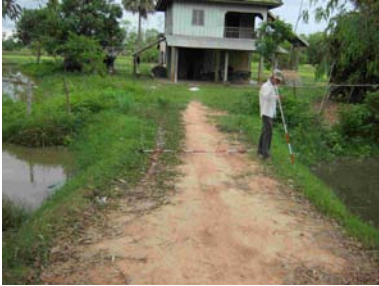
Canal No.: 3D	Kind of structure: Pipe culvert	Remarks:
Station: 0.00+280	Coordinate< Northing: 1219976 Easting: 454952	Routine survey

Up Stream View	Down Stream View	Side View

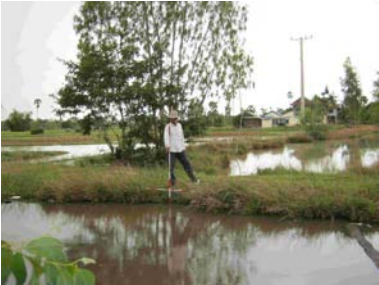
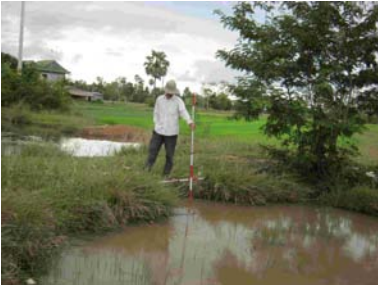
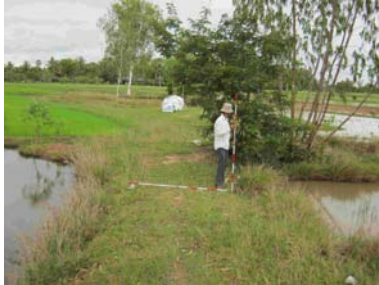
Canal No.: 3D	Kind of structure: Pipe culvert	Remarks:
Station: 0.00+360	Coordinate< Northing: 1219937 Easting: 455016	Routine survey

Up Stream View	Down Stream View	Side View

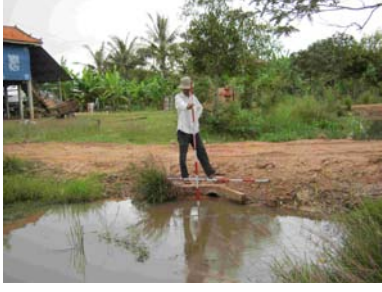
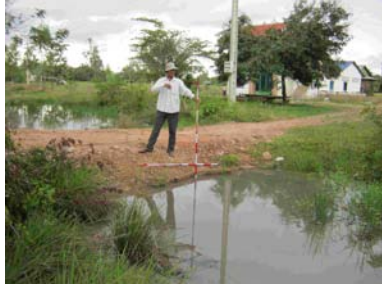
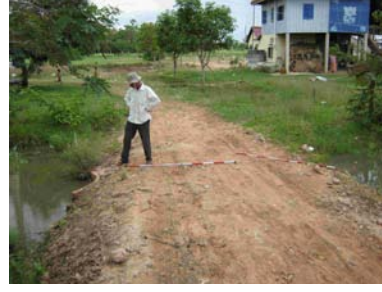
Canal No.: 3D	Kind of structure: Pipe culvert	Remarks:
Station: 0.00+480	Coordinate< Northing: 1219876 Easting: 455114	Routine survey

Up Stream View	Down Stream View	Side View

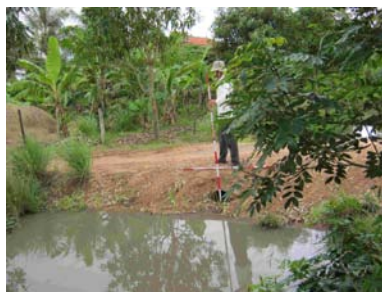
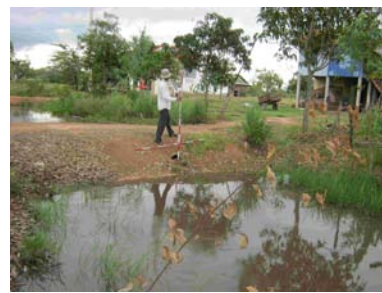
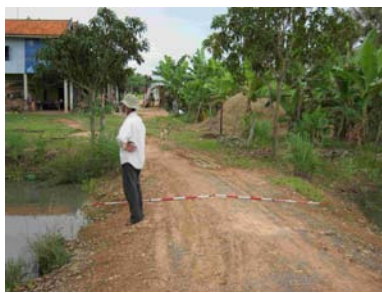
Canal No.: 3D	Kind of structure: Pipe culvert	Remarks:
Station: 0.00+500	Coordinate< Northing: 1219867 Easting: 455126	Routine survey

Up Stream View	Down Stream View	Side View

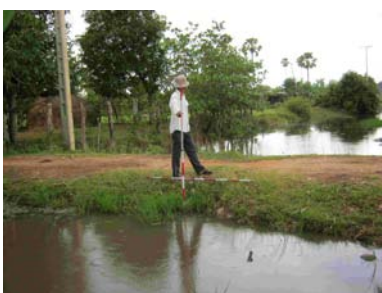
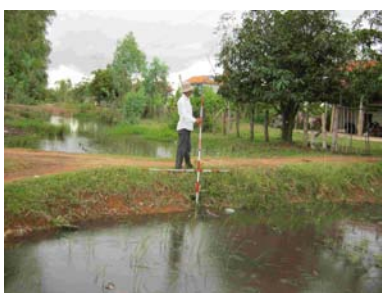
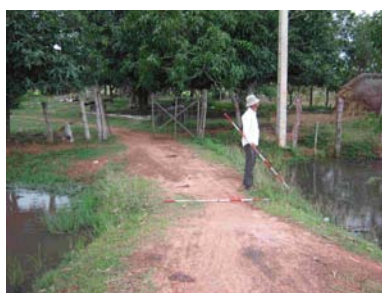
Canal No.: 3D	Kind of structure: Pipe culvert	Remarks:
Station: 0.00+540	Coordinate< Northing: 1219841 Easting: 455168	Routine survey

Up Stream View	Down Stream View	Side View

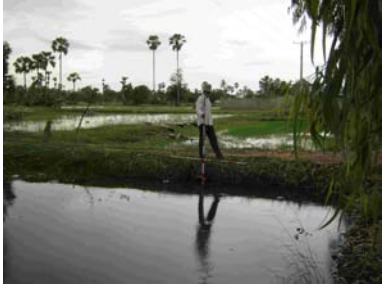
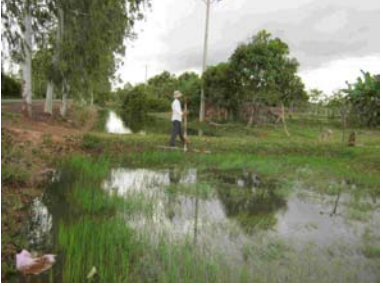
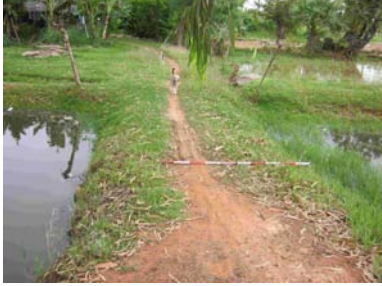
Canal No.: 3D	Kind of structure: Pipe culvert	Remarks:
Station: 0.00+640	Coordinate< Northing: 1219796 Easting: 455247	Routine survey

<div style="display: flex; justify-content: space-around;"> <span>Up Stream View</span> <span>Down Stream View</span> <span>Side View</span> </div>

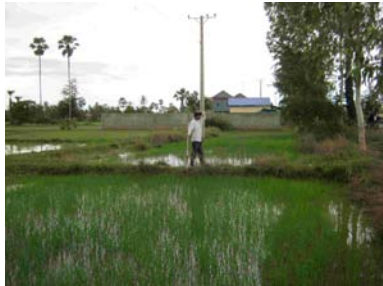
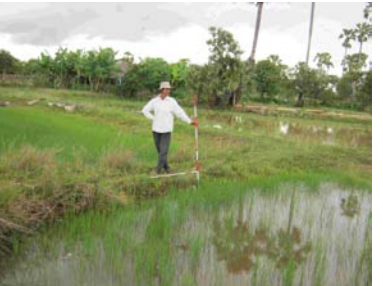
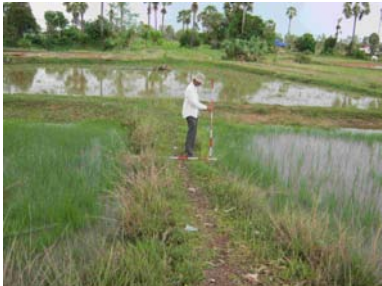
Canal No.: 3D	Kind of structure: Pipe culvert	Remarks:
Station: 0.00+660	Coordinate< Northing: 1219777 Easting: 455274	Routine survey

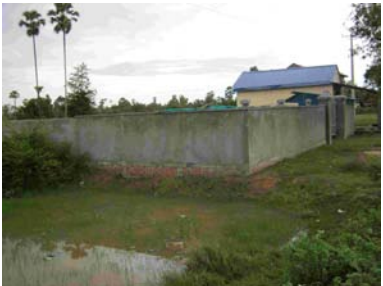
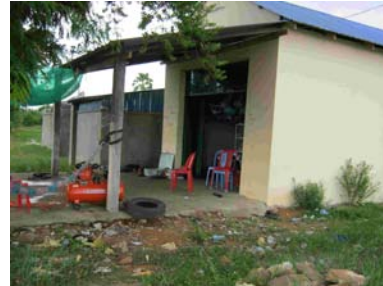
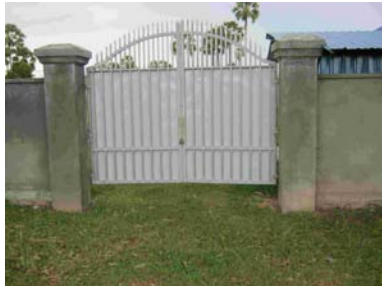
Canal No.: 3D	Kind of structure: House	Remarks:
Station: 0.00+700	Coordinate< Northing: 1219752 Easting: 455309	Routine survey

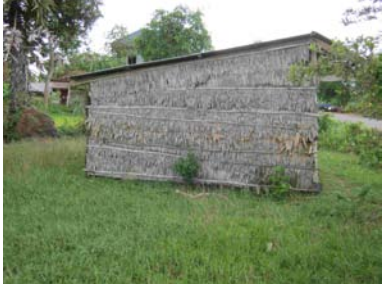
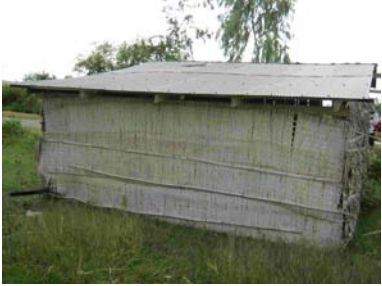
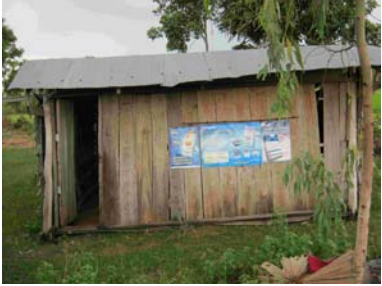
Canal No.: 3D	Kind of structure: House	Remarks: Routine survey Secondary B.P.
Station: 0.00+740	Coordinate< Northing: 1219711 Easting: 455374	
<div style="display: flex; justify-content: space-around; align-items: center;"> <div style="text-align: center;">

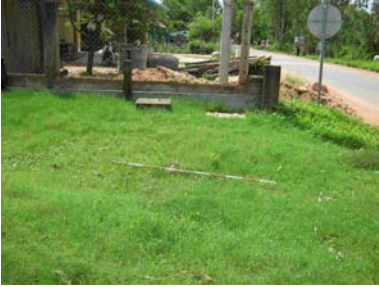
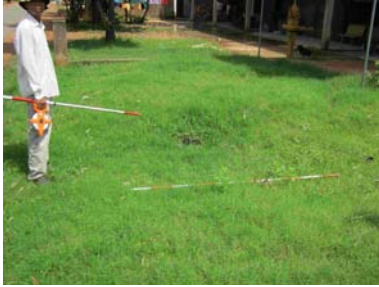
Canal No.: 3D	Kind of structure: Canal	Remarks: Routine survey
Station: 1.00+260	Coordinate< Northing: 1219485 Easting: 455810	
<div style="display: flex; justify-content: space-around; align-items: center;"> <div style="text-align: center;">

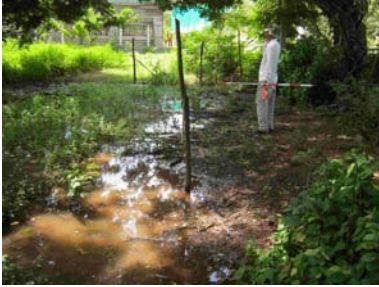
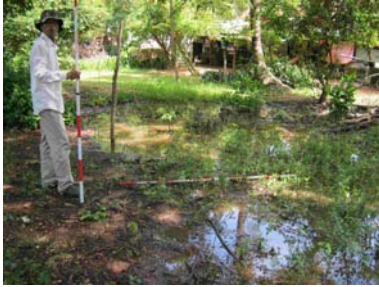
Canal No.: 3D	Kind of structure: Canal	Remarks: Routine survey
Station: 1.00+760	Coordinate< Northing: 1219409 Easting: 456291	
<div style="display: flex; justify-content: space-around; align-items: center;"> <div style="text-align: center;">

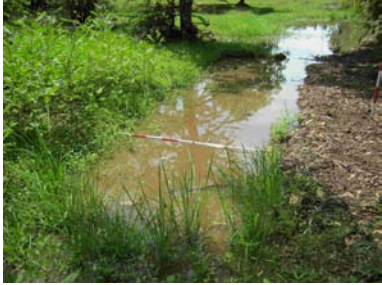
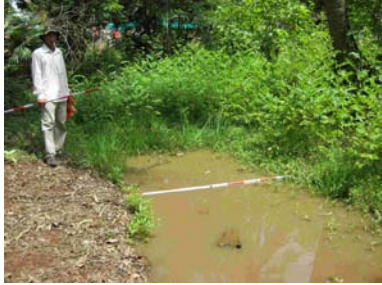
Canal No.: 3D	Kind of structure: Canal	Remarks: Routine survey Sub B.P.
Station: 2.00+50	Coordinate< Northing: 1219363 Easting: 456538	
<div style="display: flex; justify-content: space-around; align-items: center;"> <div style="text-align: center;">

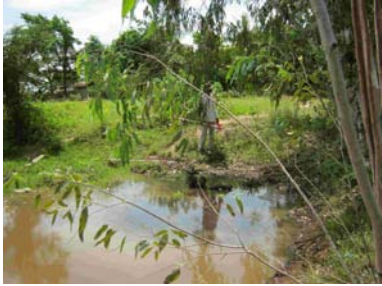
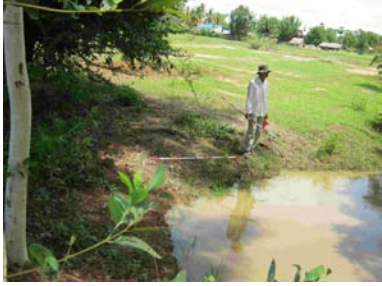
Canal No.: 3D	Kind of structure: Embankment	Remarks: Routine survey
Station: 2.00+140	Coordinate< Northing: 1219337 Easting: 456630	
<div style="display: flex; justify-content: space-around; align-items: center;"> <div style="text-align: center;">

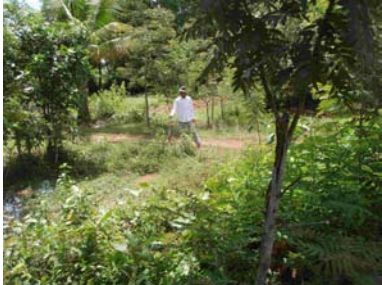
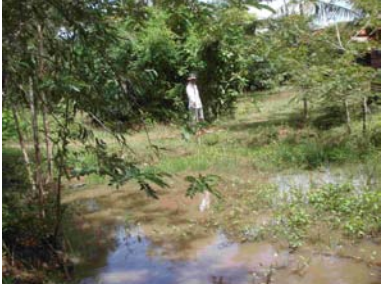
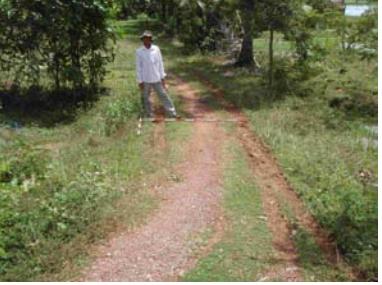
Canal No.: 3D	Kind of structure: Pipe culvert	Remarks: Routine survey
Station: 2.00+240	Coordinate< Northing: 1219322 Easting: 456704	
<div style="display: flex; justify-content: space-around; align-items: center;"> <div style="text-align: center;">

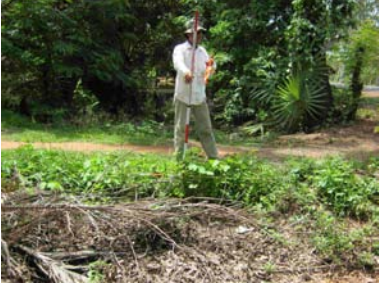
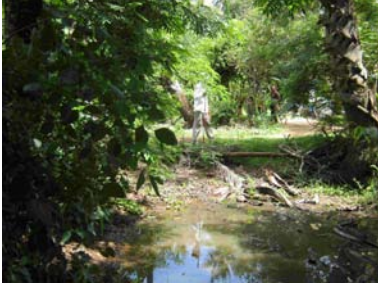
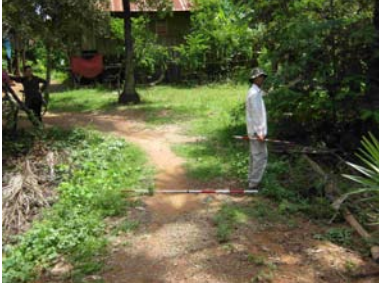
Canal No.: 3D	Kind of structure: Pipe culvert(small)	Remarks: Routine survey
Station: 2.00+300	Coordinate< Northing: 1219306 Easting: 456778	
<div style="display: flex; justify-content: space-around;"> <div style="text-align: center;">

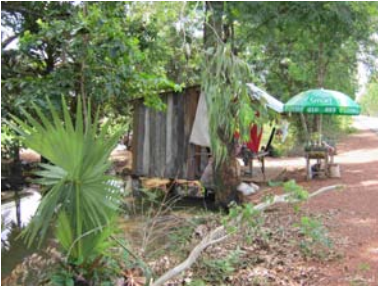
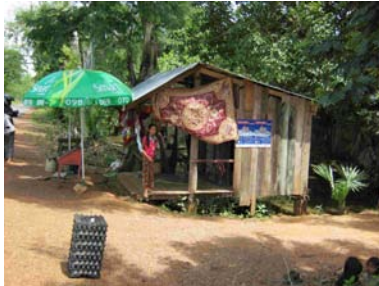
Canal No.: 3D	Kind of structure: House	Remarks: Routine survey
Station: 2.00+330	Coordinate< Northing: 1219291 Easting: 456821	
<div style="display: flex; justify-content: space-around;"> <div style="text-align: center;">

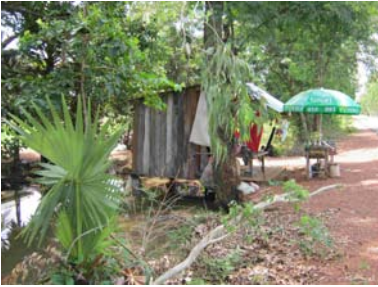
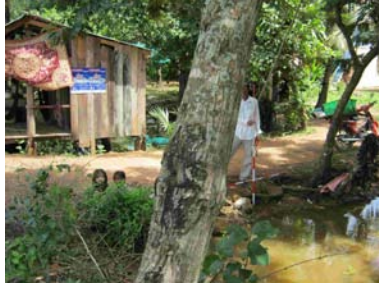
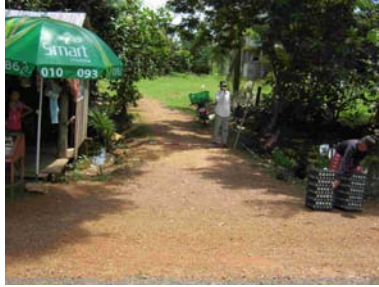
Canal No.: 3D	Kind of structure: Pipe culvert	Remarks: Routine survey
Station: 2.00+370	Coordinate< Northing: 1219282 Easting: 456865	
<div style="display: flex; justify-content: space-around;"> <div style="text-align: center;">

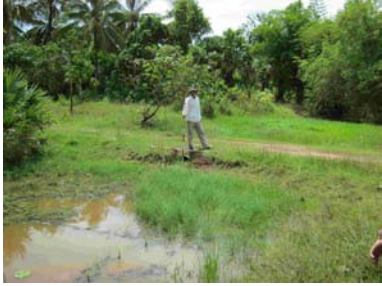
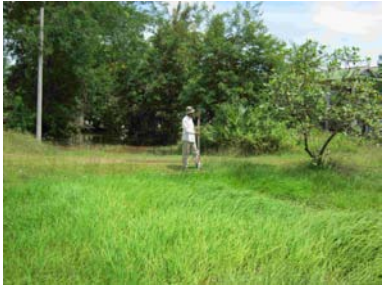
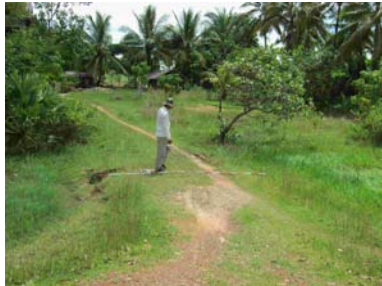
Canal No.: 3D	Kind of structure: Pipe culvert	Remarks: Routine survey
Station: 2.00+400	Coordinate< Northing: 1219274 Easting: 456903

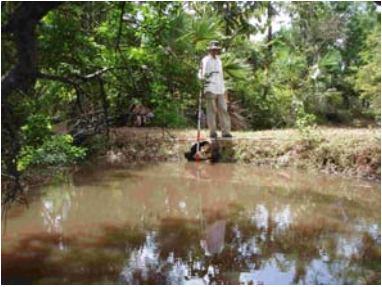
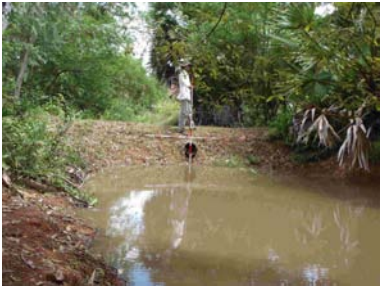
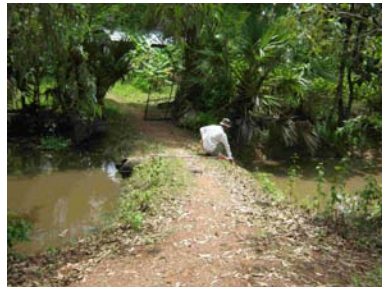
Canal No.: 3D	Kind of structure: Pipe culvert	Remarks: Routine survey
Station: 2.00+430	Coordinate< Northing: 1219264 Easting: 456929

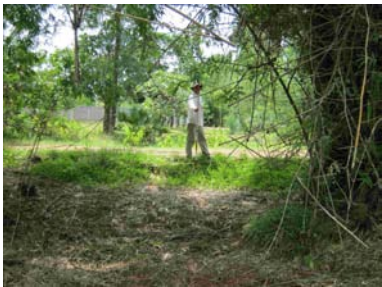
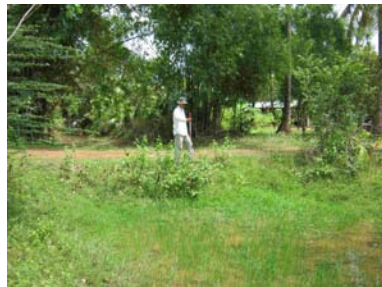
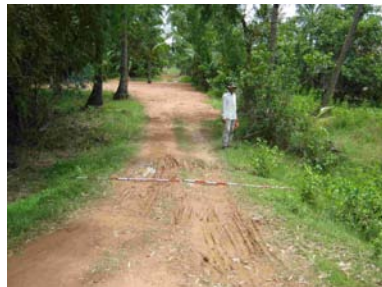
Canal No.: 3D	Kind of structure: Pipe culvert	Remarks: Routine survey
Station: 2.00+440	Coordinate< Northing: 1219259 Easting: 456956

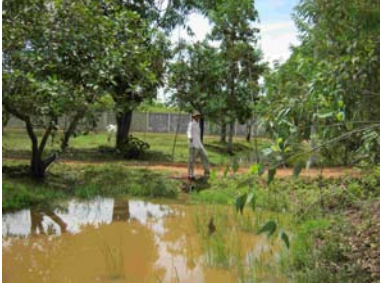
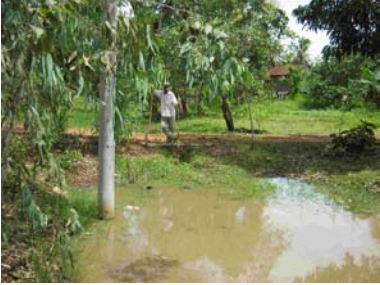
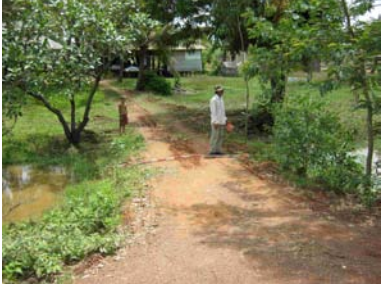
Canal No.: 3D	Kind of structure: Pipe culvert	Remarks: Routine survey
Station: 2.00+470	Coordinate< Northing: 1219245 Easting: 456995

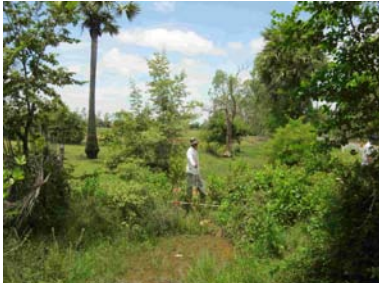
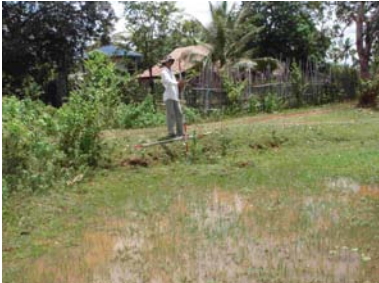
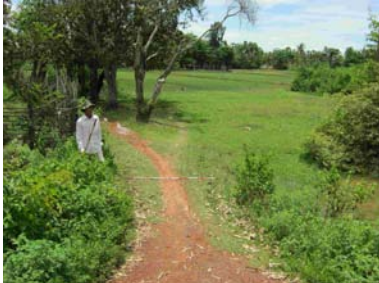
Canal No.: 3D	Kind of structure: Pipe culvert	Remarks:
Station: 3.00+200	Coordinate< Northing: 1219062 Easting: 457738	Routine survey

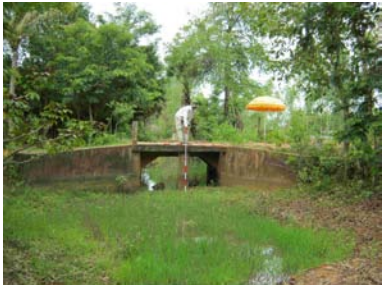
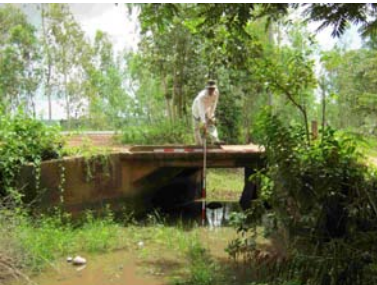
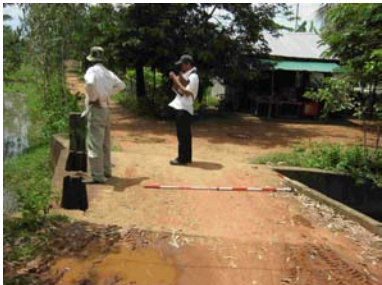
Canal No.: 3D	Kind of structure: Bridge	Remarks:
Station: 3.00+500	Coordinate< Northing: 1218929 Easting: 457998	There is a groove

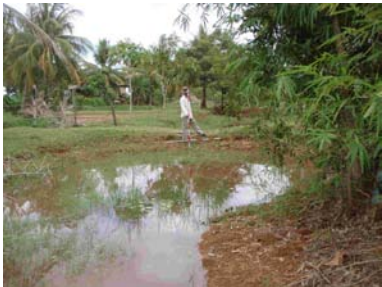
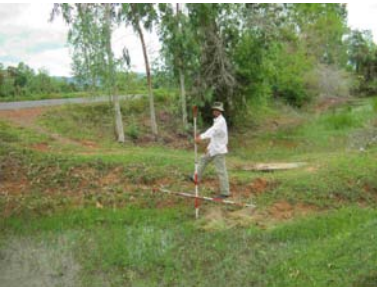
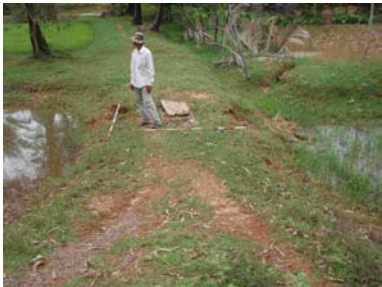
Canal No.: 3D	Kind of structure: Embankment	Remarks:
Station: 3.00+610	Coordinate< Northing: 1218880 Easting: 458083	Routine survey

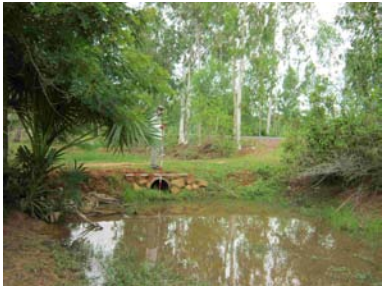
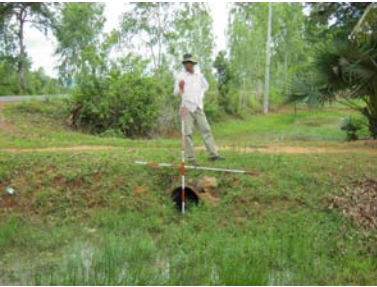
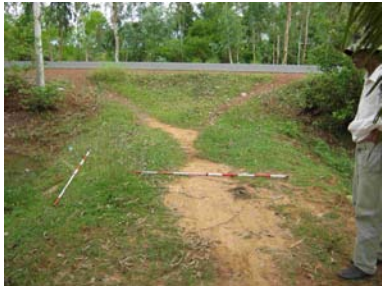
Canal No.: 3D	Kind of structure: Pipe culvert	Remarks:
Station: 3.00+620	Coordinate< Northing: 1218872 Easting: 458112	Routine survey

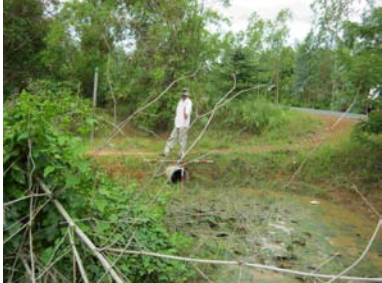
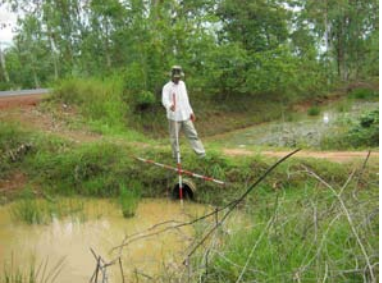
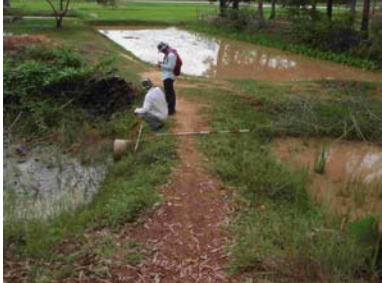
Canal No.: 3D	Kind of structure: Pipe Culvert	Remarks:
Station: 3.00+710	Coordinate< Northing: 1218845 Easting: 458162	Routine survey

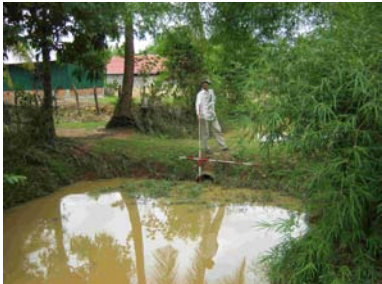
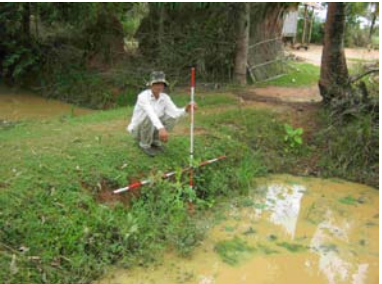
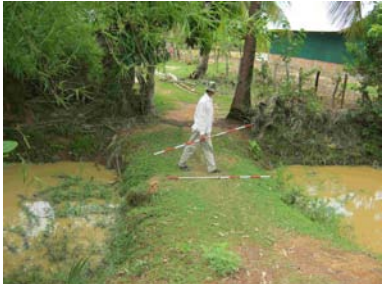
Canal No.: 3D	Kind of structure: Pipe Culvert	Remarks:
Station: 3.00+770	Coordinate< Northing: 1218819 Easting: 458203	Routine survey

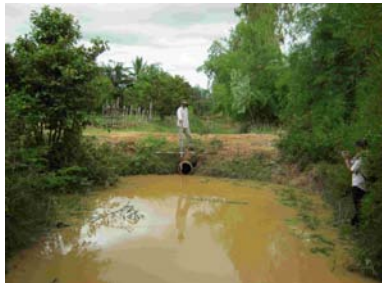
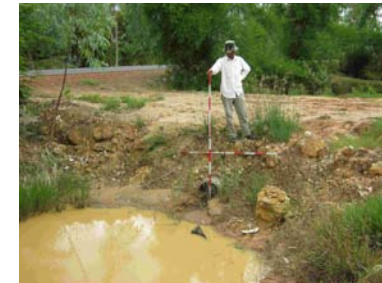
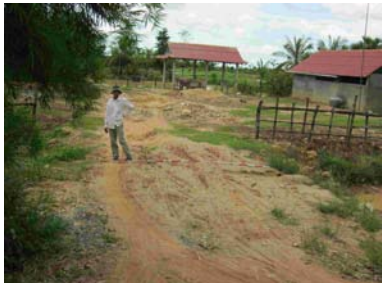
Canal No.: 3D	Kind of structure: Pipe culvert	Remarks:
Station: 3.00+780	Coordinate< Northing: 1218806 Easting: 458220	Routine survey

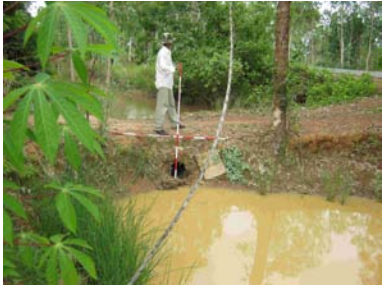
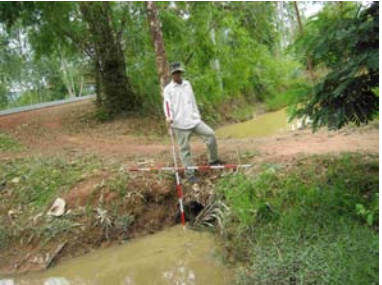
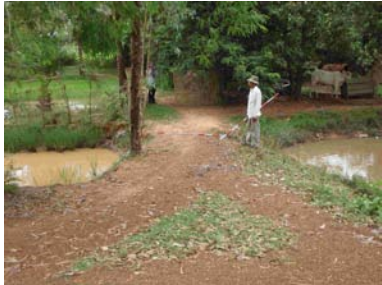
Canal No.: 3D	Kind of structure: Pipe culvert	Remarks:
Station: 3.00+870	Coordinate< Northing: 1218776 Easting: 458283	Routine survey

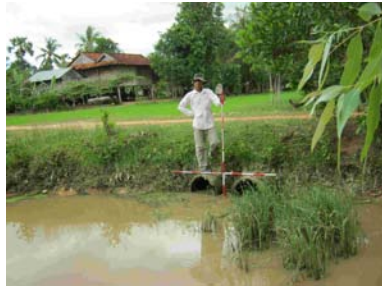
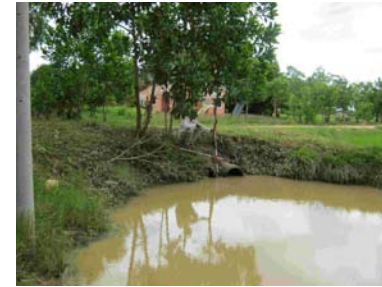
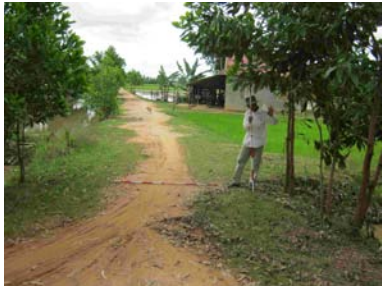
Canal No.: 3D	Kind of structure: Pipe culvert (Double)	Remarks:
Station: 3.00+990	Coordinate< Northing: 1218739 Easting: 458351	Routine survey

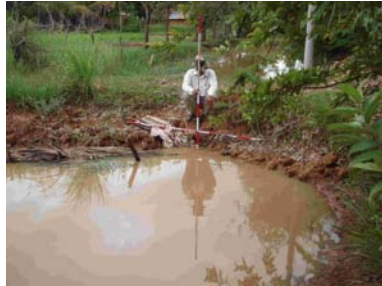
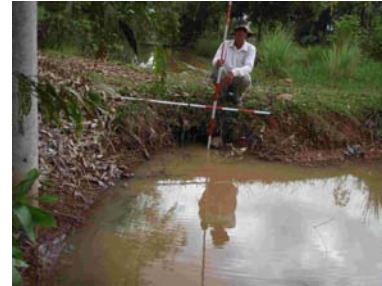
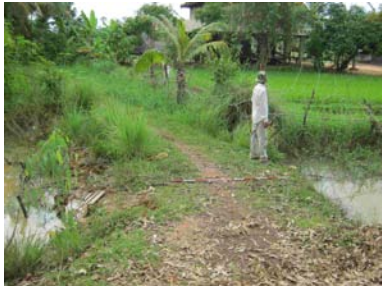
Canal No.: 3D	Kind of structure: Pipe culvert	Remarks:
Station: 4.00+100	Coordinate< Northing: 1218684 Easting: 458448	Routine survey

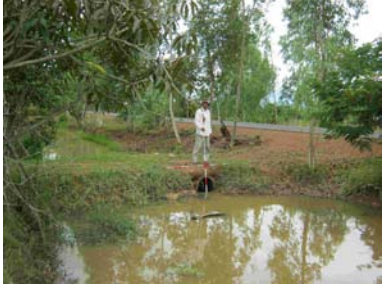
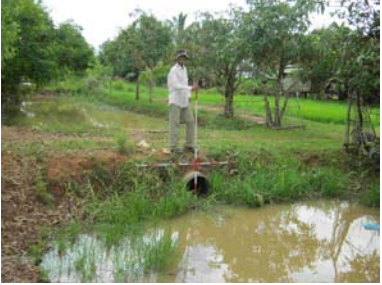
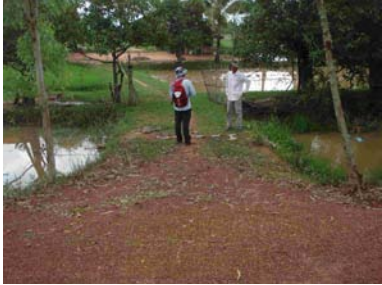
Canal No.: 3D	Kind of structure: Pipe culvert	Remarks:
Station: 4.00+120	Coordinate< Northing: 1218675 Easting: 458472	Routine survey

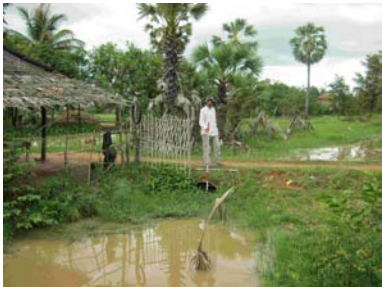
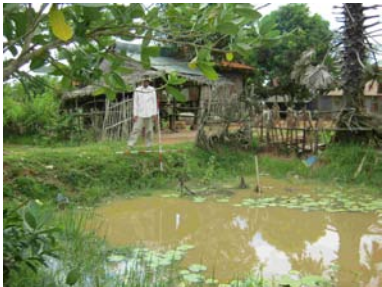
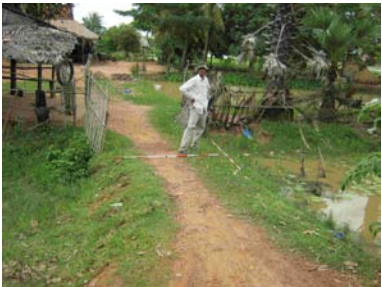
Canal No.: 3D	Kind of structure: Pipe culvert	Remarks:
Station: 4.00+160	Coordinate< Northing: 1218657 Easting: 458506	Routine survey

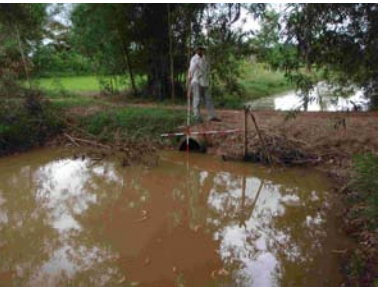
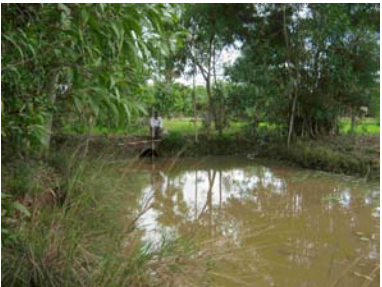
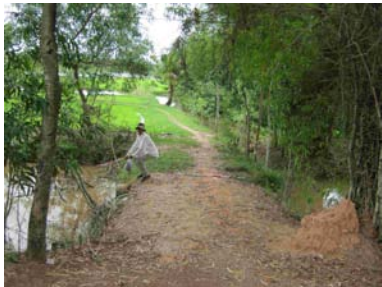
Canal No.: 3D	Kind of structure: Pipe culvert	Remarks:
Station: 4.00+250	Coordinate< Northing: 1218604 Easting: 458602	Routine survey

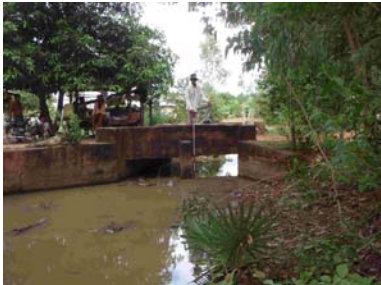
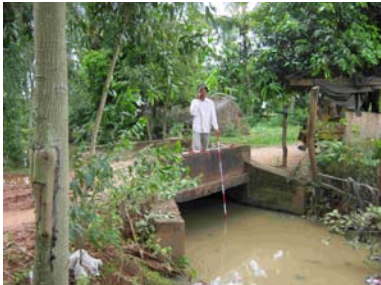
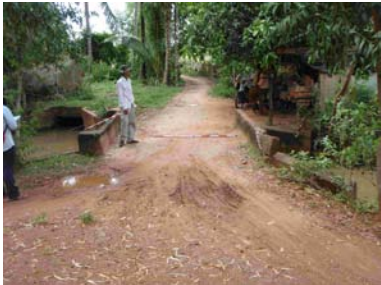
Canal No.: 3D	Kind of structure: Bridge	Remarks:
Station: 4.00+750	Coordinate< Northing: 1218396 Easting: 458991	There is a groove

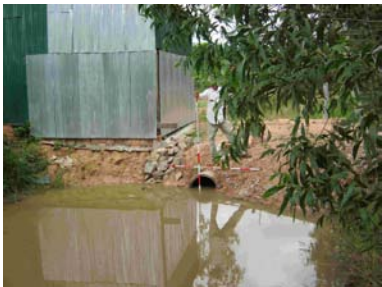
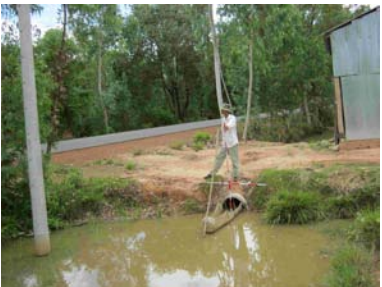
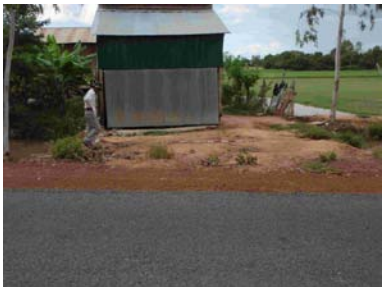
Canal No.: 3D	Kind of structure: Pipe culvert	Remarks:
Station: 4.00+840	Coordinate< Northing: 1218356 Easting: 459060	There is a house

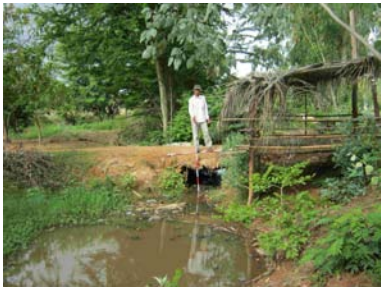
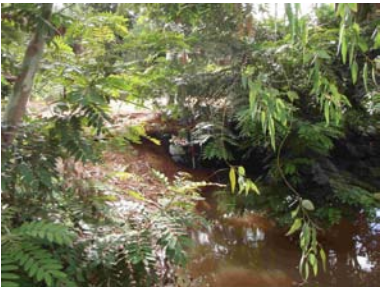
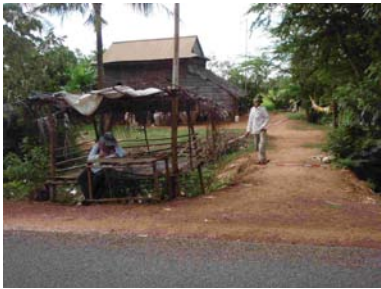
Canal No.: 3D	Kind of structure: Pipe culvert	Remarks:
Station: 6.00+710	Coordinate< Northing: 1217748 Easting: 460760	There is a house (cottage)

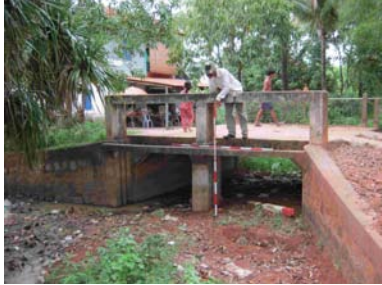
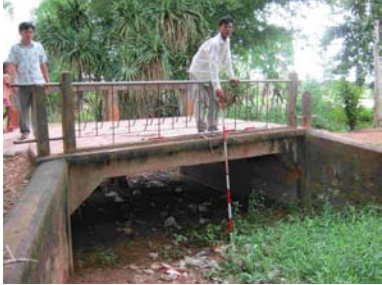
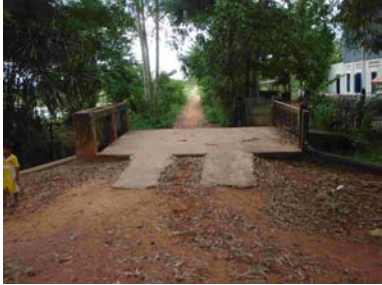
Sta.	E	N	Structure	Condition	Evaluation	Flow Capacity	Remarks
6,890	0460989	1217707	Bridge-6 (Private) & Groove	Regulating structure, 1.6m span and 4m wide with grooves for planks	B/D		Village road
6,930	0461032	1217697	Bridge-7 (Private)/ House-11	W=2.2m made by wood/ House on canal	B		House
6,970	0461067	1217685	Bridge-8 (Private)	W=1.6m made by wood	B		House access
7,000	0461093	1217683	Bridge-9 (Private)	W=2.5m made by concrete	B		House access
7,030	0461120	1217677	Pipe Culvert 55	Single pipe with 1.5m dia and 4.5m long at one side (upstream) and three pipes 0.5m dia each at other side (downstream)	B		House access
7,190	0461275	1217644	Bridge-10 (Private)	W=1.5m made by wood	B		House access
7,300	0461386	1217622	Bridge-11 (Private) & House-12	W=4m made by concrete/ Shop on canal	B		Shop
7,320	0461402	1217619	Shops/Houses (B.P.3)	Canteen & house on canal			(B.P.3):up to Sta. 7,830
7,420	0461500	1217602	Pipe Culvert 56 (Double)	Two pipes with 0.8m dia each and 3m long	B		Village road

Canal No.: 3D	Kind of structure: Bridge (private)	Remarks:
Station: 6.00+920	Coordinate< Northing: 1217707 Easting: 460989	There is a groove

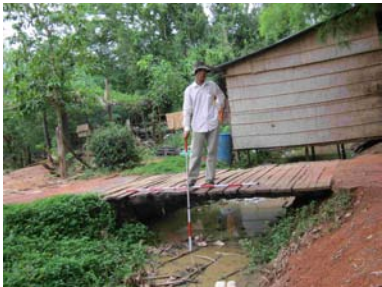
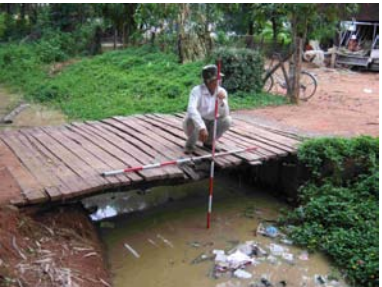
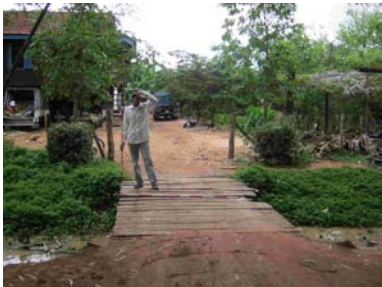
Canal No.: 3D	Kind of structure: Bridge (private)	Remarks:
Station: 6.00+970	Coordinate< Northing: 1217697 Easting: 461032	There is a house

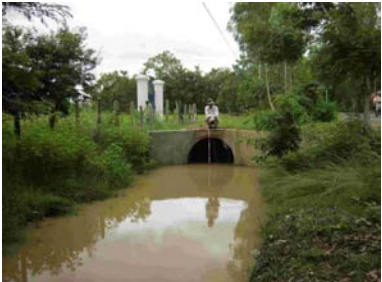
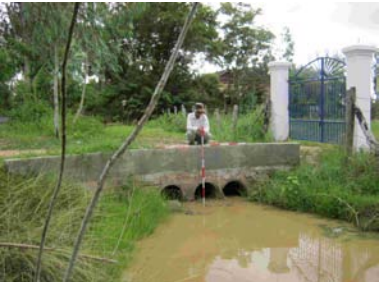
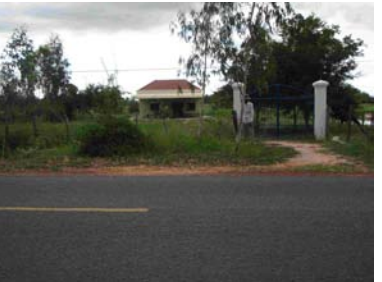
Canal No.: 3D	Kind of structure: Pipe culvert	Remarks:
Station: 7.00+50	Coordinate< <div style="display: flex; justify-content: space-between; padding: 0 10px;"> <span>Northing: 1217677</span> <span>Easting: 461120</span> </div>	Routine survey

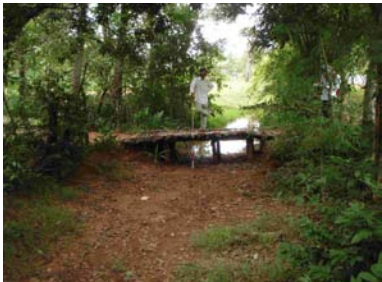
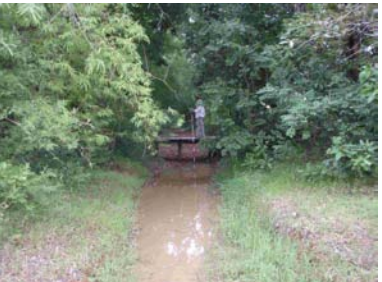
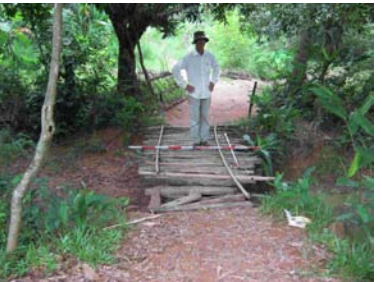
Canal No.: 3D	Kind of structure: Bridge (private)	Remarks:
Station: 7.00+220	Coordinate< <div style="display: flex; justify-content: space-between; padding: 0 10px;"> <span>Northing: 1217644</span> <span>Easting: 461275</span> </div>	Routine survey

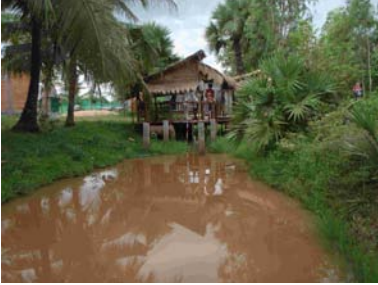
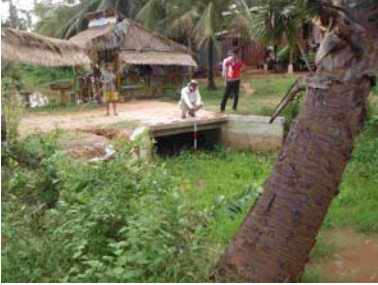
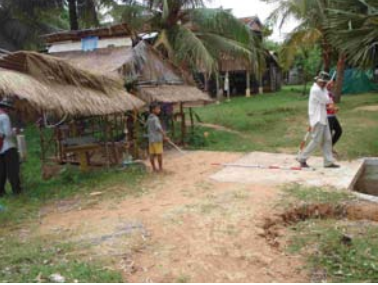
Canal No.: 3D	Kind of structure: Bridge (private)	Remarks:
Station: 7.00+340	Coordinate< Northing: 1217622 Easting: 461386	There is a house

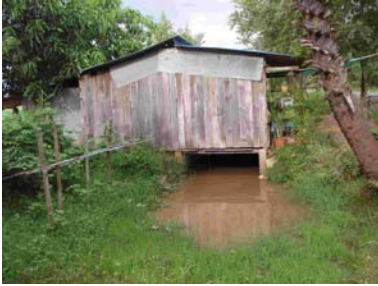
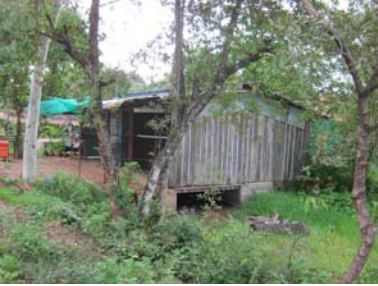
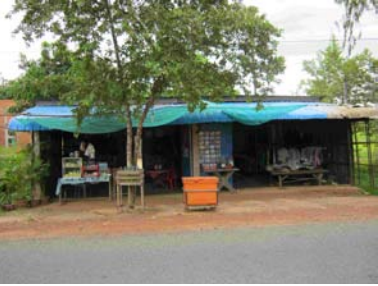
Canal No.: 3D	Kind of structure: House (Double)	Remarks:
Station: 7.00+360	Coordinate< Northing: 1217619 Easting: 461402	Routine survey

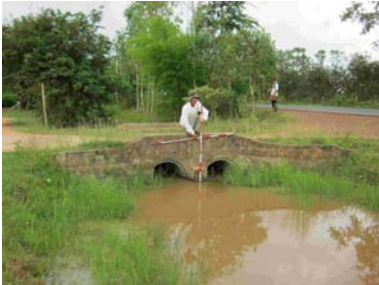
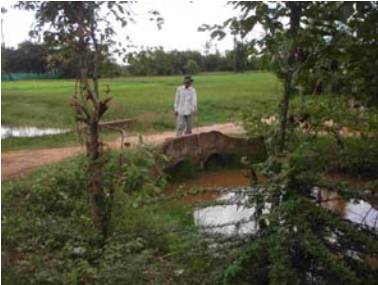
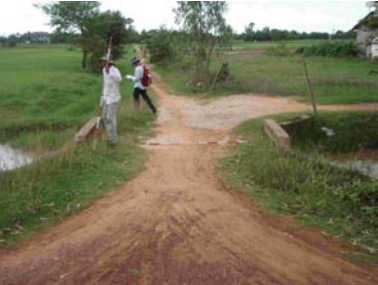
Canal No.: 3D	Kind of structure: Pipe culvert (Double)	Remarks:
Station: 7.00+450	Coordinate< Northing: 1217602 Easting: 461500	Routine survey

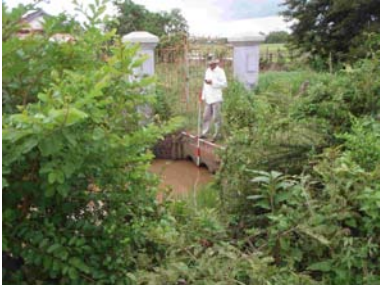
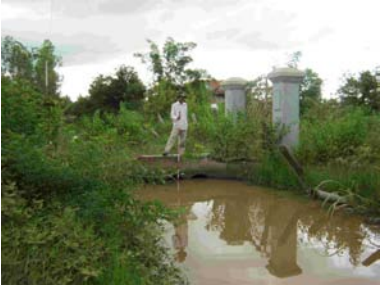
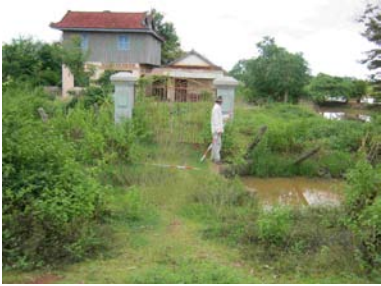
Canal No.: 3D	Kind of structure: Pipe culvert (Triple)	Remarks:
Station: 7.00+550	Coordinate< Northing: 1217581 Easting: 461575	Routine survey

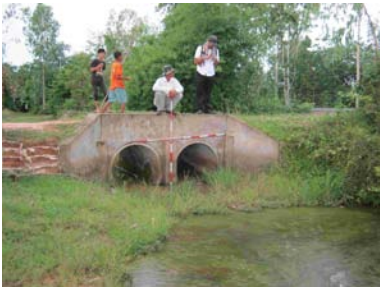
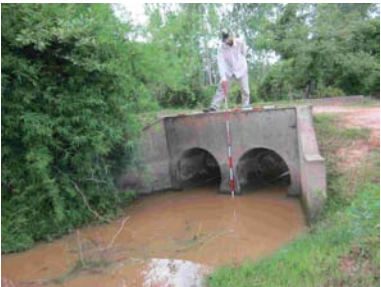
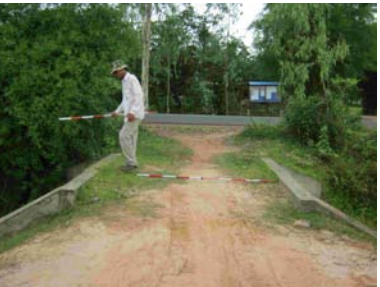
Canal No.: 3D	Kind of structure: Pipe culvert (Double)	Remarks:
Station: 7.00+720	Coordinate< Northing: 1217551 Easting: 461741	There is a groove

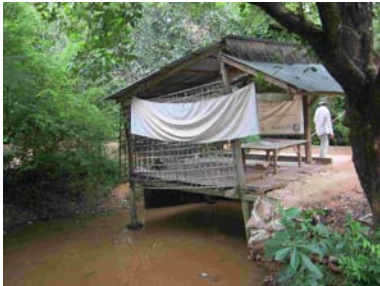
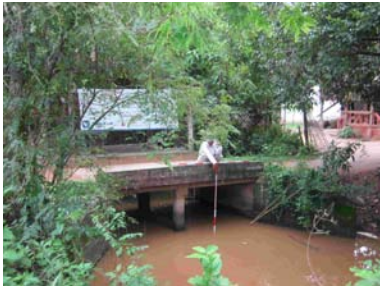
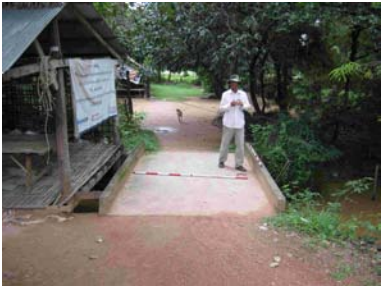
Canal No.: 3D	Kind of structure: Bridge (private)	Remarks:
Station: 7.00+900	Coordinate< Northing: 1217517 Easting: 461902	There is a house

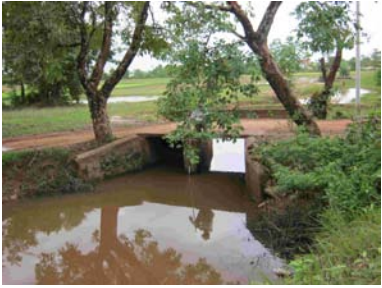
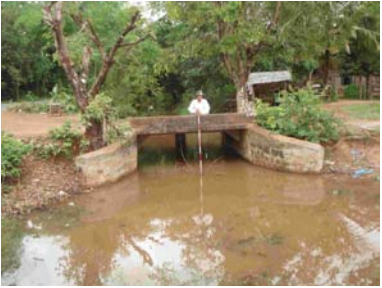
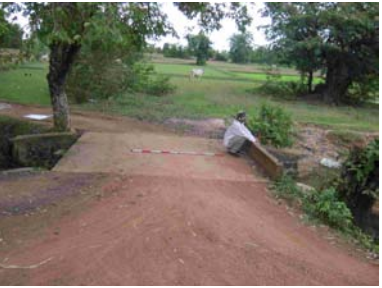
Canal No.: 3D	Kind of structure: Bridge (private)	Remarks: There is a groove
Station: 8.00+10	Coordinate< Northing: 1217494 Easting: 462014

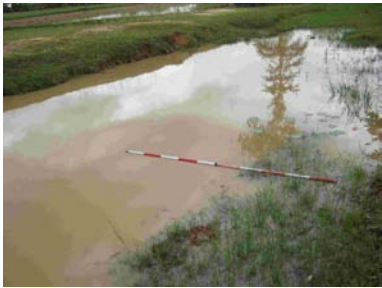
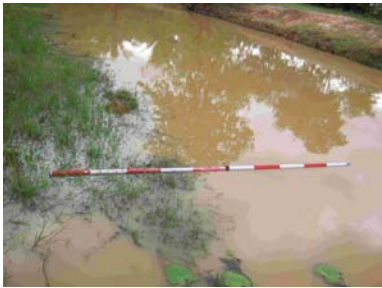
Canal No.: 3D	Kind of structure: Canal	Remarks: Routine survey Length: 7000m
Station: 8.00+50	Coordinate< Northing: 1217551 Easting: 461741

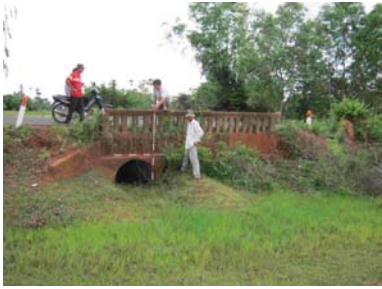
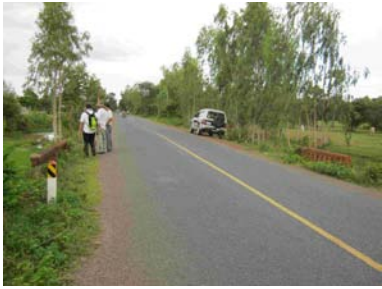
Canal No.: 3D	Kind of structure: Bridge (Pol Pot regime)	Remarks: There is a pipe culvert (triple)
Station: 8.00+240	Coordinate< Northing: 1217452 Easting: 462230

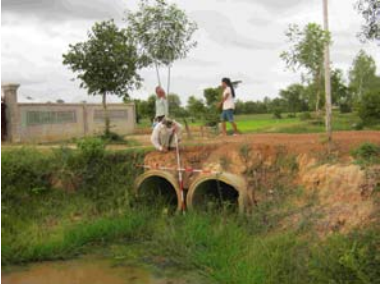
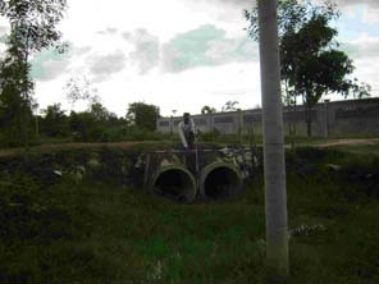
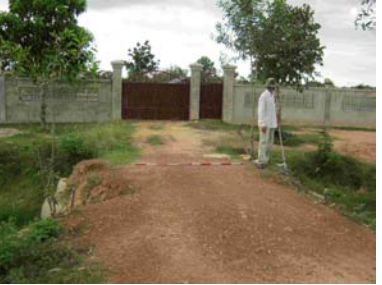
Canal No.: 3D	Kind of structure: Pipe culvert (Double)	Remarks:
Station: 8.00+320	Coordinate< <div style="display: flex; flex-direction: column; align-items: flex-start;"> <span>Northing: 1217441</span> <span>Easting: 462306</span> </div>	Routine survey
<div style="display: flex; justify-content: space-around;"> <div style="text-align: center;">

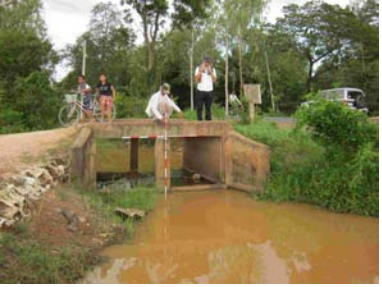
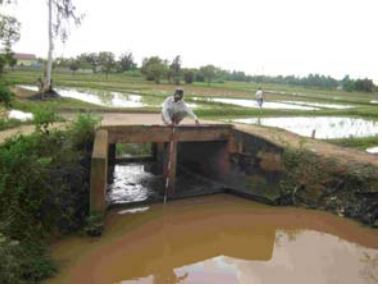
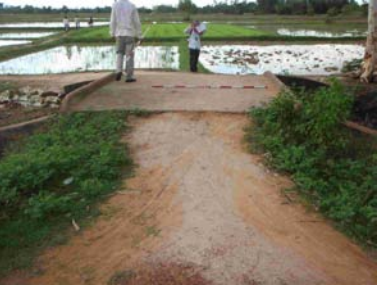
Canal No.: 3D	Kind of structure: Bridge (village)	Remarks:
Station: 8.00+510	Coordinate< <div style="display: flex; flex-direction: column; align-items: flex-start;"> <span>Northing: 1217411</span> <span>Easting: 462491</span> </div>	There is a groove
<div style="display: flex; justify-content: space-around;"> <div style="text-align: center;">

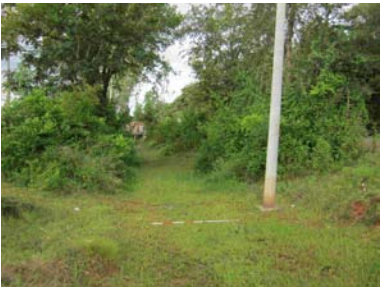
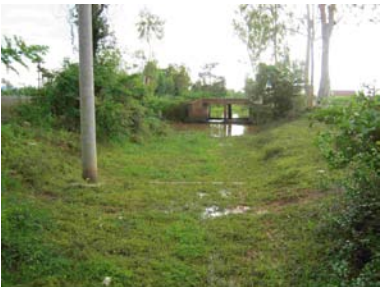
Canal No.: 3D	Kind of structure: Canal	Remarks:
Station: 8.00+530(EP)	Coordinate< <div style="display: flex; flex-direction: column; align-items: flex-start;"> <span>Northing: 1217400</span> <span>Easting: 462517</span> </div>	Routine survey
<div style="display: flex; justify-content: space-around;"> <div style="text-align: center;">

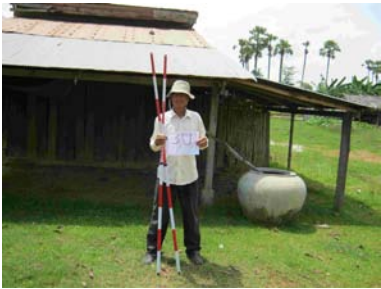
Canal No.: 3U	Kind of structure: House	Remarks: - Cross the National Road 130A
Station: 0.00(B.P.)	Coordinate< Northing: 1223101 Easting: 449634	
<div style="display: flex; justify-content: space-around; align-items: center;"> <div style="text-align: center;">

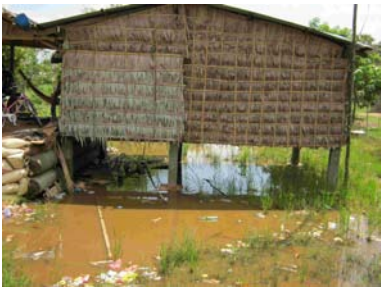
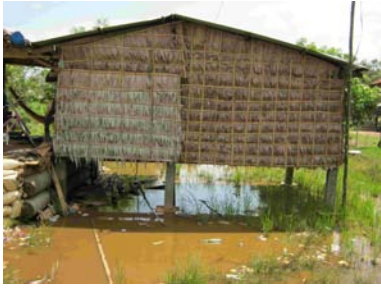
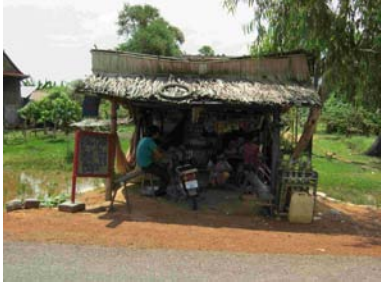
Canal No.: 3U	Kind of structure: House (Cottage)	Remarks: House is under canal
Station: 0.00+50	Coordinate< Northing: 1223100 Easting: 449674	
<div style="display: flex; justify-content: space-around; align-items: center;"> <div style="text-align: center;">

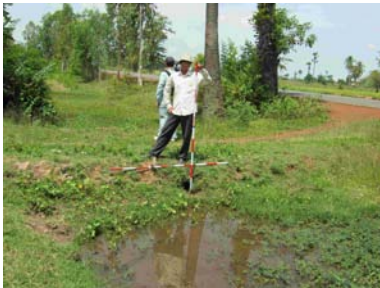
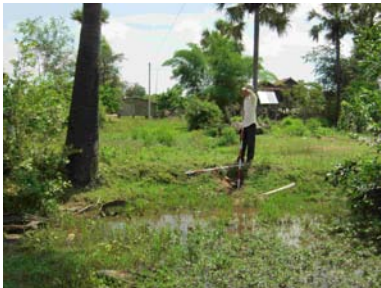
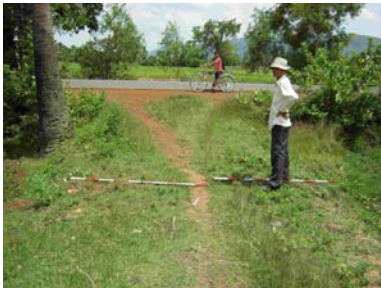
Canal No.: 3U	Kind of structure: Pipe culvert (Small)	Remarks: Routine survey
Station: 0.00+110	Coordinate< Northing: 1223103 Easting: 449731	
<div style="display: flex; justify-content: space-around; align-items: center;"> <div style="text-align: center;">
