*Results of Inventory Survey for  
Proposed Rehabilitation Works in  
Roleang Chrey Headworks Rehabilitation Sub-project*

PREPARATORY SURVEY FOR IRRIGATION AND DRAINAGE  
SYSTEM REHABILITATION AND IMPROVEMENT PROJECT

Japan International Cooperation Agency

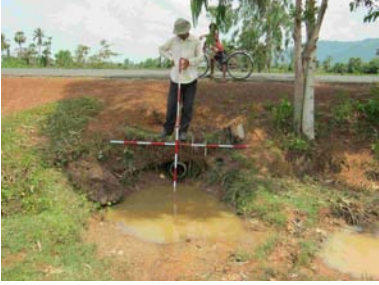
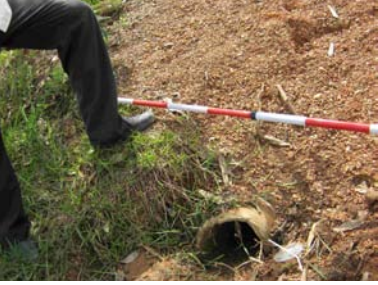
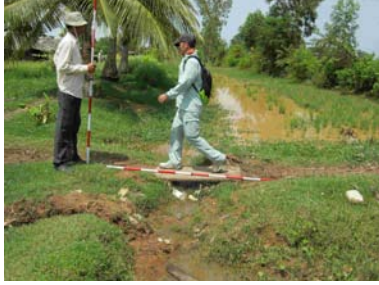
Canal No.: 3U	Kind of structure: Intake	Remarks:
Station: 0.00+180	Coordinate< Northing: 1223106 Easting: 449801	Routine survey

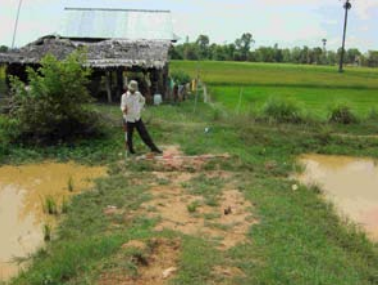
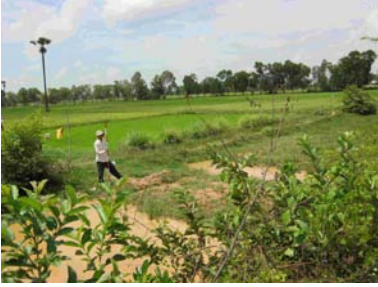
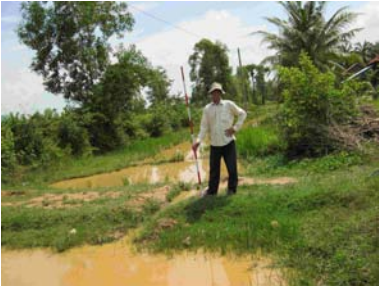
Canal No.: 3U	Kind of structure: Earth Check	Remarks:
Station: 0.00+230	Coordinate< Northing: 1223106 Easting: 449845	Routine survey

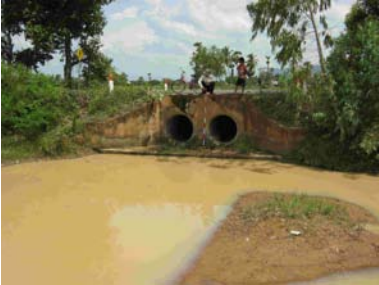
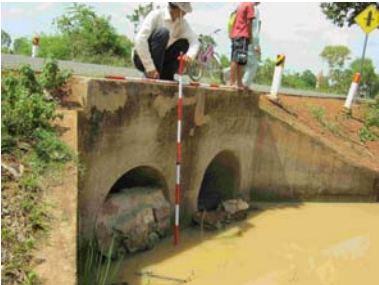
Canal No.: 3U	Kind of structure: Pipe culvert	Remarks:
Station: 0.00+260	Coordinate< Northing: 1223121 Easting: 449881	Pipe culvert is along the National road

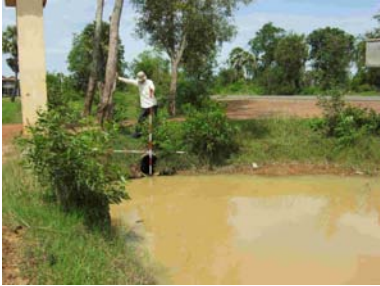
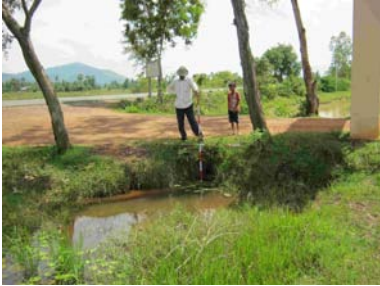
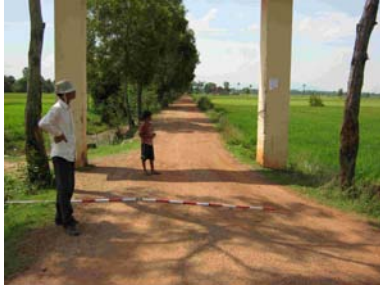
Canal No.: 3U	Kind of structure: Pipe culvert	Remarks: - Under commune road - There is a groove
Station: 0.00+360	Coordinate< Northing: 1223118 Easting: 449982

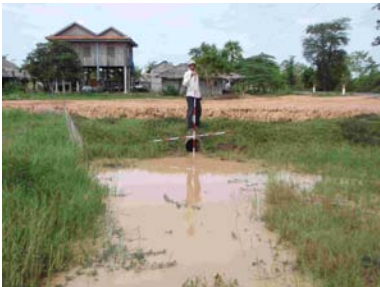
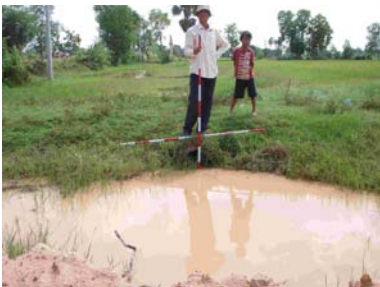
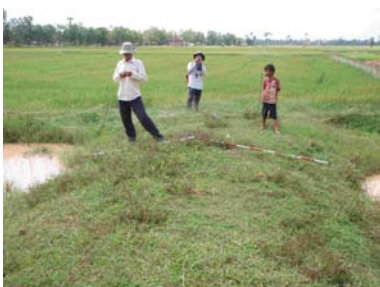
Canal No.: 3U	Kind of structure: Pipe culvert	Remarks: Routine survey
Station: 0.00+500	Coordinate< Northing: 1223122 Easting: 450087

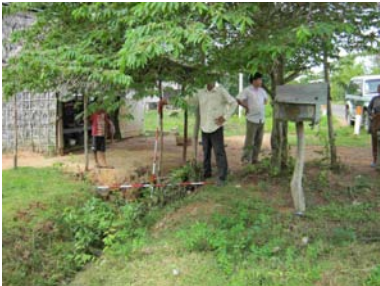
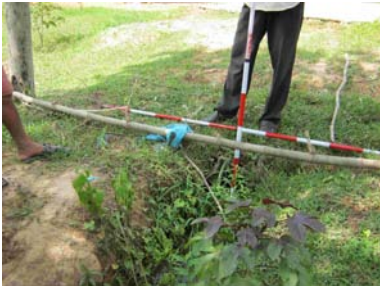
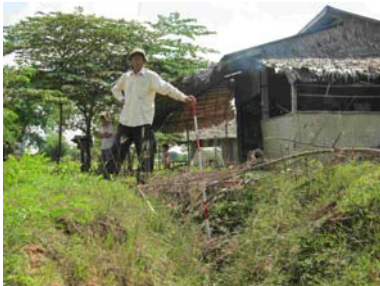
Canal No.: 3U	Kind of structure: Pipe culvert	Remarks: Pipe Culvert is under the land
Station: 0.00+550	Coordinate< Northing: 1223125 Easting: 450138

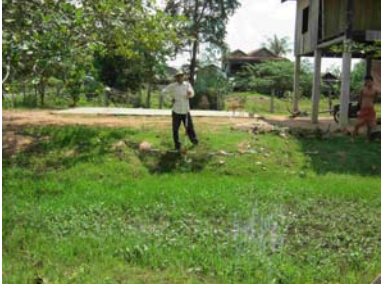
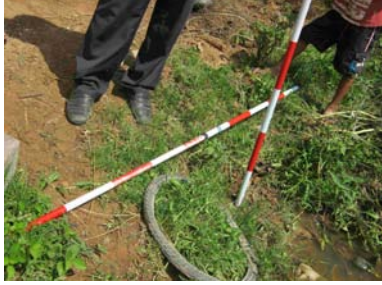
Canal No.: 3U	Kind of structure: Pipe culvert (Small)	Remarks: Pipe Culvert is under the land
Station: 0.00+600	Coordinate< Northing: 1223127 Easting: 450180	
<div style="display: flex; justify-content: space-around; align-items: center;"> <div style="text-align: center;">

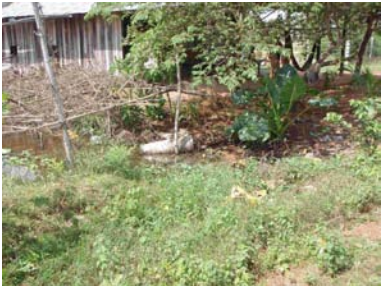
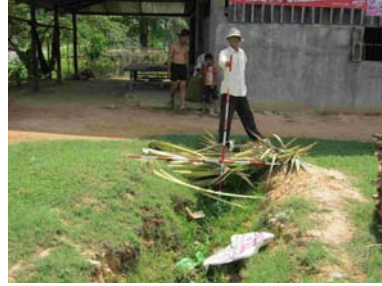
Canal No.: 3U	Kind of structure: Pipe Culvert	Remarks: Pipe Culvert is under the land
Station: 0.00+620	Coordinate< Northing: 1223117 Easting: 450232	
<div style="display: flex; justify-content: space-around; align-items: center;"> <div style="text-align: center;">

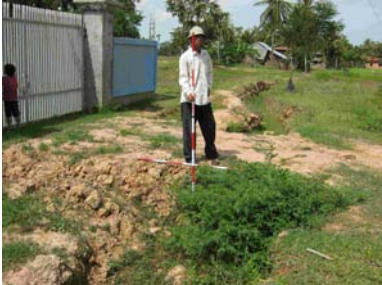
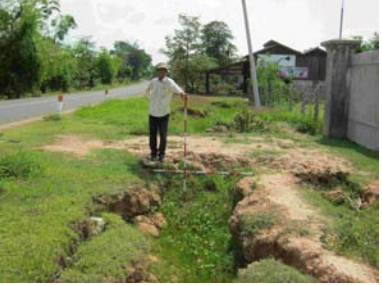
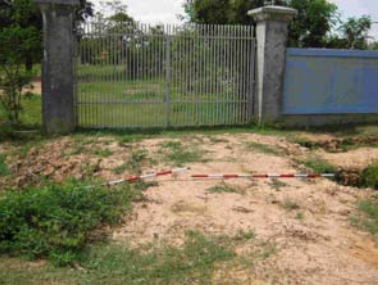
Canal No.: 3U	Kind of structure: Pipe culvert	Remarks: Pipe Culvert is under the land
Station: 0.00+660	Coordinate< Northing: 1223114 Easting: 450272	
<div style="display: flex; justify-content: space-around; align-items: center;"> <div style="text-align: center;">

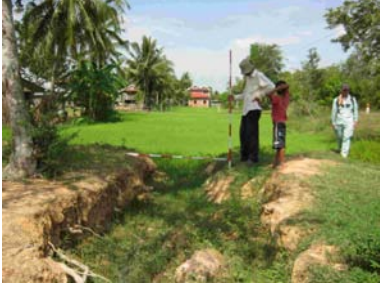
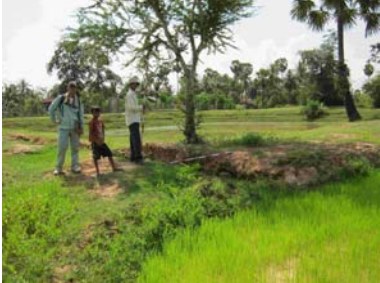
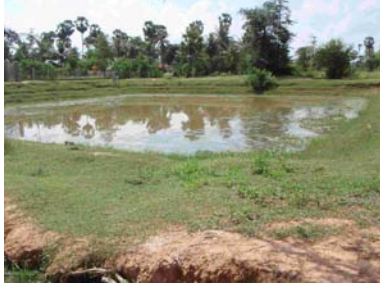
Canal No.: 3U	Kind of structure: Structure Party	Remarks:
Station: 0.00+710	Coordinate< Northing: 1223112 Easting: 450328	Routine survey

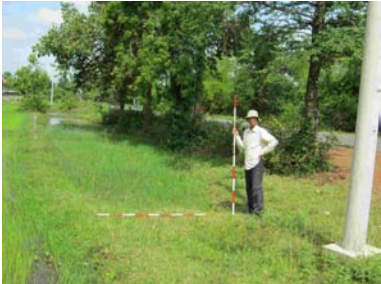
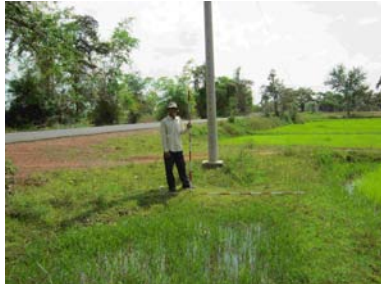
Canal No.: 3U	Kind of structure: Canal	Remarks:
Station: 0.00+790	Coordinate< Northing: 1223088 Easting: 450387	Routine survey Second B.P.

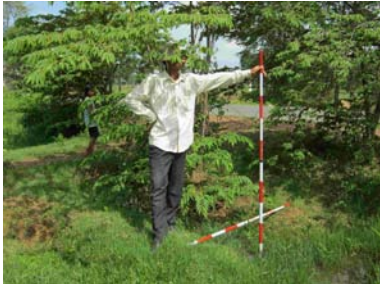
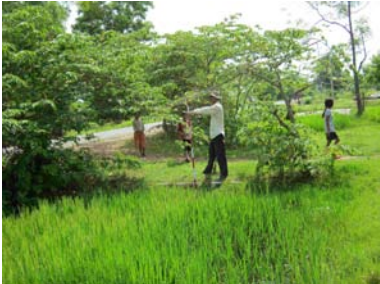
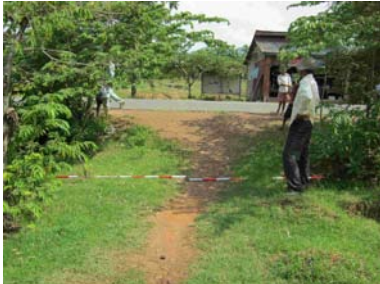
950	450511	1223046	Canal section	No canal section remains.	D		
1,030	450573	1223024	Canal section	The canal was filled for the land of building. No culvert nor canal trace is found at present.	D		House was constructed
1,100	450653	1222999	Private road	Canal section is re-filled by earth for house yard,	D		The canal area was refilled and fenced as private land
1,510	450993	1222891	Culvert 8 & EP Groove, Intake	Canal section is re-filled by earth for house access	D		House was constructed

Canal No.: 3U	Kind of structure: Pipe culvert	Remarks:
Station: 0.00+950	Coordinate< Northing: 1223046 Easting: 450511	Routine survey

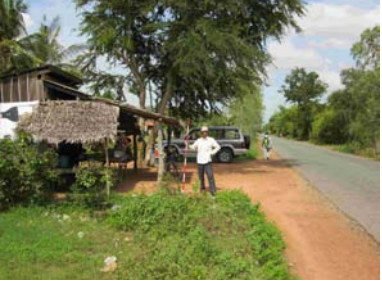
Canal No.: 3U	Kind of structure: Canal	Remarks: Routine survey House is along the canal
Station: 1.00+30	Coordinate< Northing: 1223024 Easting: 450573	
<div style="display: flex; justify-content: space-around; align-items: center;"> <div style="text-align: center;">

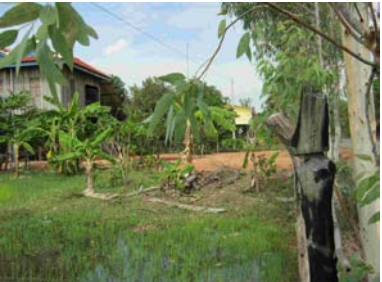
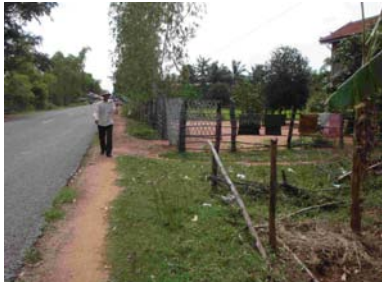
Canal No.: 3U	Kind of structure: Canal	Remarks: Private road is on the canal
Station: 1.00+100	Coordinate< Northing: 1222999 Easting: 450653	
<div style="display: flex; justify-content: space-around; align-items: center;"> <div style="text-align: center;">

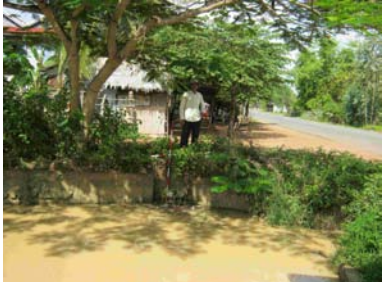
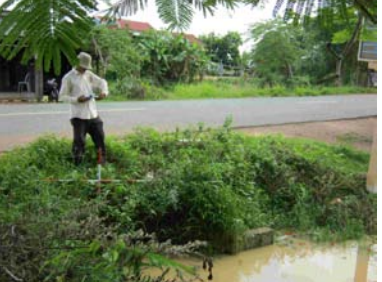
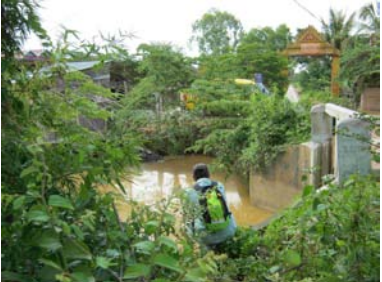
Canal No.: 3U	Kind of structure: Pipe Culvert	Remarks: There are Groove and Intake
Station: 1.00+510(EP)	Coordinate< Northing: 1222891 Easting: 450993	
<div style="display: flex; justify-content: space-around; align-items: center;"> <div style="text-align: center;">
