# ***ANNEX D***

*Results of Inventory Survey for Irrigation and Drainage*

*Facilities in Kandal Stung – Bati Irrigation System*

*Rehabilitation Sub-project*

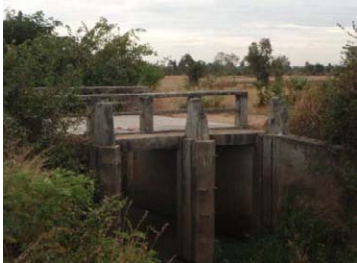
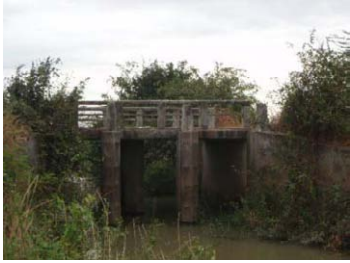
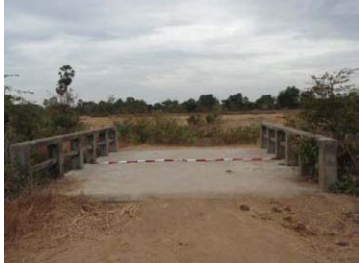
Canal No.: KC-1	Kind of structure(s): Intake	Remarks:
Station: 0.00(B.P.)	Coordinate< Northing: 1260992 Easting: 478161	Intake from Stung Touch

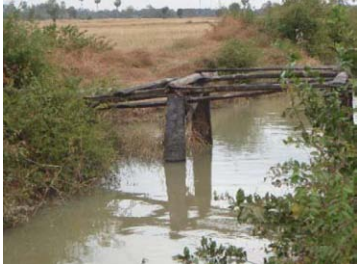
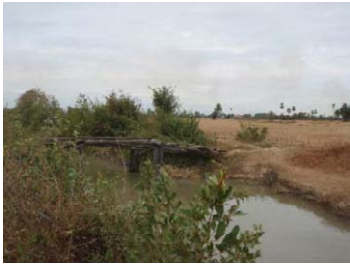
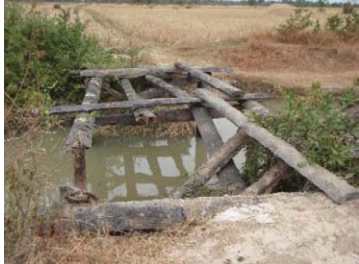
Canal No.: KC-1	Kind of structure(s): Wooden bridge	Remarks:
Station: 0.00+770	Coordinate< Northing: 1261001 Easting: 478718	Temporary

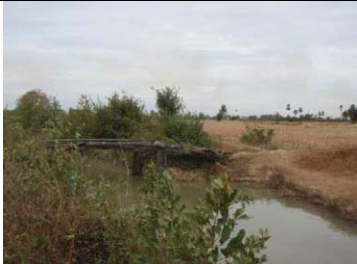
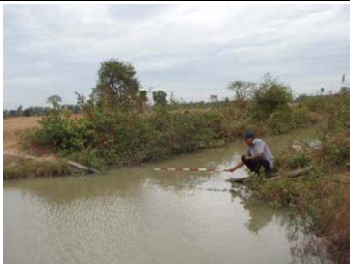
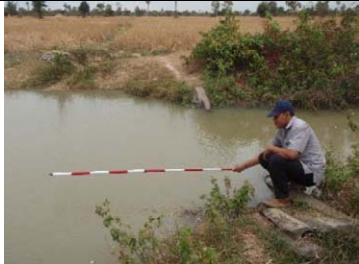
Canal No.: KC-1	Kind of structure(s): Foot path bridge	Remarks:
Station: 1.00+500	Coordinate< Northing: 1260994 Easting: 479318	Broken

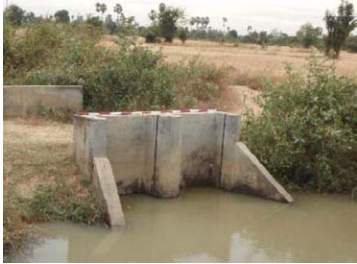
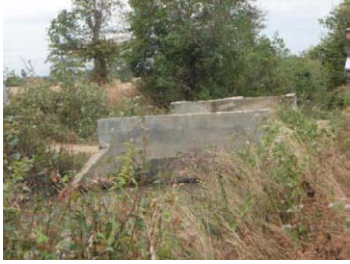
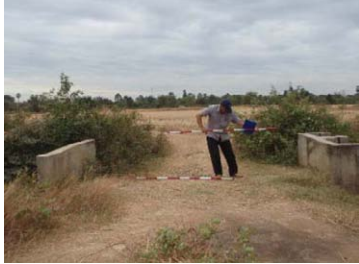
Canal No.: KC-1	Kind of structure(s): Bridge	Remarks:
Station: 1.00+710	Coordinate< Northing: 1261000 Easting: 479521	Bridge with groove

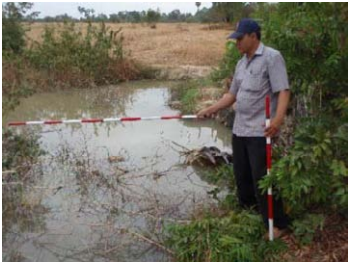
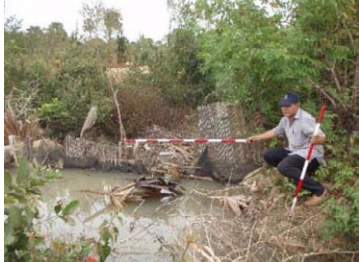
Canal No.: KC-1	Kind of structure(s): Check structure	Remarks:
Station: 2.00+280	Coordinate< Northing: 1260997 Easting: 480025	Check structure cum fish net by bamboo barrage (Temporary)

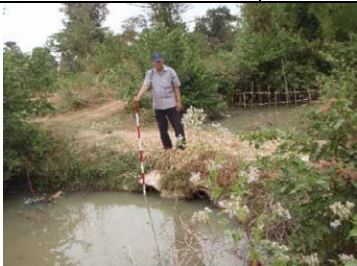
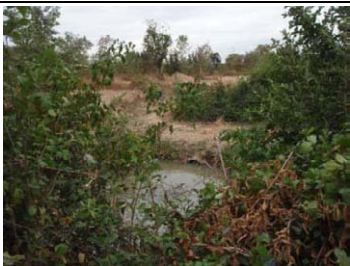
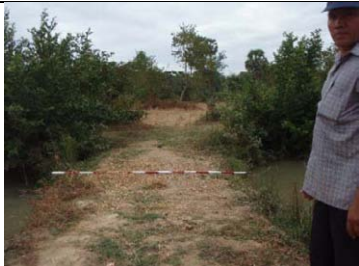
Canal No.: KC-1	Kind of structure(s): Pip culvert	Remarks:
Station: 2.00+390	Coordinate< Northing: 1261003 Easting: 480109	Pip culvert (Double)

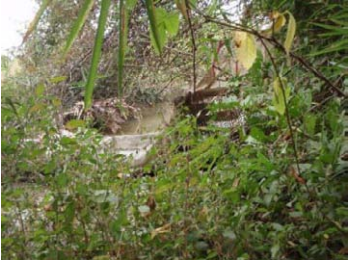
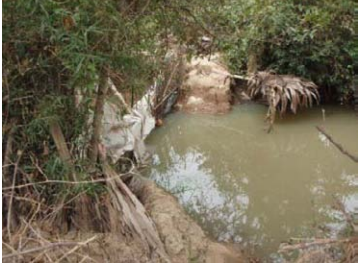
Canal No.: KC-1	Kind of structure(s): Check structure	Remarks:
Station: 2.00+450	Coordinate< Northing: 1261012 Easting: 480161	Check structure by bamboo net (Temporary)

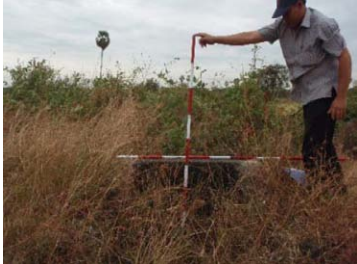
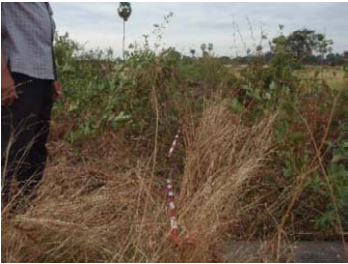
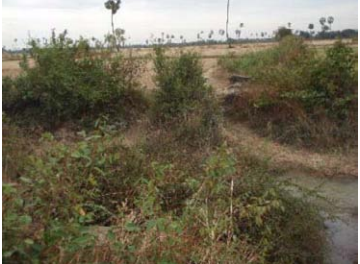
Canal No.: KC-1	Kind of structure(s): Turn Out	Remarks:
Station: 2.00+790	Coordinate< Northing: 1261015 Easting: 480743	Abandoned (use in wet season)

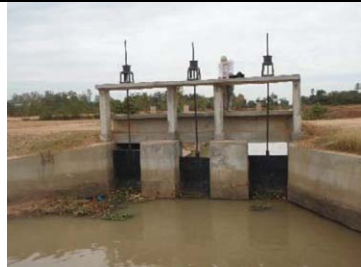
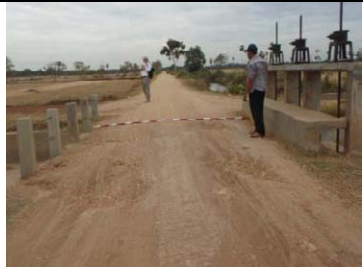
Canal No.: KC-1	Kind of structure(s): Regulator	Remarks:
Station: 3.00+420	Coordinate< Northing: 1261005 Easting: 480994	Regulator on commune road with 3 gates

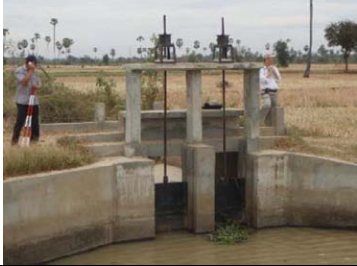
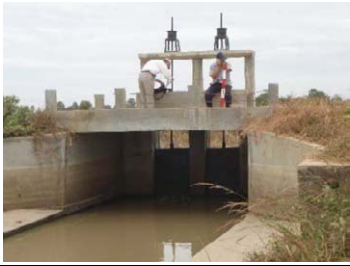
Canal No.: KC-1	Kind of structure(s): Regulator	Remarks:
Station: 3.00+420	Coordinate< Northing: 1261005 Easting: 480994	Regulator with 2 gates

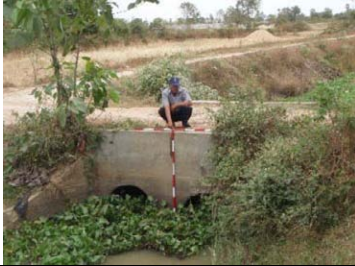
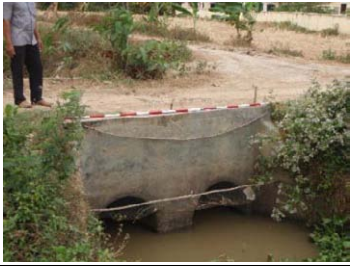
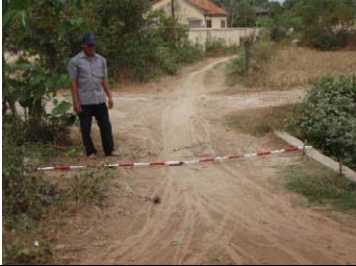
Canal No.: KC-1	Kind of structure(s): Pipe Culvert	Remarks:
Station: 4.00+180	Coordinate< Northing: 1261008 Easting: 481612	Double Culverts

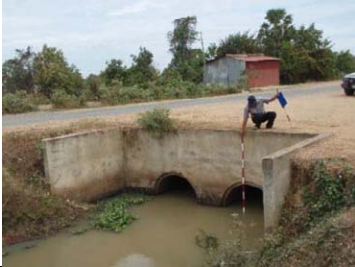
Canal No.: KC-1	Kind of structure(s): Pipe Culvert	Remarks:
Station: 4.00+850 (E.P)	Coordinate< Northing: 1261011 Easting: 481943	Double Culverts on Provincial Road

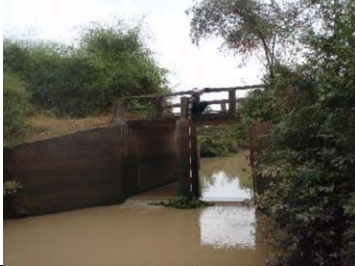
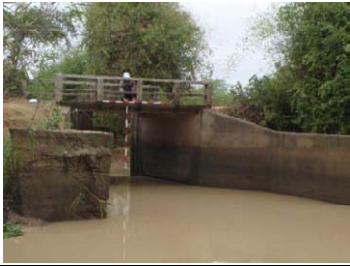
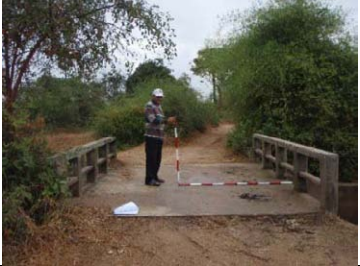
Canal No.: KC-2	Kind of structure(s): Bridge with groove	Remarks: No gate on the Intake
Station: 0.00 (B.P.)	Coordinate< Northing: 1260282 Easting: 480212

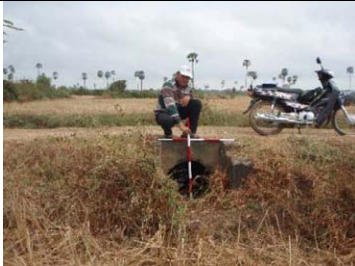
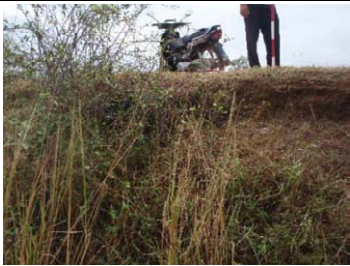
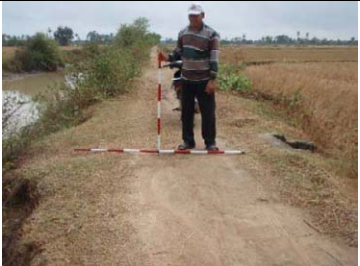
Canal No.: KC-2	Kind of structure(s): Drain Inlet	Remarks:
Station: 0.00+200	Coordinate< Northing: 1260284 Easting: 480345

Sta.	E	N	Structure	Condition	Evaluation	Remarks
0	480212	1260282	B.P. Intake for KC-2 with bridge (public)	Existing weir exists about 100 m downstream, no gate is equipped	C	Bridge; W=4.8m, L=3.2m,
200	480345	1260284	Drain Inlet,	Pipe and wing wall is still in good condition	B	W=4m, L=1,2m, dia=0.6m
400	480597	1260289	Bridge on commune road	Bridge is stil functioned	C	W=6.5m, L=3m
400	480597	1260289	Regulator	2 nos. of slide gates without lifting spindle and gear	C	W=3m, L=3m
500	480699	1260292	Canal Section	-	-	
800	4800960	1260299	Turnout	Outlet wall has been deteriorated	C	(Private), dia=0.3m
900	481101	1260298	Turnout dia=0.3 m	Outlet wall has been deteriorated	C	(Private), dia=0.3m
1,000	481211	1260302	Canal Section	Section is still remained, but covered by grass and trees	C	
1,400	481611	1260312	Drain Inlet	Broken	D	dia=0.3m
1,500	481682	1260310	Box Culvert with groove (public)	Structures looks new, not jeevable but for motor cycles	B	W=1.3m, L=1.5m

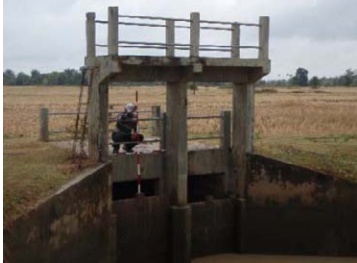
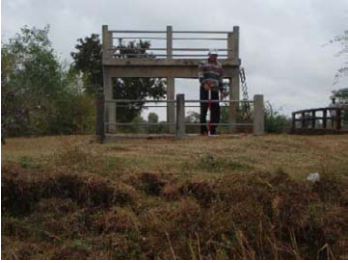
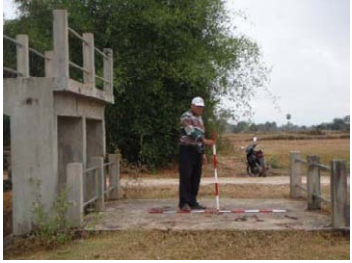
Canal No.: KC-2	Kind of structure(s): Turn-out (Off-take)	Remarks:
Station: 0.00+400	Coordinate< Northing: 1260289 Easting: 480597	No lifting gear, though gates were installed

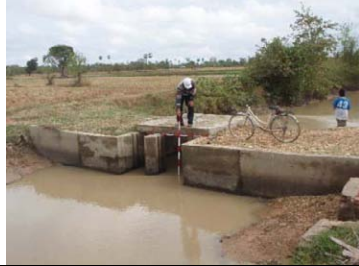
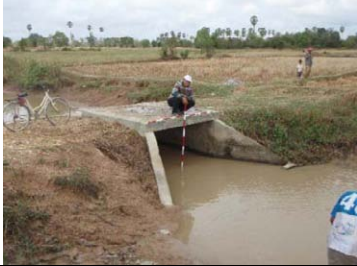
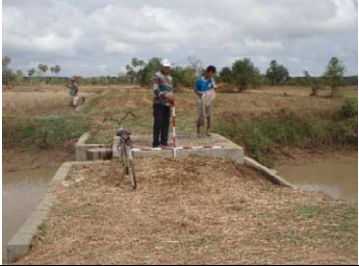
Canal No.: KC-2	Kind of structure(s): Box Culvert	Remarks:
Station: 1.00+500	Coordinate< Northing: 1260310 Easting: 481682	Box Culvert with groove

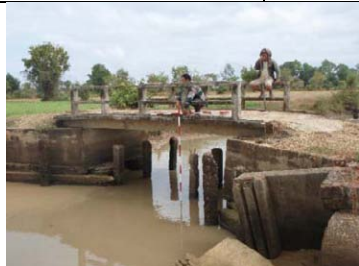
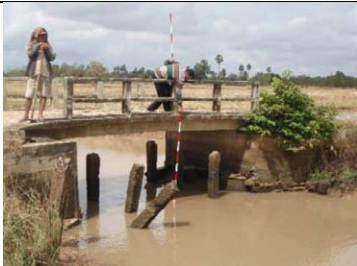
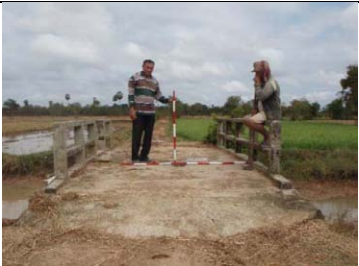
Canal No.: KC-2	Kind of structure(s): Bridge	Remarks:
Station: 2.00+000	Coordinate< Northing: 1260316 Easting: 482075

Drain inlet	Temporality installed pipe	C	W=1.3m, L=1m, dia=0.3m
2,000	482075	1260316	Bridge on commune toad	Reconstructed bridge but rather damaged	C	W=2.5m, L=4.8m
			Drain Inlet	Temporality installed pipe	C	dia=0.6m
2,350	482476	1260324	Bridge (Private),	House access	C	W=2.5m, L=2.5m
2,400	482530	1260328	Wooden Bridge (Private),	House access	C	W=0.5m, L=5m
2,430	482583	1260329	Turnout	with Box Culvert with groove	C	W=4.5m, L=3.5m
			Bridge with groove Commune road	Surface of bridge is damaged lot	C	W=4 m, L=3.5m
2,450	482612	1260323	Pipe Culvert Private	Canal section is blocked by dike and small pipe is clogged	C	L=6m, dia=0.6m
2,500	482688	1260327	Wooden Bridge (Private)	Temporary bamboo bridge	-	W=0.5m, L=6 m
2,950	4883105	1260334	Canal Section	Section is still remained though eroded, and covered by grass	C	
3,000	483158	1260343	Pipe Culvert (Double), on village road	Rather in good condition	B	W=2.5m, L=2.5m, dia=1m

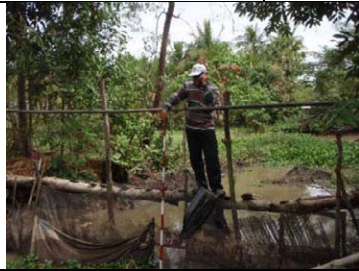
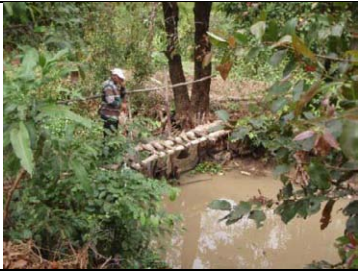
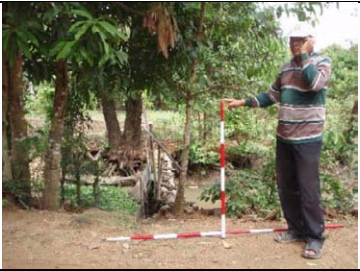
Canal No.: KC-2	Kind of structure(s): Wooden Bridge	Remarks: Foot path bridge (Private)
Station: 2.00+400	Coordinate< Northing: 1260328 Easting: 482530

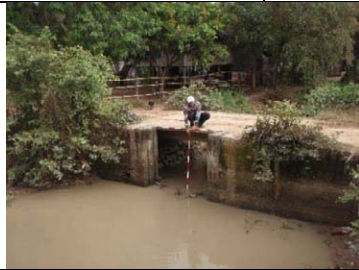
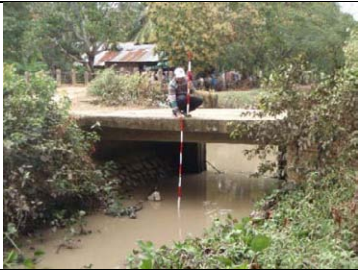
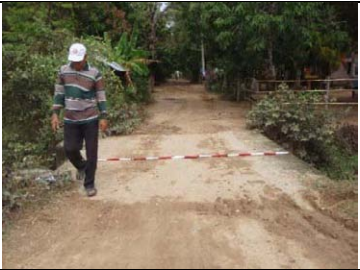
Canal No.: KC-2	Kind of structure(s): Box Culvert	Remarks: Box Culvert with groove
Station: 2.00+430	Coordinate< Northing: 1260329 Easting: 482583

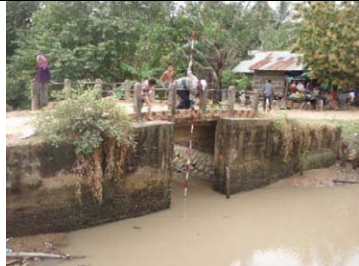
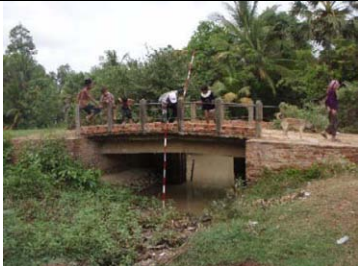
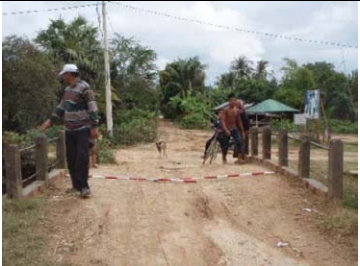
Canal No.: KC-2	Kind of structure(s): Turn Out	Remarks:
Station: 2.00+430	Coordinate< Northing: 1260329 Easting: 482583

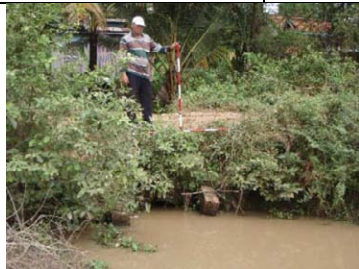
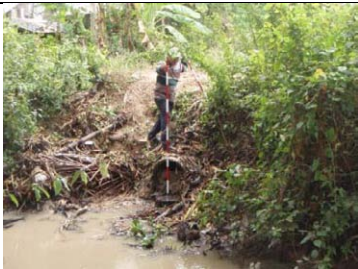
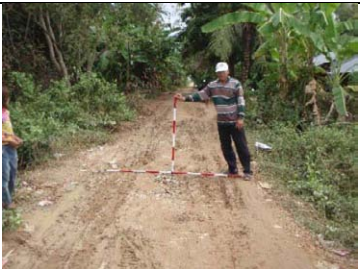
Canal No.: KC-2	Kind of structure(s): Pipe Culvert	Remarks:
Station: 2.00+450	Coordinate< Northing: 1260323 Easting: 482612

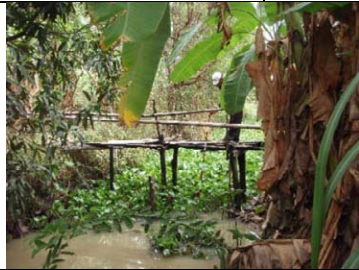
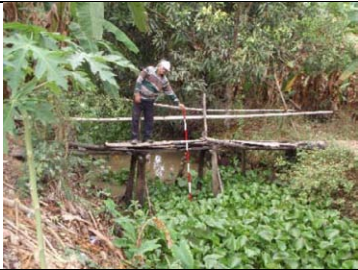
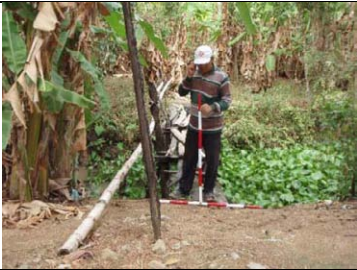
Canal No.: KC-2	Kind of structure(s): Wooden Bridge	Remarks: (Private)
Station: 2.00+500	Coordinate< Northing: 1260327 Easting: 482688

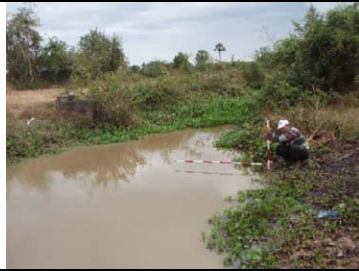
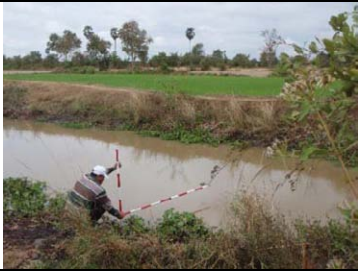
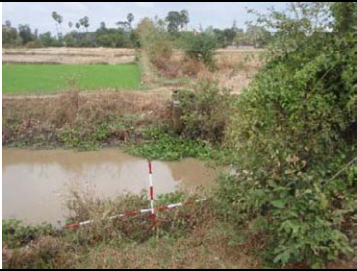
Canal No.: KC-2	Kind of structure(s): Canal section	Remarks:
Station: 2.00+950	Coordinate< Northing: 1260334 Easting: 4883105

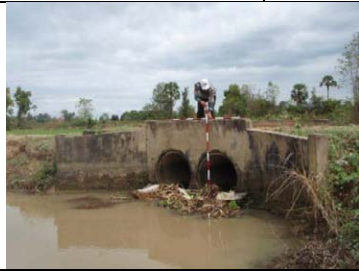
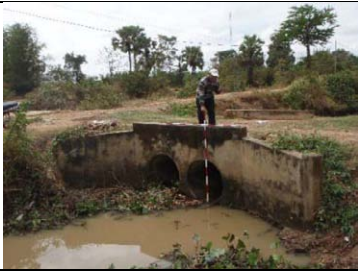
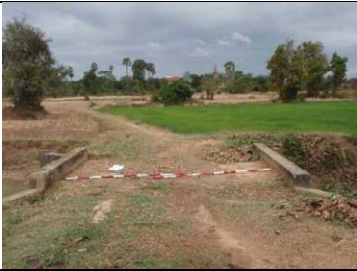
Canal No.: KC-2	Kind of structure(s): Pipe Culvert	Remarks: Double culverts
Station: 3.00+000	Coordinate< Northing: 1260343 Easting: 483158

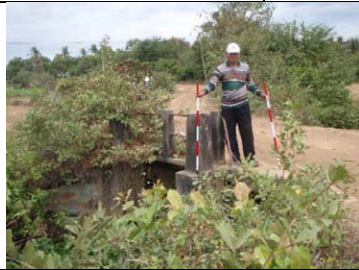
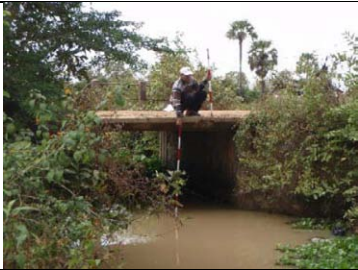
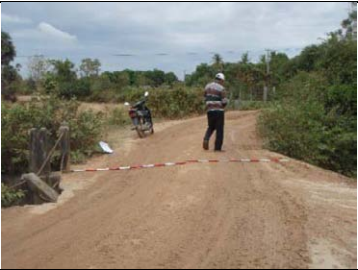
3,200	483372	1260347	Bridge with groove on commune road	Broken handrail	B	W=4.5m, L=4.5m

Canal No.: KC-2	Kind of structure(s): Bridge	Remarks:
Station: 3.00+200	Coordinate< Northing: 1260347 Easting: 483372	Bridge with groove

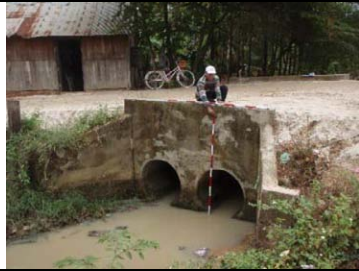
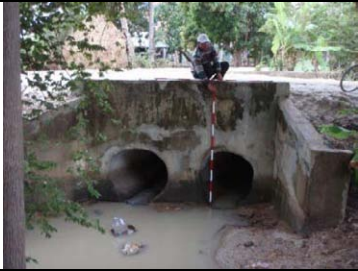
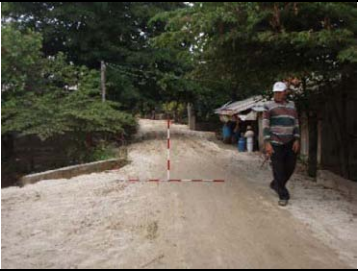
3,400	483619	1260347	Pipe Culvert (Double) on village road	Recently repaired	B	W=4m, L=5m, dia=1m
3,500	483693	1260341	Turnout	Burried by earth, not functioned	D	Pipe portion: W=4m, L=1m, dia=1m
3,700	483910	1260344	Turnout	Burried by earth, not functioned		Pipe portion: W=5m, L=1.2m, dia=0.6
3,800	483984	1260345	Wooden Bridge (Private)	House access	C	W=1.2m, L=6m
4,000	484211	1260347	Canal Section	Many water plants obstructs water flow	C	
4,150	484424	1260350	Check Structure	Check wall with groove, but no use at present	C	, W=2m, L=0.8m
			Bridge on village road	Good condtion	B	W=4m, L=8m
4,400	484605	1260354	Pipe Culvert (private; house access)	Good condtion	B	W=5m, L=4m, dia=0.8m (Double)
4,430	484635	1260356	Wooden Bridge (Private),	village area	C	W=2.5m, L=5m
4,500	484731	1260350	Canal Section	Section is covered by thick grass and trees	D	No use as canal at present
4,530	484772	1260354	E.P. Pipe Culvert (Private)	Access to School "Siem Reap	C	W=5m, L=3m, D=0.6m (3 culverts)

Canal No.: KC-2	Kind of structure(s): Pipe Culvert	Remarks:
Station: 3.00+400	Coordinate< Northing: 1260347 Easting: 483619	Double Pipe Culvert

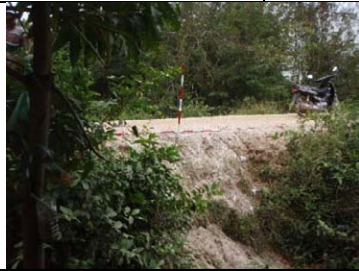
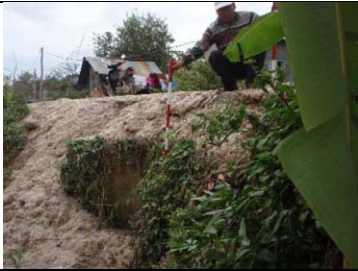
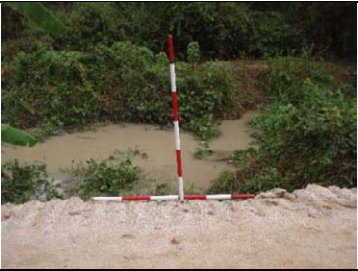
Canal No.: KC-2	Kind of structure(s): Turnout	Remarks:
Station: 3.00+500	Coordinate< Northing: 1260341 Easting: 483693

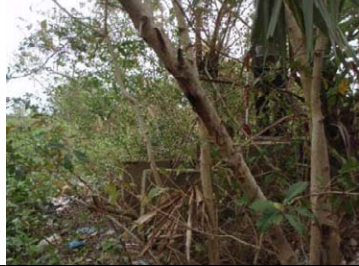
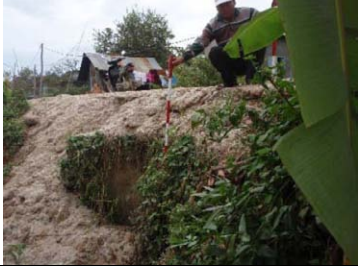
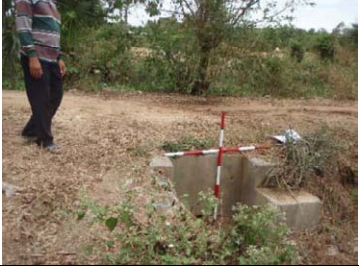
Canal No.: KC-2	Kind of structure(s): Turnout	Remarks:
Station: 3.00+700	Coordinate< Northing: 1260344 Easting: 483910

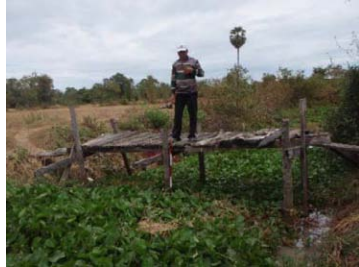
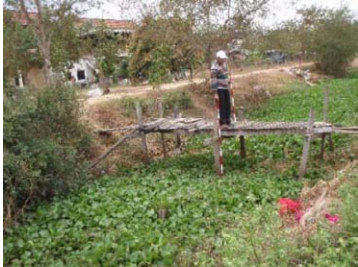
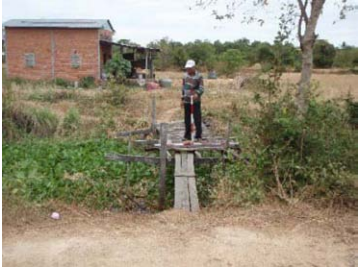
Canal No.: KC-2	Kind of structure(s): Wooden Bridge	Remarks: (Private)
Station: 3.00+800	Coordinate< Northing: 1260345 Easting: 483984

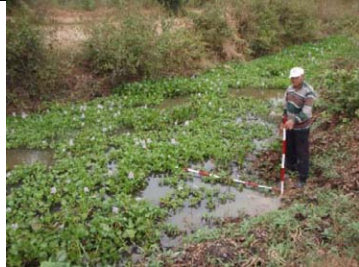
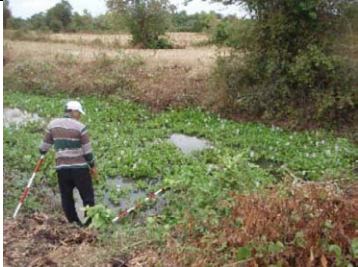
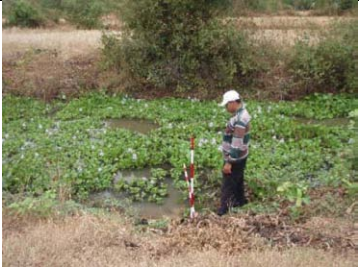
Canal No.: KC-2	Kind of structure(s): Canal Section	Remarks:
Station: 4.00+000	Coordinate< Northing: 1260347 Easting: 484211

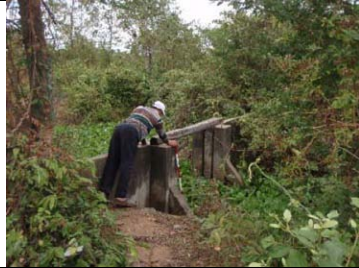
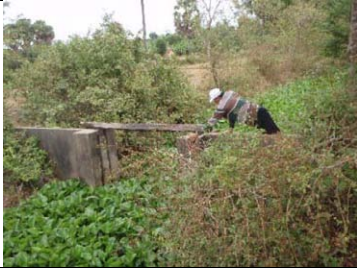
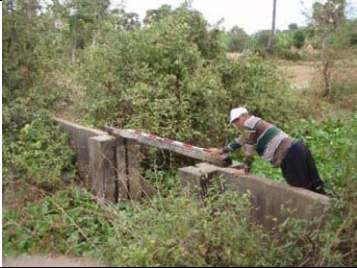
Canal No.: KC-2	Kind of structure(s): Check Structure	Remarks:
Station: 4.00+150	Coordinate< Northing: 1260350 Easting: 484424

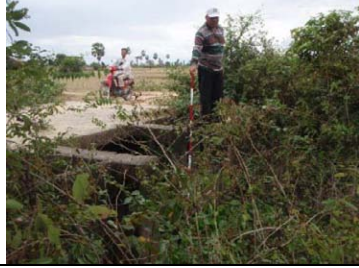
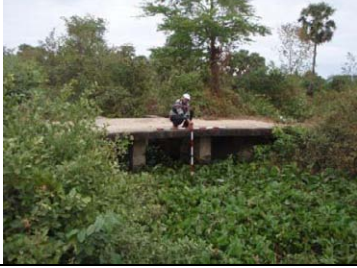
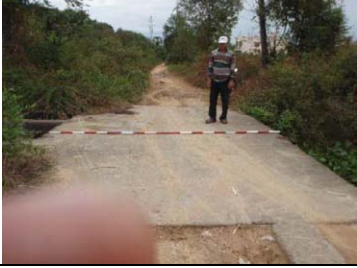
Canal No.: KC-2	Kind of structure(s): Bridge on village road	Remarks:
Station: 4.00+150	Coordinate< Northing: 1260350 Easting: 484424

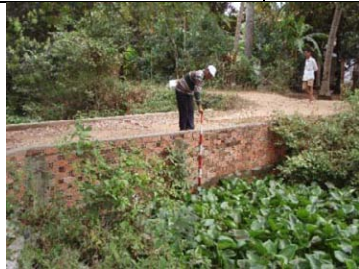
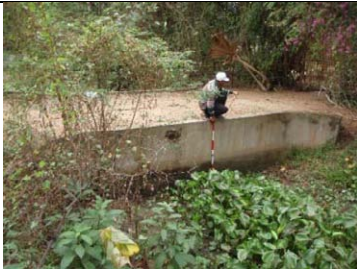
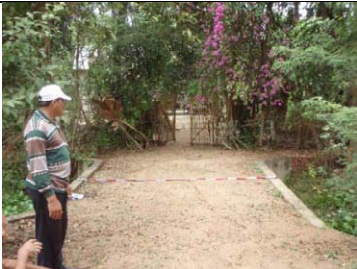
Canal No.: KC-2	Kind of structure(s): Pipe Culvert (Private)	Remarks: Double culverts
Station: 4.00+400	Coordinate< Northing: 1260354 Easting: 484605

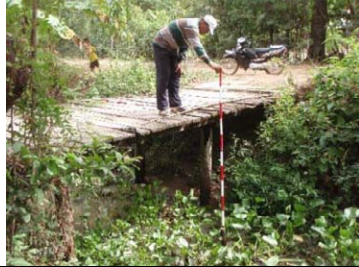
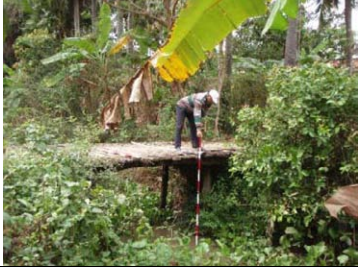
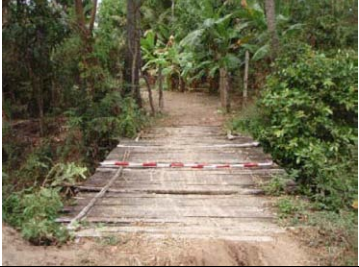
Canal No.: KC-2	Kind of structure(s): Wooden Bridge	Remarks: (Private)
Station: 4.00+430	Coordinate< Northing: 1260356 Easting: 484635

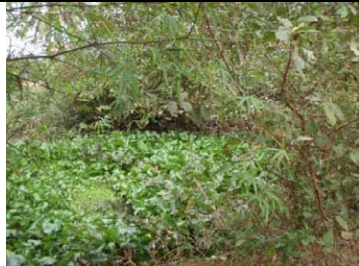
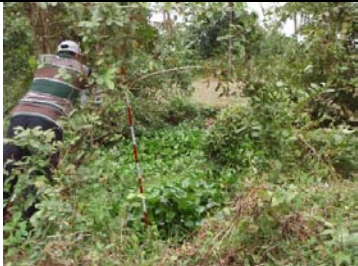
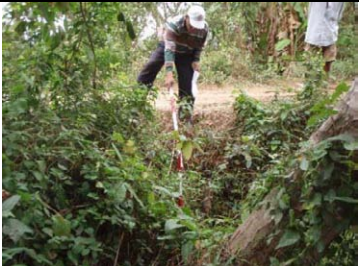
Canal No.: KC-2	Kind of structure(s): Canal Section	Remarks:
Station: 4.00+500	Coordinate< Northing: 1260350 Easting: 484731

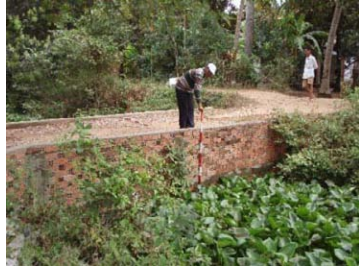
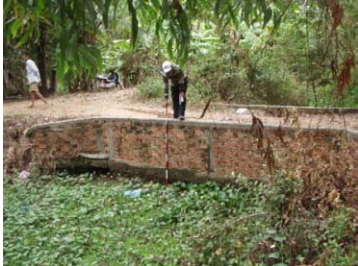
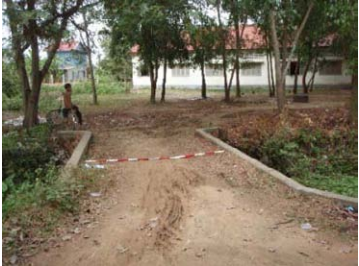
Canal No.: KC-2	Kind of structure(s): Pipe Culvert	Remarks: 3 culverts and road connected to School
Station: 4.00+530 (E.P)	Coordinate< Northing: 1260354 Easting: 484772

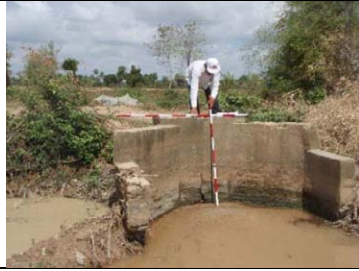
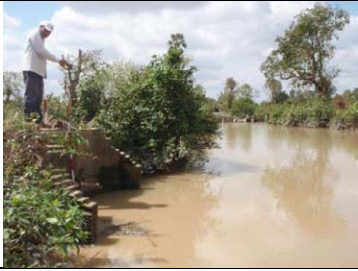
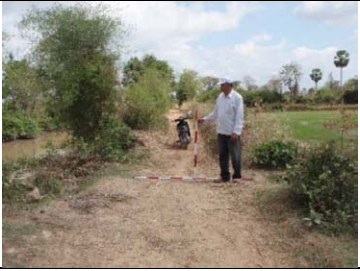
Canal No.: KC-3-1	Kind of structure(s): Turnout	Remarks:
Station: 0.00+400	Coordinate< Northing: 1258306 Easting: 482077

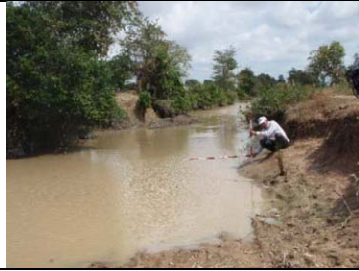
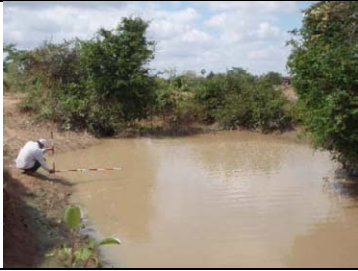
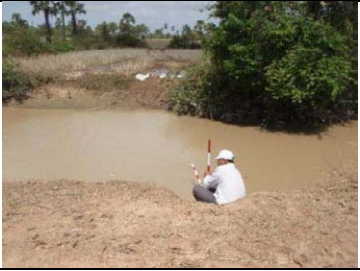
Canal No.: KC-3-1	Kind of structure(s): Canal Section	Remarks:
Station: 0.00+500	Coordinate< Northing: 1258310 Easting: 482250

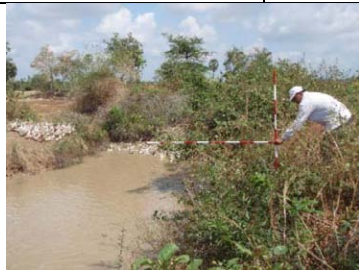
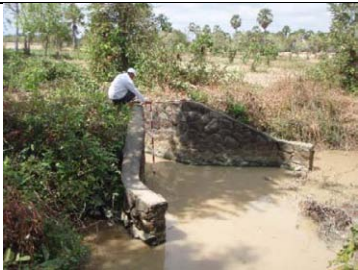
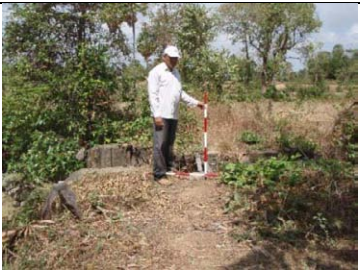
Canal No.: KC-3-1	Kind of structure(s): Regulator	Remarks:
Station: 0.00+800	Coordinate< Northing: 1258309 Easting: 482473	No slab floor and stop log (abandoned)

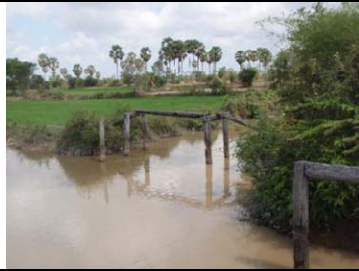
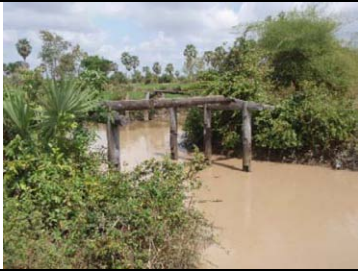
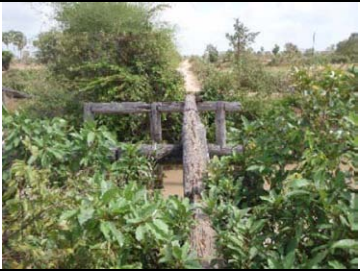
Canal No.: KC-3-1	Kind of structure(s): Wooden Bridge	Remarks:
Station: 0.00+900	Coordinate< Northing: 1258308 Easting: 482590	On commune road

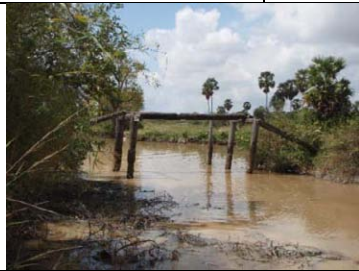
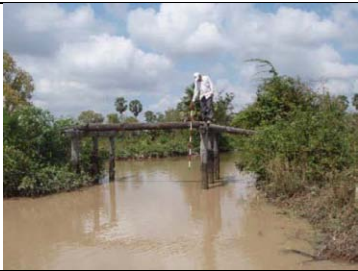
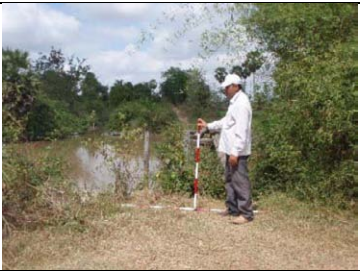
Canal No.: KC-3-1	Kind of structure(s): Wooden Bridge	Remarks:
Station: 0.00+900	Coordinate< Northing: 1258308 Easting: 482590	This bridge is connected to another canal (Canal 83, (local name)).

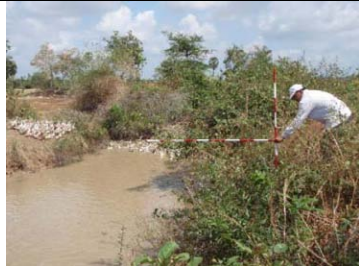
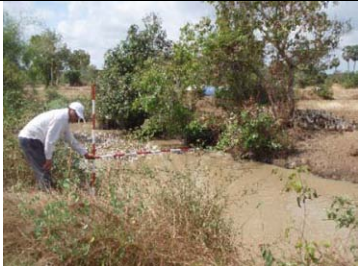
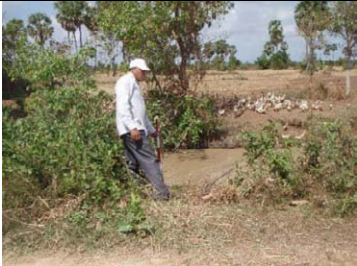
Canal No.: KC-3-1	Kind of structure(s): Canal Section	Remarks:
Station: 1.00+000	Coordinate< Northing: 1258310 Easting: 482723

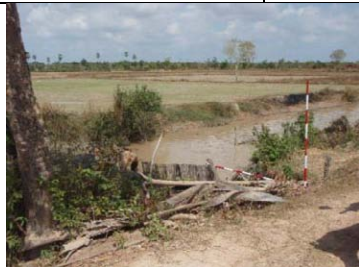
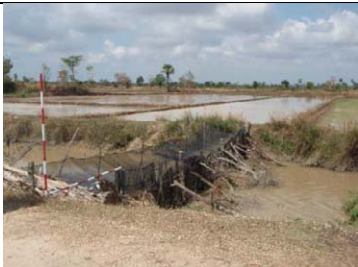
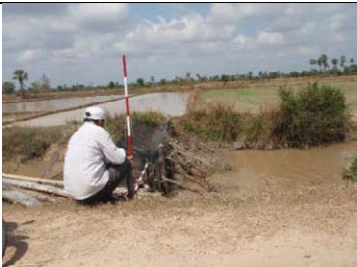
Canal No.: KC-3-1	Kind of structure(s): Canal Section	Remarks: Bamboo Barrage Private
Station: 1.00+500	Coordinate< Northing: 1258312 Easting: 483183

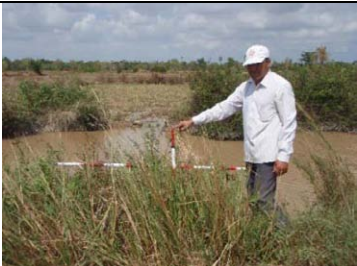
Canal No.: KC-3-1	Kind of structure(s): Turnout	Remarks: Broken
Station: 2.00+000	Coordinate< Northing: 1258319 Easting: 483675

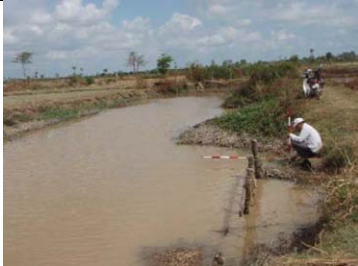
2,300	483954	1258319	Turnout	Broken and clogged	D	dia=0.4m
2,500	484153	1258320	Canal Section	No obstruction is found, though some trees grow on canal slope and banks	C	
2,900	484449	1258321	Box Culvert with groove,	Across canal 85 (local name), No R&L banks, road is completely eroded	D	w=3m, L=1.5m
3,000	484577	1258339	Canal Section	No obstruction is found, though some trees grow on canal slope and banks	C	
3,200	484815	1258340	Pipe Culvert Private	Road connected to house	B	W=2m, L=7.5m, dia=1m (3 culverts)
3,400	485043	1258323	E.P. Bridge on NR-2	Good condition	A	W=6m, L=8m, (3 spans =1.8m),

Canal No.: KC-3-1	Kind of structure(s): Turnout	Remarks:
Station: 2.00+300	Coordinate< Northing: 1258319 Easting: 483954	Broken

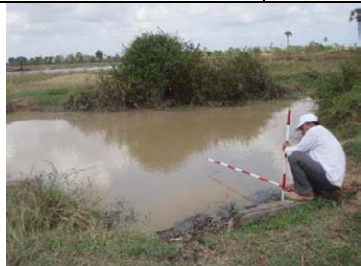
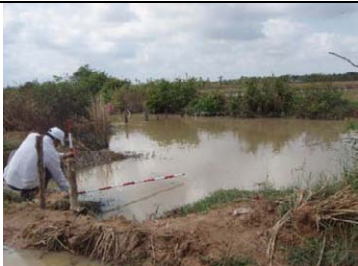
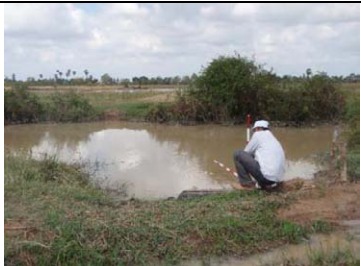
Canal No.: KC-3-1	Kind of structure(s): Canal Section	Remarks:
Station: 2.00+500	Coordinate< Northing: 1258320 Easting: 484153

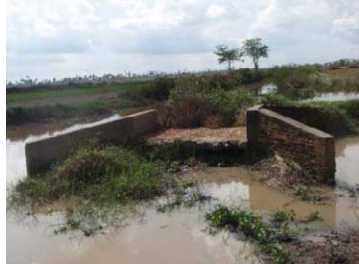
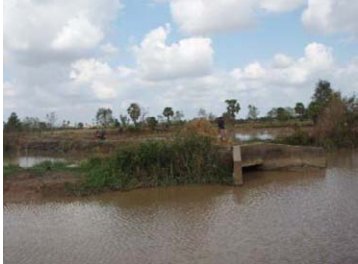
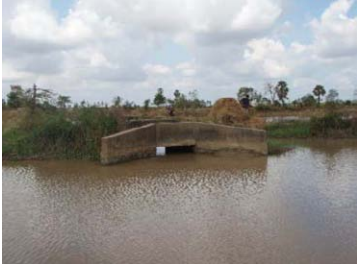
Canal No.: KC-3-1	Kind of structure(s): Box Culvert	Remarks:
Station: 2.00+900	Coordinate< Northing: 1258321 Easting: 484449	Box Culvert with groove (abandoned)

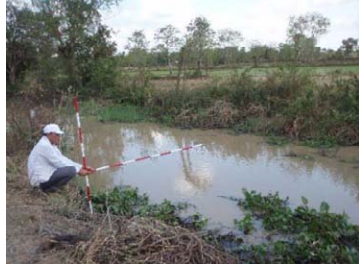
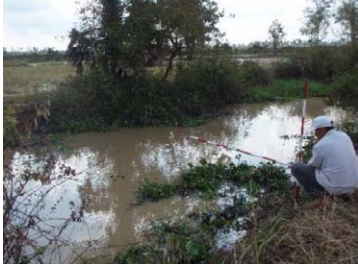
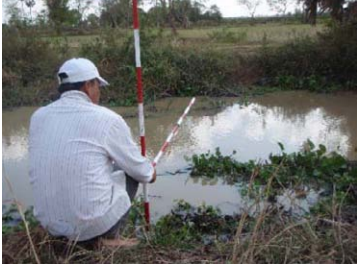
Canal No.: KC-3-1	Kind of structure(s): Canal Section	Remarks:
Station: 3.00+000	Coordinate< Northing: 1258339 Easting: 484577

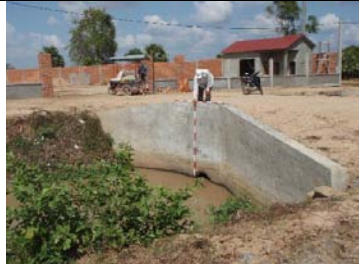
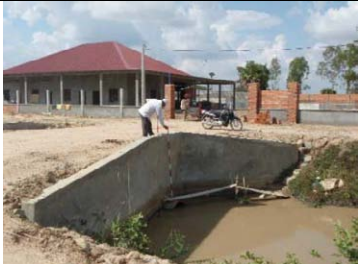
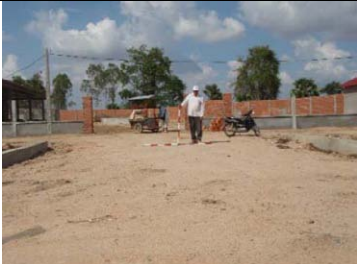
Canal No.: KC-3-1	Kind of structure(s): Pipe Culvert	Remarks:
Station: 3.00+200	Coordinate< Northing: 1258340 Easting: 484815	3 culverts (road connected to house)

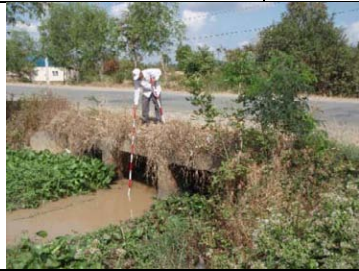
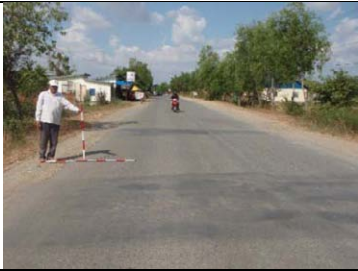
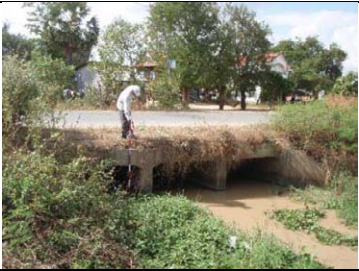
Canal No.: KC-3-1	Kind of structure(s): Bridge	Remarks:
Station: 3.00+400 (E.P)	Coordinate< Northing: 1258323 Easting: 485043	Bridge on NR2

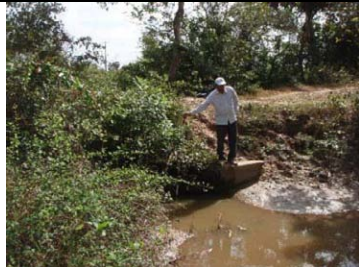
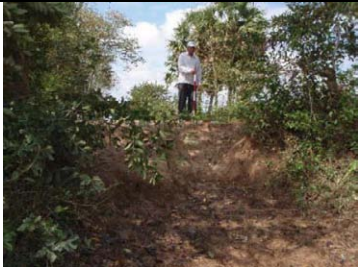
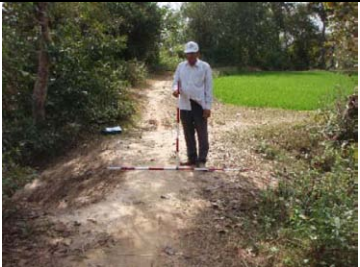
Sta.	E	N	Structure	Condition	Evaluation	Remarks
0	481773	1258310	Receiving structure	Water intaked on left bank conveyed to this structure on right bank thru the concrete pipe laid on Stung Toch river bed	D	L=50m, dia=0.6m (single) The pipe is passing the village road
500	481417	1258308	Canal section	Canal route was flooded about 0.8-1.2m	D	
800	481069	1258397		E.P. Canal route was flooded about 0.8-1.2m	D

Canal No.: KC-3-2	Kind of structure(s): Receiving structure	Remarks: (Water is supplied through underground pipe)
Station: 0.00 (B.P)	Coordinate< Northing: 1258310 Easting: 481773

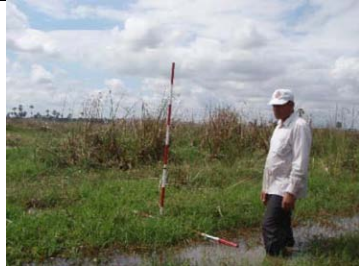
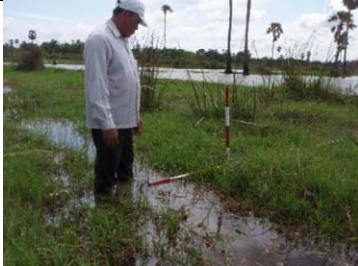
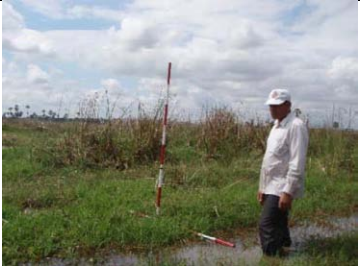
Canal No.: KC-3-2	Kind of structure(s): Canal Section	Remarks: Canal route was flooded
Station: 0.00+500	Coordinate< Northing: 1258308 Easting: 481417

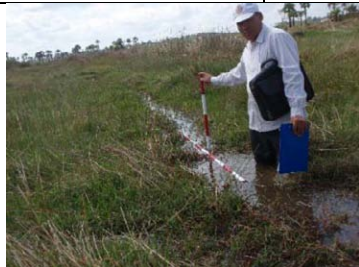
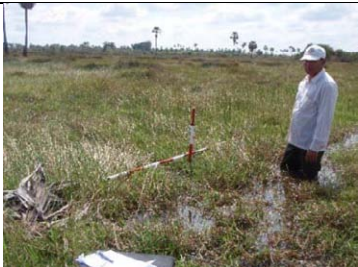
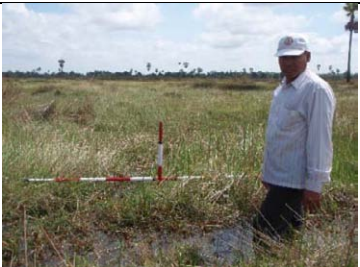
Canal No.: KC-3-2	Kind of structure(s): Canal	Remarks: Canal route was flooded about 0.8-1.2m
Station: 0.00+800 (E.P)	Coordinate< Northing: 1258397 Easting: 481069

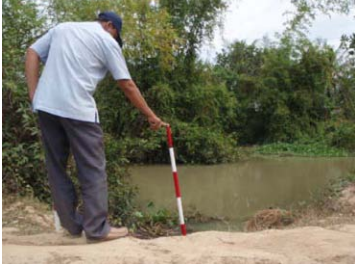
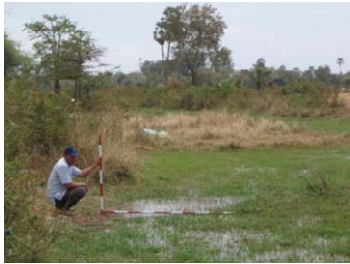
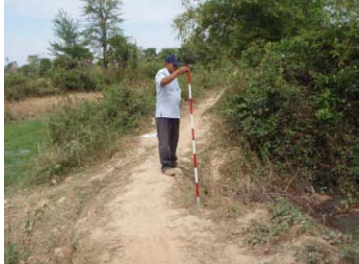
Sta.	E	N	Structure	Condition	Evaluation	Remarks
0	481618	1258142	B.P. Intake on Stung Toch	No structure is found and canal is clogged by debris and trees/grass	D	
500	481601	1257614	Canal Section	Canal is filled by earth for commune road	D	Across commune road
600	481594	1257535	Pipe Culvert on Commune road	Functioned as culvert	C	W=6m, L=6.5m, dia=1m
1,000	481593	1256931	Canal Section	No obstruction is found, though some grass grow on canal slope and banks	B	
1,500	481598	1256443	Canal Section	No obstruction is found, though some grass grow on canal slope and banks	B	
1,700	481593	1256175	Pipe Culvert, on village road	Broken	D	L=8m, dia=0.6m
2,000	481590	1255814	Canal Section	Upland and covering by trees and many sediment on the canal bed	D	
2,500	481598	1255543	Box culvert with groove under commune road	Sand bags are used for checking up the water level and storing water	C	W=5m, L=1.3m, H=2m
2,700	481601	1255380	Turnout	No outlet wall is provided; just temporary placing for drain and inlet the water	C	L=6m, dia=0.3m (Double)

Canal No.: KC-4	Kind of structure(s): Intake	Remarks:
Station: 0.00(B.P.)	Coordinate< Northing: 1258142 Easting: 481618	Intake from Stung Touch

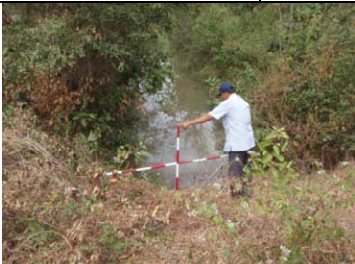
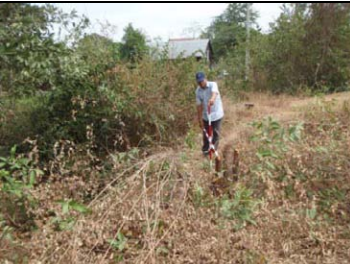
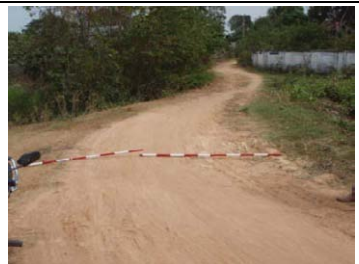
Canal No.: KC-4	Kind of structure(s): Canal Section	Remarks:
Station: 0.00+500	Coordinate< Northing: 1257614 Easting: 481601	Canal Section and commune road across canal

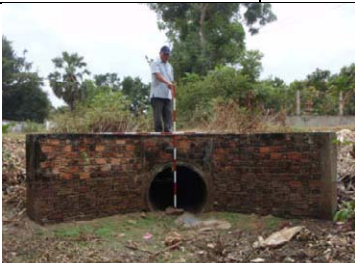
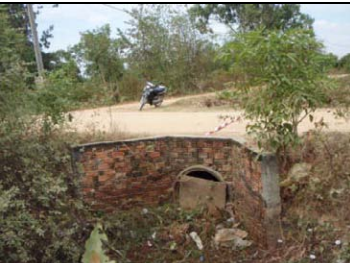
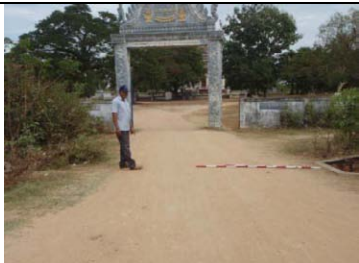
Canal No.: KC-4	Kind of structure(s): Pipe Culvert	Remarks:
Station: 0.00+600	Coordinate< Northing: 1257535 Easting: 481594	Pipe Culvert under commune road

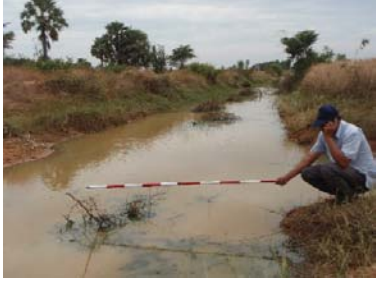
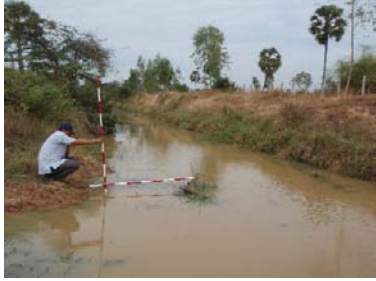
Canal No.: KC-4	Kind of structure(s): Canal Section	Remarks:
Station: 1.00+000	Coordinate< Northing: 1256931 Easting: 481593

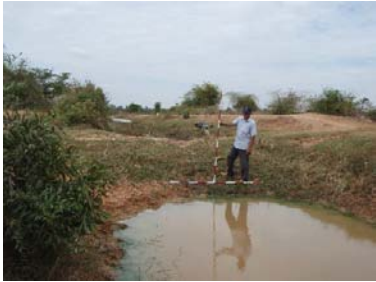
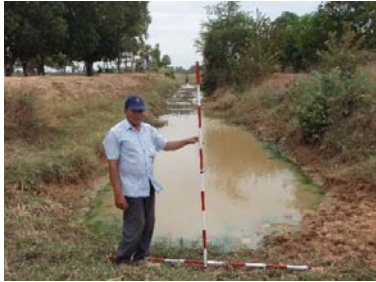
Canal No.: KC-4	Kind of structure(s): Canal Section	Remarks:
Station: 1.00+500	Coordinate< Northing: 1256443 Easting: 481598

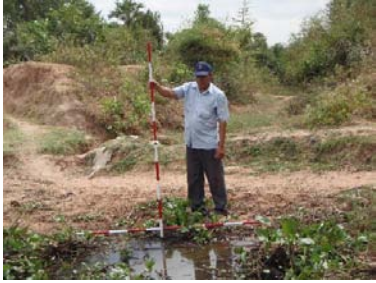
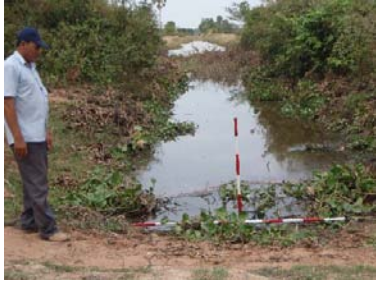
Canal No.: KC-4	Kind of structure(s): Canal Section	Remarks:
Station: 2.00+000	Coordinate< Northing: 1255814 Easting: 481590	Routine survey (every 500m) Up land & Covering by trees

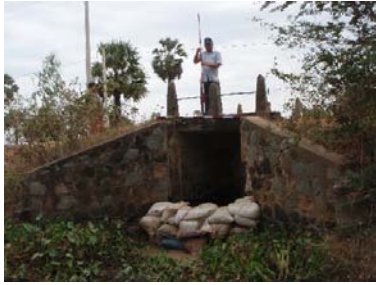
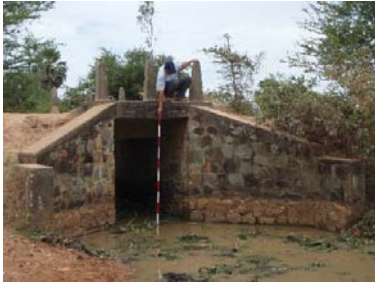
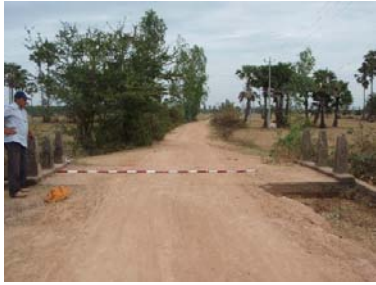
Canal No.: KC-4	Kind of structure(s): Box Culvert with groove	Remarks:
Station: 2.00+500	Coordinate< Northing: 1255543 Easting: 481598	Box culvert on commune road

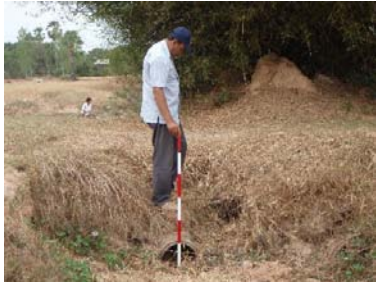
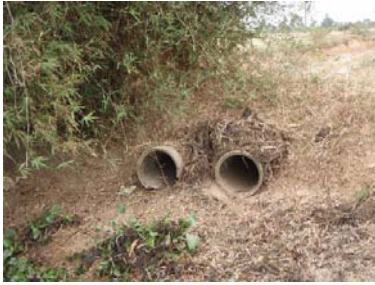
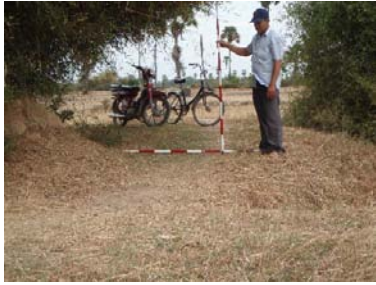
Canal No.: KC-4	Kind of structure(s): Pipe Culvert	Remarks:
Station: 2.00+700	Coordinate< Northing: 1255380 Easting: 481601

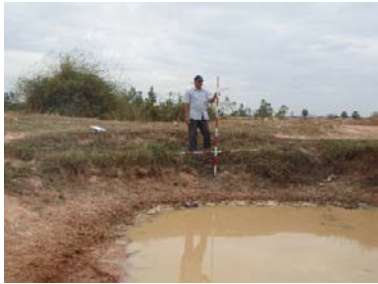
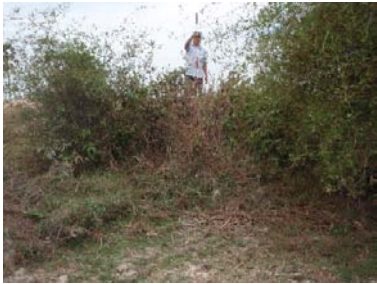
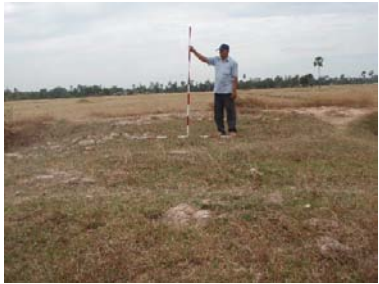
3,100	481595	1254976	Canal Section	Canal section is checked by earth dike for rain storing water	D	
3,500	481593	1254742	E.P. Box Culvert on commune road (flood kike)	Structurally in good condition, but no gate is provided	C	W=4.9m, L=1.4m, H=2m

Canal No.: KC-4	Kind of structure(s): Canal Section	Remarks: Village road across canal in order to divert water to rice field.
Station: 3.00+100	Coordinate< Northing: 1254976 Easting: 481595

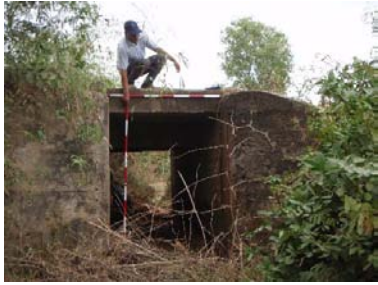
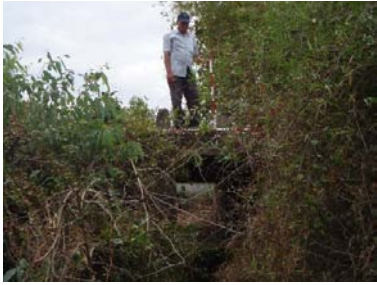
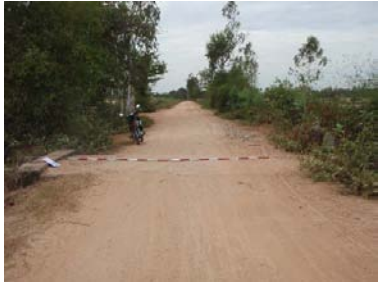
Canal No.: KC-4	Kind of structure(s): Box Culvert	Remarks: Box culvert with groove under commune road.
Station: 3.00+500 (E.P.)	Coordinate< Northing: 1254742 Easting: 481593

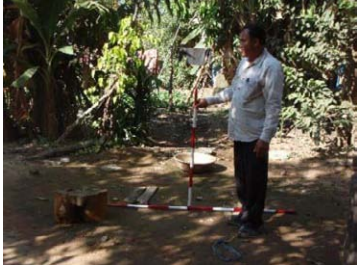
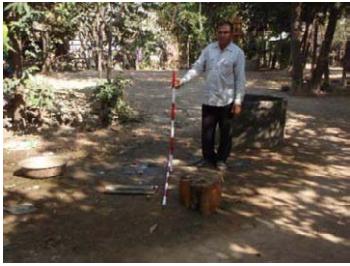
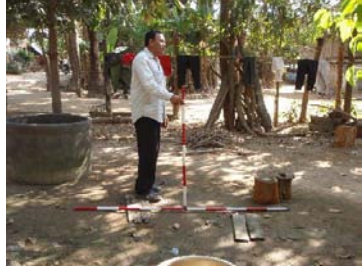
Sta.	E	N	Structure	Condition	Evaluation	Remarks
0	482573	1257519	B.P. Stung Toch	The canal section was filled and used as house access in the village: the canal has not used for long time	D	Houses accesses in the village
300	482570	1257430	Pipe Culvert, Private	Temporary installation of pipe to house access	D	L=3m, dia=0.5m
500	482578	1257310	Box Culvert with groove on village road	Wooden planks are installed and functioned as check	B	W=3.5m, L=2m
800	482578	1257092	Turnout (private)	Temporary installation of pipe to divert water from the canal	C	Pipe: L=3m, dia=0.5m
1,000	482585	1256639	Canal Section	Bath banks of the canal is swamp, and right bank of the canal was lost	D	No canal shape remains, but road section only remained
1,500	482593	1256133	Canal Section	do.	D	do.
2,000	482597	1255597	Canal Section	Some canal section remains and used as pond	C	Making road across canal near canal section.
2,500	482598	1255131	Canal Section	do.	D	do.

Canal No.: KC-5	Kind of structure(s): Intake on Stung Touch	Remarks:
Station: 0.00(B.P.)	Coordinate< Northing: 1257519 Easting: 482573	The canal was filled as used as house access in the village

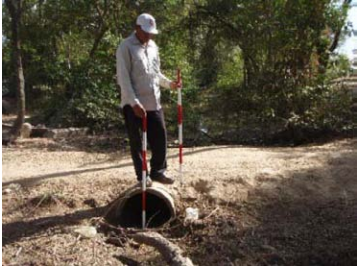
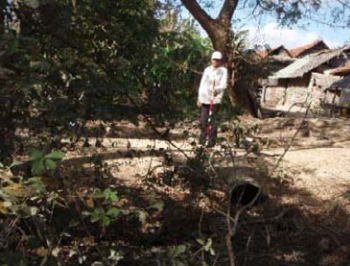
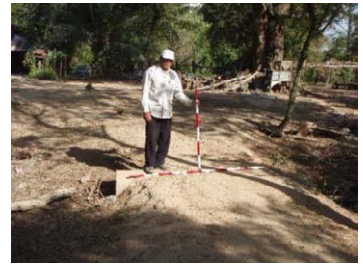
Canal No.: KC-5	Kind of structure(s): Pipe culvert	Remarks:
Station: 0.00+300	Coordinate< Northing: 1257430 Easting: 482570	Private

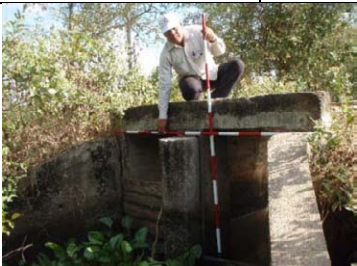
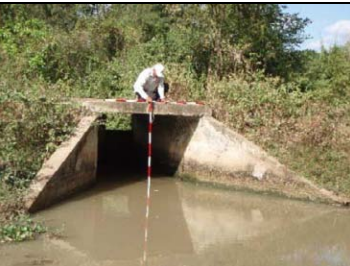
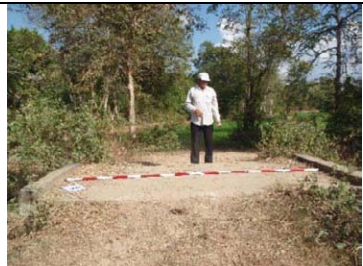
Canal No.: KC-5	Kind of structure(s): Box Culvert	Remarks:
Station: 0.00+500	Coordinate< Northing: 1257310 Easting: 482578	Box Culvert with groove Village road

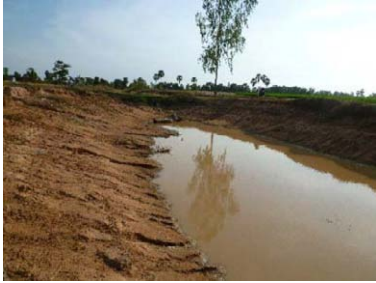
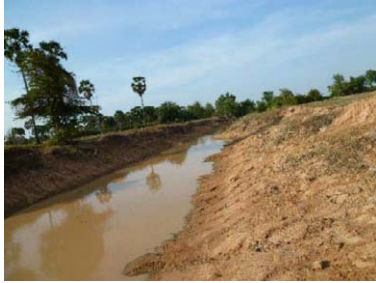
Canal No.: KC-5	Kind of structure(s): Canal Section	Remarks:
Station: 2.00+000	Coordinate< Northing: 1255597 Easting: 482597	Making road across canal near canal section
