# ***ANNEX D***

*Results of Inventory Survey for Irrigation and Drainage*

*Facilities in Kandal Stung – Bati Irrigation System*

*Rehabilitation Sub-project*

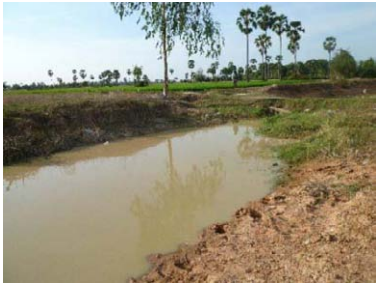
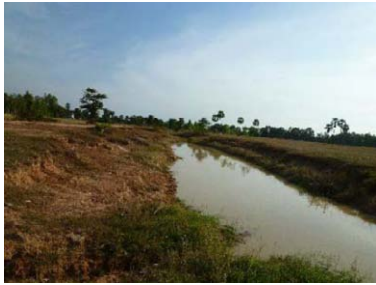
Sta.	E	N	Structure	Condition	Evaluation	Remarks
0	482573	1257519	B.P. Stung Toch	The canal section was filled and used as house access in the village: the canal has not used for long time	D	Houses accesses in the village
300	482570	1257430	Pipe Culvert, Private	Temporary installation of pipe to house access	D	L=3m, dia=0.5m
500	482578	1257310	Box Culvert with groove on village road	Wooden planks are installed and functioned as check	B	W=3.5m, L=2m
800	482578	1257092	Turnout (private)	Temporary installation of pipe to divert water from the canal	C	Pipe: L=3m, dia=0.5m
1,000	482585	1256639	Canal Section	Bath banks of the canal is swamp, and right bank of the canal was lost	D	No canal shape remains, but road section only remained
1,500	482593	1256133	Canal Section	do.	D	do.
2,000	482597	1255597	Canal Section	Some canal section remains and used as pond	C	Making road across canal near canal section.
2,500	482598	1255131	Canal Section	do.	D	do.

Canal No.: KC-5	Kind of structure(s): Canal Section	Remarks:
Station: 2.00+500	Coordinate< Northing: 1255131 Easting: 482598	Making road across canal near canal section

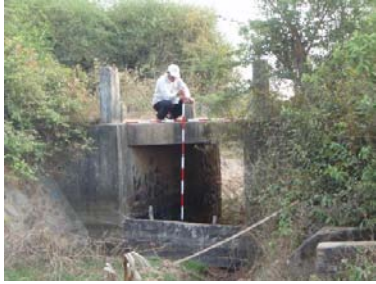
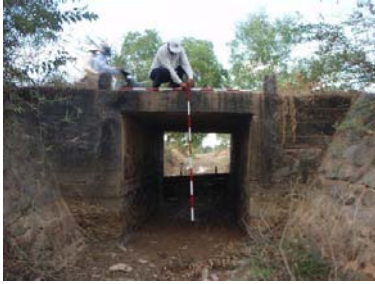
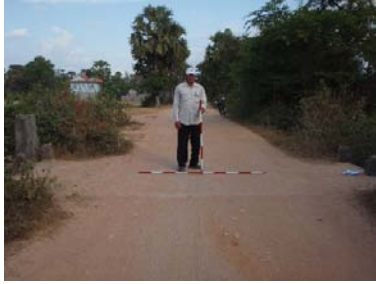
Canal No.: KC-5	Kind of structure(s): Bok Culvert	Remarks:
Station: 3.00+000 (E.P)	Coordinate< Northing: 1254769 Easting: 482585	Box Culvert with groove & Drain Inlet

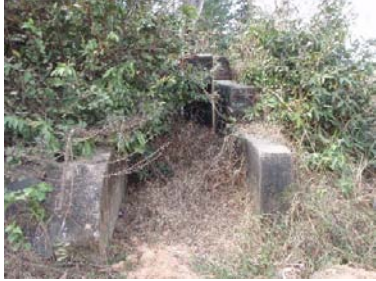
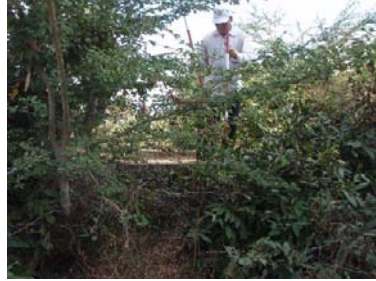
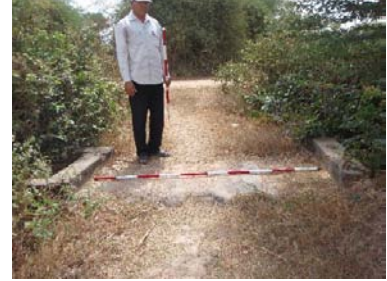
Canal No.: KC-5	Kind of structure(s): Box Culvert	Remarks:
Station: 3.00+000	Coordinate< Northing: 1254769 Easting: 482585	Box Culvert with groove & Drain Inlet

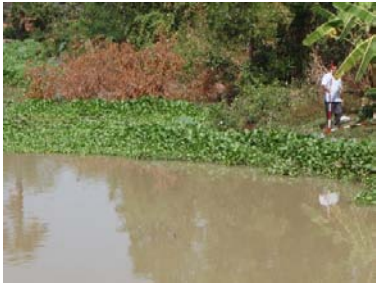
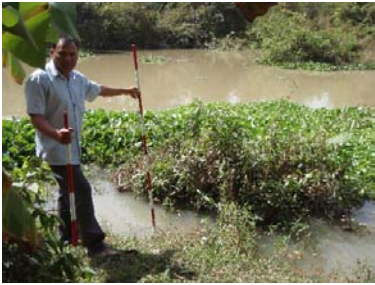
Sta.	E	N	Structure	Condition	Evaluation	Remarks
0	481106	1259314	B.P Stung Toch	No structure, use as drainage canal	-	Existing canal in the village
250	481288	1259325	Pipe Culvert Private	Canal was filled and the pipe was installed, and <u>primary school building</u> was constructed	D	L=100m, dia=0.5m
550	481607	1259316	Canal Section	Canal section remains and rather in good condition, water is supplied from KC-2	B	Crossing points with canal 82 (local name), O&M cost was provided by Commune Fund
1,050	482063	1259324	Canal Section	do.	B	do.
1,550	442585	1259330	Bridge, On commune road	Crossing with canal 83 (local name), O&M was made by Commune Fund	B	W=3m, L=5m
1,750	442727	1259337	Canal Section	Canal section become small and covered by bush and growing trees	C	
2,050	482994	1259332	Pipe Culvert Farm access (private)	Across to rice field, Private	C	W=2.7m, L=3m, dia=0.6m (Double),
2,250	483238	1259327	Pipe Culvert, Commune road	Condition is rather in good condition, but not used so frequently	B	W=5.6m, L=2m, dia=1m

Canal No.: KD-1	Kind of structure(s): Intake	Remarks: Connected from Stung Toch
Station: 0.00 (B.P)	Coordinate< Northing: 1259314 Easting: 481106

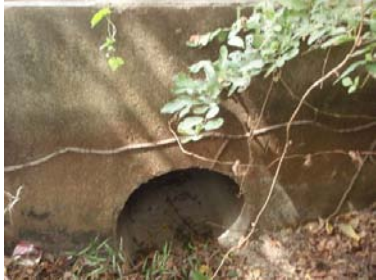
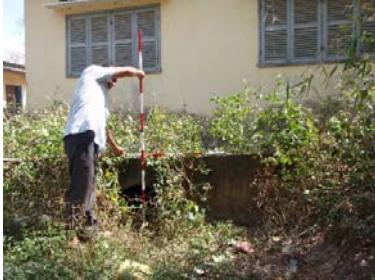
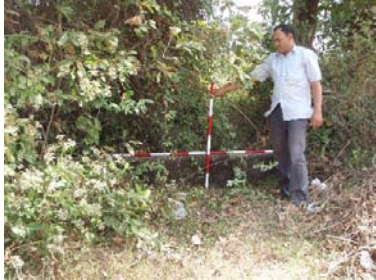
Canal No.: KD-1	Kind of structure(s): Pipe Culvert	Remarks: Pipe culvert under school building
Station: 0.00+250	Coordinate< Northing: 1259325 Easting: 481288

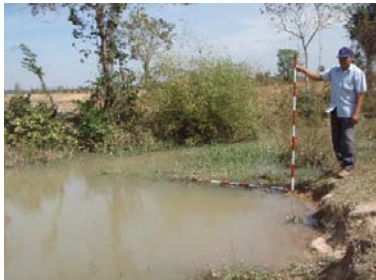
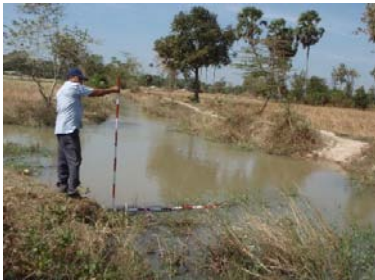
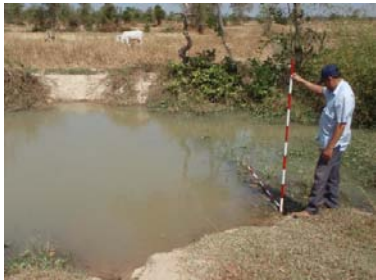
Canal No.: KD-1	Kind of structure(s): Canal Section	Remarks: Across canal 83 (local name)
Station: 0.00+550	Coordinate< Northing: 1259316 Easting: 481607

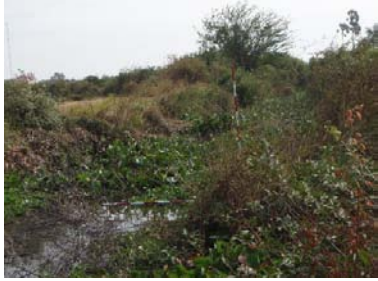
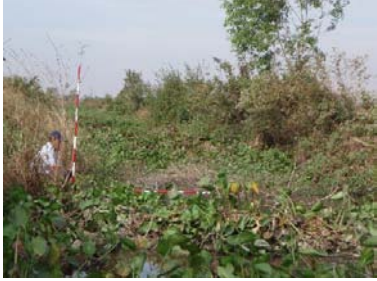
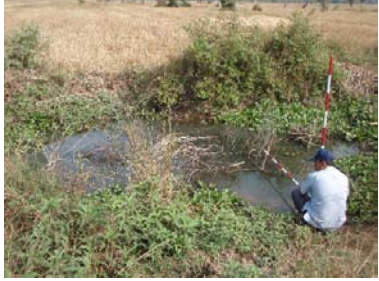
Canal No.: KD-1	Kind of structure(s): Canal section	Remarks:
Station: 3.00+750	Coordinate< Northing: 1259338 Easting: 484641	Canal section with grass & bush

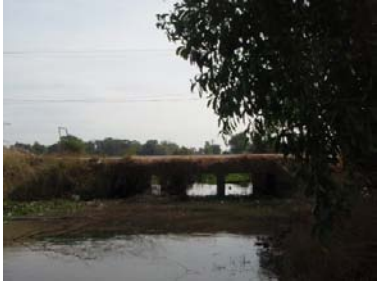
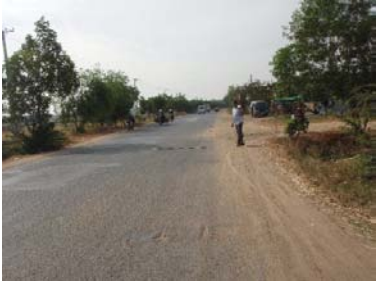
2,350	483363	1259333	Wooden Bridge, Private	House access	B	W=4m, L=1.2m
2,750	483659	1259334	Box Culvert, Commune road	Old culvert, but still functioned	B	Across canal 84 (local name), W=4m, L=1.2m
3,250	484127	1259337	Pipe Culvert, on commune road	The culvert was constructed by commune fund recently	B	W=1.5m, L=6.3m, dia=1m
3,550	484428	1259336	Turnout	Broken, hollow brick made structure	D	Near crossing point with canal 85 (local name)
3,750	484641	1259338	Canal Section	Section is obstructed by water plants and bush	D	Canal section with grass & bush
4,250	485154	1259346	E.P. Bridge, on NR-2	Flow section of the bridge is enough for flowing	B	W=12m, L=6m

Canal No.: KD-1	Kind of structure(s): Bridge	Remarks:
Station: 4.00+250 (E.P)	Coordinate< Northing: 1259346 Easting: 485154	Bridge on NR.2

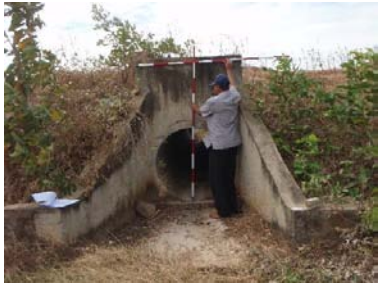
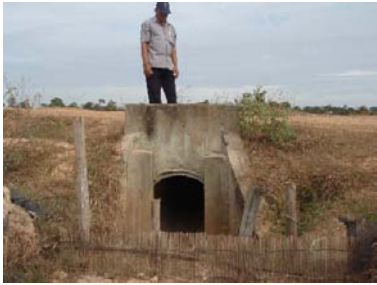
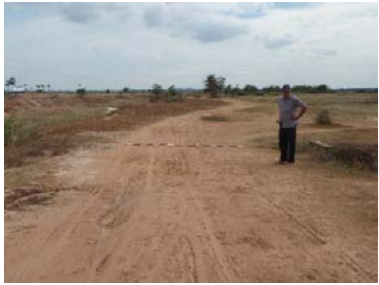
Canal No.:	Connection Canal	Kind of structure(s): Drain Inlet	Remarks: Structure is good, but no water drain from rice field
Station: 1.00+800	Coordinate<	Northing: 1258995 Easting: 478041

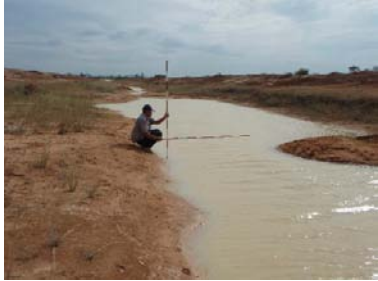
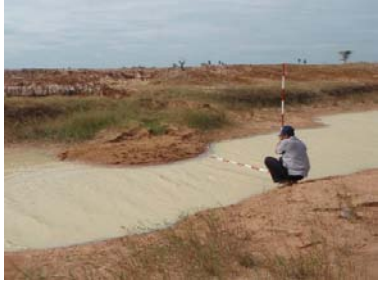
Canal No.:	Connection Canal	Kind of structure(s): Canal Section	Remarks:
Station: 2.00+500	Coordinate<	Northing: 1258292 Easting: 478047

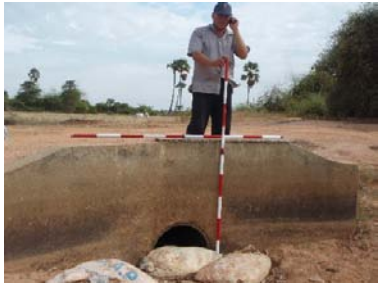
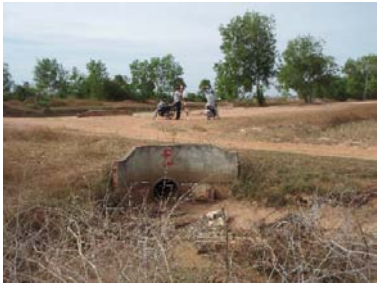
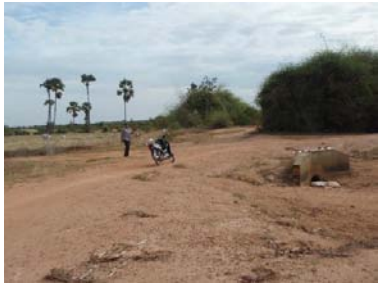
Canal No.: Connection Canal	Kind of structure(s): Earth bund and turnout	Remarks:
Station: 3.00+800	Coordinate< Northing: 1257008 Easting: 478043	Turnout was constructed by Word Vision in 2004

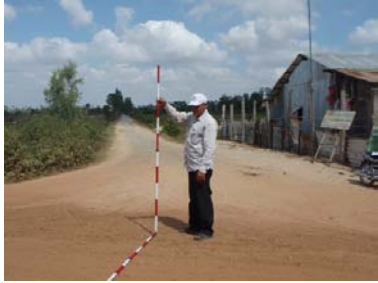
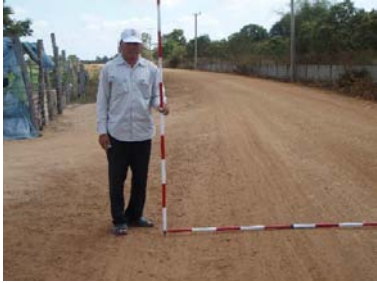
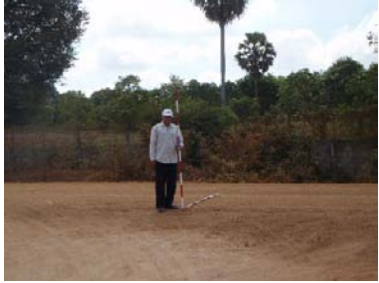
1. All dike/ road sections are in good condition with laterite soil pavement from B.P to E.P (NR).
2. Some structures were constructed in Pot Pot regime, but still functioning.

Canal No.: Flood dike	Kind of structure(s): Provincial road	Remarks:
Station: 0.00 (B.P)	Coordinate< Northing: 1254005 Easting: 4780409	Junction between Provincial and flood dike/ road

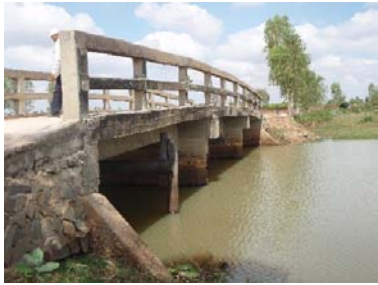
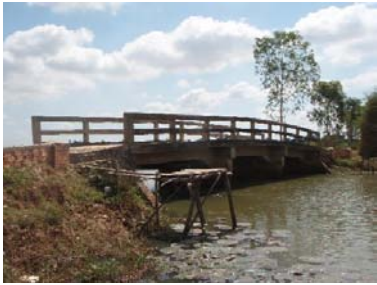
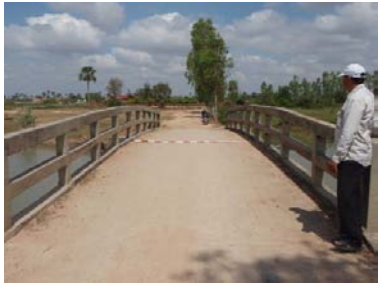
Canal No.: Flood dike	Kind of structure(s): Bridge	Remarks:
Station: 0.00+400	Coordinate< Northing: 1254393 Easting: 480396	On the Tonle Bati river

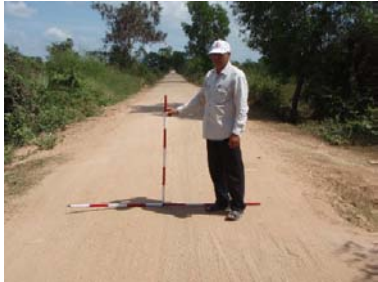
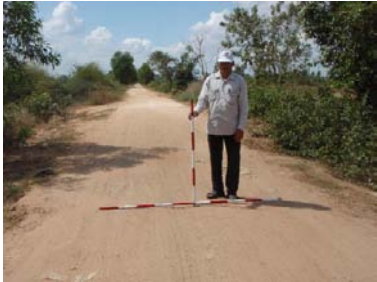
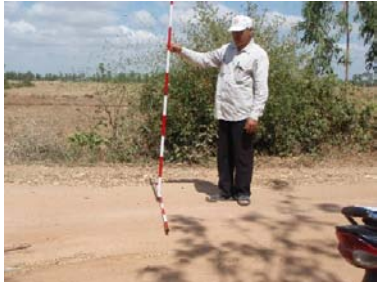
Canal No.: Flood dike	Kind of structure(s): Box Culvert	Remarks:
Station: 2.00+000	Coordinate< Northing: 1254745 Easting: 481591	Box Culvert with groove On KC-4

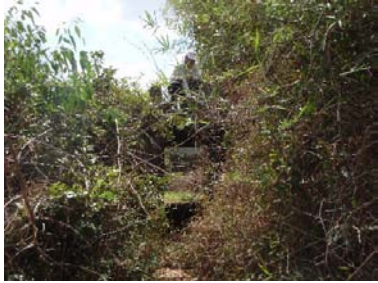
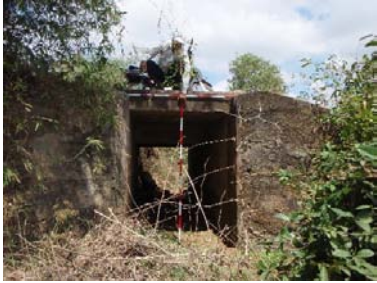
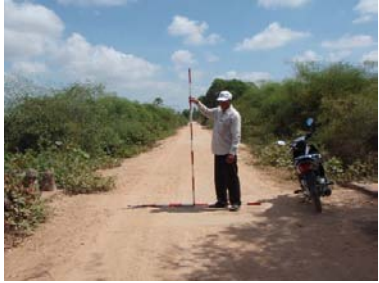
Canal No.: Flood dike	Kind of structure(s): Road Section	Remarks:
Station: 2.00+500	Coordinate< Northing: 1254756 Easting: 482084

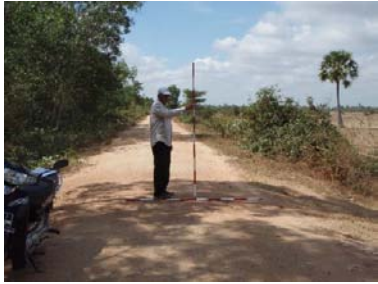
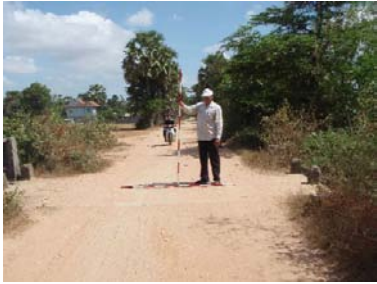
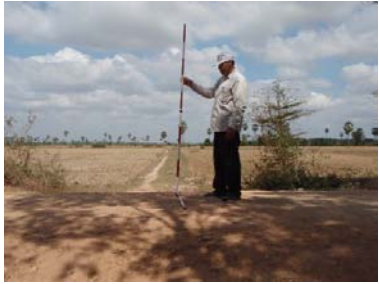
Canal No.: Flood dike	Kind of structure(s): Box Culvert	Remarks:
Station: 3.00+000	Coordinate< Northing: 1254770 Easting: 482585	Box Culvert with groove & Drain Inlet on KC-5

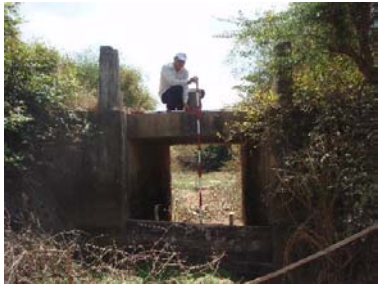
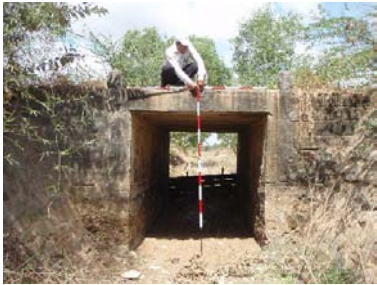
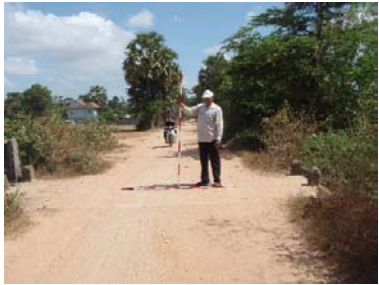
Sta.	E	N	Structure	Condition	Evaluation	Remarks
0	4780409	1254005	B.P. Dike/ Road	Dike/ Road surface is paved by laterite	A	Junction between Provincial road and dike/road
400	480396	1254393	Bridge, Commune road	Bridge is still in good condition, but submerged in 2010 flood	B	W=3.5, L=17m
500	480415	1254553	Dike/ Road Section	Gravel and sand pavement remain and surface is smooth	A	Junction to pagoda
800	480670	1254511	Dike/ Road Section	do.	A	Pagoda (Koh Sokroam)
1,000	480736	1254719	Dike/ Road Section	do.	A	
1,500	481199	1254737	Dike/ Road Section	do.	A	
2,000	481591	1254745	Box Culvert with groove	Occasionally used as drain outlet Need to improve (widening)	B	Outlet of KC-4 W=5m, L=2.5m
2,500	482084	1254756	Dike/ Road Section	Gravel and sand pavement remain and surface is smooth	A	
3,000	482585	1254770	Box Culvert with groove,	Culvert is in good condition	B	Outlet of KC-5 W=5.3m, L=2m, H=1.7 m
			Drain Inlet	Section is clogged by soils and grass	C	W=2m, L=1m

Canal No.: Flood dike	Kind of structure(s): Drain Inlet	Remarks: Box Culvert with groove & Drain Inlet
Station: 3.00+000	Coordinate< Northing: 1254770 Easting: 482585

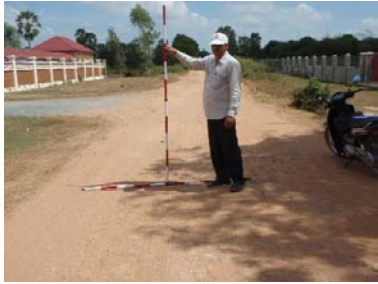
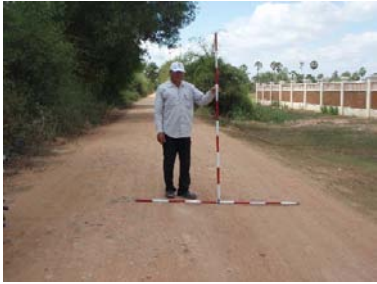
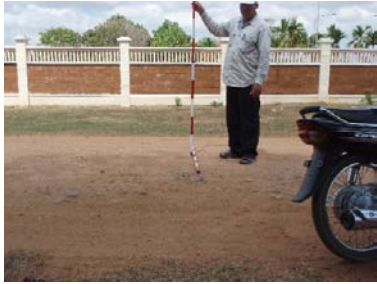
3,500	483144	1254794	Dike/ Road Section	Gravel and sand pavement remain and surface is smooth	A	
4,000	483670	1254821	Dike/ Road Section	do.	A	
4,500	484155	1254857	Dike/ Road Section	do.	A	
5,000	484549	1254846	Bridge with regulator (2 gates)	Bridge is still in good condition	B	Outlet of Stung Toch river W=5.3m, L=2m, H=1.7 m
5,300	484832	1254905	Pipe Culvert	do.	B	W=5.3m, L=4m, dia=0.8m (3 pipes)
5,330	484873	1254908	Pipe Culvert,	do.	B	W=5.3m, L=1.2m, dia=1m
5,500	485108	1254922	Dike/ Road Section	Gravel and sand pavement remain and surface is smooth	A	
6,000	485600	1254958	E.P.	do.	A	NR.2

Canal No.: Flood dike	Kind of structure(s): Road Section	Remarks:
Station: 4.00+000	Coordinate< Northing: 1254821 Easting: 483670

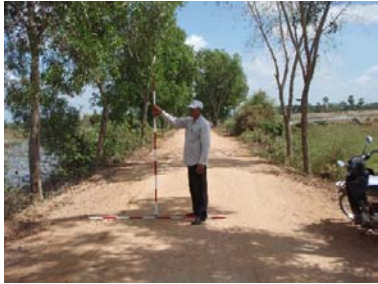
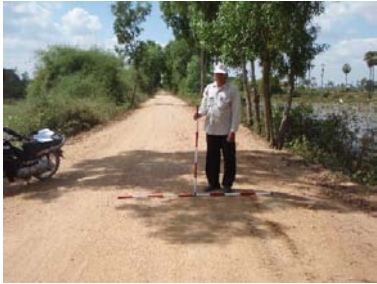
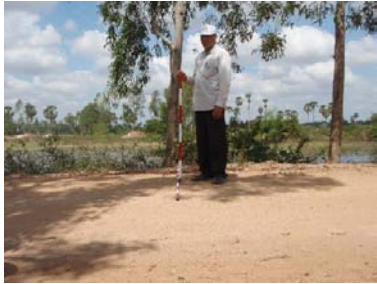
Canal No.: Flood dike	Kind of structure(s): Road Section	Remarks:
Station: 4.00+500	Coordinate< Northing: 1254857 Easting: 484155

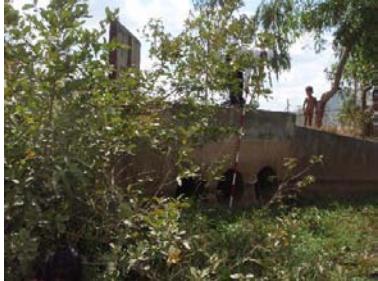
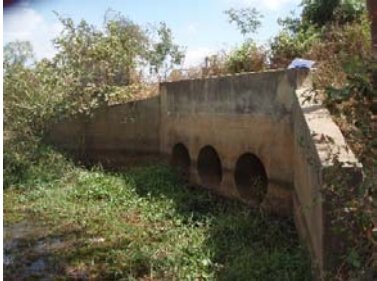
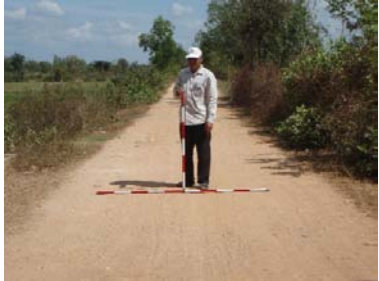
Canal No.: Flood dike	Kind of structure(s): Pipe Culvert	Remarks:
Station: 5.00+330	Coordinate< Northing: 1254908 Easting: 484873

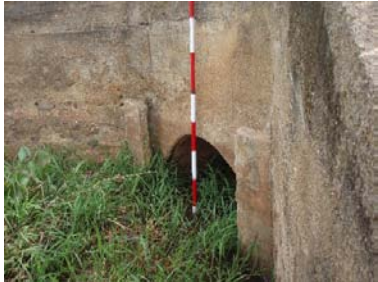
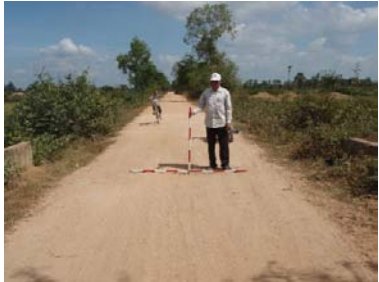
Canal No.: Flood dike	Kind of structure(s): Road Section	Remarks:
Station: 5.00+550	Coordinate< Northing: 1254922 Easting: 485108

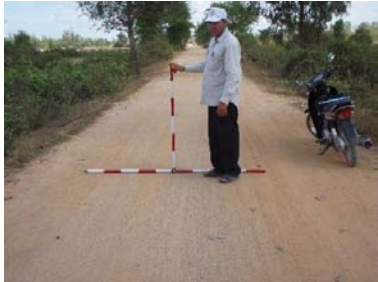
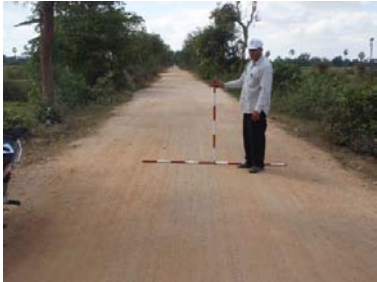
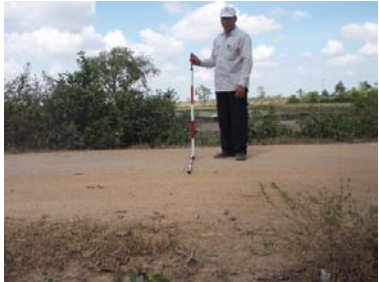
Canal No.: Flood dike	Kind of structure(s):	Remarks:
Station: 6.00+000 (E.P)	Coordinate< Northing: 1254958 Easting: 485600	Junction with NR.2

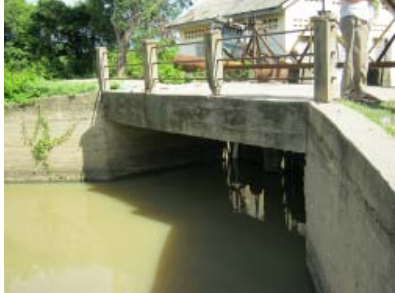
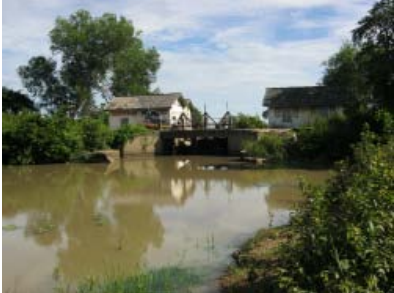
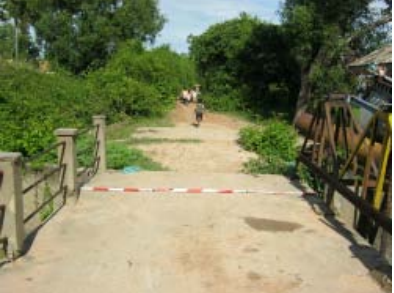
Canal No.: MC1	Kind of structure(s): Pumping Station No. 22-23 , Gate & Bridge	Remarks: Village Road
Station: 0.00(B.P.)	Coordinate< Northing: 1252808 Easting: 0484026	Routine Survey

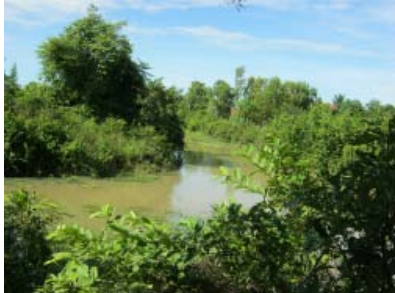
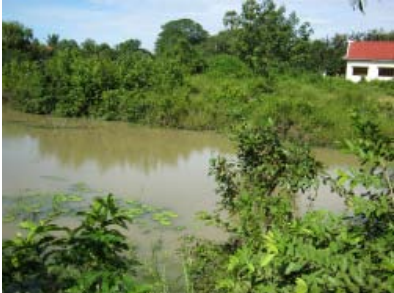
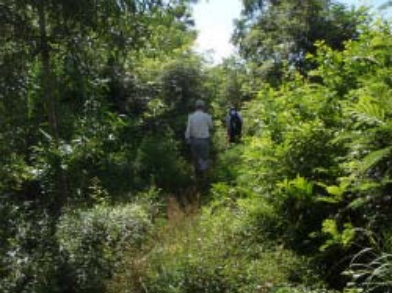
Canal No.: MC1	Kind of structure(s): Canal	Remarks: Turning Point
Station: 0.00+200	Coordinate< Northing: 1252644 Easting: 0484028	Routine Survey

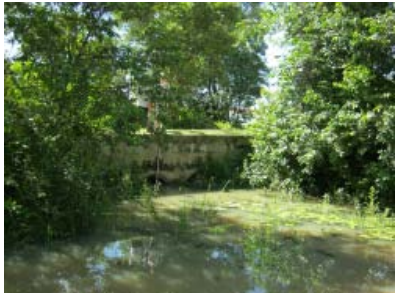
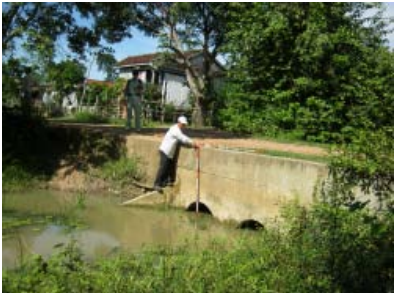
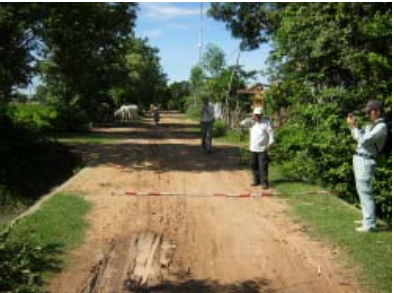
Canal No.: MC1	Kind of structure(s): Pipe Culvert(Private)	Remarks: Double Pipe Culvert
Station: 0.00+300	Coordinate< Northing: 1252631 Easting: 0484103	Commune Road

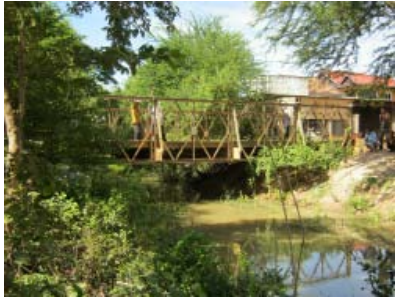
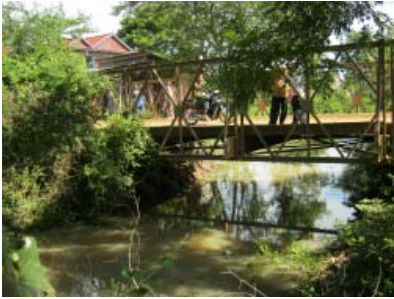
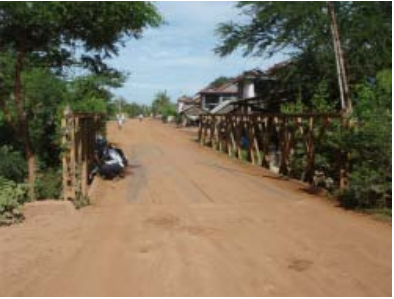
Canal No.: MC1	Kind of structure(s): Bridge	Remarks:
Station: 0.00+630	Coordinate< Northing: 1252412 Easting: 0484016	Krang Knong Commune Bridge Routine Survey

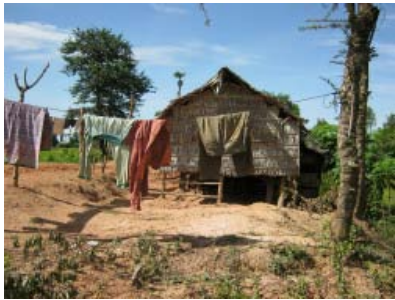
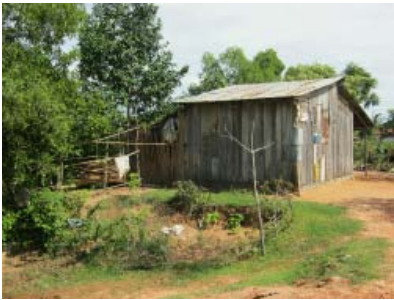
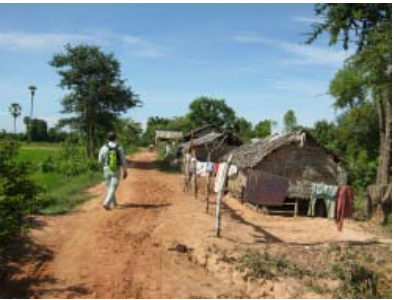
Canal No.: MC1	Kind of structure(s): Houses(Temporary)	Remarks:
Station: 0.00+730	Coordinate< Northing: 1252309 Easting: 0484023	Village Road Routine Survey

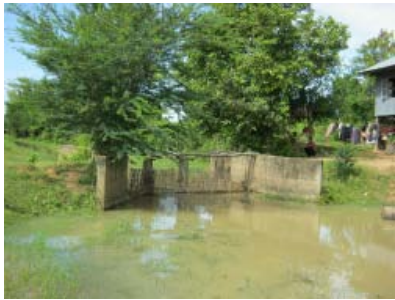
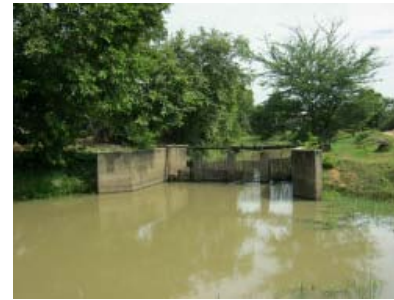
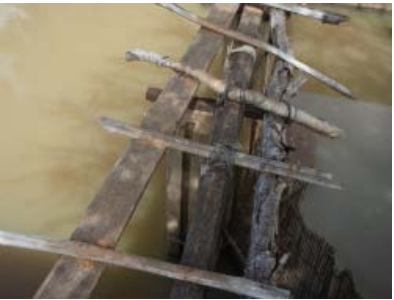
Canal No.: MC1	Kind of structure(s): Bridge(Wooden)	Remarks:
Station: 0.00+850	Coordinate< Northing: 1252190 Easting: 0484022	House Access Bridge with Concrete Wall

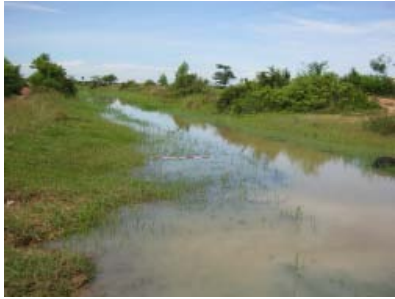
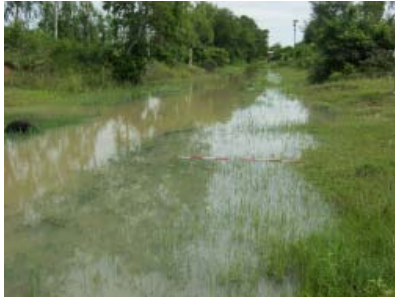
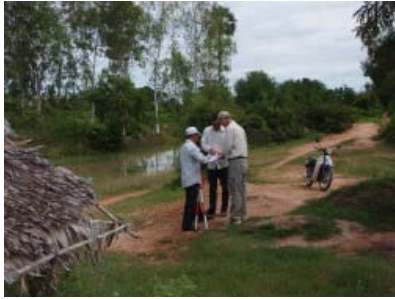
Canal No.: MC1	Kind of structure(s): Canal	Remarks:
Station: 1.00+90	Coordinate< Northing: 1251977 Easting: 0484026	Measurement Point

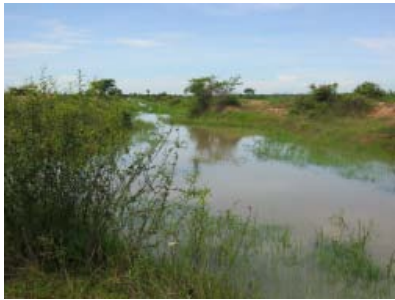
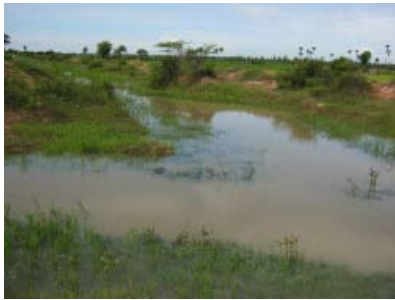
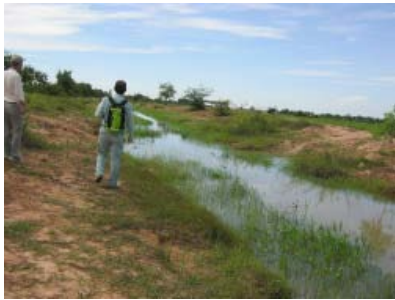
Canal No.: MC1	Kind of structure(s): Canal	Remarks:
Station: 1.00+160	Coordinate< Northing: 1251913 Easting: 0484028	Diversion Point of Canal L4 Routine Survey

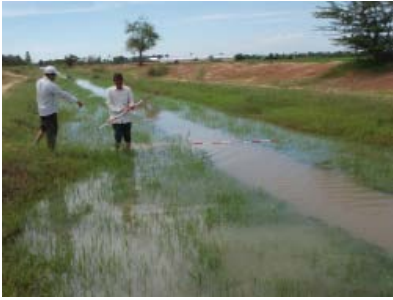
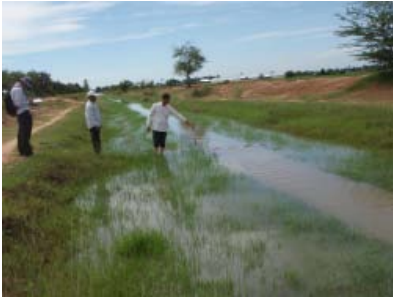
Canal No.: MC1	Kind of structure(s): Canal	Remarks:
Station: 1.00+230	Coordinate< Northing: 1251876 Easting: 0484087	Routine Survey Length: 1000m

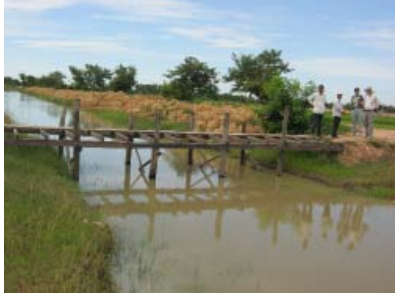
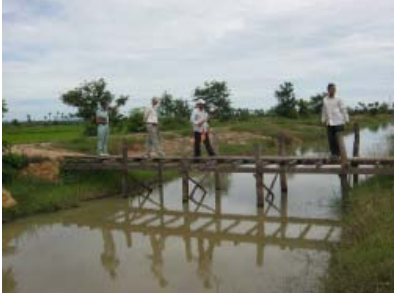
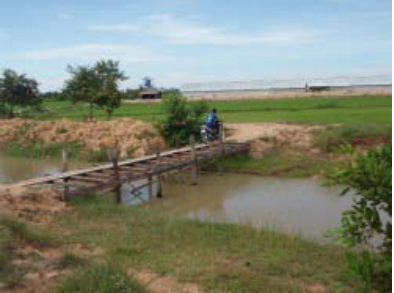
Canal No.: MC1	Kind of structure(s): Bridge (Private Wooden)	Remarks: Farm Access
Station: 1.00+580	Coordinate< Northing: 1251712 Easting: 0484361	Routine Survey

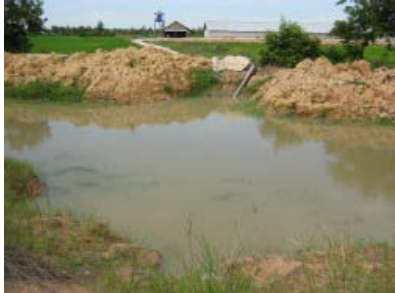
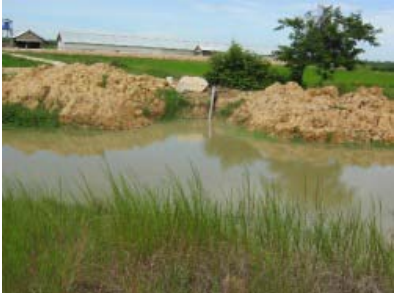
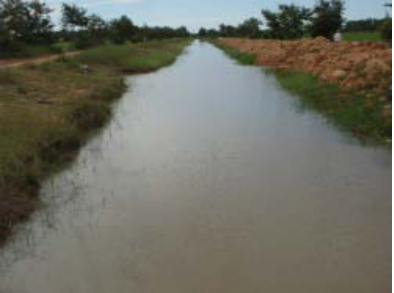
Canal No.: MC1	Kind of structure(s): Canal	Remarks: Private Pump to Farm Use
Station: 1.00+620	Coordinate< Northing: 1251696 Easting: 0484390	Routine Survey

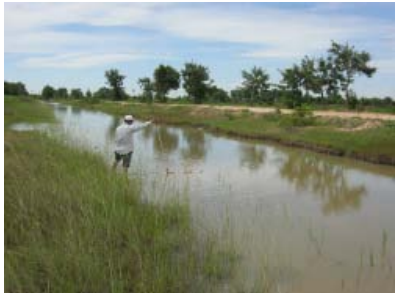
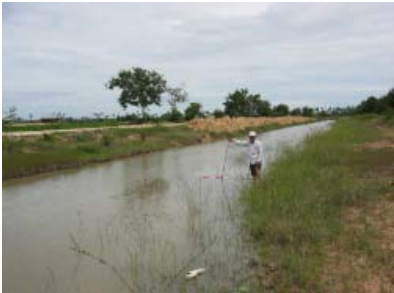
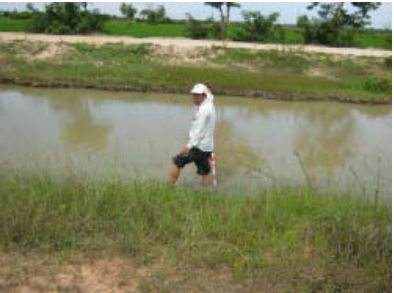
Canal No.: MC1	Kind of structure(s): Canal	Remarks: Routine Survey
Station: 1.00+770	Coordinate< Northing: 1251631 Easting: 0484496	Length: 1500m

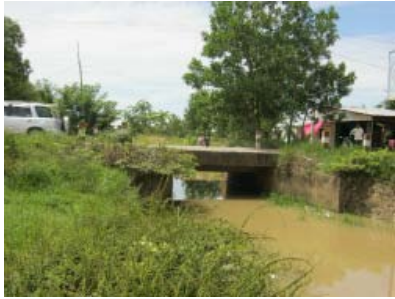
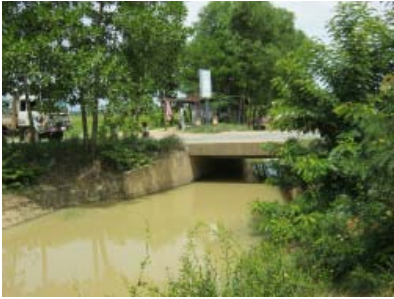
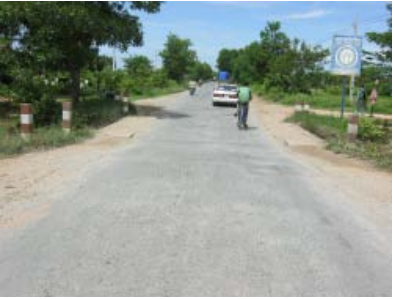
Up Stream View	Down Stream View	Structure/Side View

Canal No.: MC1	Kind of structure(s): Bridge (Concrete)	Remarks:
Station: 2.00+170	Coordinate< Northing: 1251437 Easting: 0484795	Bridge across National Road N° 2 Routine Survey

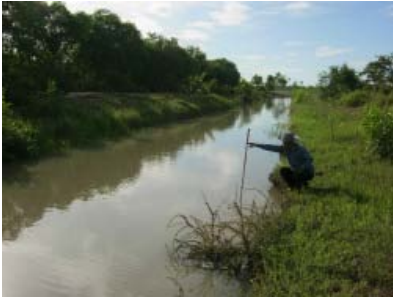
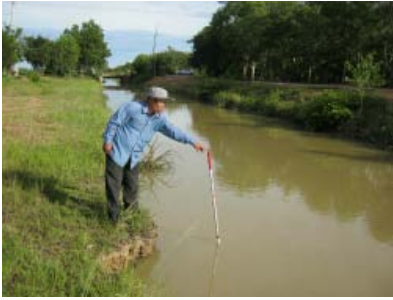
Up Stream View	Down Stream View	Structure/Side View

Canal No.: MC1	Kind of structure(s): Canal	Remarks:
Station: 2.00+280	Coordinate< Northing: 1251387 Easting: 0484862	Routine Survey Length: 2000m

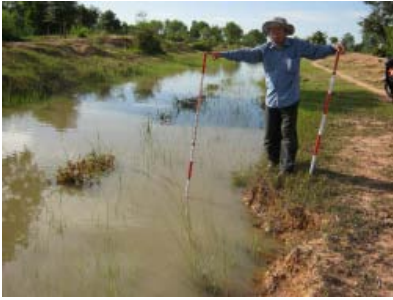
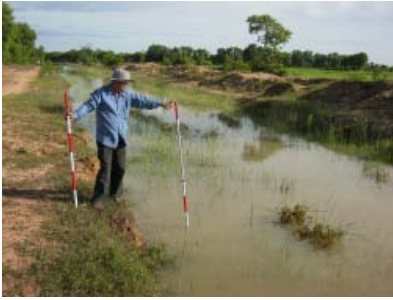
Up Stream View	Down Stream View

Canal No.: MC1	Kind of structure(s): Canal	Remarks:
Station: 2.00+780	Coordinate< Northing: 1251024 Easting: 0485172	Routine Survey Length: 2500m

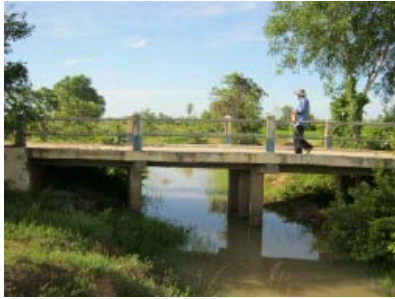
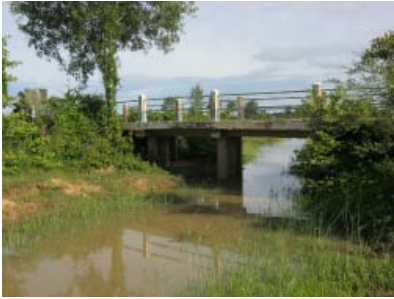
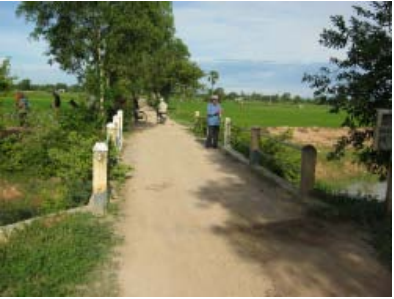
Up Stream View	Down Stream View

Canal No.: MC1	Kind of structure(s): Bridge (Village)	Remarks:
Station: 2.00+960	Coordinate< Northing: 1250874 Easting: 0485276	Village Road Routine Survey

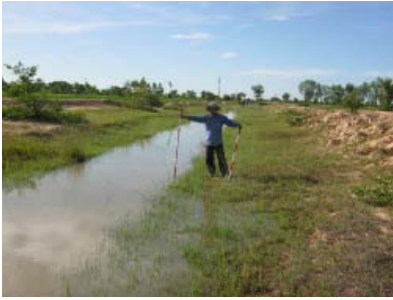
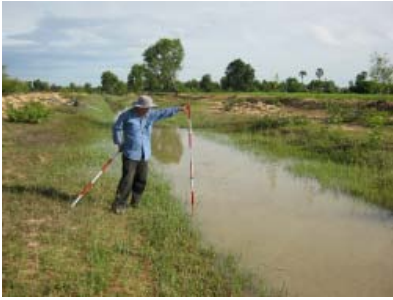
Up Stream View	Down Stream View	Structure/Side View

Canal No.: MC1	Kind of structure(s): Canal	Remarks:
Station: 3.00+320	Coordinate< Northing: 1250596 Easting: 0485465	Routine Survey Length: 3000m

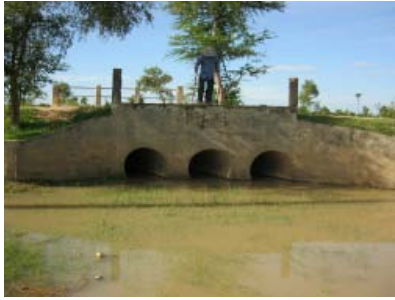
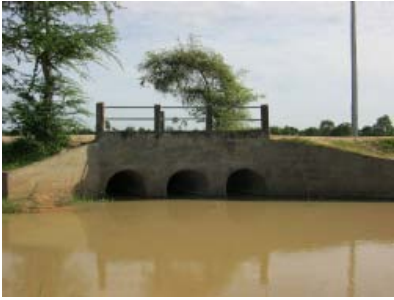
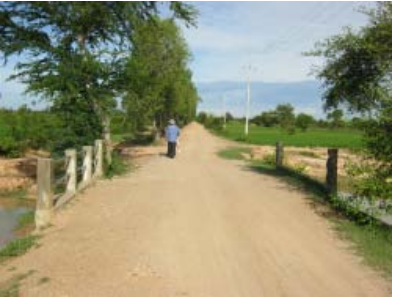
Up Stream View	Down Stream View

Canal No.: MC1	Kind of structure(s): Bridge (Village)	Remarks:
Station: 3.00+520	Coordinate< Northing: 1250445 Easting: 0485572	There are Triple Pipe Culvert Village Road

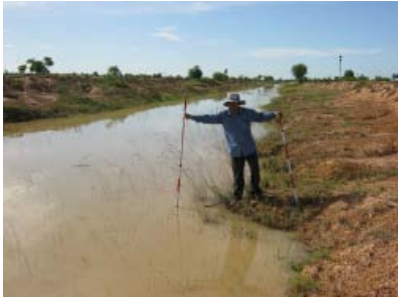
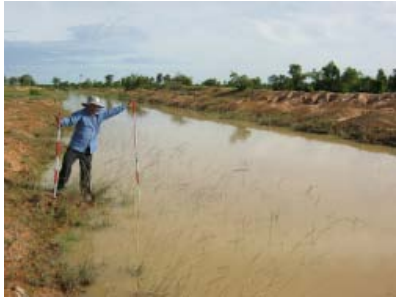
Up Stream View	Down Stream View	Structure/Side View

Canal No.: MC1	Kind of structure(s): Canal	Remarks:
Station: 3.00+820	Coordinate< Northing: 1250186 Easting: 0485742	Routine Survey Length: 3500m

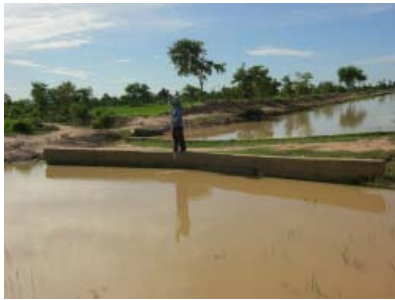
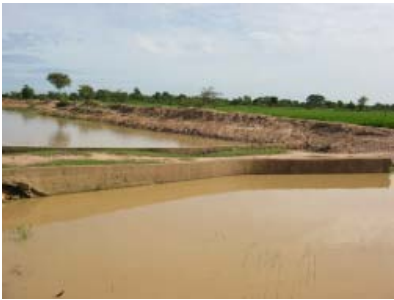
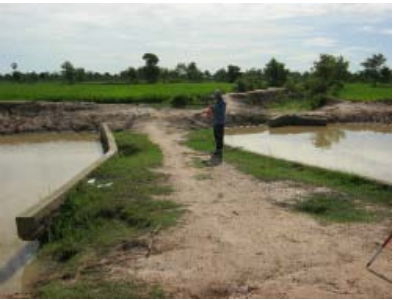
Up Stream View		Down Stream View

Canal No.: MC1	Kind of structure(s): Pipe Culvert	Remarks:
Station: 4.00+230	Coordinate< Northing: 1249873 Easting: 0485966	Farm Access Routine Survey

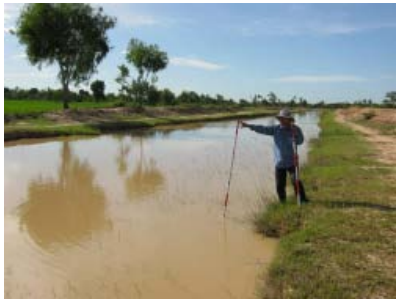
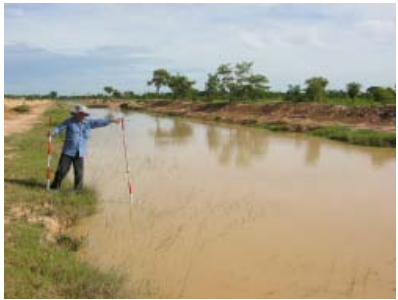
Structure/Side View

Canal No.: MC1	Kind of structure(s): Canal	Remarks:
Station: 4.00+320	Coordinate< Northing: 1249782 Easting: 0486018	Routine Survey Length: 4000m

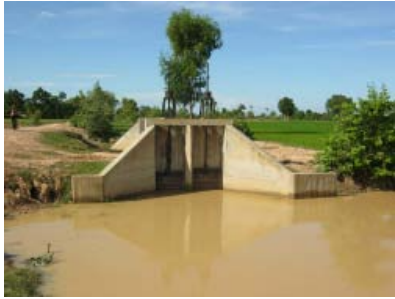
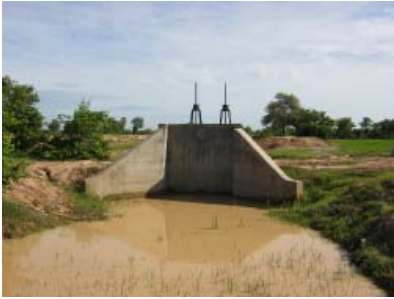
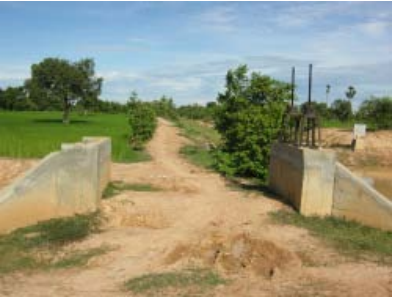
Up Stream View		Down Stream View

Canal No.: MC1	Kind of structure(s): Gate Structure	Remarks:
Station: 4.00+850	Coordinate< Northing: 1249359 Easting: 0486248	Village Road Length: 4500m

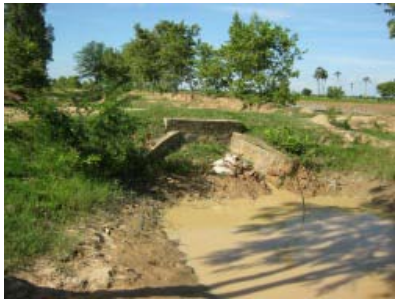
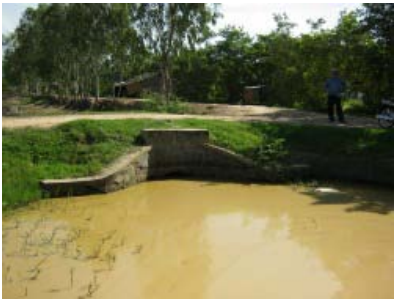
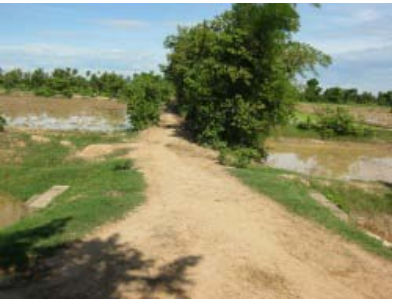
Up Stream View	Down Stream View	Structure/Side View

Canal No.: MC1	Kind of structure(s): Pipe Culvert	Remarks:
Station: 5.00+190	Coordinate< Northing: 1249026 Easting: 0486253	Built by World Vision of Cambodia Farm Access

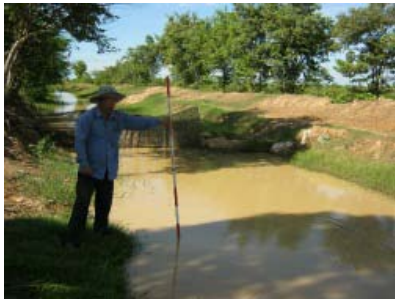
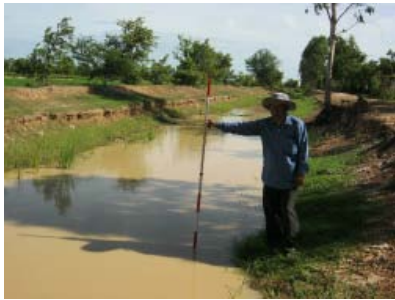
Up Stream View	Down Stream View	Structure/Side View

Canal No.: MC1	Kind of structure(s): Canal	Remarks:
Station: 5.00+360	Coordinate< Northing: 1248853 Easting: 0486255	Routine Survey Length: 5000m

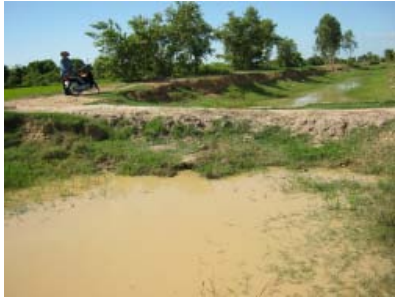
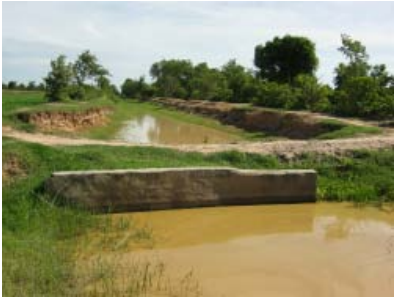
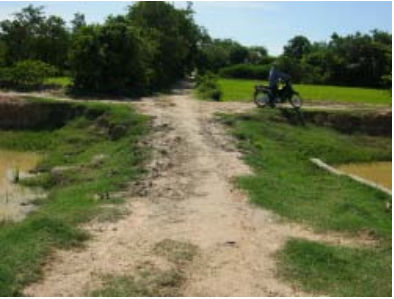
Up Stream View	Down Stream View

Canal No.: MC1	Kind of structure(s): Pipe Culvert	Remarks:
Station: 5.00+600	Coordinate< Northing: 1248618 Easting: 0486251	Farm Access Routine Survey

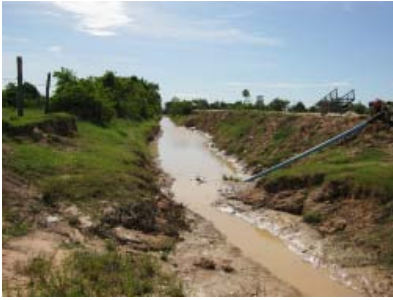
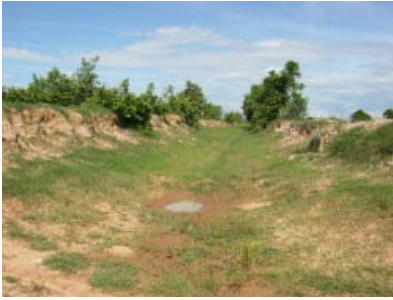
Up Stream View	Down Stream View	Structure/Side View

Canal No.: MC1	Kind of structure(s): Canal	Remarks:
Station: 5.00+860	Coordinate< Northing: 1248358 Easting: 0486246	Private Pump Length: 5500m

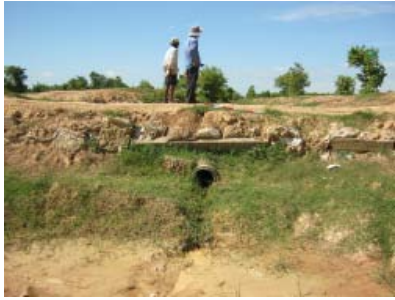
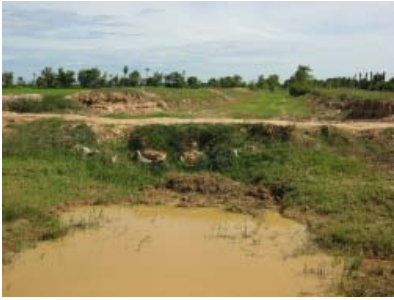
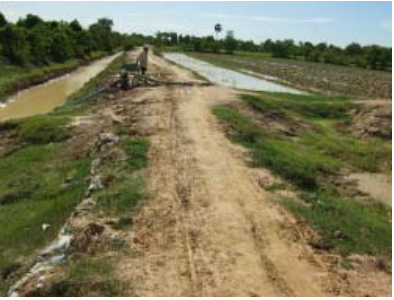
Up Stream View	Down Stream View

Canal No.: MC1	Kind of structure(s): Pipe Culvert	Remarks:
Station: 5.00+930	Coordinate< Northing: 1248298 Easting: 0486239	Diversion Point Private Pump

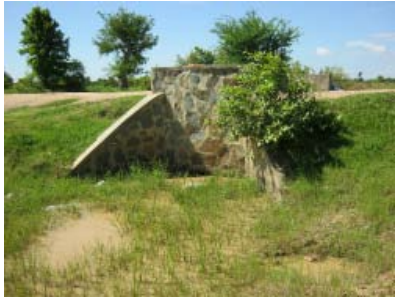
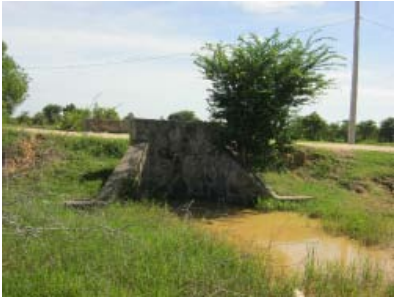
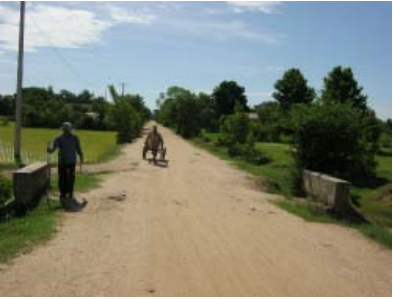
Canal No.: MC1	Kind of structure(s): Pipe Culvert	Remarks:
Station: 6.00+370	Coordinate< Northing: 1247888 Easting: 0486240	Commune Road by World Vision Length: 6000m

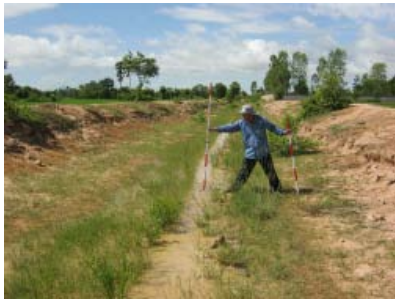
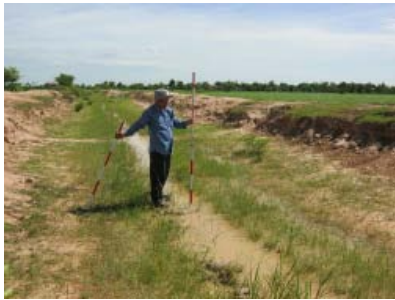
Canal No.: MC1	Kind of structure(s): Canal	Remarks:
Station: 6.00+870	Coordinate< Northing: 1247378 Easting: 0486230	Routine Survey Length: 6500m

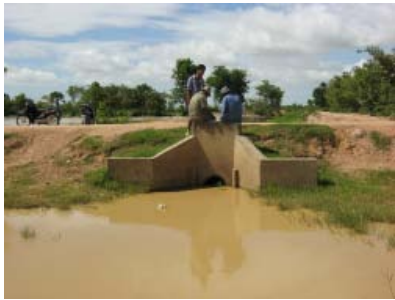
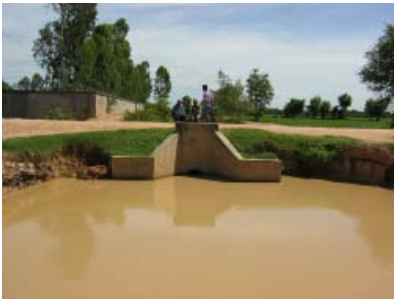
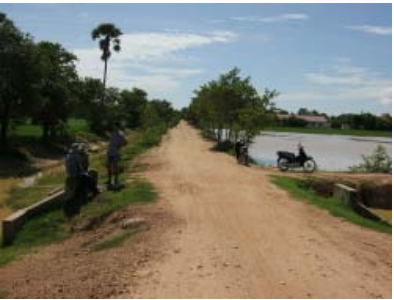
Canal No.: MC1	Kind of structure(s): Pipe Culvert	Remarks:
Station: 7.00+100	Coordinate< Northing: 1247165 Easting: 0486231	Commune Road Diversion Point

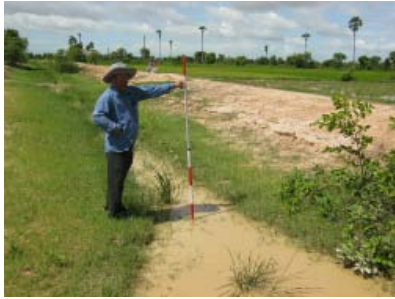
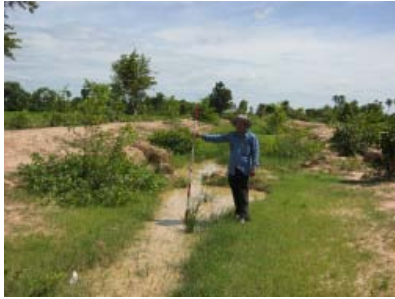
Canal No.: MC1	Kind of structure(s): Canal	Remarks:
Station: 7.00+380	Coordinate< Northing: 1246890 Easting: 0486232	Routine Survey Length: 7000m

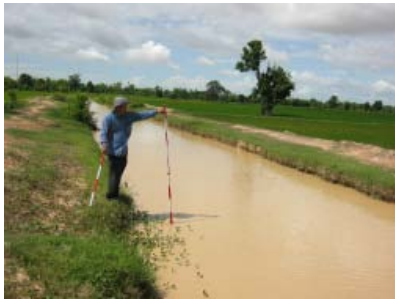
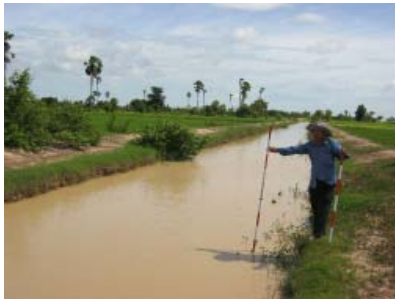
Canal No.: MC1	Kind of structure(s): Canal	Remarks:
Station: 7.00+880	Coordinate< Northing: 1246376 Easting: 0486231	Routine Survey Length: 7500m

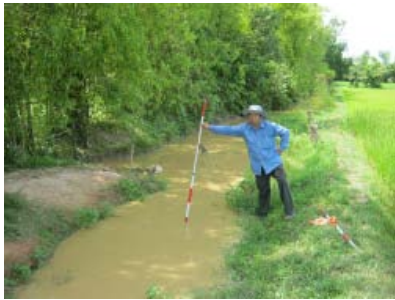
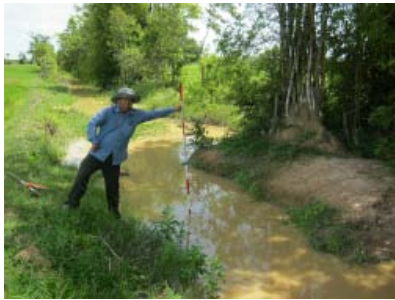
Canal No.: MC1	Kind of structure(s): Canal	Remarks:
Station: 8.00+380	Coordinate< Northing: 1245938 Easting: 0486221	Routine Survey Length: 8000m

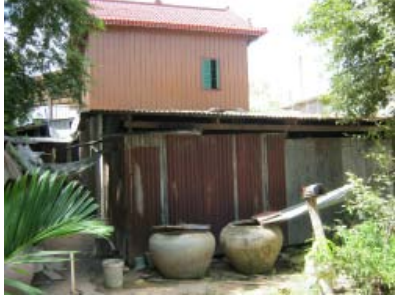
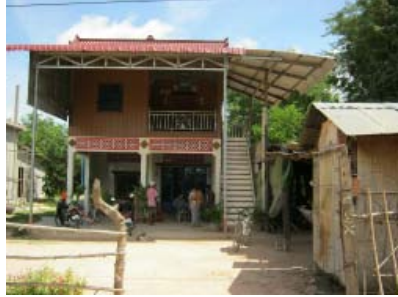
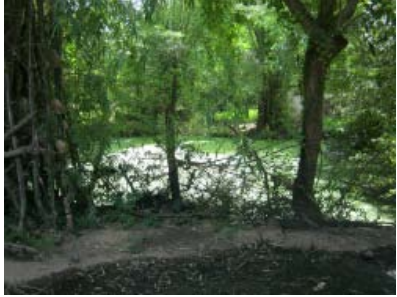
Canal No.: MC1	Kind of structure(s): Houses	Remarks: Rice fields are the downstream side across the rural road, and the house is on the upstream. This house owners has encroached the public property by filling land into the canal in order to make their own uses such as digging small pond and making their house wall surrounded by the thorny bamboo trees at the back of their house.
Station: 8.00+670(EP)	Coordinate< Northing: 1245729 Easting: 0486217

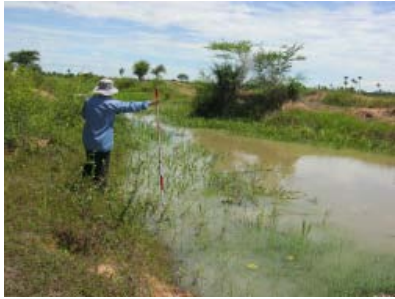
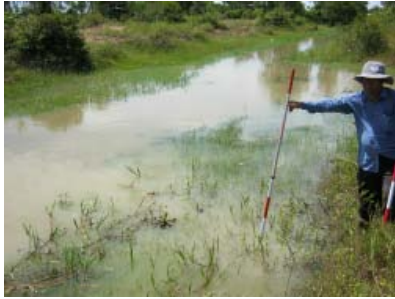
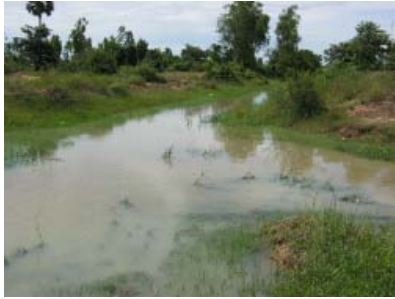
Sta.	E	N	Structure	Condition	Evaluation	Remarks
0	0484029	125189 7	B.P.	The canal is branched off from MC-1, but no division structure exists	-	Canal bed is higher than one of MC-1, so less water enter to MC-2
510	0484027	125142 4	Canal section, 500 m	The sections shallow and covered by grasses	C	
1,010	0484029	125093 9	Canal section, 1,000 m	Do.	C	
1,360	0484043	125059 4	Houses=2	Two (2) houses on the canal bank,	-	Roof and walls are made by galvanized steel plates
1,510	0484045	125044 9	Turnout Gate	Culvert portion was eroded and damaged	C	W=0.8m, H=0.5m), Width of both side=8m, Canal Width=10m, Canal Depth=0.8m, (1,500m)
1,640	0484022	125030 9	Turning Point to private pond	Water is diverted to private pond without structure (breach of the canal bank)	C	
1,810	0484018	125013 7	Bridge (Commune)	Flow area seems be enough and well maintained	B	W=5.5m, L=4.4m, H=1.7m)
2,010	0484030	124999 7	Bridge across National Road N° 2	Steel truss bridge is in good condition	A	L=13.5m, W=7.6m, Span =3.1m, H=2.2m

Canal No.: MC2	Kind of structure(s): Canal	Remarks:
Station: 0.00(B.P.)	Coordinate< Northing: 1251897 Easting: 0484029	Diversion Point of MC1 with MC2 Routine Survey

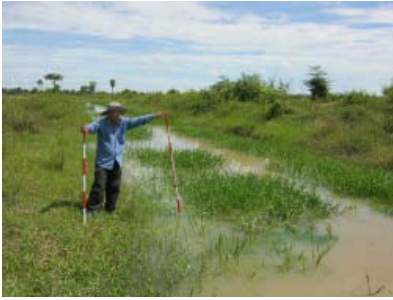
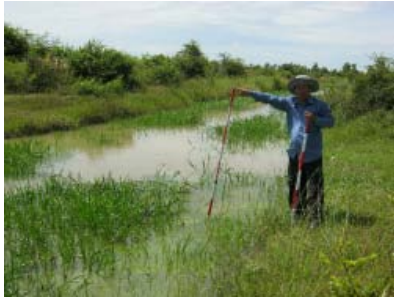
Canal No.: MC2	Kind of structure(s): Canal	Remarks:
Station: 0.00+510	Coordinate< Northing: 1251424 Easting: 0484027	Routine Survey Length: 500m

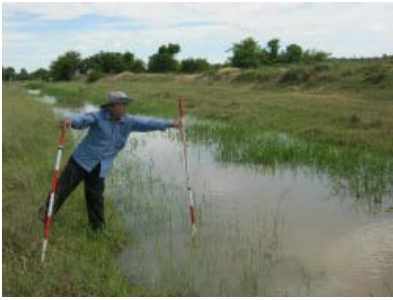
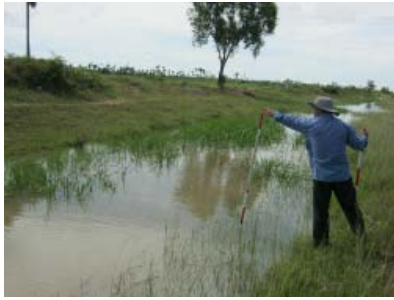
Canal No.: MC2	Kind of structure(s): Canal	Remarks:
Station: 1.00+10	Coordinate< Northing: 1250939 Easting: 0484029	Routine Survey Length: 1000m

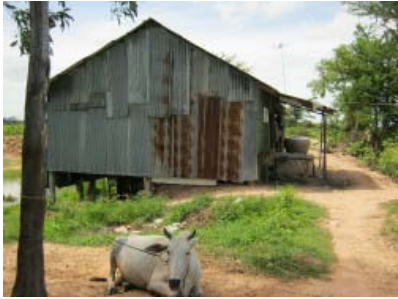
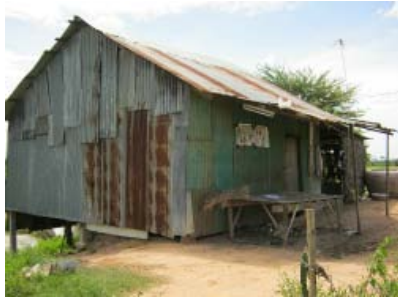
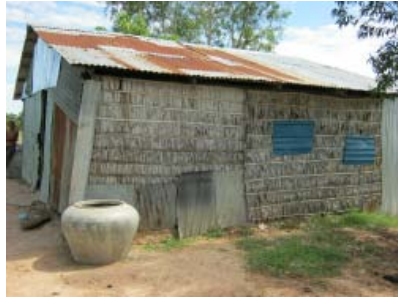
Canal No.: MC2	Kind of structure(s): Houses	Remarks:
Station: 1.00+360	Coordinate< Northing: 1250594 Easting: 0484043	Routine Survey There are two houses.
