# ***ANNEX D***

*Results of Inventory Survey for Irrigation and Drainage*

*Facilities in Kandal Stung – Bati Irrigation System*

*Rehabilitation Sub-project*

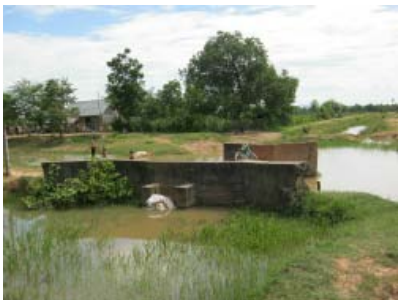
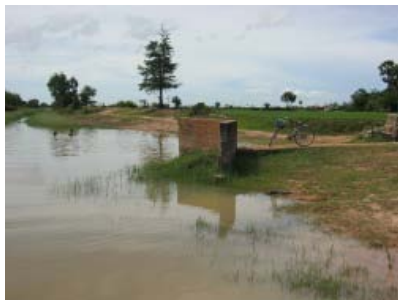
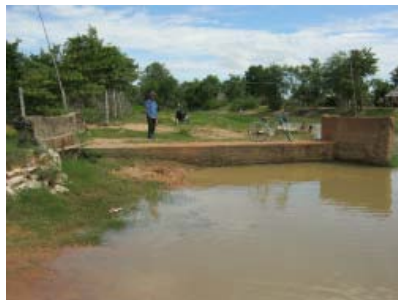
Canal No.: MC2	Kind of structure(s): Gate Structure	Remarks:
Station: 1.00+510	Coordinate< Northing: 1250449 Easting: 0484045	Diversion Point to Secondary Canal Length: 1500m Gate structure is on the left hand side of the Canal.

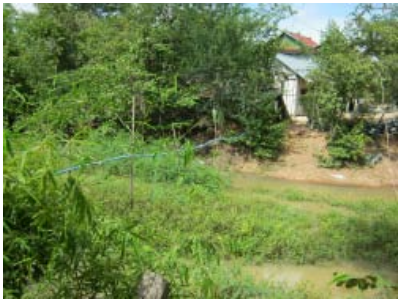
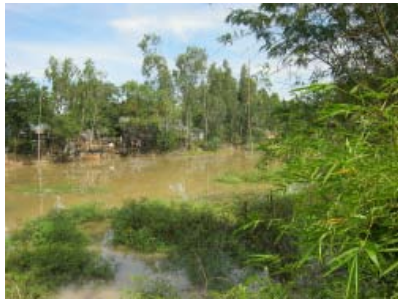
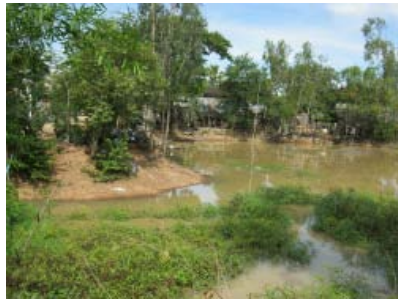
Canal No.: MC2	Kind of structure(s): Canal	Remarks:
Station: 1.00+640	Coordinate< Northing: 1250309 Easting: 0484022	Turning Point to Private Pond Routine Survey

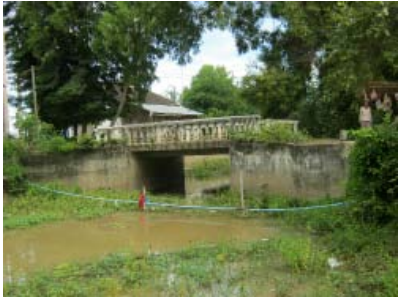
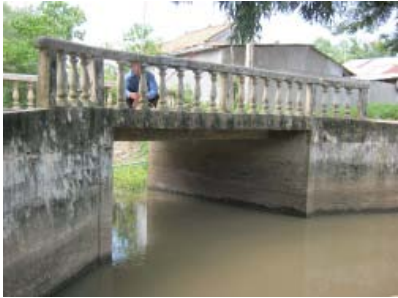
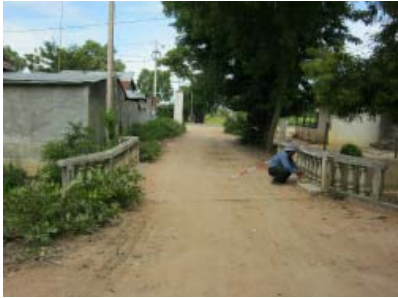
Canal No.: MC2	Kind of structure(s): Bridge (Commune)	Remarks:
Station: 1.00+810	Coordinate< Northing: 1250137 Easting: 0484018	Commune Road Routine Survey

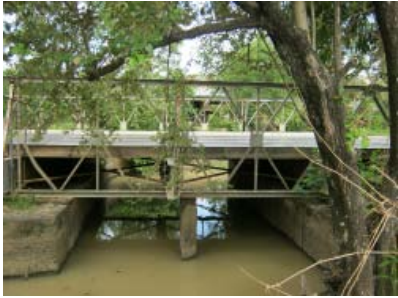
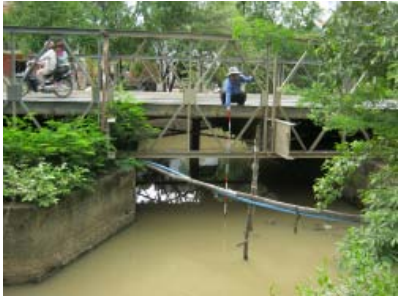
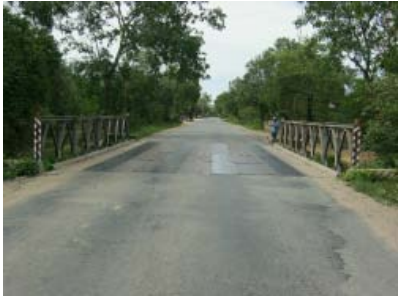
Canal No.: MC2	Kind of structure(s): Bridge	Remarks:
Station: 2.00+10	Coordinate< Northing: 1249997 Easting: 0484030	Bridge across National Road N° 2 Length: 2000m

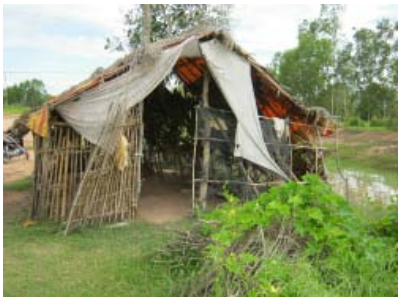
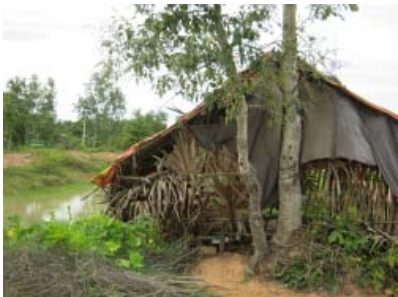
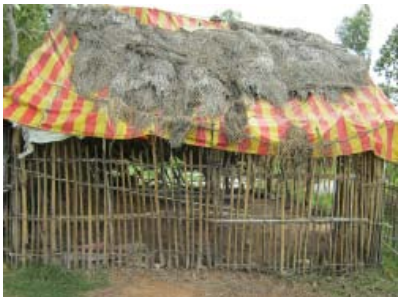
Canal No.: MC2	Kind of structure(s): House(Temporary)	Remarks:
Station: 2.00+310	Coordinate< Northing: 1249720 Easting: 0484047	Routine Survey

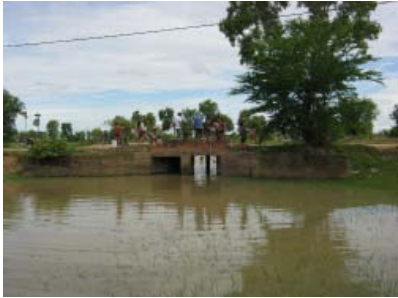
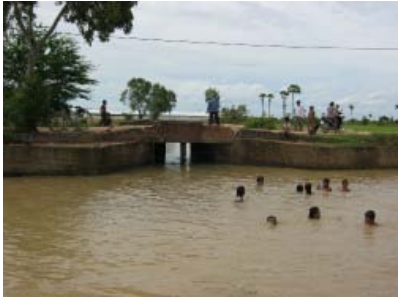
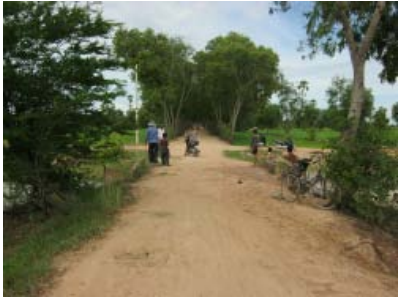
Canal No.: MC2	Kind of structure(s): Bridge (Commune)	Remarks:
Station: 2.00+550	Coordinate< Northing: 1249486 Easting: 0484037	Commune Road Length: 2500m

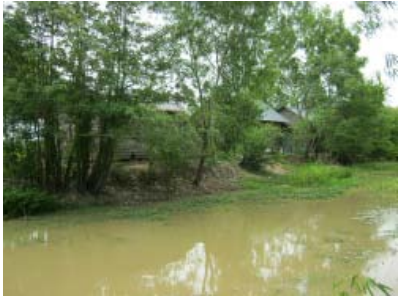
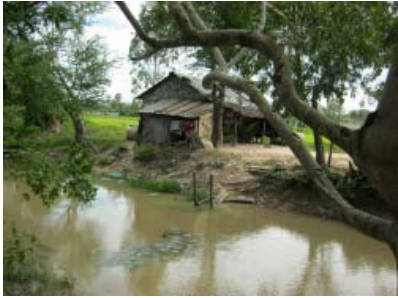
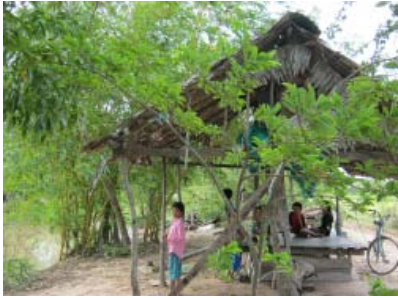
Canal No.: MC2	Kind of structure(s): Houses	Remarks:
Station: 2.00+900	Coordinate< Northing: 1249133 Easting: 0484045	There are 7 houses. Routine Survey

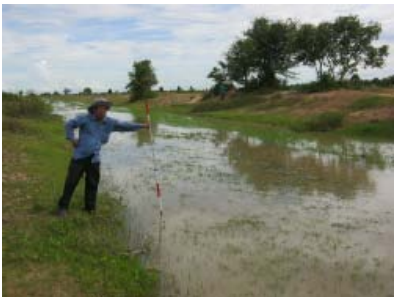
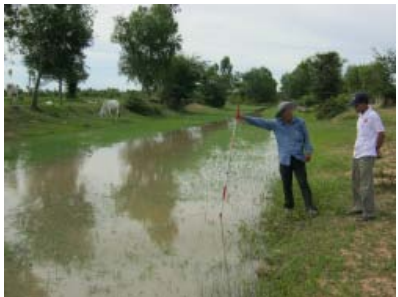
Canal No.: MC2	Kind of structure(s): Canal	Remarks:
Station: 3.00+60	Coordinate< Northing: 1248987 Easting: 0484040	Routine Survey Length: 3000m

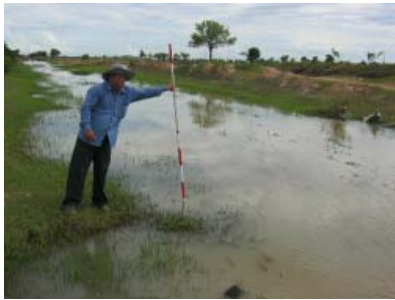
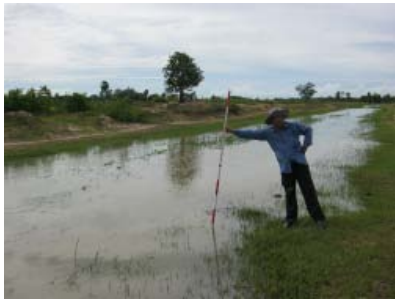
Canal No.: MC2	Kind of structure(s): Canal	Remarks:
Station: 3.00+560	Coordinate< Northing: 1248511 Easting: 0484039	Routine Survey Length: 3500m

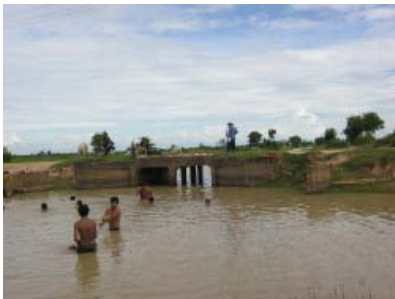
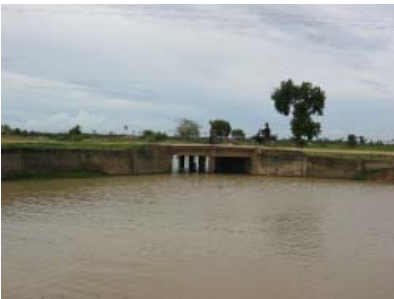
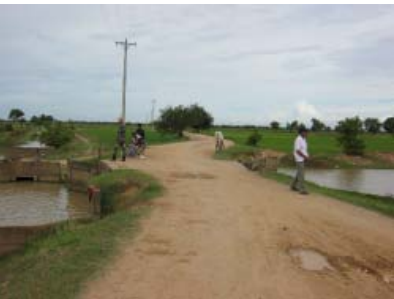
Canal No.: MC2	Kind of structure(s): Bridge (Commune)	Remarks:
Station: 3.00+810	Coordinate< Northing: 1248291 Easting: 0484034	Commune Road Routine Survey

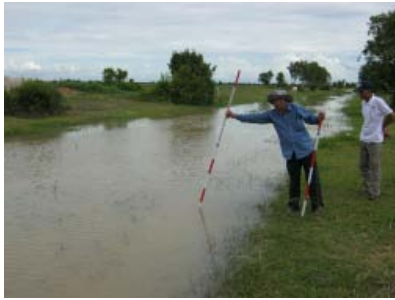
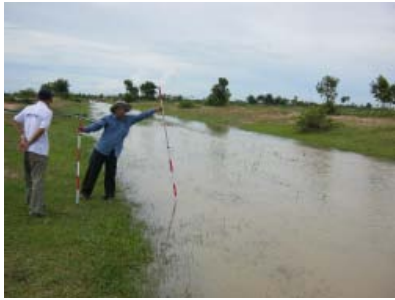
Canal No.: MC2	Kind of structure(s): Canal	Remarks:
Station: 4.00+60	Coordinate< Northing: 1248041 Easting: 0484028	Routine Survey Length: 4000m

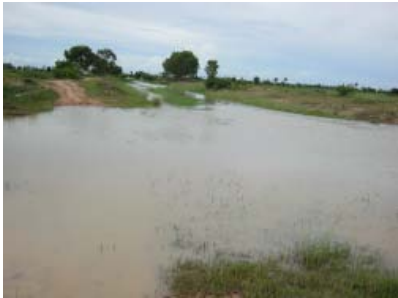
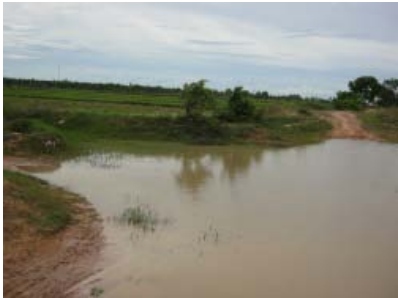
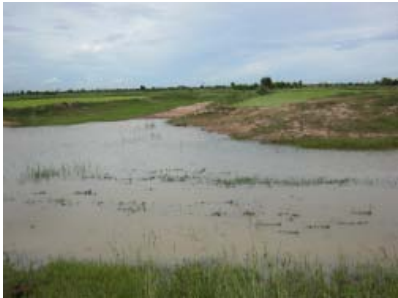
Canal No.: MC2	Kind of structure(s): Canal	Remarks: Crossing Point of Sub-Canal Routine Survey
Station: 4.00+400	Coordinate< Northing: 1247695 Easting: 0484029

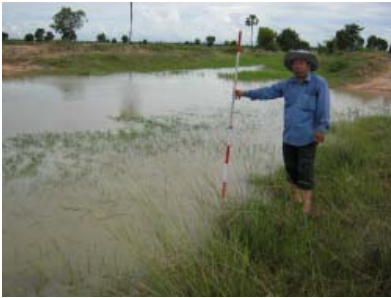
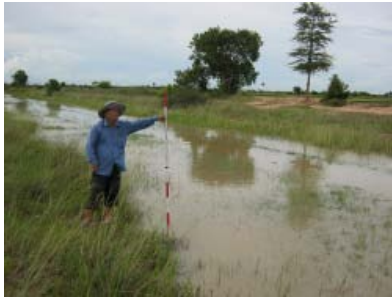
Canal No.: MC2	Kind of structure(s): Canal	Remarks: Routine Survey Length: 4500m
Station: 4.00+580	Coordinate< Northing: 1247507 Easting: 0484027

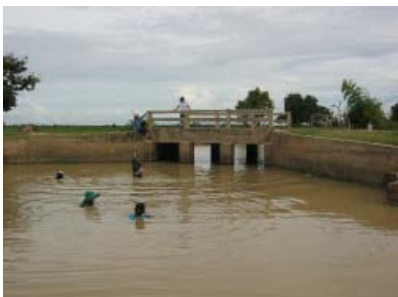
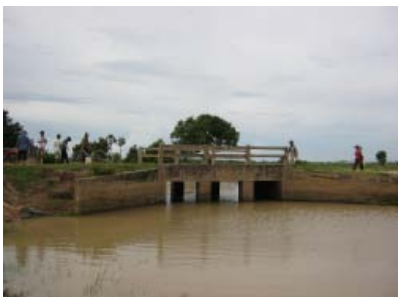
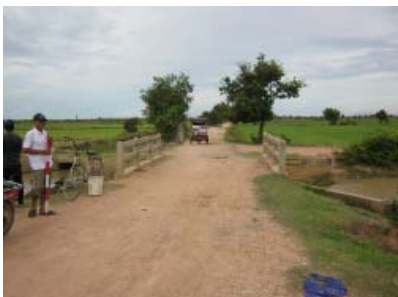
Canal No.: MC2	Kind of structure(s): Bridge (Commune)	Remarks: Commune Road Routine Survey
Station: 4.00+930	Coordinate< Northing: 1247171 Easting: 0484034

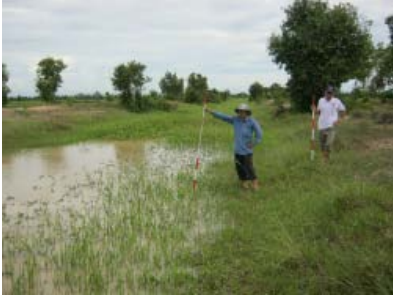
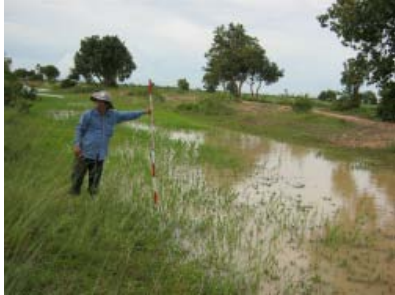
Canal No.: MC2	Kind of structure(s): Canal	Remarks: Routine Survey Length: 5000m
Station: 5.00+90	Coordinate< Northing: 1247021 East ing: 0484028

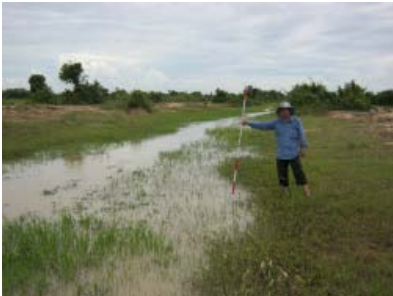
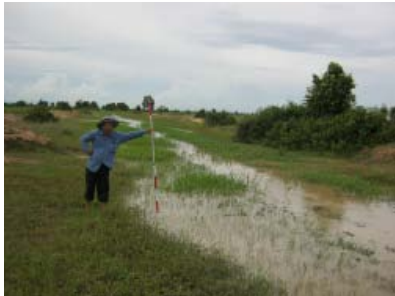
Canal No.: MC2	Kind of structure(s): Canal	Remarks: Routine Survey Length: 5500m
Station: 5.00+600	Coordinate< Northing: 1246524 East ing: 0484032

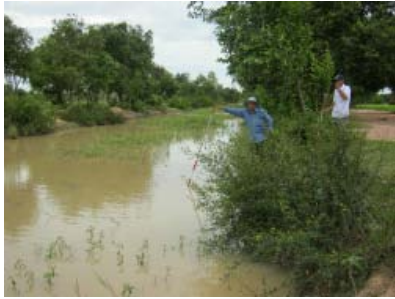
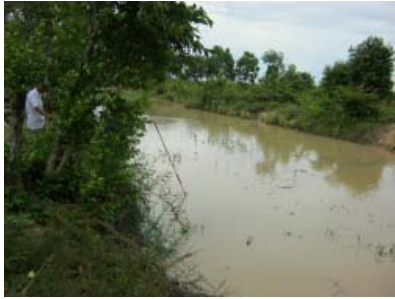
Canal No.: MC2	Kind of structure(s): Canal	Remarks:
Station: 6.00+110	Coordinate< Northing: 1246088 Easting: 0484035	Routine Survey Length: 6000m

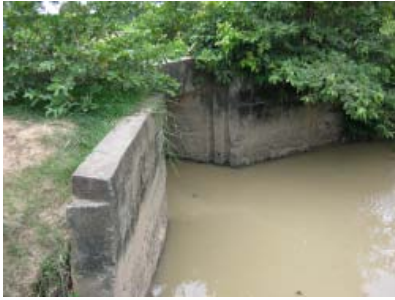
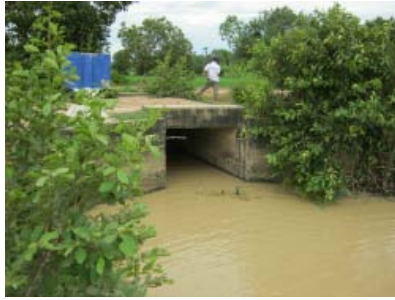
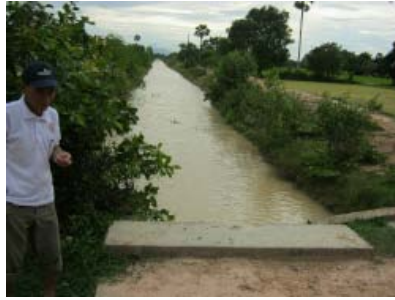
Canal No.: MC2	Kind of structure(s): Bridge (Commune)	Remarks:
Station: 6.00+570	Coordinate< Northing: 1245631 Easting: 0484034	Commune Road Routine Survey

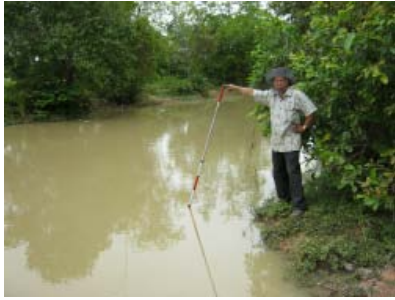
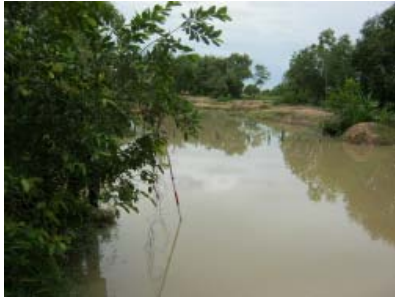
Canal No.: MC2	Kind of structure(s): Canal	Remarks:
Station: 6.00+610	Coordinate< Northing: 1245588 Easting: 0484040	Routine Survey Length: 6500m

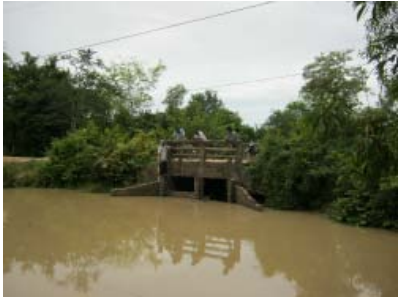
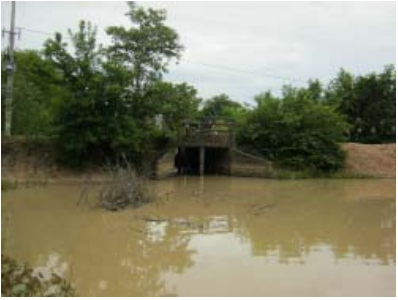
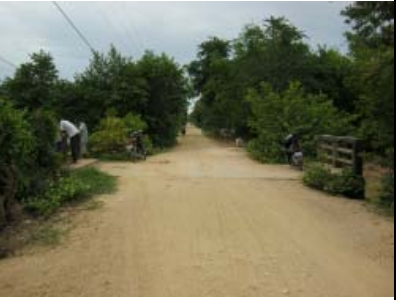
Canal No.: MC2	Kind of structure(s): Bridge	Remarks: Provincial Road (Kandal to Takeo), Krang Ompel Village
Station: 6.00+870(EP)	Coordinate< Northing: 1245343 Easting: 0484049

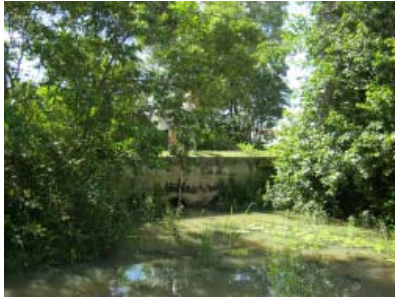
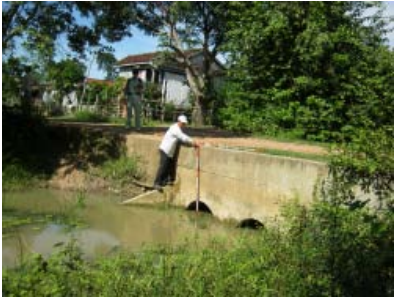
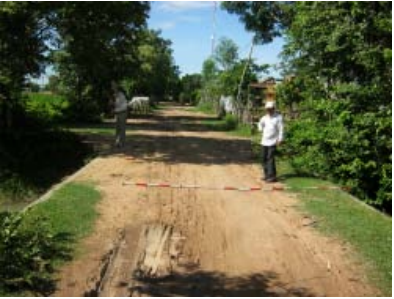
Up Stream View	Down Stream View	Structure/Side View

Sta.	E	N	Structure	Condition	Evaluation	Remarks	
0	0484103	1252631	Pipe Culvert (Double)	Road surface is damaged but culvert is functional	B	L=10.8m, W=4.5m, dia=1m	
250	0484332	1252629	Private Wooden Bridge (Broken)	Abandoned one canal section is covered by thick trees and grass	D		
360	0484442	1252631	Private Bridge	Piers are only remained (no slab plate), abandoned bridge	D		
510	0484579	1252630	Diversion Point, 500m	To lateral canal by pump	D	Lateral canal is higher than water level of MC3	
990	0485008	1252638	Pipe Culvert (Village Road)	Culvert is covered by thick grass	B	dia=1m, W=4m, built in May-2008)	
1,200	0485218	1252623	Optical Cable Line Point				
1,290	0485294	1252634	Small Private Bridge	Wooden house access	C	W=0.5 m	
1,340	0485339	1252630	Small Private Bridge	do.	C	W=0.5 m	
1,460	0485364	1252650	Turnout point to lateral canal	Turnout has no gate but groove; bridge on the lateral canal	C	Bridge & Groove (W=3.7m, L=2m)

Canal No.: MC3	Kind of structure(s): Pipe Culvert(Double)	Remarks:
Station: 0.00(B.P.)	Coordinate< Northing: 1252631 Easting: 0484103	Village Road Routine Survey

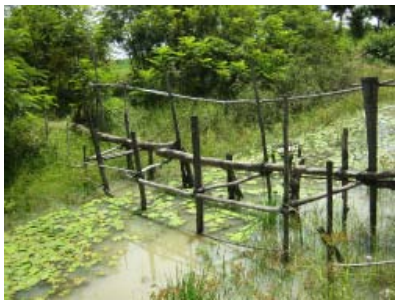
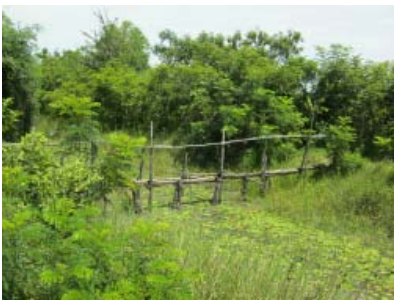
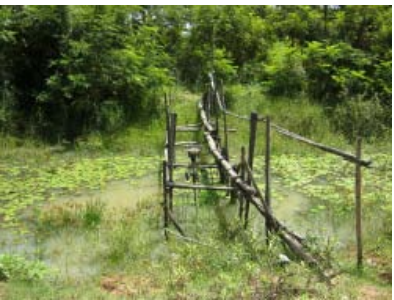
Up Stream View	Down Stream View	Structure/Side View

Canal No.: MC3	Kind of structure(s): Bridge (Private Wooden)	Remarks:
Station: 0.00+250	Coordinate< Northing: 1252629 Easting: 0484332	Farm Access Routine Survey

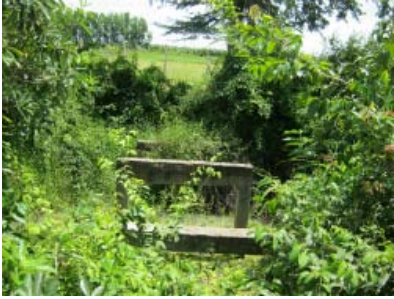
Structure/Side View

Canal No.: MC3	Kind of structure(s): Bridge (Private)	Remarks:
Station: 0.00+360	Coordinate< Northing: 1252631 Easting: 0484442	Routine Survey

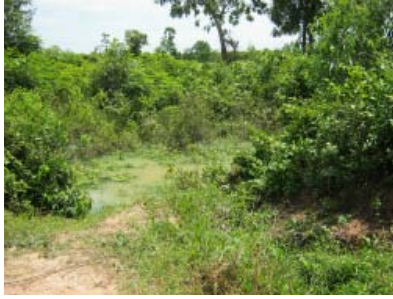
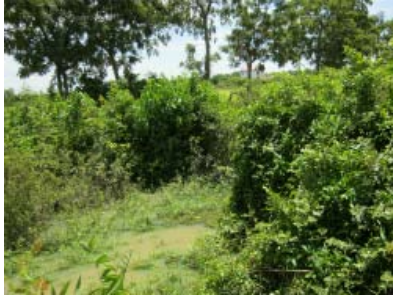
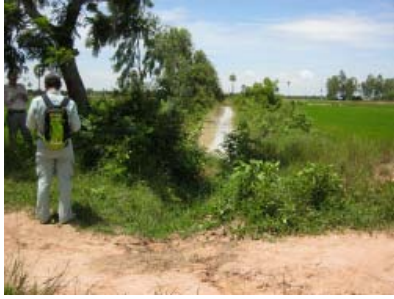
Up Stream View	Down Stream View	Secondary Canal

Canal No.: MC3	Kind of structure(s): Canal	Remarks:
Station: 0.00+510	Coordinate< Northing:1252630 Easting:0484579	Diversion Point Length: 500m

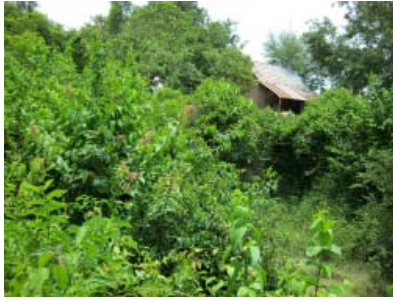
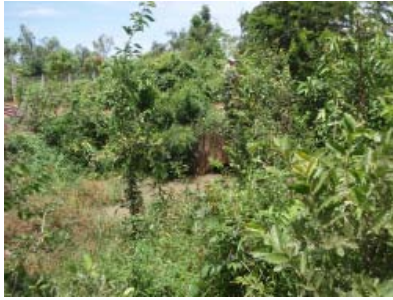
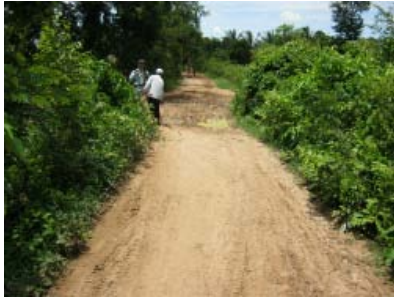
Up Stream View	Down Stream View	Road along Canal

Canal No.: MC3	Kind of structure(s): Pipe Culvert (Village)	Remarks:
Station: 0.00+990	Coordinate< Northing: 1252638 Easting: 0485008	Village Road Length: 1000m

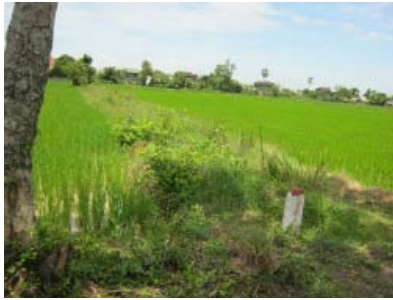
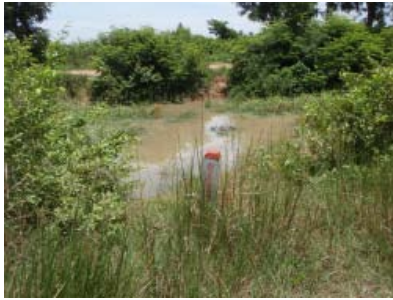
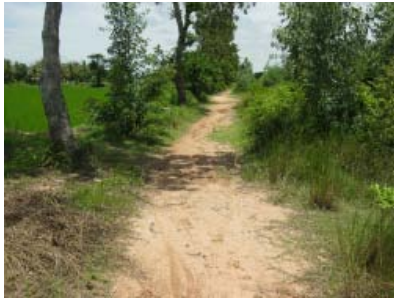
Up Stream View	Down Stream View	Road along Canal

Canal No.: MC3	Kind of structure(s): Canal (Village Road)	Remarks:
Station: 1.00+200	Coordinate< Northing: 1252623 Easting: 0485218	Optical Cable Line Point (Until Vietnam Border)

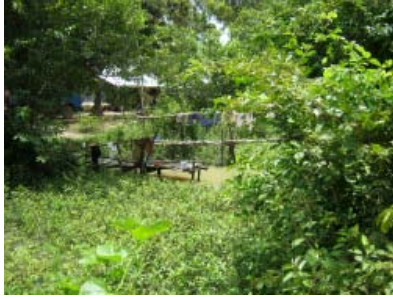
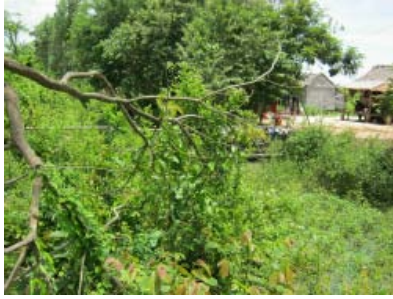
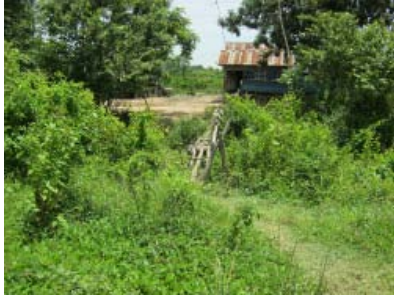
Up Stream View	Down Stream View	Structure/Side View

Canal No.: MC3	Kind of structure(s): Bridge(Small Private)	Remarks:
Station: 1.00+290	Coordinate< Northing: 1252634 Easting: 0485294	Made by wood for House Access Routine Survey

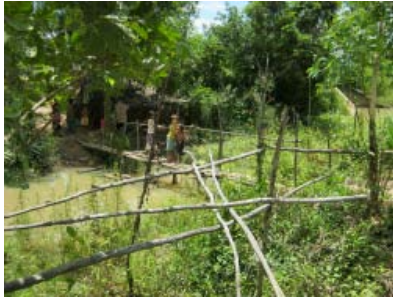
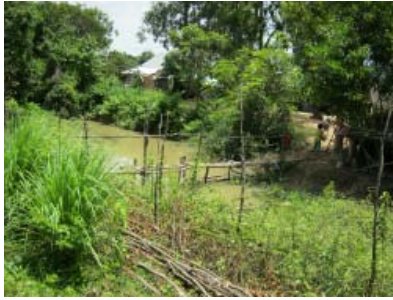
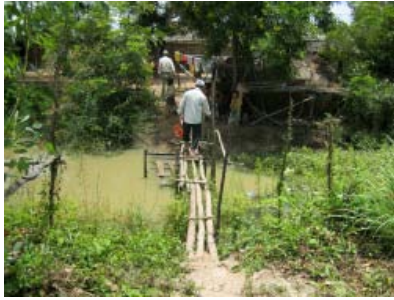
Up Stream View	Down Stream View	Structure/Side View

Canal No.: MC3	Kind of structure(s): Bridge(Small Private)	Remarks:
Station: 1.00+340	Coordinate< Northing: 1252630 Easting: 0485339	Made by wood for House Access Routine Survey

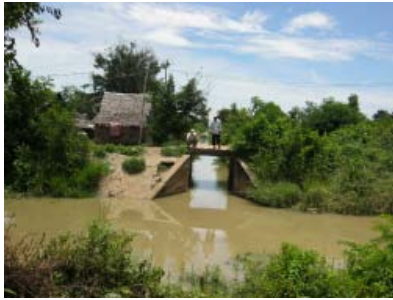
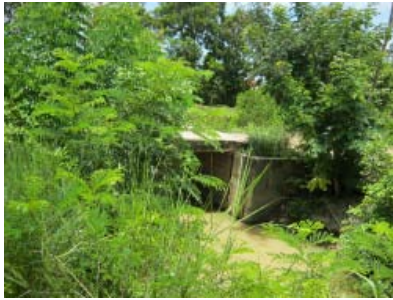
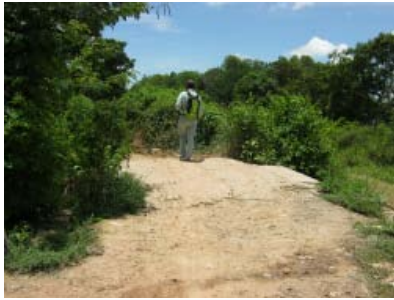
Up Stream View	Down Stream View	Structure/Side View

Canal No.: MC3	Kind of structure(s): Bridge & Groove	Remarks:
Station: 1.00+460	Coordinate< Northing: 1252650 Easting: 0485364	Village Road Bridge is on the left Bank of Canal.

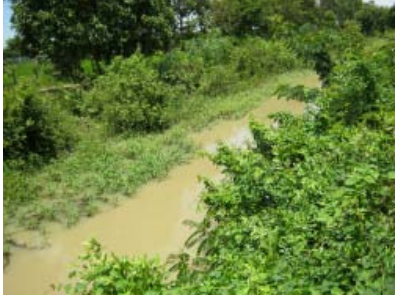
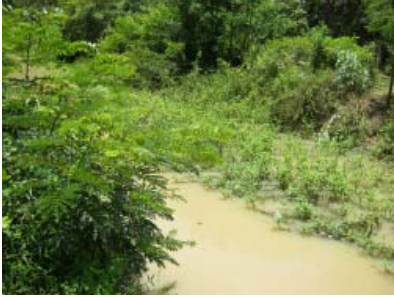
Up Stream View		Down Stream View

Canal No.: MC3	Kind of structure(s): Canal	Remarks:
Station: 1.00+530	Coordinate< Northing: 1252649 East ing: 0485437	Routine Survey Length: 1500m

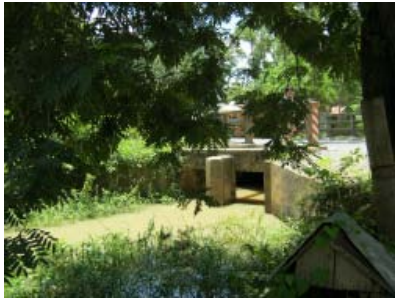
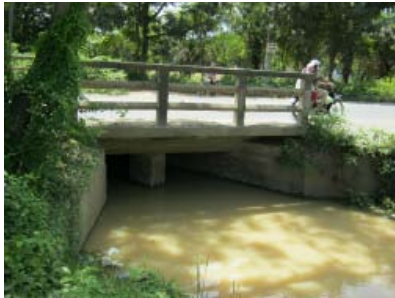
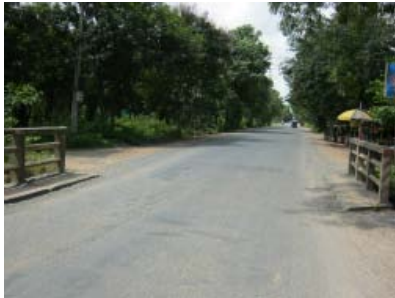
Up Stream View	Down Stream View	Structure/Side View

Canal No.: MC3	Kind of structure(s): Bridge	Remarks:
Station: 1.00+650	Coordinate< Northing: 1252638 East ing: 0485536	Bridge across National Road N° 2 Made by Concrete

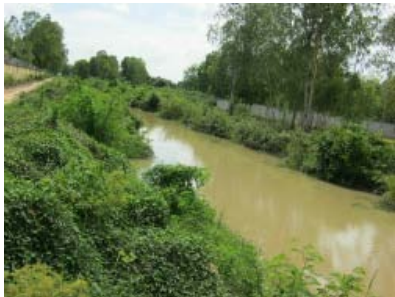
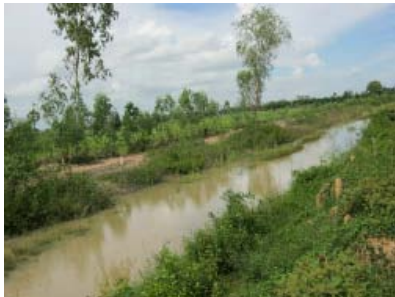
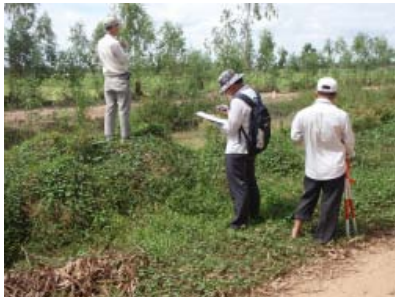
Up Stream View	Down Stream View	Structure/Side View

Canal No.: MC3	Kind of structure(s): Canal	Remarks:
Station: 2.00+50	Coordinate< Northing: 1252629 East ing: 0485934	Routine Survey Length: 2000m

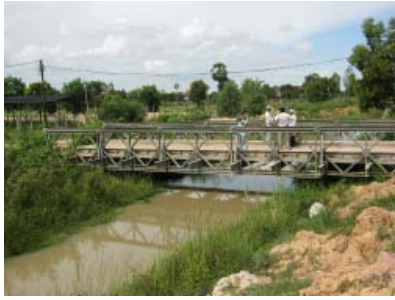
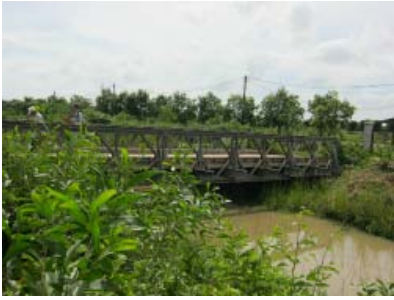
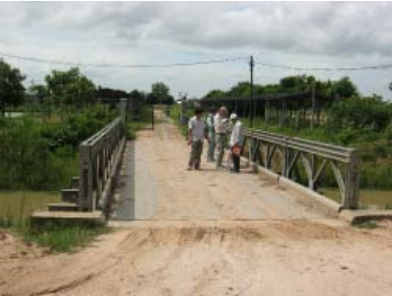
Up Stream View	Down Stream View	Structure/Side View

Canal No.: MC3	Kind of structure(s): Bridge (Private)	Remarks:
Station: 2.00+510	Coordinate< Northing: 1252630 Easting: 0486379	Farm Access Routine Survey

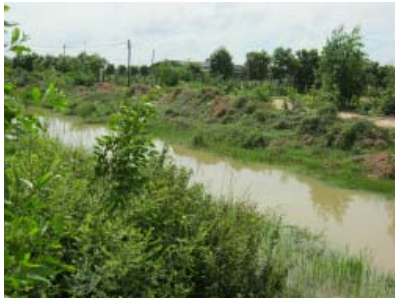
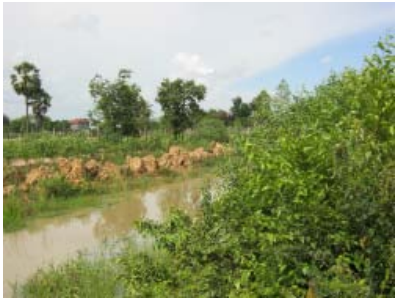
Up Stream View	Down Stream View

1. Most of canal section of 4 km out of 5.7 km was dredged in 2011 by MOWRAM, but upstream part from NR-2 did not any work yet
2. Four (4) regulators were constructed by NGO (CPP: Political Party) contribution
3. 11 houses (temporary houses made by nipper) exist at the end of canal, but no need to move under Stage 1

Canal No.: MC3	Kind of structure(s): Canal	Remarks:
Station: 2.00+570	Coordinate< Northing: 1252627 Easting: 0486431	Routine Survey Length: 2500m Dredged soils are dumped on the ridge of canal in June 2011 by MOWRAM. Dredging was done for 4Km by MOWRAM.

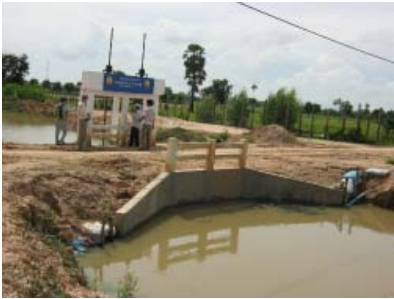
Up Stream View	Down Stream View	Structure/Side View

Canal No.: MC3	Kind of structure(s): Check Gate N° 1 & Bridge	Remarks:
Station: 2.00+700	Coordinate< Northing: 1252636 Easting: 0486549	Village Road The Structure was constructed by fund of CPP, but not PDOWRAM / MOWRAM.

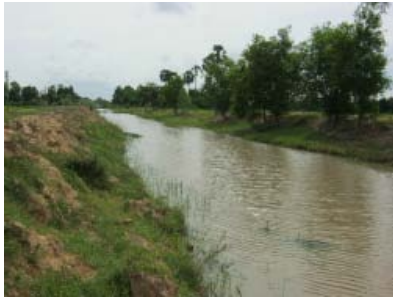
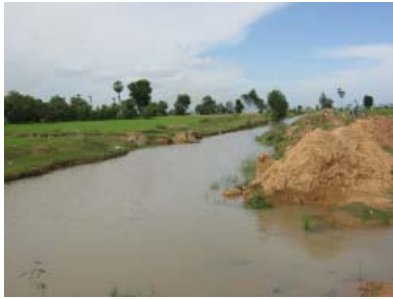
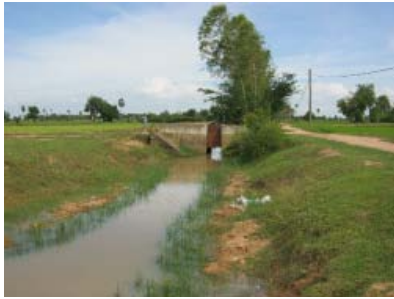
Canal No.: MC3	Kind of structure(s): Canal	Remarks: Diversion Point
Station: 3.00+20	Coordinate< Northing: 1252628 Easting: 0486857	Length: 3000m Dredged soils are dumped on canal ridge.

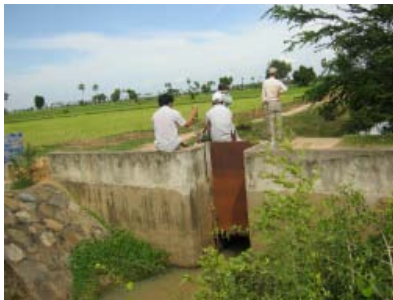
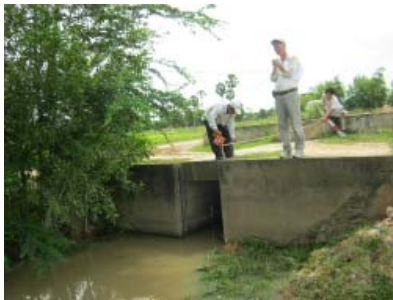
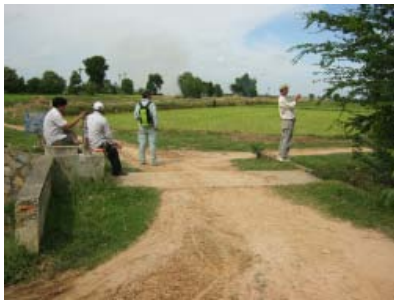
Canal No.: MC3	Kind of structure(s): Intake for Canal L3	Remarks:
Station: 3.00+60	Coordinate< Northing: 1252607 Easting: 0486881	Village Road Routine Survey

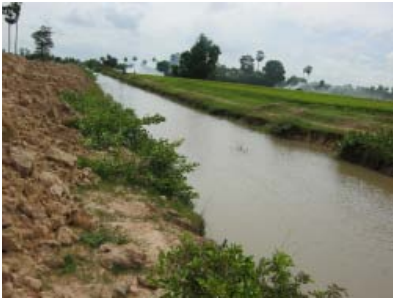
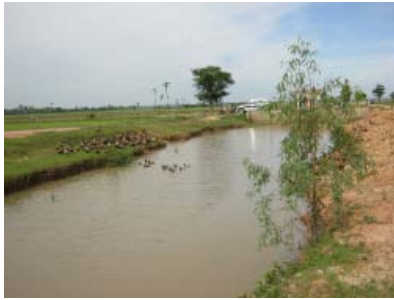
Canal No.: MC3	Kind of structure(s): Canal	Remarks:
Station: 3.00+540	Coordinate< Northing: 1252629 Easting: 0487328	Routine Survey Length: 3500m

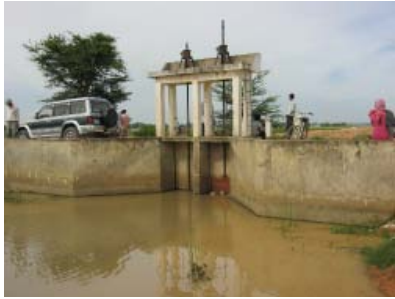
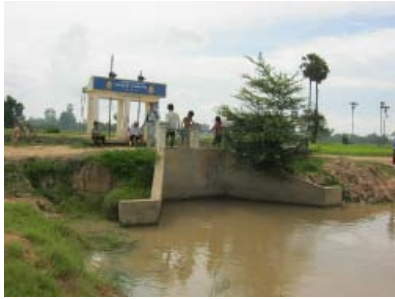
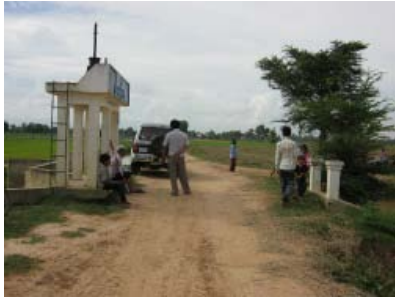
Canal No.: MC3	Kind of structure(s): Check Gate N° 2 & Bridge	Remarks: Village Road The Structure was constructed by fund of CPP, but not PDOWRAM / MOWRAM.
Station: 3.00+600	Coordinate< Northing: 1252638 Easting: 0487384

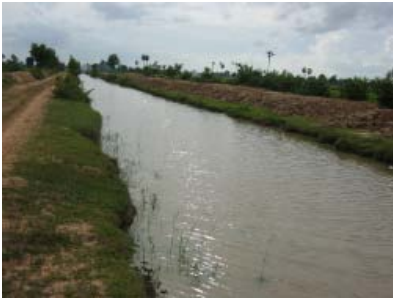
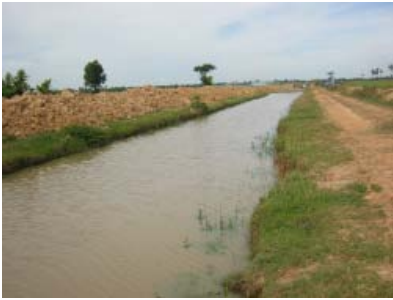
Canal No.: MC3	Kind of structure(s): Canal	Remarks: Routine Survey Length: 4000m
Station: 4.00+40	Coordinate< Northing: 1252636 Easting: 0487802

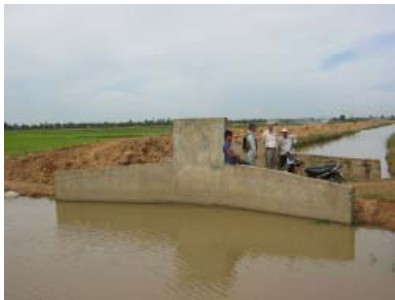
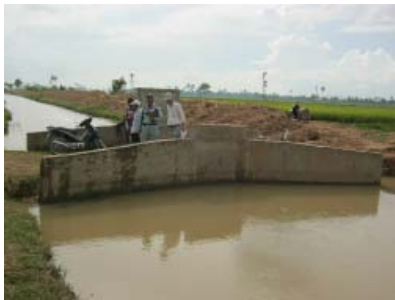
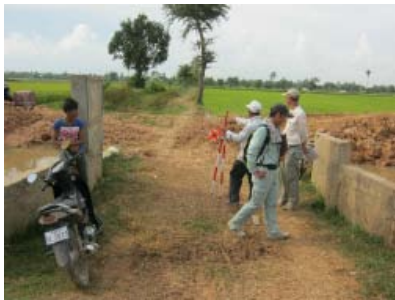
Canal No.: MC3	Kind of structure(s): Pipe Culvert(Private)	Remarks: Farm Access Routine Survey The Structure was constructed by fund of CPP, but not PDOWRAM / MOWRAM.
Station: 4.00+170	Coordinate< Northing: 1252642 Easting: 0487915

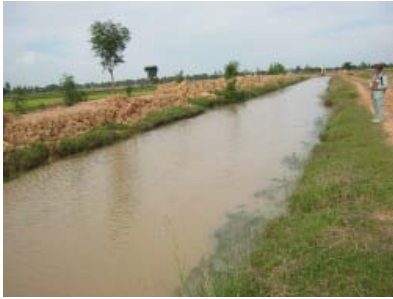
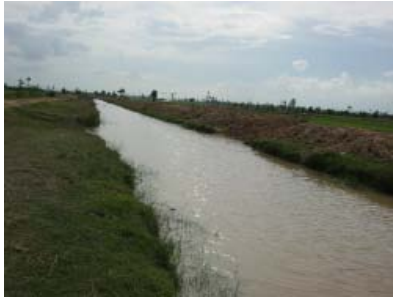
Canal No.: MC3	Kind of structure(s): Canal	Remarks: Routine Survey Length: 4500m Dredged soils are dumped on the ridge of canal in June 2011 by MOWRAM. Dredging was done for 4Km by MOWRAM.
Station: 4.00+550	Coordinate< Northing: 1252637 Easting: 0488264

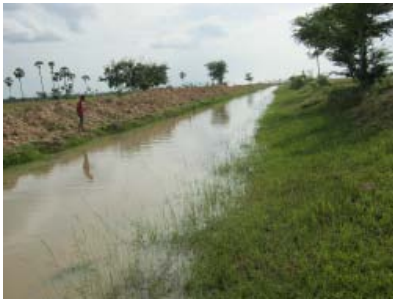
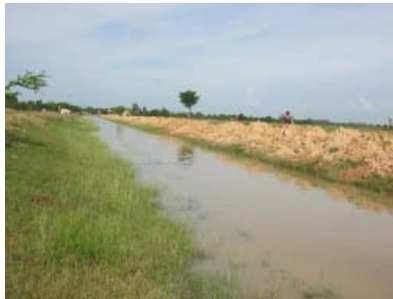
Canal No.: MC3	Kind of structure(s): Canal	Remarks: Routine Survey Length: 5000m Dredged soils are dumped on the ridge of canal in June 2011 by MOWRAM. Dredging was done for 4Km by MOWRAM.
Station: 5.00+50	Coordinate< Northing: 1252646 Easting: 0488750

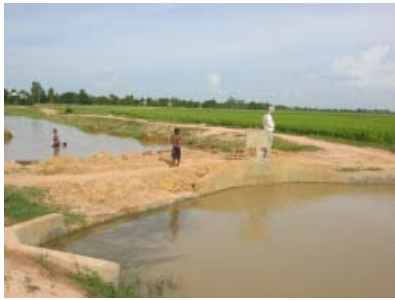
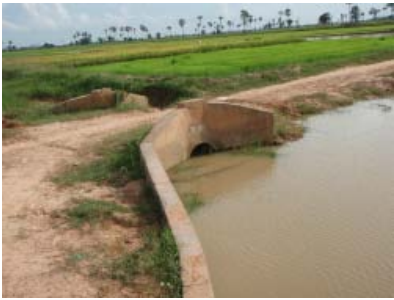
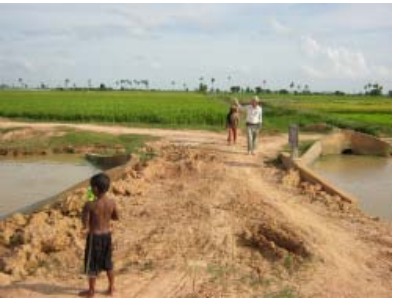
Canal No.: MC3	Kind of structure(s): Pipe Culvert (Private)	Remarks:
Station: 5.00+320	Coordinate< Northing: 1252639 Easting: 0489003	Farm Access Routine Survey

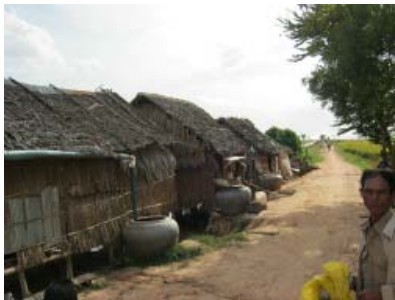
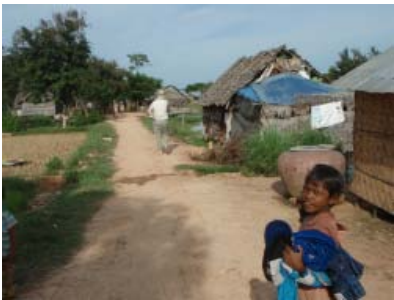
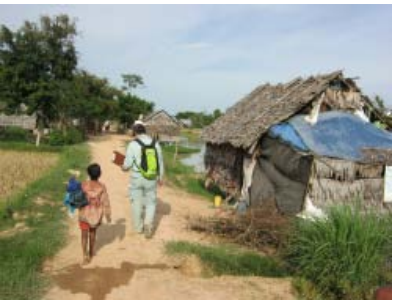
Canal No.: MC3	Kind of structure(s): Houses	Remarks:
Station: 5.00+450	Coordinate< Northing: 1252644 Easting: 0489130	Village Road Routine Survey

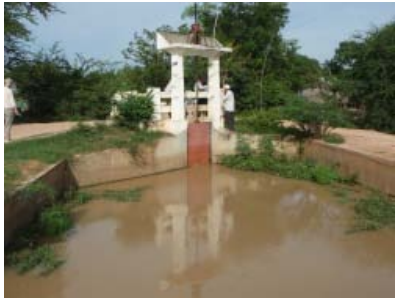
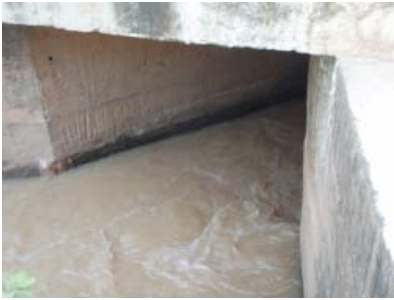
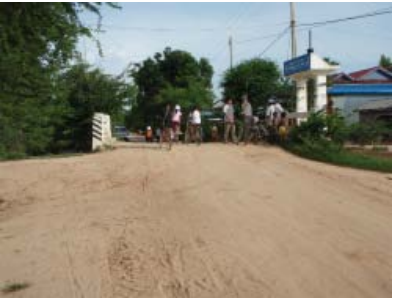
Canal No.: MC3	Kind of structure(s): Check Gate No 4 & Bridge	Remarks:
Station: 5.00+700	Coordinate< Northing: 1252633 Easting: 0489374	Commune Road Routine Survey The Structure was constructed by fund of CPP, but not PDOWRAM / MOWRAM.

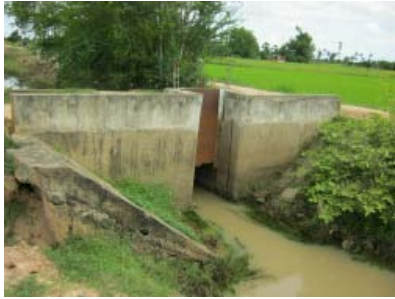
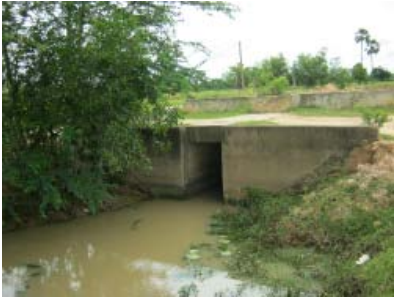
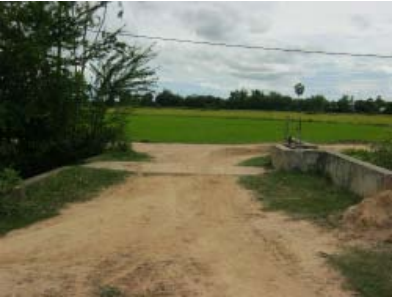
Sta.	E	N	Structure	Condition	Evaluation	Remarks
0	0486883	1252604	B.P, Intake with Gate	Gate frame and lifting gear were lost; gate is not functioned Canal section is well remained as designed	D	(H=1.5m, W=1m), Water Depth=0.8m), Width of Bridge =4.2m, Width of Canal=8.3m, Canal Depth =1.2m
520	0487152	1252173	Private Pipe Culvert	Farm access; function remain	C	(W=4.3m, dia=0.8m)
890	0487347	1251865	Private Pipe Culvert	Do.	C	(W=4m, dia=0.5m)
1,030	0487377	1251733	Canal section at 1,000 m	No erosion, slope is covered by grasses; well maintenance	B	
1,240	0487375	1251524	Private Pipe Culvert	No damage and well maintained	B	(dia=0.5m, W=4.7m, Built on 23-03-2008)
1,550	0487376	1251226	Canal section at 1,500 m	No erosion, slope is covered by grasses; well maintenance	B	
1,780	0487371	1250994	Private Pipe Culvert	No damage and well maintained	B	(dia=0.6m, W=3.8m)
2,050	0487115	1250994	Canal section at 2,000 m	Canal section become wide and shallow	C

Canal No.: L3	Kind of structure(s): Gate Structure	Remarks:
Station: 0.00(B.P.)	Coordinate< Northing: 1252604 Easting: 0486883	Along the Village Road Routine Survey

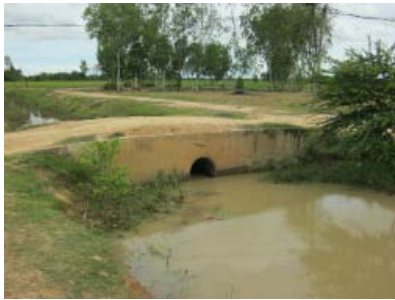
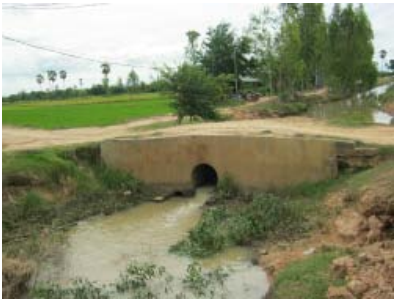
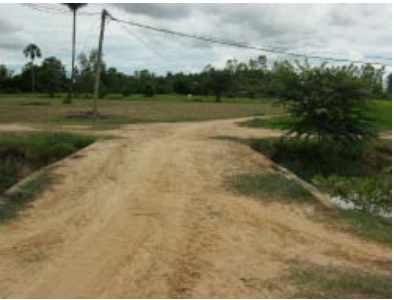
Canal No.: L3	Kind of structure(s): Pipe Culvert(Private)	Remarks:
Station: 0.00+520	Coordinate< Northing: 1252173 Easting: 0487152	Farm Access Length: 500m

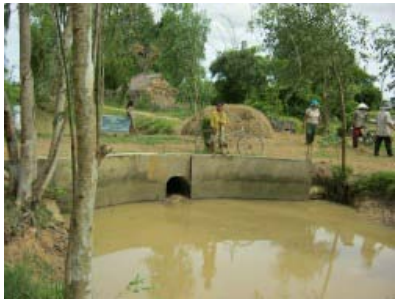
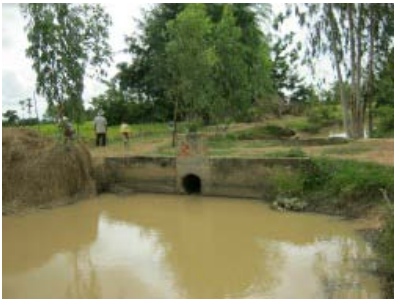
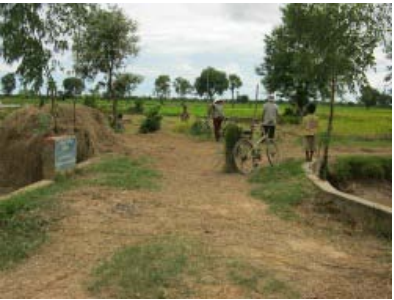
Canal No.: L3	Kind of structure(s): Pipe Culvert(Private)	Remarks:
Station: 0.00+890	Coordinate< Northing: 1251865 Easting: 0487347	Farm Access Routine Survey

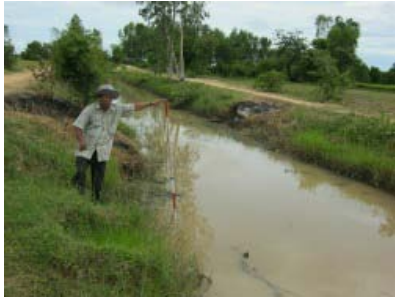
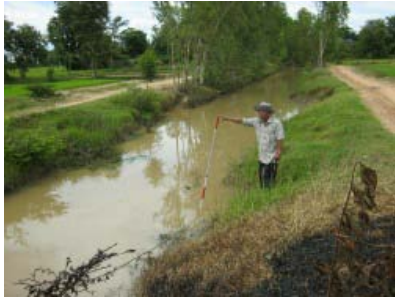
Canal No.: L3	Kind of structure(s): Canal	Remarks:
Station: 1.00+30	Coordinate< Northing: 1251733 Easting: 0487377	Routine Survey Length: 1000m

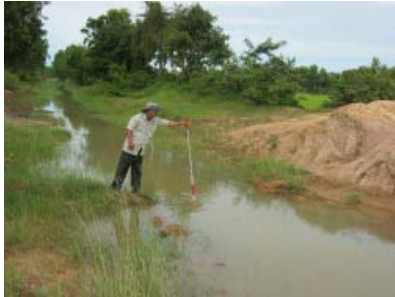
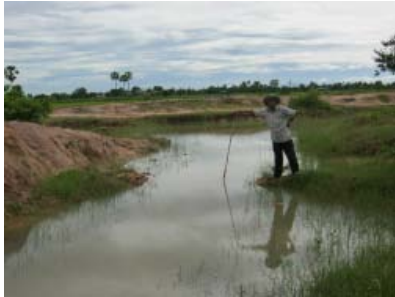
Canal No.: L4	Kind of structure(s): Canal	Remarks:
Station: 0.00(B.P.)	Coordinate< Northing: 1250990 Easting: 0485215	Diversion Point of MC1

Sta.	E	N	Structure	Condition	Evaluation	Remarks
0	0485215	1250990	B.P, Diversion Point of MC1	No structure at the diversion point Canal has been deteriorated (become shallow and widened)	-	
560	0485737	1250995	Canal section at 500m	Canal section is maintained in Village area	-	
640	0485807	1250992	Regulator with two Gates	Good condition	B	W=1m, H=1m
			Bridge	Good condition	B	(L(inside)=4.7m, L(outside)=5.6m, W=2.8m) & Pipe Culvert (Double, dia=0.8m) & E.P.

1. Canal section of the first 500 m has been deteriorated and many grasses on the canal bed
2. Only one structure combined of regulator and bridge exists on the canal

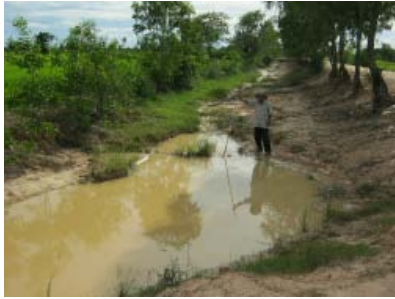
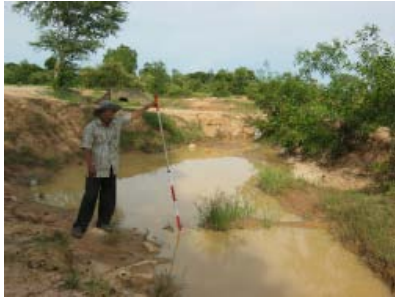
Canal No.: L5	Kind of structure(s): Canal	Remarks: Along the Commune Road Routine Survey
Station: 0.00(B.P.)	Coordinate< Northing: 1250442 Easting: 0485546

Sta.	E	N	Structure	Condition	Evaluation	Remarks
0	0485546	1250442	B.P. Diversion point from MC-1	Canal has been eroded and no sufficient flow has reached	-	
150	0485412	1250442	Private Pipe Culvert	Pipe has mostly clogged by soils Farm access	C	dia=0.5m, L=4.1m
350	0485207	1250442	Private Pipe Culvert	Pipe dia seems to be too small for conveying water Farm access	C	dia=0.4m, L=3.1m
500	0485066	1250442	Canal section at 500 m	The section has been eroded and become flat; many sediments on the bed	-	
710	0484870	1250446	Pipe Culvert on village road	Pipe has mostly clogged by soils	C	dia=0.8m, W=6m
1,000	0484562	1250450	Canal section at 1,000 m	The section has been eroded and become flat; many sediments on the bed	-	
1,110	0484442	1250449	Private Pipe Culvert & E.P.		C	dia=0.8m, W=5.2m

1. Canal sections are heavily deteriorated due to erosion and no maintenance work for long period
2. Structures are also not in good condition

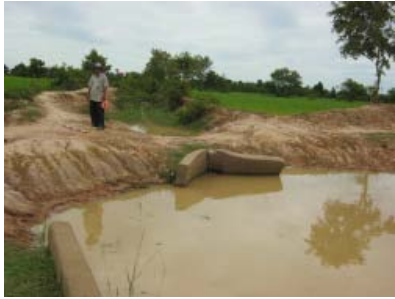
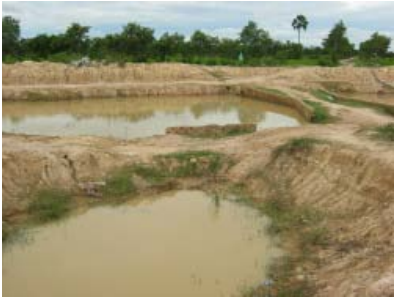
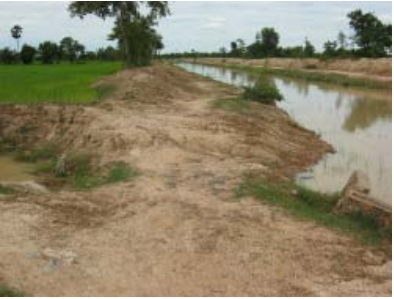
Canal No.: L6	Kind of structure(s): Pipe Culvert(Private)	Remarks:
Station: 0.00(B.P.)	Coordinate< Northing: 1249877 Easting: 0485978	Along the Farm Access Routine Survey

Sta.	E	N	Structure	Condition	Evaluation	Remarks
0	0485978	1249877	B.P, Pipe Culvert Private	Inlet of the canal is considerably narrowed by this culvert To be removed	D	dia=0.5m, W=4.6m, Farm access
300	0486265	1249875	Pipe Culvert (Private)	Pipe might be clogged and no protection of embankment is done	D	dia=0.6m, W=4m Farm access
500	0486462	1249873	Pipe Culvert (Private)	Pipe is submerged by soils	D	dia=0.5m, W=4m
510	0486477	1249871	Pipe Culvert (Private)	House access	C	dia=0.4m, W=6m
660	0486627	1249874	Pipe Culvert Village road	Condition of road and protection of embankment is rather good	C	Double, , dia=0.4m & 0.5m, W=5.5m
760	0486731	1249869	Private Pipe Culvert	Farm access	C	dia=0.5m, W=3m
870	0486856	1249868	Pipe Culvert (Private)	Diversion Point	C	dia=0.5m, W=4m,
1,010	0487003	1249866	Canal section at 1,000 m	No shape of canal remained; canal become narrow and shallow considerably	-	
1,070	0487064	1249868	Pipe Culvert (Private)	Temporary farm access	C	dia=0.4m, W=1.9m

1. Canal section has been deteriorated due to no maintenance for long period
2. Canal is privately obstructed by installing pipes for farm access
3. Soil characteristics for embankment is clay and silt

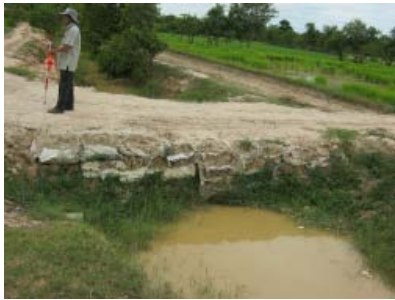
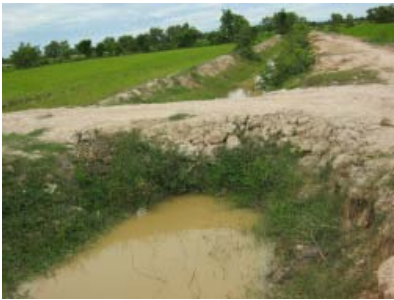
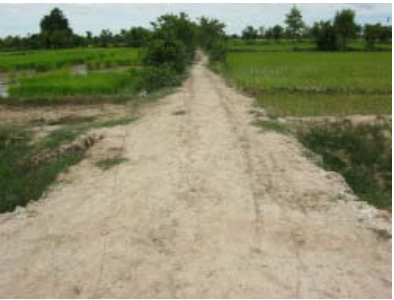
Canal No.: L6	Kind of structure(s): Pipe Culvert(Private)	Remarks:
Station: 0.00+300	Coordinate< Northing: 1249875 Easting: 0486265	Farm Access Routine Survey

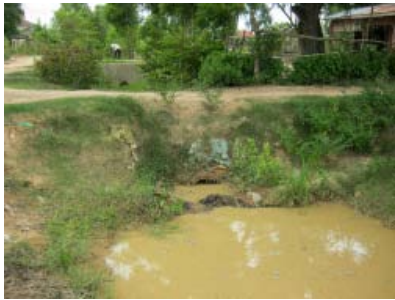
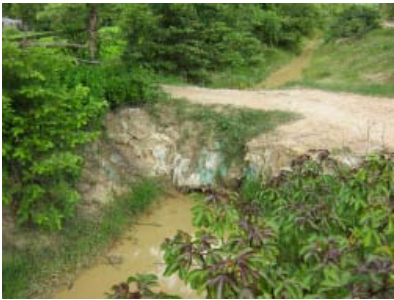
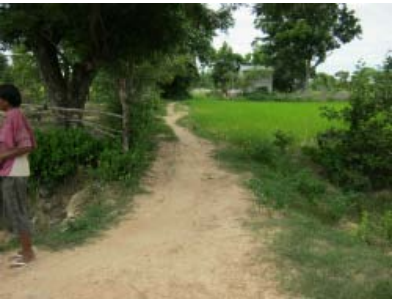
Canal No.: L6	Kind of structure(s): Pipe Culvert(Private)	Remarks:
Station: 0.00+500	Coordinate< Northing: 1249873 Easting: 0486462	Farm Access Length: 500m

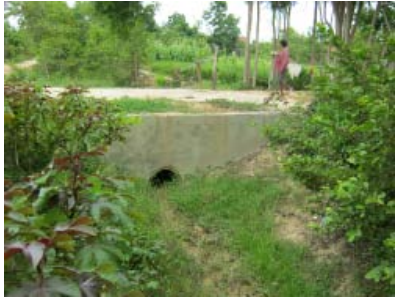
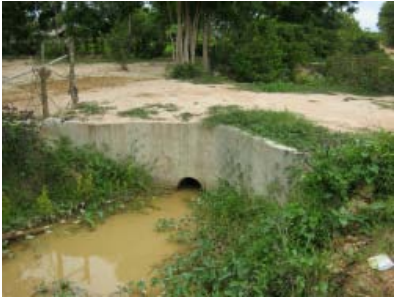
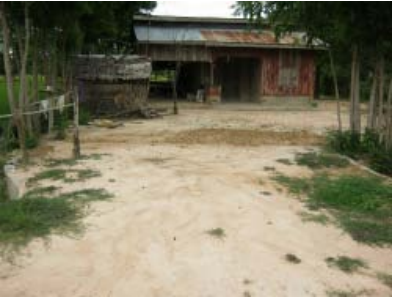
Canal No.: L6	Kind of structure(s): Pipe Culvert(Private)	Remarks:
Station: 0.00+510	Coordinate< Northing: 1249871 Easting: 0486477	House Access Routine Survey

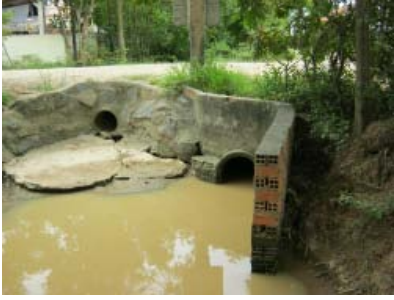
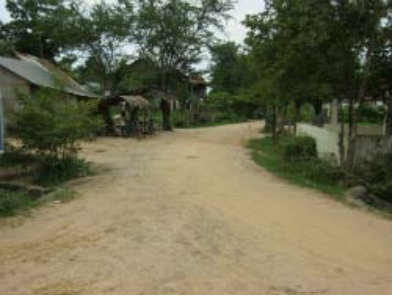
Canal No.: L6	Kind of structure(s): Double Pipe Culvert (Village)	Remarks:
Station: 0.00+660	Coordinate< Northing: 1249874 Easting: 0486627	Village Road Routine Survey

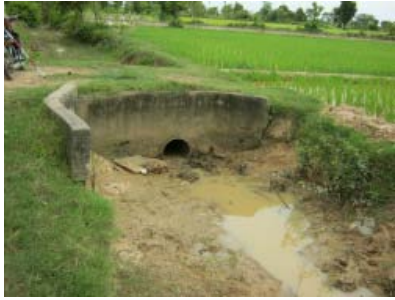
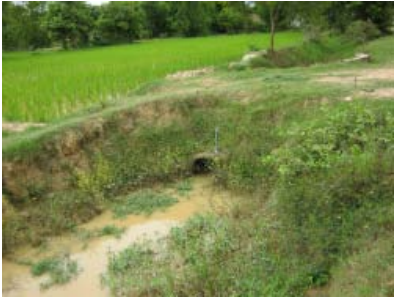
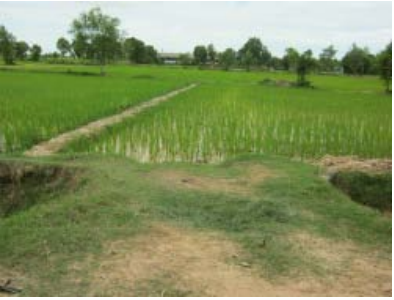
Canal No.: L6	Kind of structure(s): Pipe Culvert(Private)	Remarks:
Station: 0.00+760	Coordinate< Northing: 1249869 Easting: 0486731	Farm Access Routine Survey

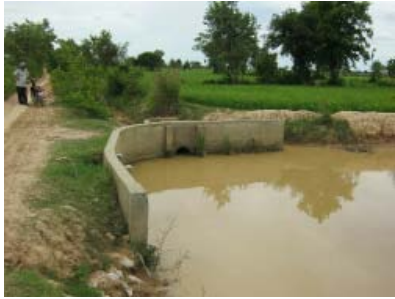
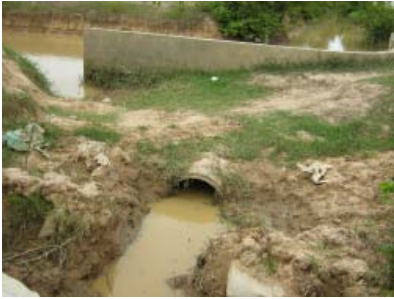
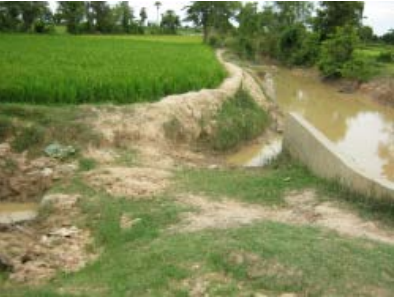
Canal No.: L6	Kind of structure(s): Pipe Culvert(Private)	Remarks:
Station: 0.00+870	Coordinate< Northing: 1249868 Easting: 0486856	There is a Diversion Point Farm Access
