# ***ANNEX D***

*Results of Inventory Survey for Irrigation and Drainage*

*Facilities in Kandal Stung – Bati Irrigation System*

*Rehabilitation Sub-project*

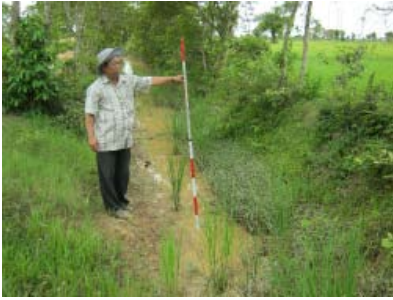
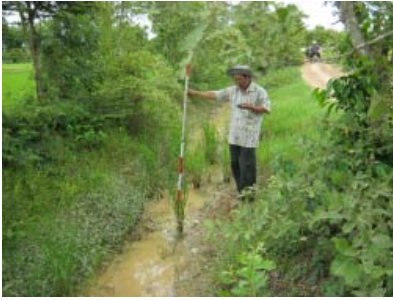
Canal No.: L6	Kind of structure(s): Canal	Remarks:
Station: 1.00+10	Coordinate< Northing: 1249866 Easting: 0487003	Routine Survey Length: 1000m

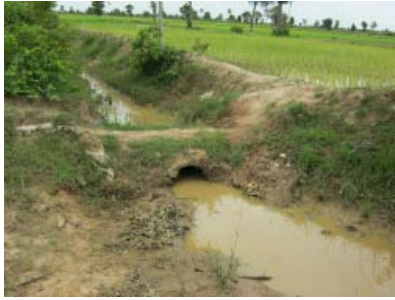
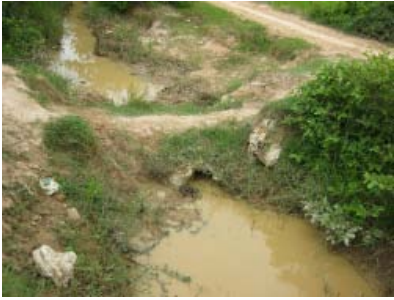
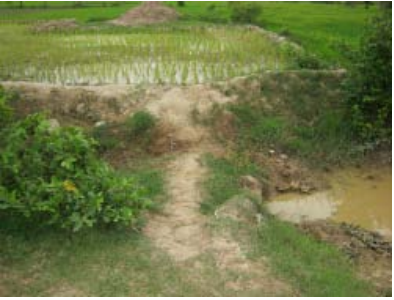
Canal No.: L6	Kind of structure(s): Pipe Culvert(Private)	Remarks:
Station: 1.00+70	Coordinate< Northing: 1249868 Easting: 0487064	Farm Access Routine Survey

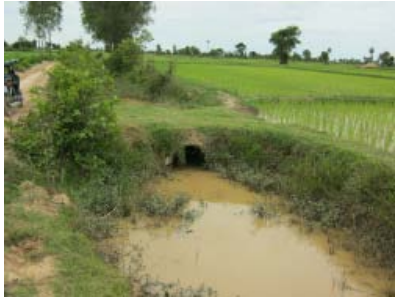
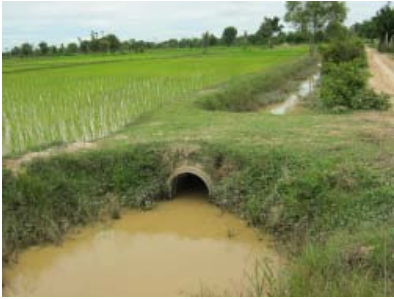
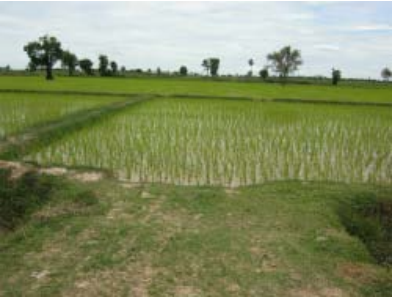
1,210	0487208	1249862	Pipe Culvert (Private)	Farm access	C	dia=0.6m, W=4m
1,380	0487366	1249861	Diversion Point	No structure is found	-	
1,450	0487436	1249857	Pipe Culvert (Private)	Farm access	C	dia=0.3m, W=2m
1,510	0487491	1249857	Canal section at 1,500 m	Canal section remained, but less maintenance	-	
1,840	0487807	1249852	Pipe Culvert (Private)	Farm access	C	dia=0.4m, W=1m
1,920	0487879	1249853	Embankment	Canal is blocked by embankment	-	No moral to use the canal
2,010	0487966	1249852	2,000m & E.P.	Canal section is used as pond and rice field	-

Canal No.: L6	Kind of structure(s): Pipe Culvert(Private)	Remarks:
Station: 1.00+210	Coordinate< Northing: 1249862 Easting: 0487208	Farm Access Routine Survey

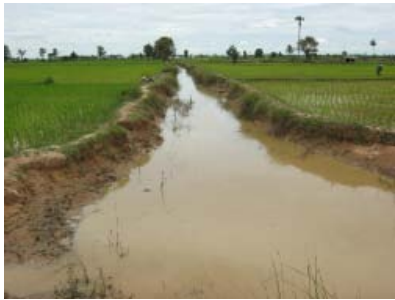
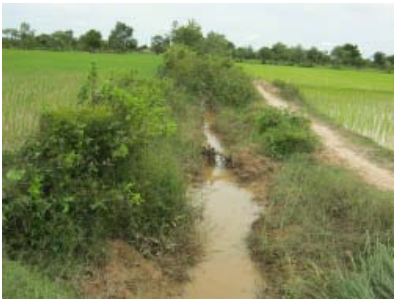
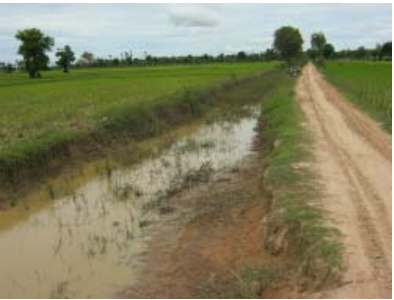
Canal No.: L6	Kind of structure(s): Canal	Remarks:
Station: 1.00+380	Coordinate< Northing: 1249861 Easting: 0487366	Diversion Point Village Road

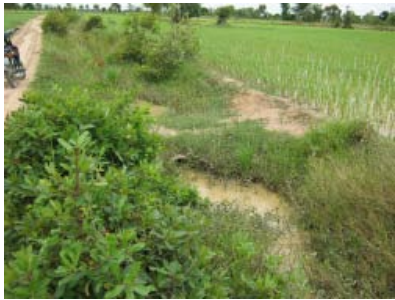
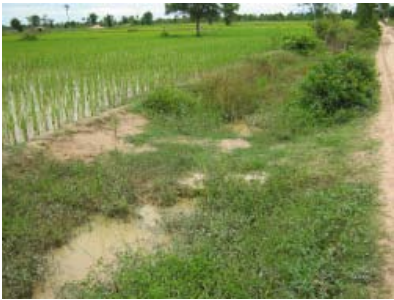
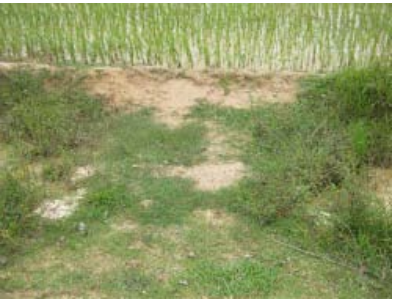
Canal No.: L6	Kind of structure(s): Pipe Culvert(Private)	Remarks:
Station: 1.00+450	Coordinate< Northing: 1249857 Easting: 0487436	Farm Access Routine Survey

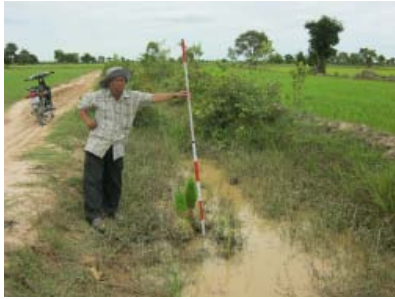
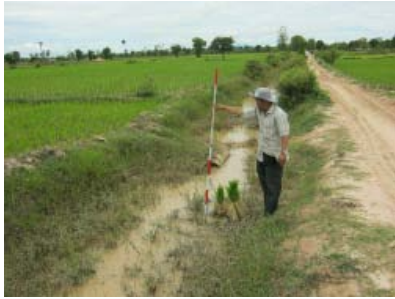
Canal No.: L6	Kind of structure(s): Canal	Remarks:
Station: 1.00+510	Coordinate< Northing:1249857 Easting: 0487491	Routine Survey Length: 1500m

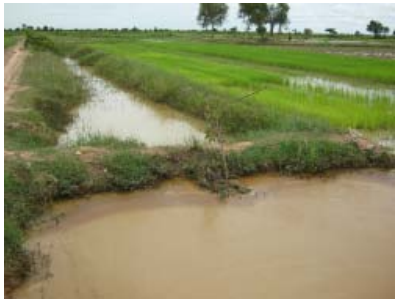
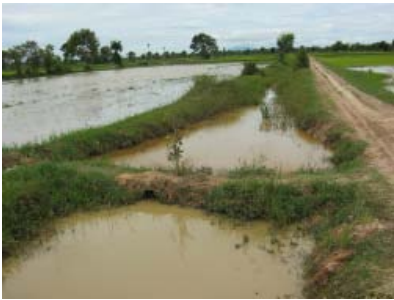
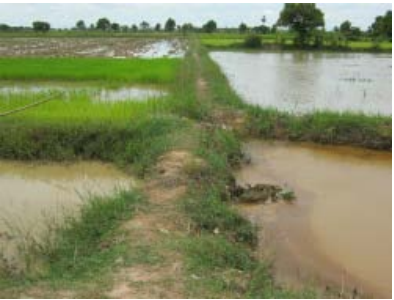
Canal No.: L6	Kind of structure(s): Pipe Culvert(Private)	Remarks:
Station: 1.00+840	Coordinate< Northing: 1249852 Easting: 0487807	Farm Access Routine Survey

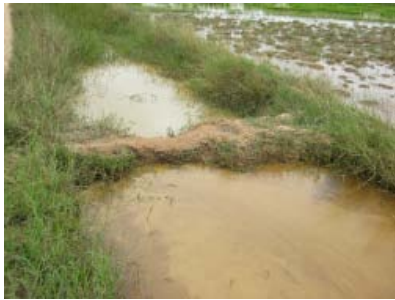
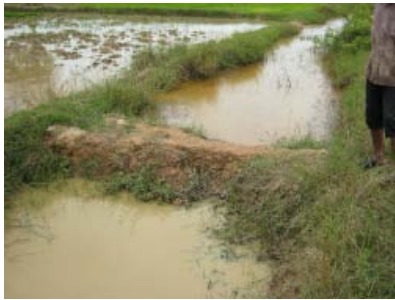
Canal No.: L6	Kind of structure(s): Embankment	Remarks:
Station: 1.00+920	Coordinate< Northing: 1249853 Easting: 0487879	Farm Access Routine Survey

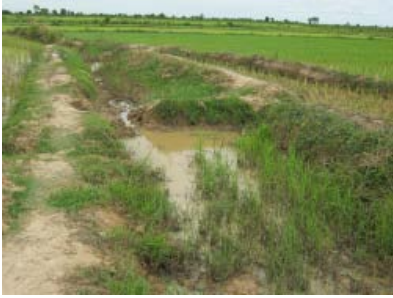
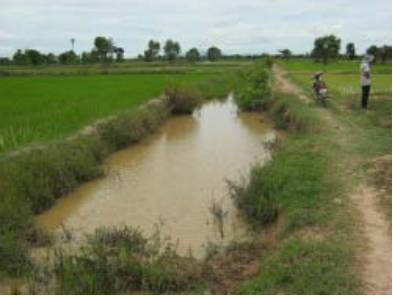
Canal No.: L6	Kind of structure(s): Canal	Remarks:
Station: 2.00+10(EP)	Coordinate< Northing: 1249852 Easting: 0487966	Routine Survey Length: 2000m

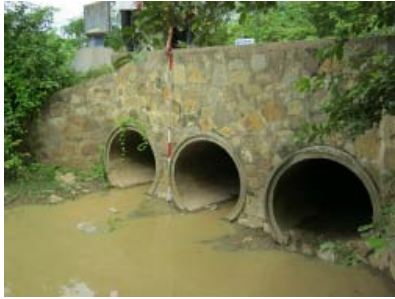
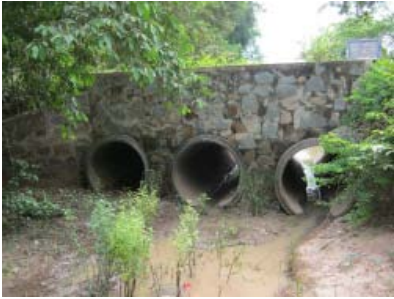
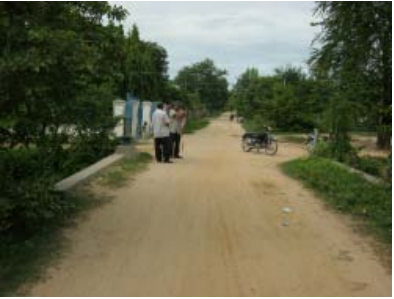
Canal No.: L8	Kind of structure(s): Pipe Culvert(Triple)	Remarks:
Station: 0.00(B.P.)	Coordinate< Northing: 1247164 Easting: 0486846	Commune Road Routine Survey

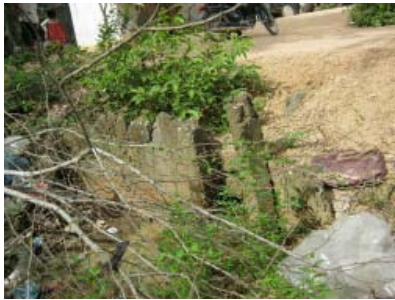
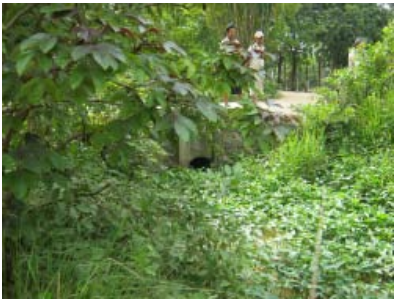
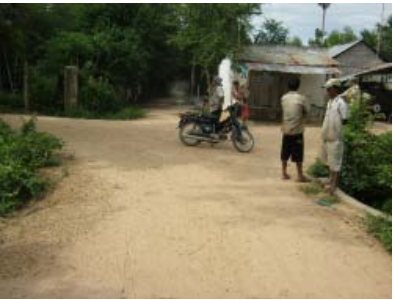
Canal No.: L8	Kind of structure(s): Pipe Culvert(Private)	Remarks:
Station: 0.00+100	Coordinate< Northing: 1247165 Easting: 0486753	House Access Village Road

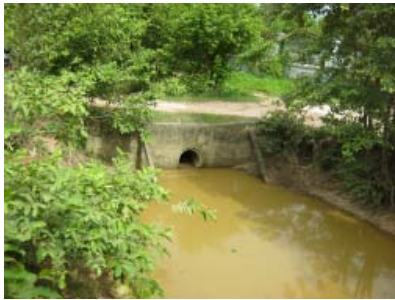
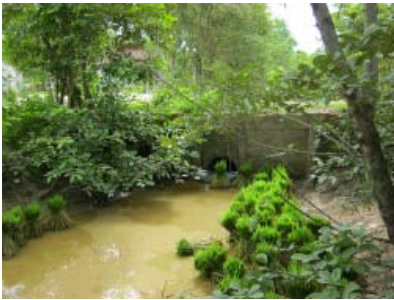
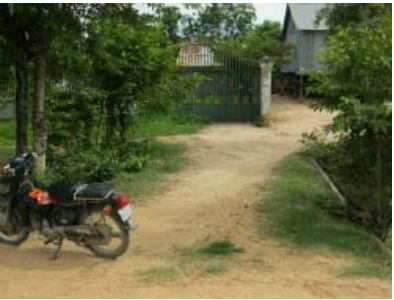
Canal No.: L8	Kind of structure(s): Pipe Culvert(Private)	Remarks:
Station: 0.00+190	Coordinate< Northing: 1247165 Easting: 0486671	House Access Routine Survey

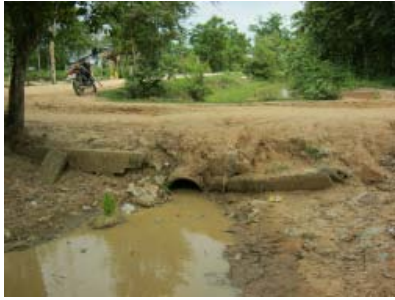
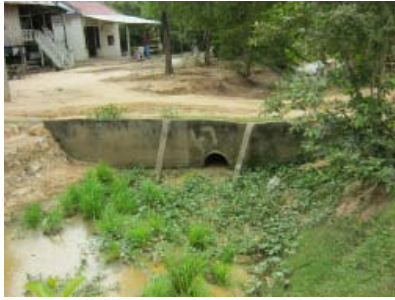
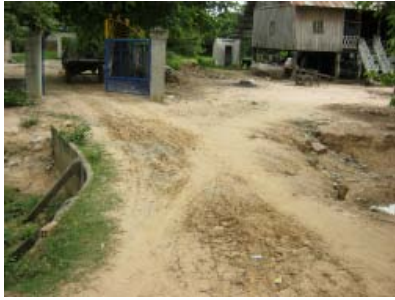
Canal No.: L8	Kind of structure(s): Pipe Culvert(Private)	Remarks:
Station: 0.00+260	Coordinate< Northing: 1247164 Easting: 0486617	House Access Routine Survey

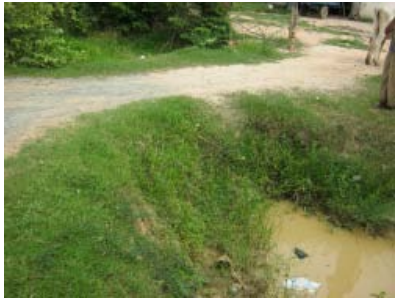
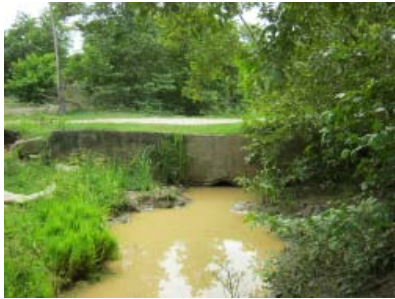
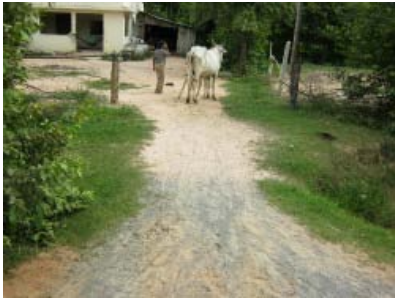
Canal No.: L8	Kind of structure(s): Pipe Culvert(Private)	Remarks:
Station: 0.00+310	Coordinate< Northing: 1247168 Easting: 0486571

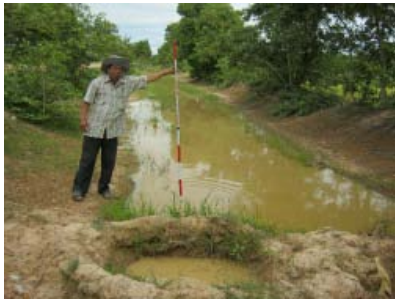
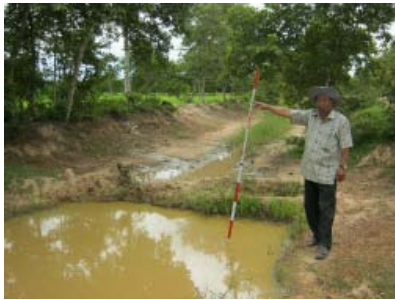
Canal No.: L8	Kind of structure(s): Canal	Remarks:
Station: 0.00+500	Coordinate< Northing: 1247166 Easting: 0486380	Routine Survey Length: 500m

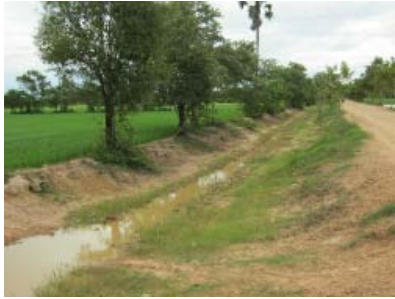
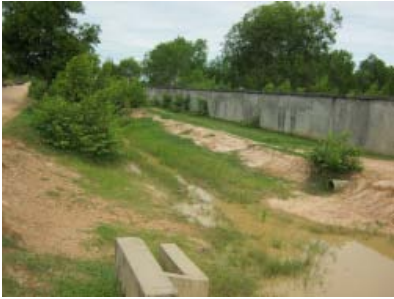
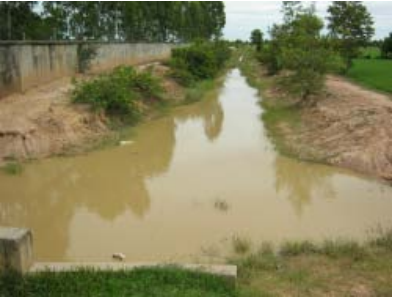
Canal No.: L8	Kind of structure(s): Canal	Remarks:
Station: 0.00+650	Coordinate< Northing: 1247164 Easting: 0486234	Diversion Point Routine Survey

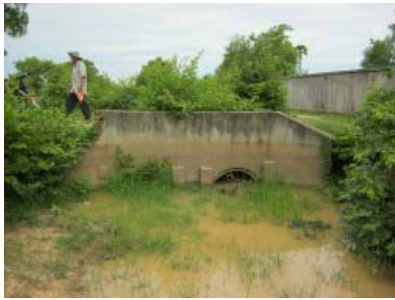
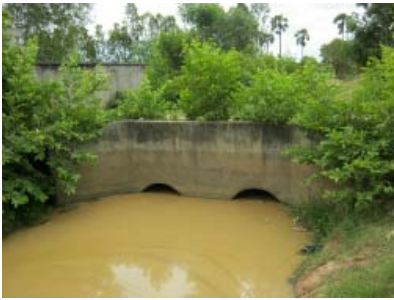
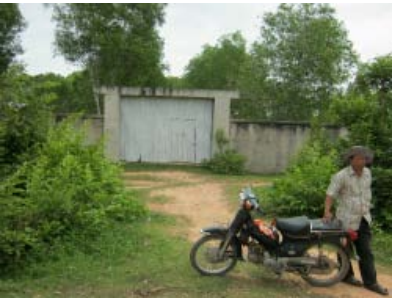
Canal No.: L8	Kind of structure(s): Pipe Culvert (Double Private)	Remarks:
Station: 0.00+700	Coordinate< Northing: 1247167 Easting: 0486179	Land Access Routine Survey

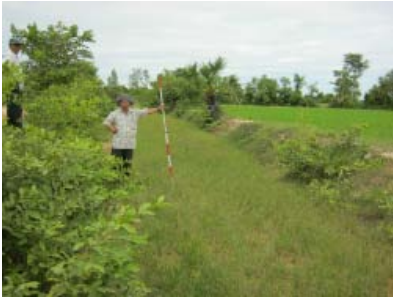
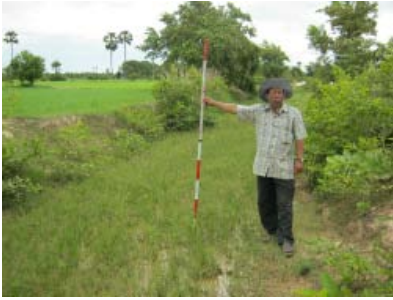
1,000	0485884	1247169	Canal section at BP of L7 and L8, (1,000m from EP of L8)	Canal section remains, and some grass on the canal bed due to small discharge from MC-1	-	BP of L7 & L8
1,170	0485721	1247171	Embankment	Culvert is under construction (pipes are at site)	B	Future Pipe Culvert (dia=0.8m, W=5m)
1,180	0485702	1247172	Embankment	Do.	B	Future Pipe Culvert (dia=0.8m, W=5m)
1,510	0485383	1247170	Canal section at 500 m from BP of L7	Canal section remains, and rather in good condition, though some sediments on the canal bed	-	
1,700	0485201	1247169	Pipe Culvert (Private)	Farm access	C	W=3m, dia=0.5m
2,010	0484899	1247174	Canal section at 1,000 m from BP of L7	No water reached to this point, canal section remains without serious erosion	-	
2,200	0484693	1247172	Canal section at 1,200 m from BP of L7	Canal section is slightly eroded and covered by grass	-	EP of L7

Canal No.: L7	Kind of structure(s): Canal	Remarks:
Station: 1.00	Coordinate< Northing: 1247169 Easting: 0485884	EP of Canal L8 and BP of Canal L7 Length: 1000m

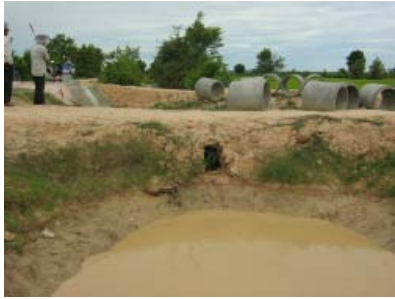
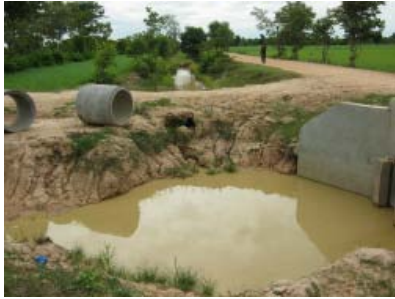
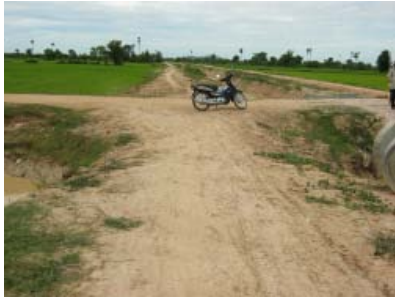
Canal No.: L7	Kind of structure(s): Embankment	Remarks:
Station: 1.00+170	Coordinate< Northing: 1247171 Easting: 0485721	Future Pipe Culvert Routine Survey

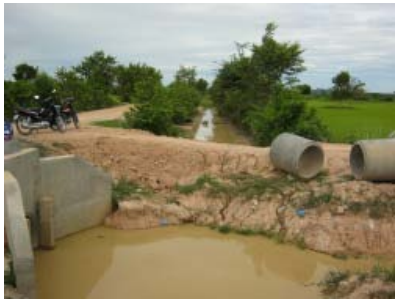
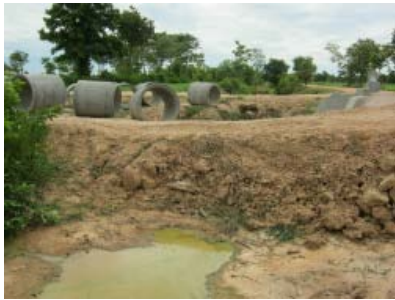
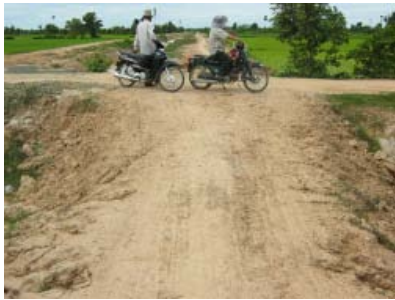
Canal No.: L7	Kind of structure(s): Embankment	Remarks:
Station: 1.00+180	Coordinate< Northing: 1247172 Easting: 0485702	Future Pipe Culvert Routine Survey

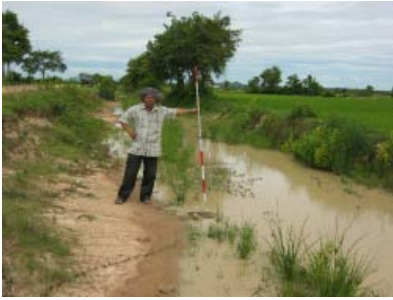
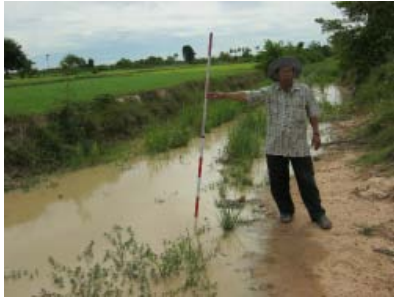
Canal No.: L7	Kind of structure(s): Canal	Remarks:
Station: 1.00+510	Coordinate< Northing: 1247170 Easting: 0485383	Routine Survey Length: 1500m

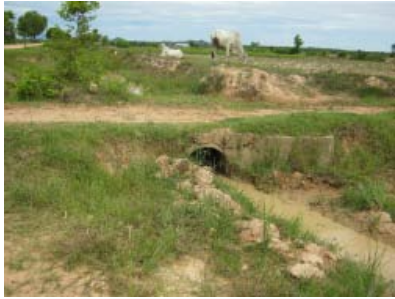
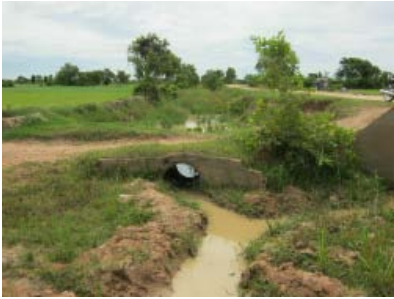
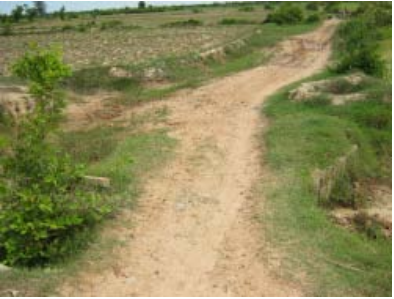
Canal No.: L7	Kind of structure(s): Pipe Culvert(Private)	Remarks:
Station: 1.00+700	Coordinate< Northing: 1247169 Easting: 0485201	Farm Access Routine Survey

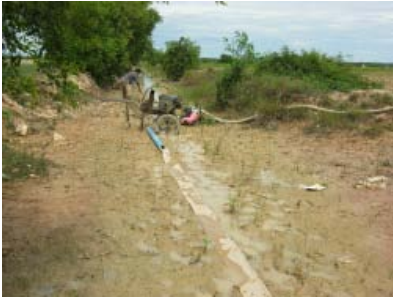
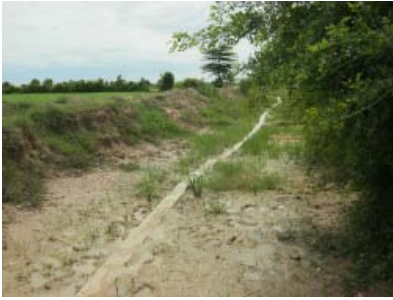
Canal No.: L7	Kind of structure(s): Canal	Remarks:
Station: 2.00+10	Coordinate< Northing: 1247174 Easting: 0484899	Routine Survey Length: 2000m

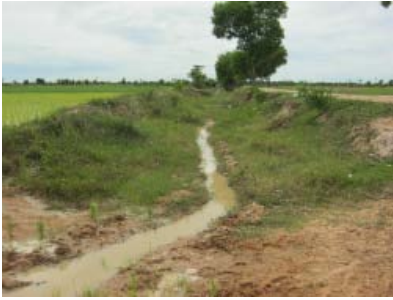
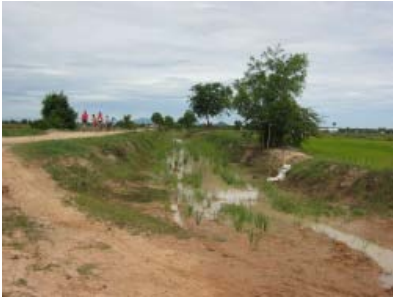
Canal No.: L7	Kind of structure(s): Canal	Remarks:
Station: 2.00+200 (EP)	Coordinate< Northing: 1247172 Easting: 0484693	Routine Survey

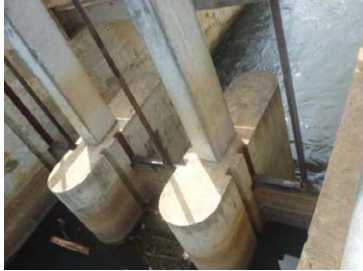
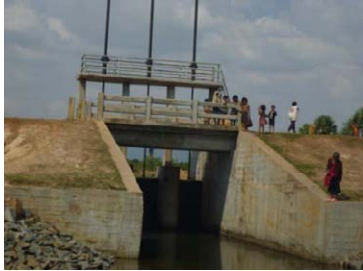
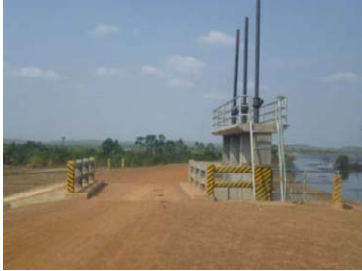
Canal No.: MC	Kind of structure: Intake KPOB KROUS Reservoir	Remarks:
Station:	Coordinate< Northing: 1238652 Easting: 443411

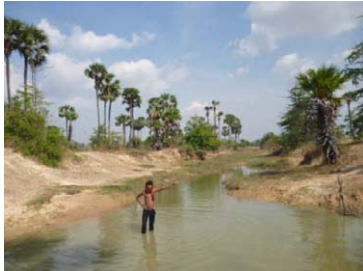
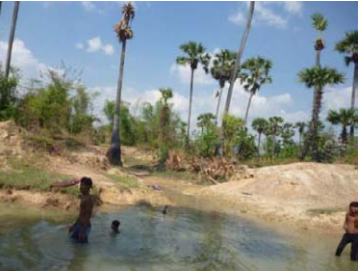
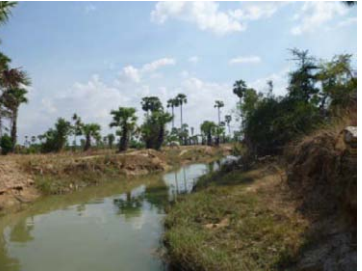
Canal No.: MC	Kind of structure: Secondary Canal	Remarks: At the left side but no structure.
Station:	Coordinate< Northing: 1238320 Easting: 443790

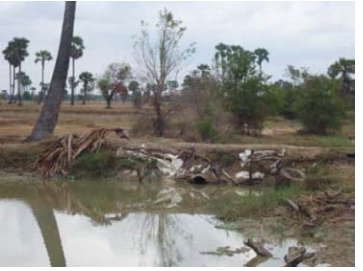
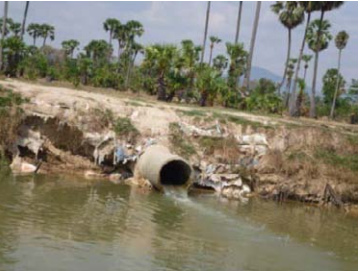
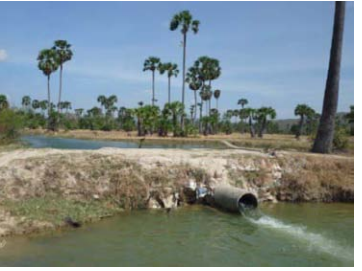
Canal No.: MC	Kind of structure: Pipe culvert	Remarks: Along the Main Canal
Station:	Coordinate< Northing: 1238128 Easting: 443812

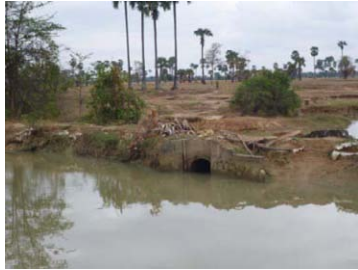
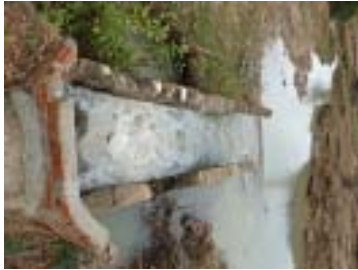
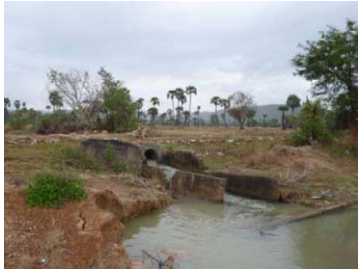
Canal No.: MC	Kind of structure: Secondary Canal	Remarks: At the right side has pipe culvert
Station:	Coordinate< Northing: 1237926 Easting: 443838

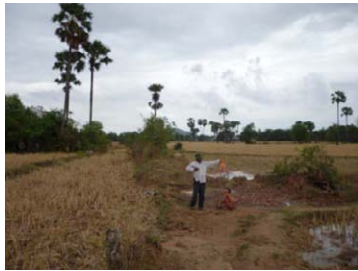
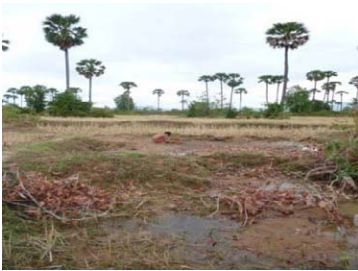
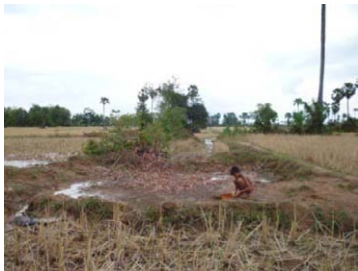
Canal No.: MC	Kind of structure: Secondary Canal	Remarks: At the right side but no structure.
Station:	Coordinate< Northing: 1237949 Easting: 444362

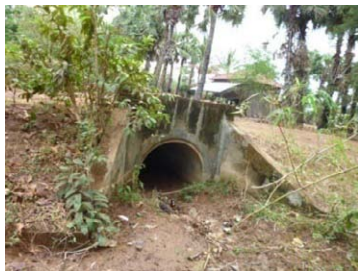
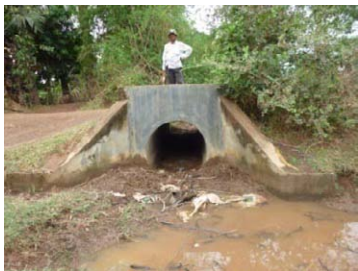
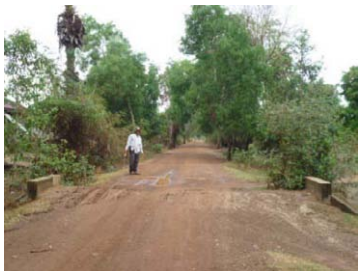
Canal No.: MC	Kind of structure: Road	Remarks: Crossing the Main Canal; has pipe culvert.
Station:	Coordinate< Northing: 1237960 Easting: 444851

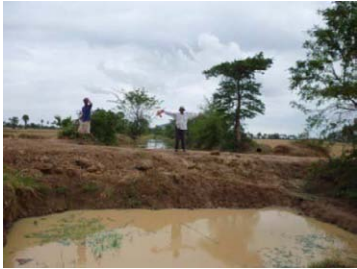
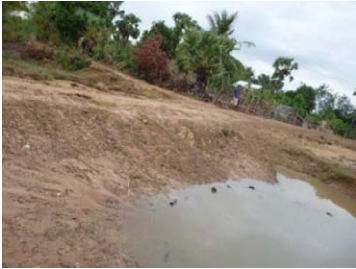
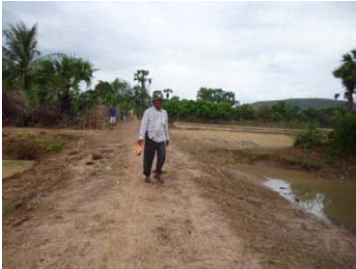
Canal No.: MC	Kind of structure: Road	Remarks: Crossing the Main Canal but no structure.
Station:	Coordinate< Northing: 1237968 Easting: 445233

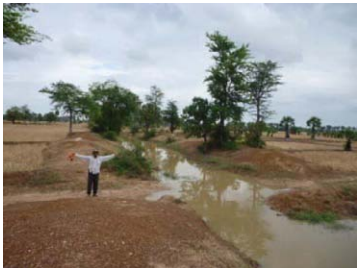
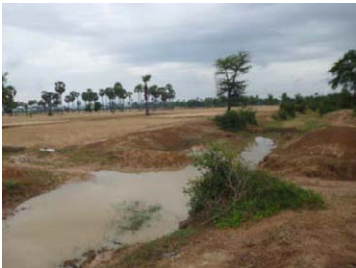
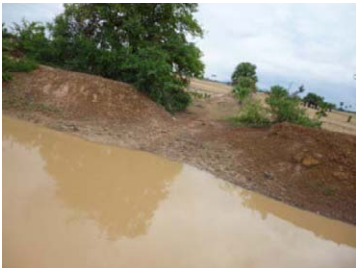
Canal No.: MC	Kind of structure: Secondary Canal	Remarks: Crossing main canal but no structure.
Station:	Coordinate< Northing: 1237973 Easting: 445509

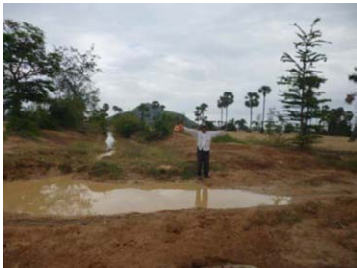
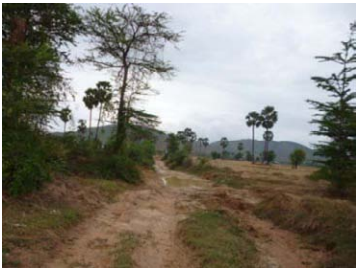
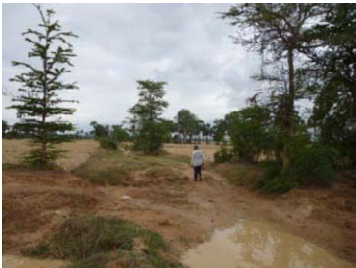
Canal No.: MC	Kind of structure: Main turn right	Remarks:
Station:	Coordinate< Northing: 1237986 Easting: 446006

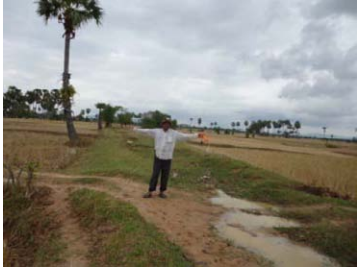
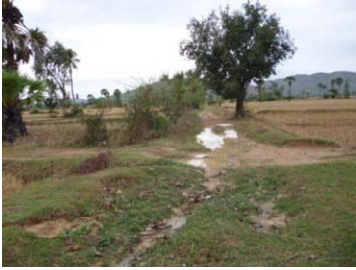
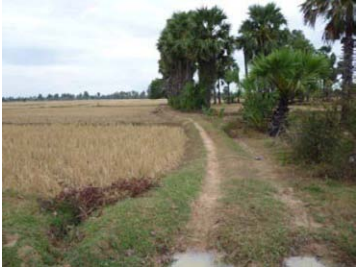
Canal No.: MC	Kind of structure: Road	Remarks: Crossing the main canal
Station:	Coordinate< Northing: 1237832 Easting: 446021

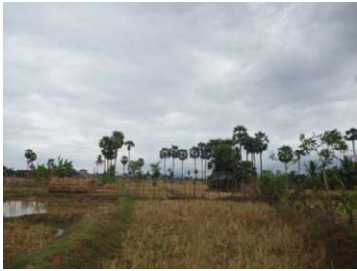
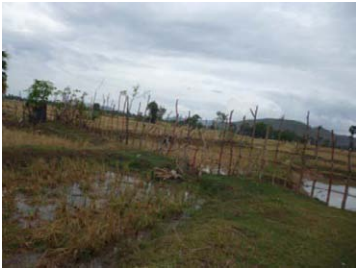
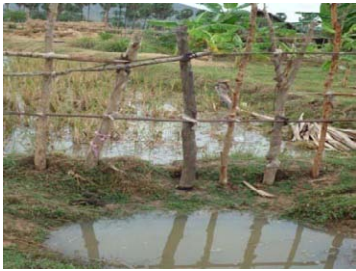
Canal No.: MC	Kind of structure: Garden house	Remarks: Based on the main canal
Station:	Coordinate< Northing: 1237506 Easting: 446050

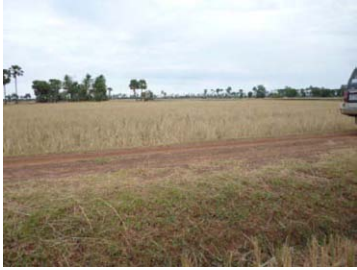
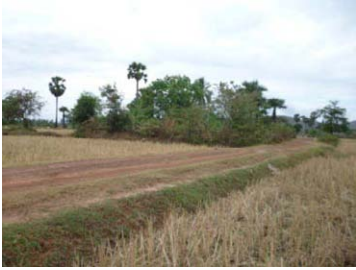
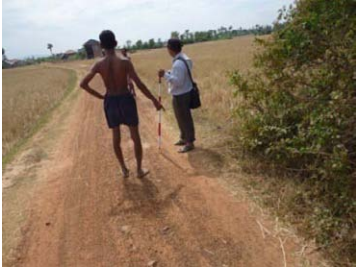
Canal No.: MC	Kind of structure: Main Canal	Remarks: It curves to the left side.
Station:	Coordinate< Northing: 1237248 Easting: 446077

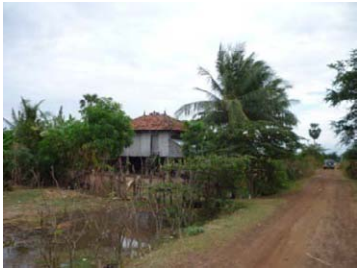
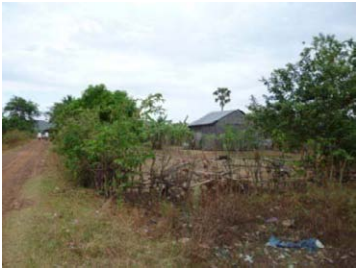
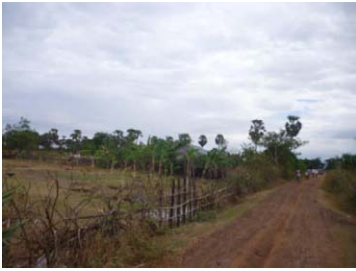
Canal No.: MC	Kind of structure: Garden house	Remarks: Based on the main canal.
Station:	Coordinate< Northing: 1236773 Easting: 446107

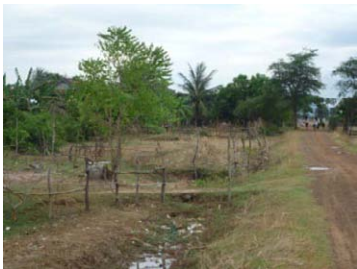
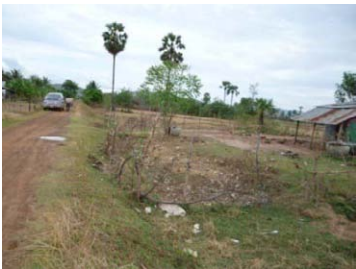
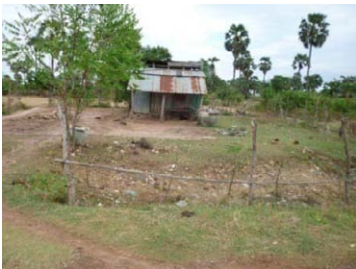
Canal No.: MC	Kind of structure: Garden house	Remarks: Based on the main canal.
Station:	Coordinate< Northing: 1326182 Easting: 446157

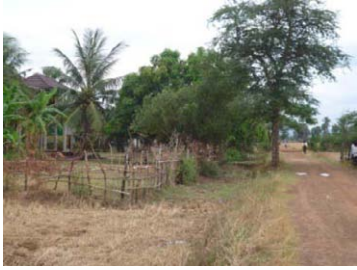
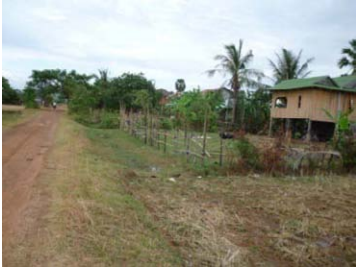
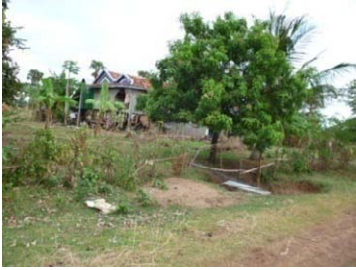
Canal No.: MC	Kind of structure: Garden house	Remarks: Based on the main canal.
Station:	Coordinate< Northing: 1236171 Easting: 446158

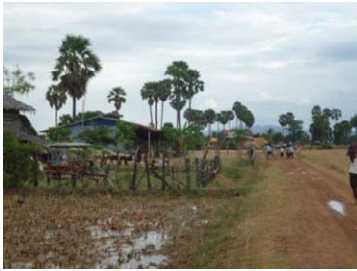
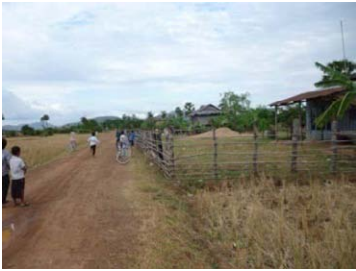
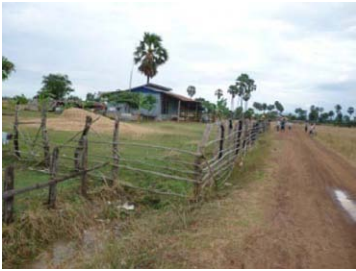
Canal No.: MC	Kind of structure: Garden house	Remarks: Based on the main canal.
Station:	Coordinate< Northing: 1236015 Easting: 446173

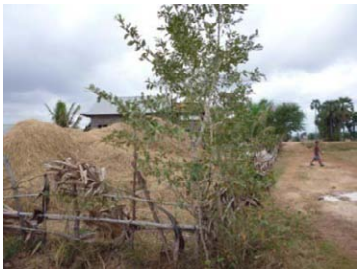
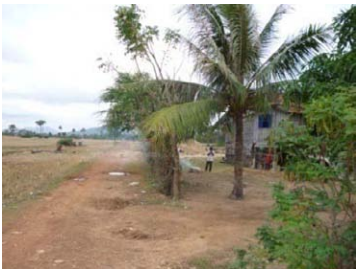
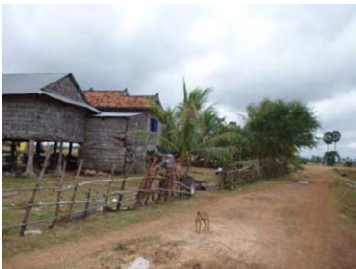
Canal No.: MC	Kind of structure: Garden house	Remarks: Based on the main canal.
Station:	Coordinate< Northing: 1235889 Easting: 446182

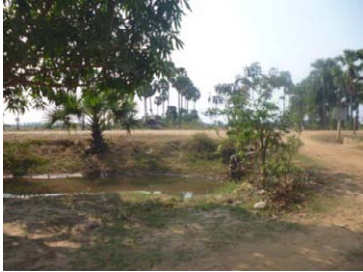
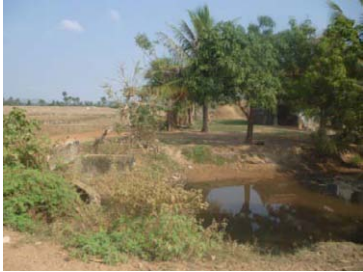
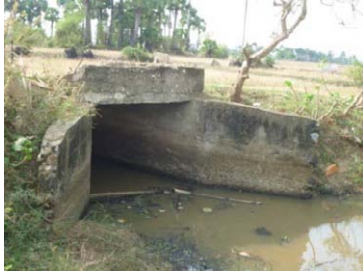
Canal No.: MC	Kind of structure: Secondary Canal	Remarks: Crossing main canal, have structure.
Station:	Coordinate< Northing: 1235674 Easting: 446195

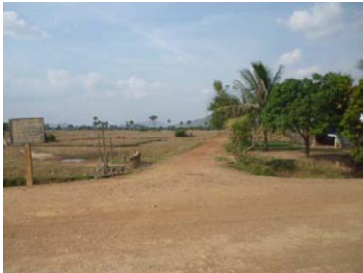
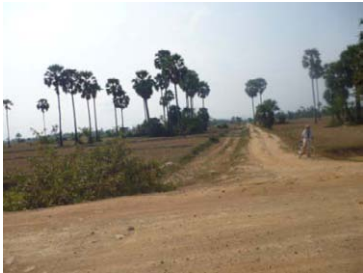
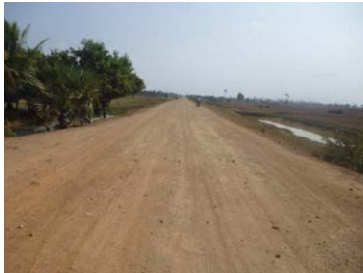
Canal No.: MC	Kind of structure: Road	Remarks: Crossing main canal.
Station:	Coordinate< Northing: 1235665 Easting: 446197

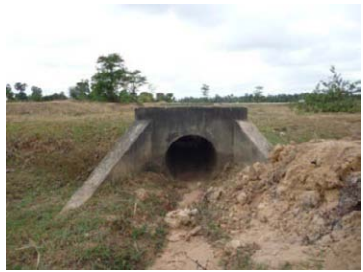
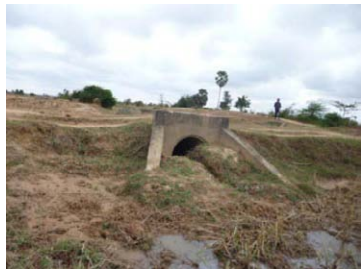
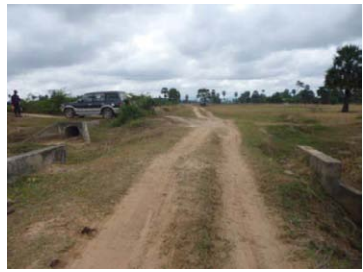
Canal No.: MC	Kind of structure: Pipe culvert	Remarks: At the right side
Station:	Coordinate< Northing: 1235357 Easting: 446225

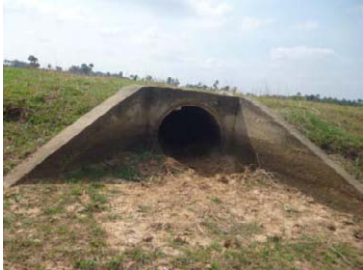
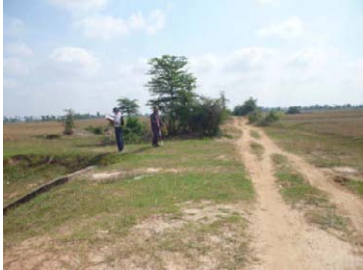
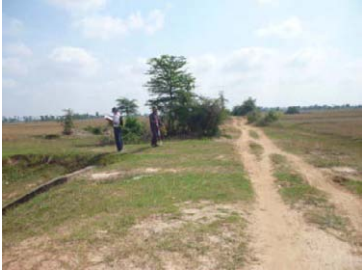
Canal No.: MC	Kind of structure: Secondary canal	Remarks: At the right side, has pipe culvert.
Station:	Coordinate< Northing: 1235300 Easting: 446799

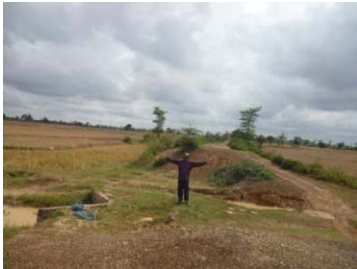
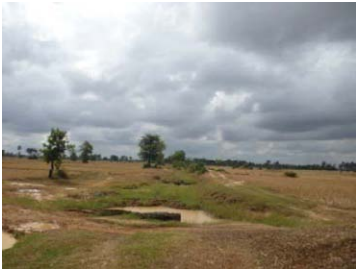
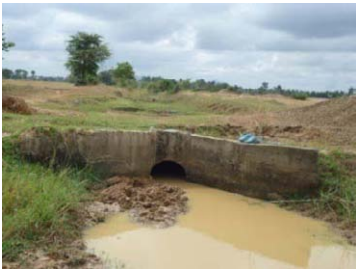
Canal No.: MC	Kind of structure: Secondary canal	Remarks: Secondary canal (Right), Drain (Left), has pipe culvert.
Station:	Coordinate< Northing: 1235269 Easting: 447288

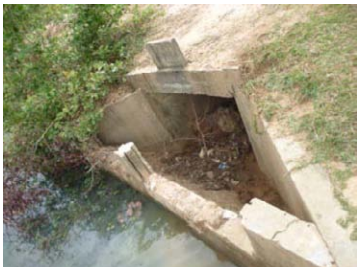
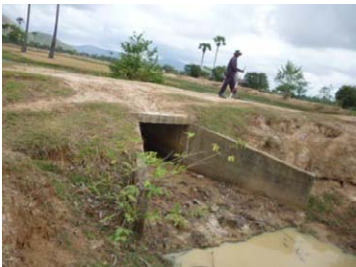
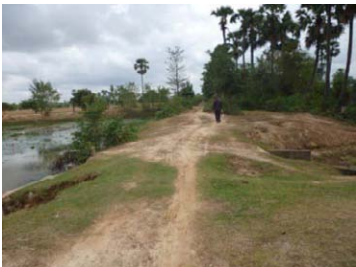
Canal No.: MC	Kind of structure: Secondary canal	Remarks: Crossing main canal, has box culvert.
Station:	Coordinate< Northing: 1235177 Easting: 448337

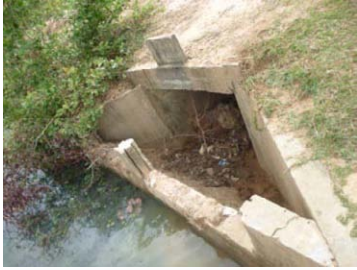
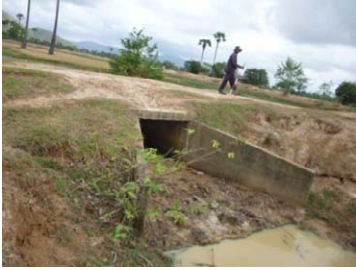
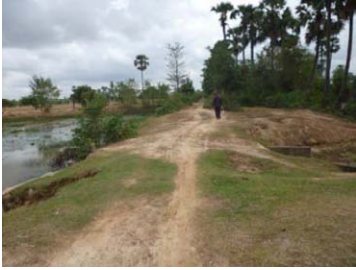
Canal No.: MC	Kind of structure: Secondary canal	Remarks: Crossing main canal; has box culvert.
Station:	Coordinate< Northing: 1235177 Easting: 448337

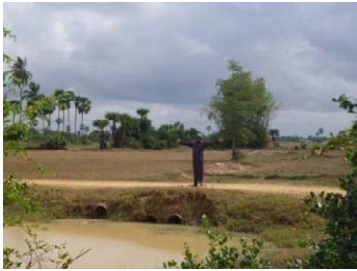
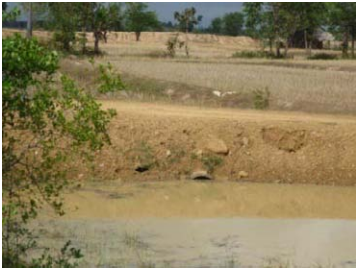
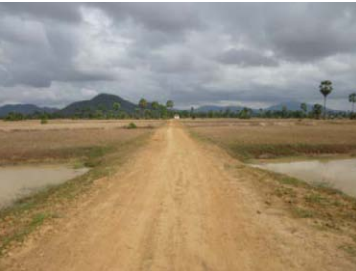
Canal No.: MC	Kind of structure: Road	Remarks: Crossing main canal; has pipe culvert.
Station:	Coordinate< Northing: 1235169 Easting: 448523

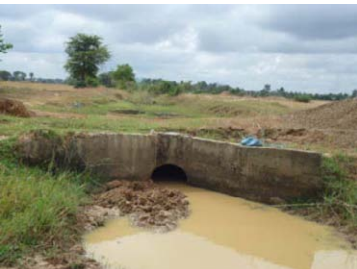
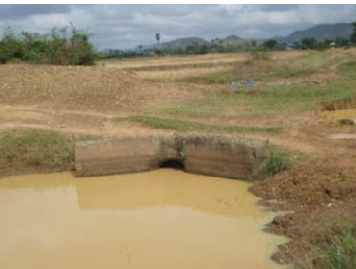
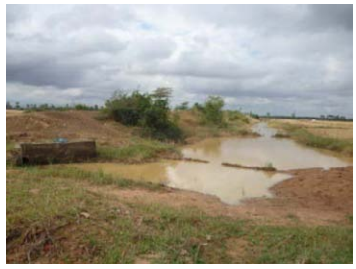
Canal No.: MC	Kind of structure: Secondary Canal	Remarks: At the right side
Station:	Coordinate< Northing: 1235160 Easting: 448636

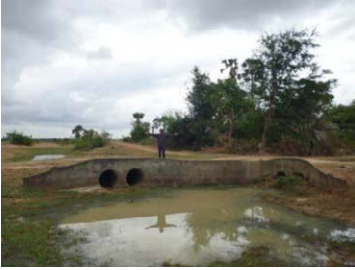
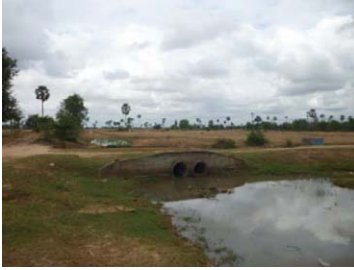
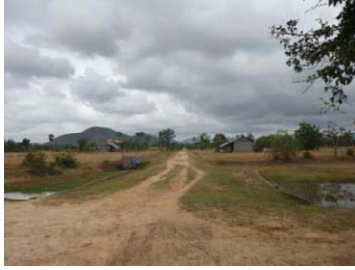
Canal No.: MC	Kind of structure: Secondary Canal	Remarks: Secondary canal (Right), Drain (Left), has two structures.
Station:	Coordinate< Northing: 1235021 Easting: 449351

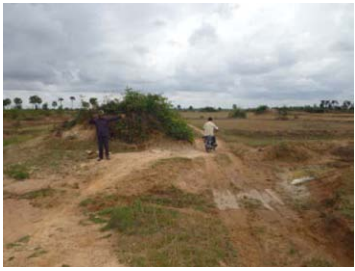
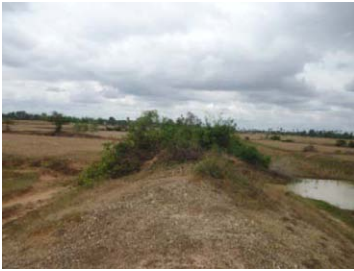
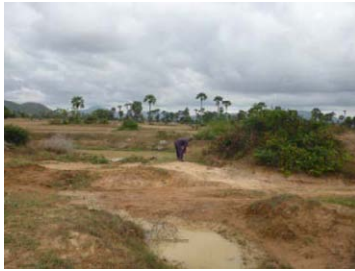
Canal No.: MC	Kind of structure: Secondary Canal	Remarks: At the right side.
Station:	Coordinate< Northing: 1235223 Easting: 449896

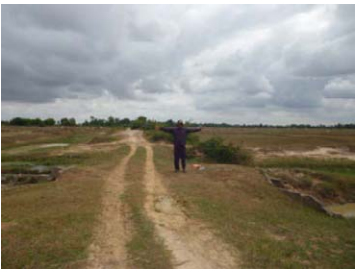
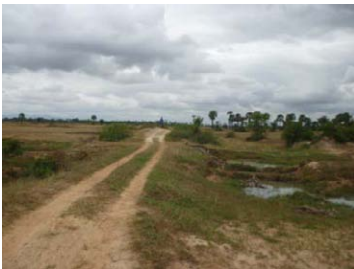
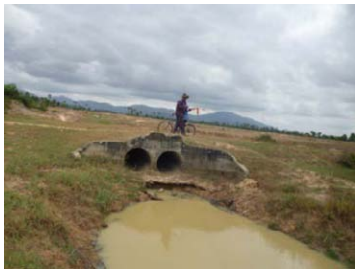
Canal No.: MC	Kind of structure: Secondary Canal	Remarks: Secondary canal (Right), Drain (Left), has double pipes.
Station:	Coordinate< Northing: 1235287 Easting: 450355

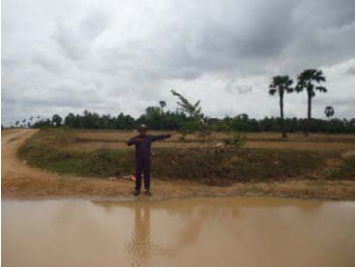
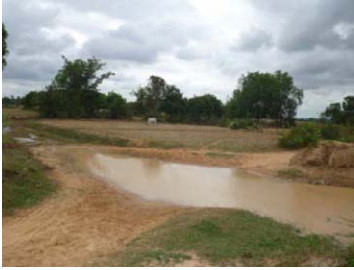
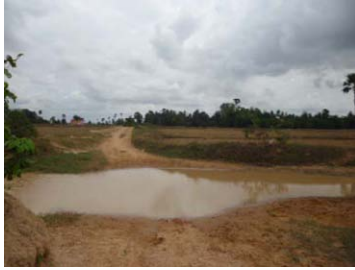
Canal No.: MC	Kind of structure: Secondary Canal	Remarks: At the right side.
Station:	Coordinate< Northing: 1235418 Easting: 451002

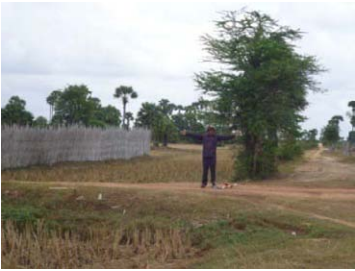
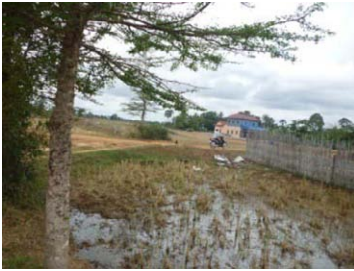
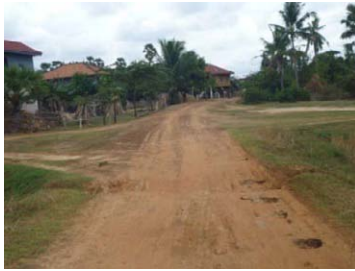
Canal No.: MC	Kind of structure: Road	Remarks: Crossing the main canal but no structure.
Station:	Coordinate< Northing: 1235579 Easting: 451395

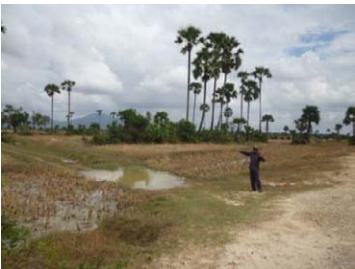
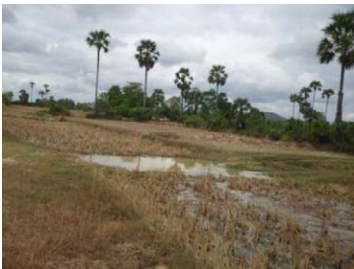
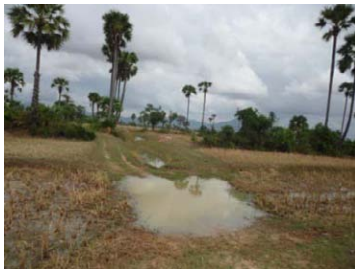
Canal No.: MC	Kind of structure: Secondary Canal	Remarks: At the left side.
Station:	Coordinate< Northing: 1235684 Easting: 451679

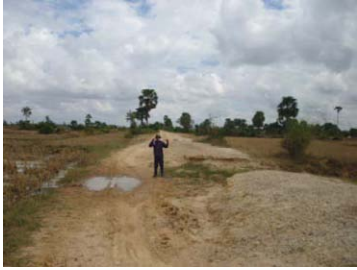
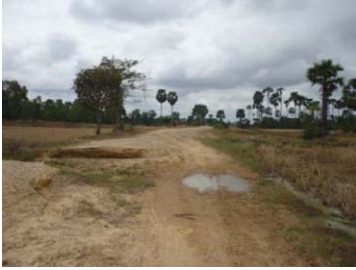
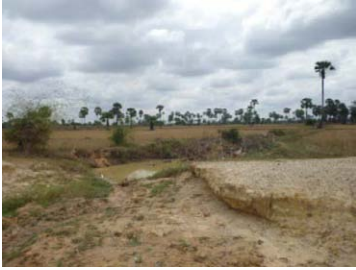
Canal No.: MC	Kind of structure: Secondary Canal	Remarks: At the right side.
Station:	Coordinate< Northing: 1235750 Easting: 451852

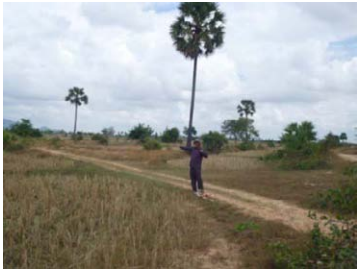
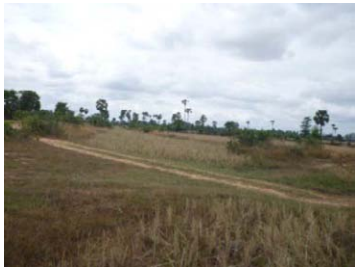
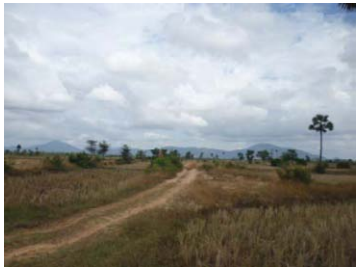
Canal No.: MC	Kind of structure: Secondary Canal	Remarks: At the left side.
Station:	Coordinate< Northing: 1235820 Easting: 452037

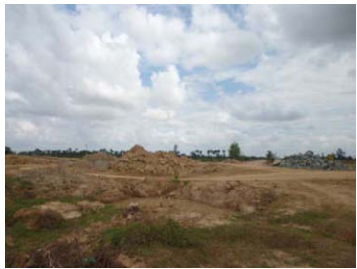
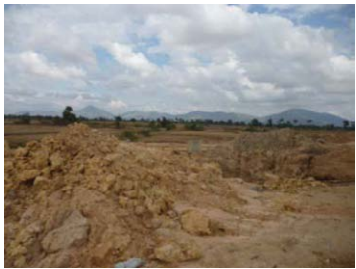
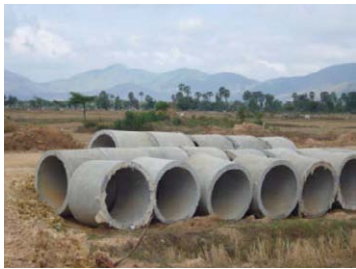
Canal No.: MC	Kind of structure: Road DONG DOUNG	Remarks: Under construction
Station:	Coordinate< Northing: 1235979 Easting: 452604

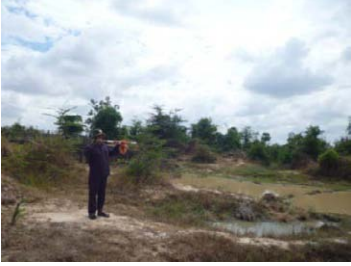
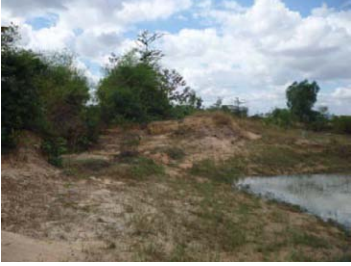
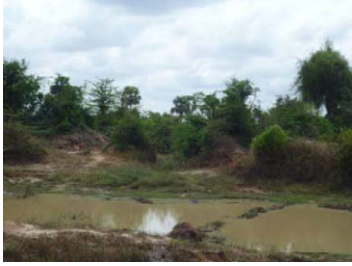
Canal No.: MC	Kind of structure: Secondary canal	Remarks: At the right side.
Station:	Coordinate< Northing: 1236056 Easting: 453251

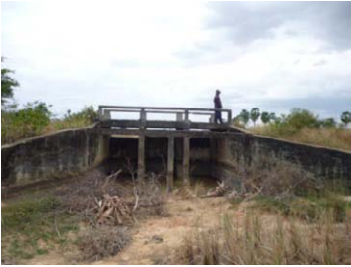
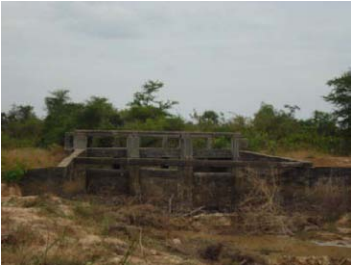
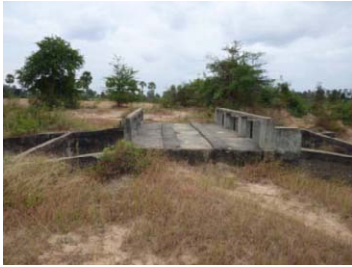
Canal No.: MC	Kind of structure:	Remarks: Check Structure
Station:	Coordinate< Northing: 1236049 Easting: 453267

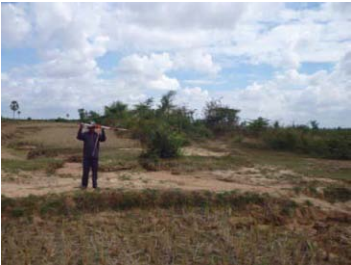
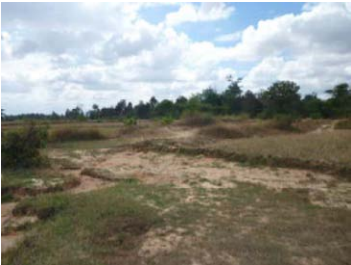
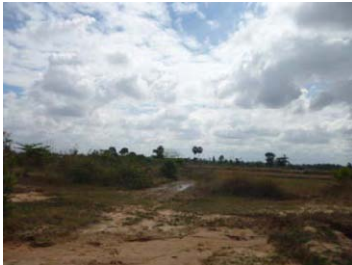
Canal No.: MC	Kind of structure: Secondary Canal	Remarks: At the right side
Station:	Coordinate< Northing: 1235998 Easting: 453773

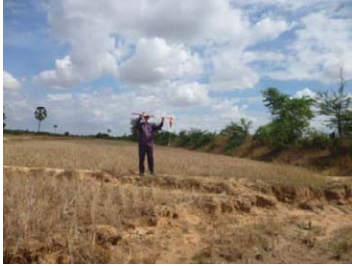
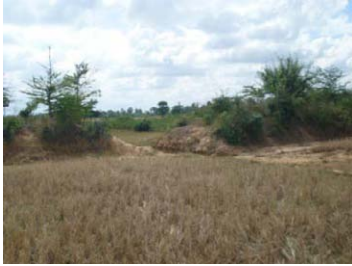
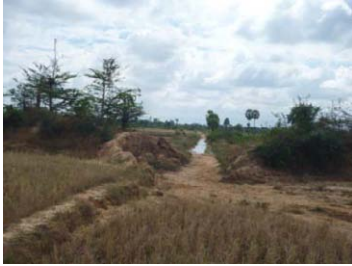
Canal No.: MC	Kind of structure: Secondary Canal	Remarks: At the right side
Station:	Coordinate< Northing: 1235970 Easting: 454236

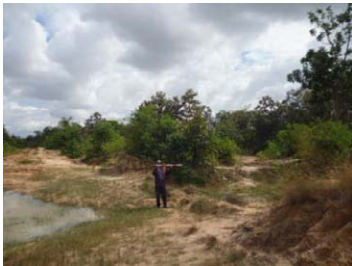
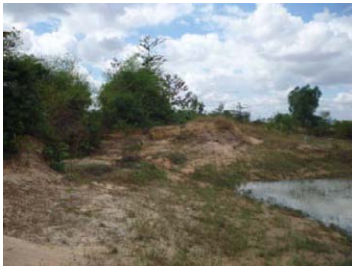
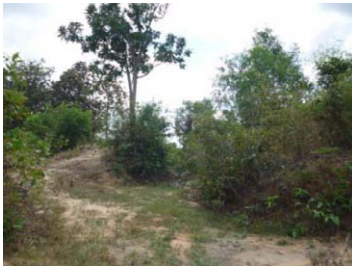
Canal No.: MC	Kind of structure: Secondary Canal	Remarks: At the right side
Station:	Coordinate< Northing: 1235964 Easting: 454302

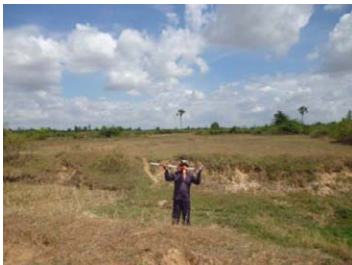
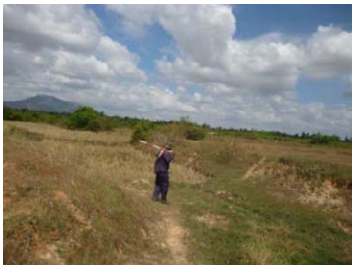
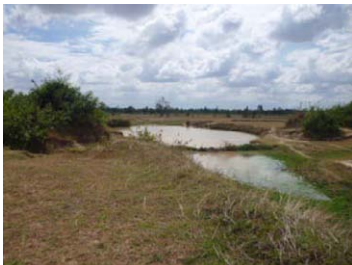
Canal No.: MC	Kind of structure: Secondary Canal	Remarks: At the left side
Station:	Coordinate< Northing: 1235955 Easting: 454516

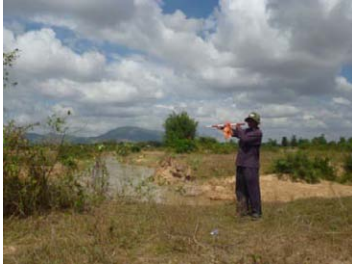
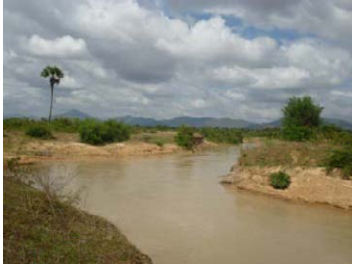
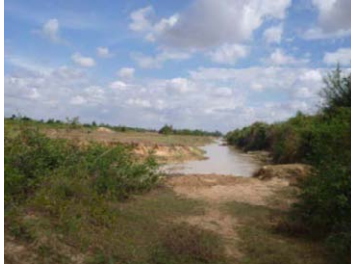
Canal No.: MC	Kind of structure: Secondary Canal	Remarks: At the left side
Station:	Coordinate< Northing: 1235959 Easting: 454701
