# ***ANNEX D***

*Results of Inventory Survey for Irrigation and Drainage*

*Facilities in Kandal Stung – Bati Irrigation System*

*Rehabilitation Sub-project*

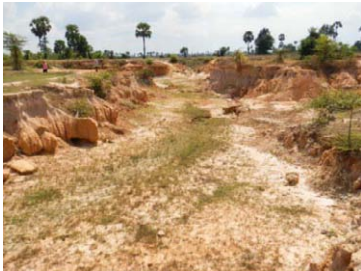
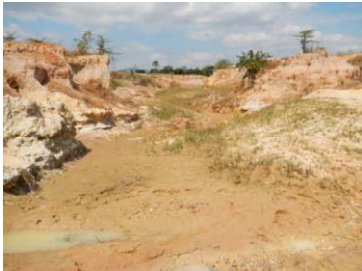
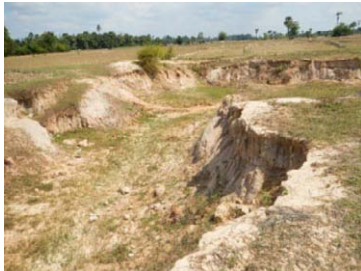
Canal No.: MC	Kind of structure: Secondary Canal	Remarks: At the left side
Station:	Coordinate< Northing: 1235935 Easting: 454847

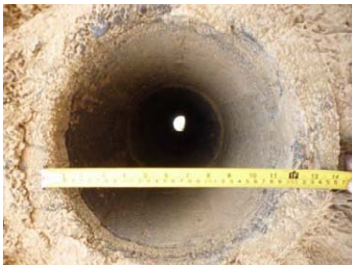
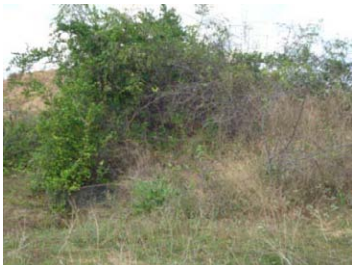
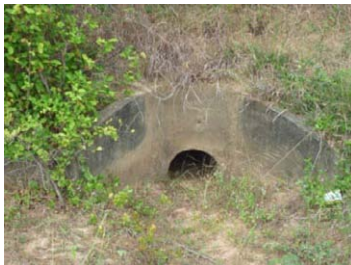
Canal No.: MC	Kind of structure: Pipe culvert	Remarks: To the field at the right side
Station:	Coordinate< Northing: 1235866 Easting: 455299

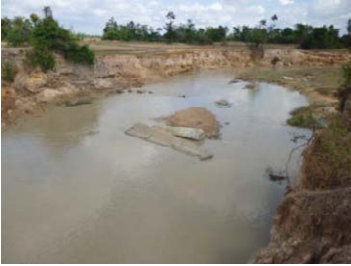
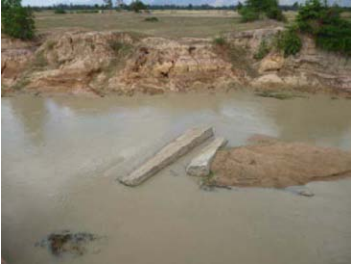
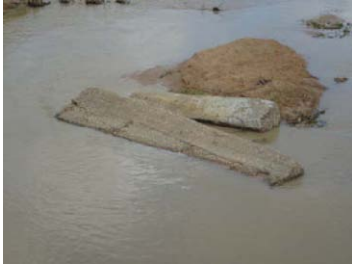
Canal No.: MC	Kind of structure: Old structure	Remarks: Has broken
Station:	Coordinate< Northing: 1235848 Easting: 455644

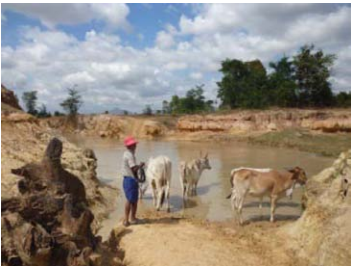
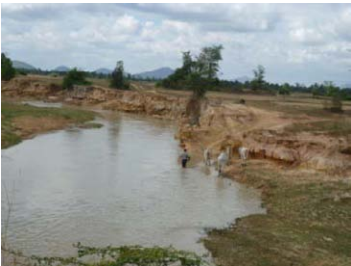
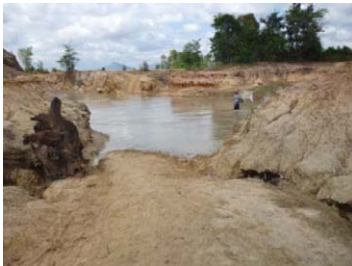
Canal No.: MC	Kind of structure: Road	Remarks: Crossing the main canal
Station:	Coordinate< Northing: 1235834 Easting: 455730

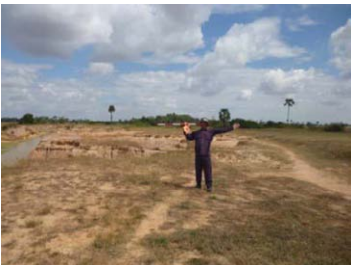
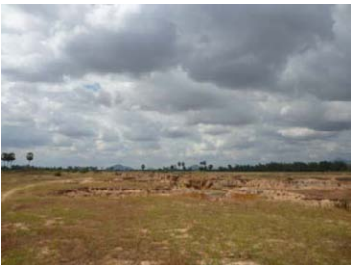
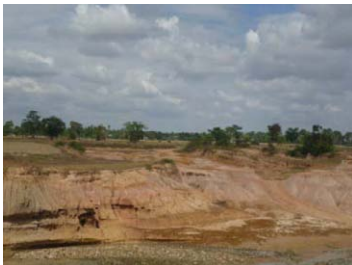
Canal No.: MC	Kind of structure: Road	Remarks: Crossing the main canal
Station:	Coordinate< Northing: 1235803 Easting: 457065

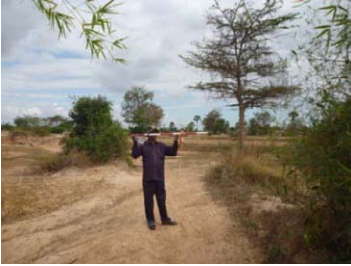
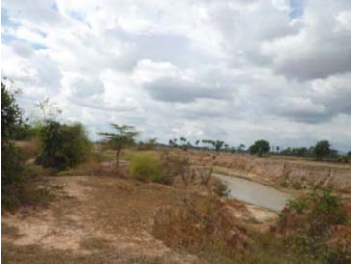
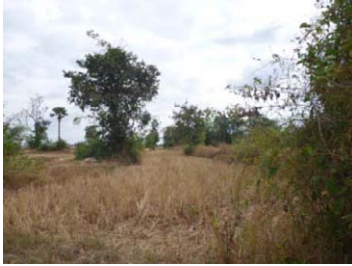
Canal No.: MC	Kind of structure: Secondary Canal	Remarks: At the right side
Station:	Coordinate< Northing: 1235794 Easting: 457999

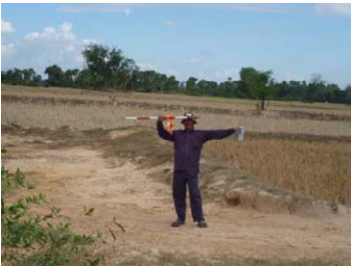
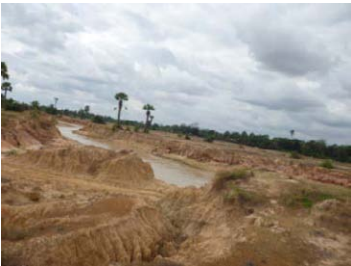
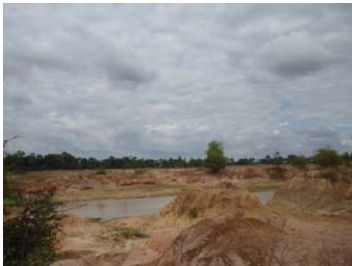
Canal No.: MC	Kind of structure: Road	Remarks: Crossing the main canal
Station:	Coordinate< Northing: 1235796 Easting: 458018

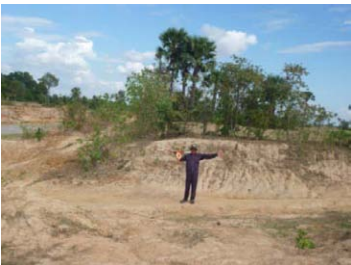
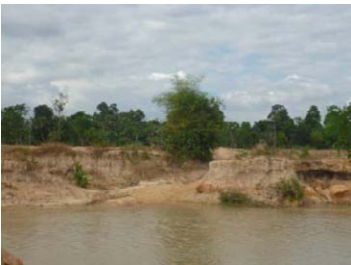
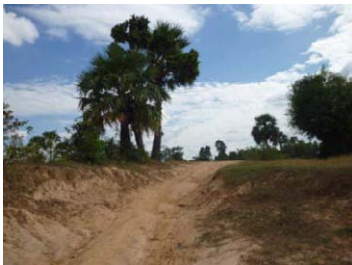
Canal No.: MC	Kind of structure: Road	Remarks: Crossing the main canal
Station:	Coordinate< Northing: 1235775 Easting: 459628

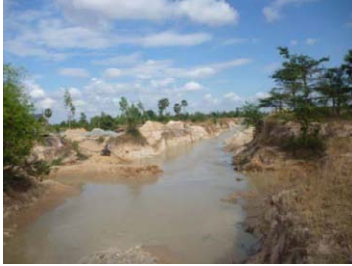
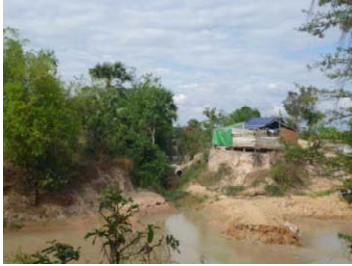
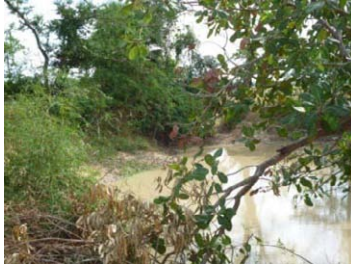
Canal No.: MC	Kind of structure: Secondary Canal	Remarks: Crossing the main canal
Station:	Coordinate< Northing: 1235755 Easting: 460233

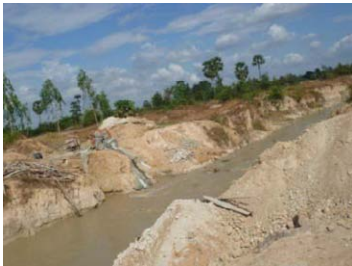
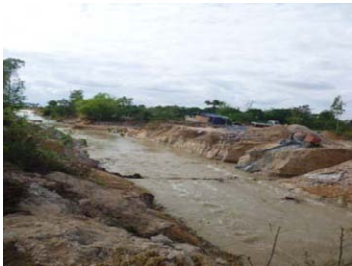
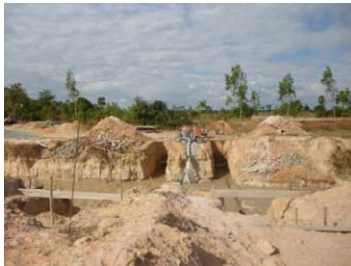
Canal No.: MC	Kind of structure:	Remarks: Check structure is under construction.
Station:	Coordinate< Northing: 1235756 Easting: 460277

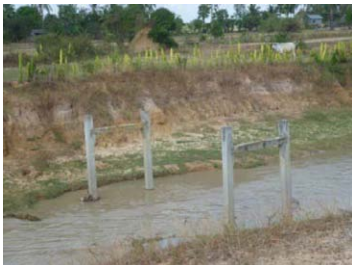
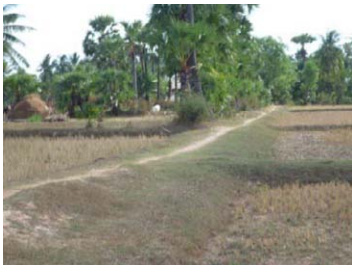
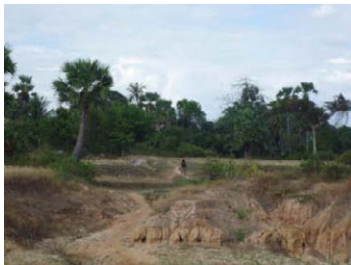
Canal No.: MC	Kind of structure: Road	Remarks: Crossing the main canal
Station:	Coordinate< Northing: 1235620 Easting: 460948

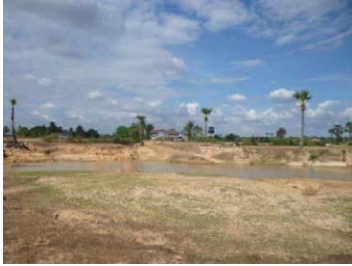
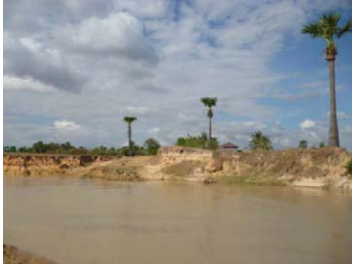
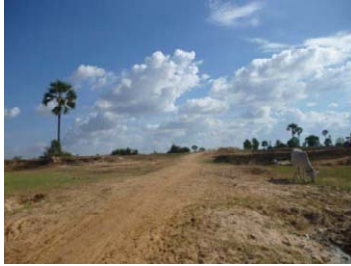
Canal No.: MC	Kind of structure: Road (24)	Remarks: Crossing the main canal
Station:	Coordinate< Northing: 1235530 Easting: 461397

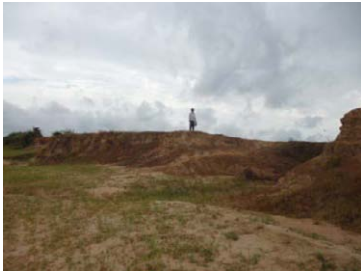
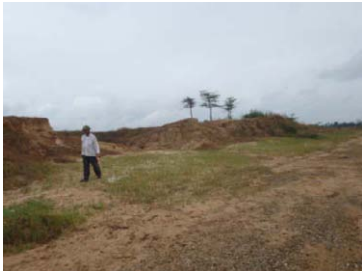
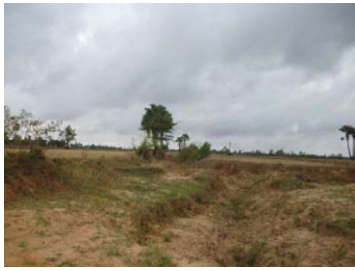
Canal No.: MC	Kind of structure: Secondary Canal	Remarks: At the right side
Station:	Coordinate< Northing: 1235319 Easting: 461934

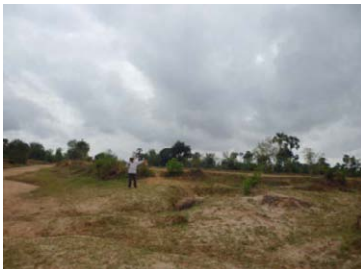
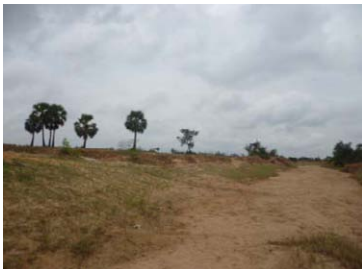
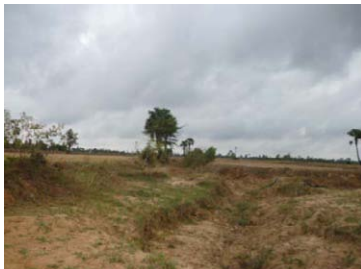
Canal No.: MC	Kind of structure: Secondary Canal	Remarks: At the right side
Station:	Coordinate< Northing: 1234957 Easting: 463677

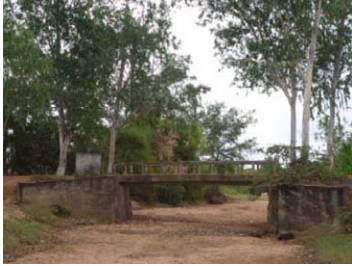
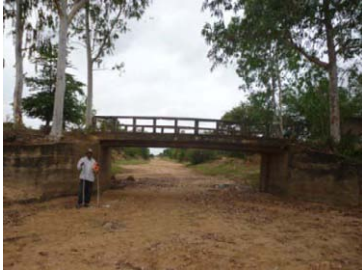
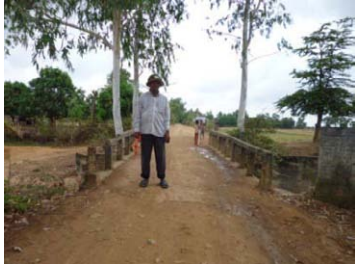
Canal No.: MC	Kind of structure: Road	Remarks: Crossing the main canal but has bridge.
Station:	Coordinate< <div style="display: flex; flex-direction: column; margin-left: 10px;"> <span>Northing: 1234900</span> <span>Easting: 464113</span> </div>	
<div style="display: flex; justify-content: space-around; align-items: center;"> <div style="text-align: center;">

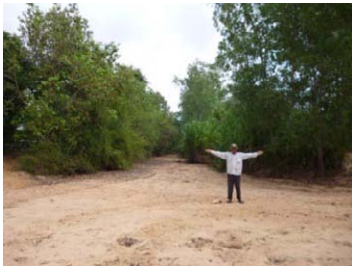
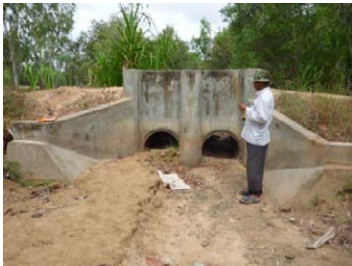
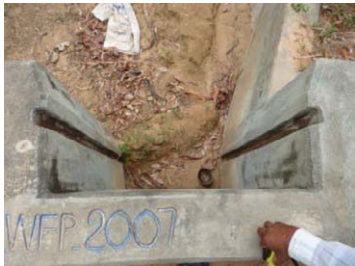
Canal No.: MC	Kind of structure: Secondary Canal	Remarks: Crossing the main canal but has double pipes at the right.
Station:	Coordinate< <div style="display: flex; flex-direction: column; margin-left: 10px;"> <span>Northing: 1234518</span> <span>Easting: 465434</span> </div>	
<div style="display: flex; justify-content: space-around; align-items: center;"> <div style="text-align: center;">

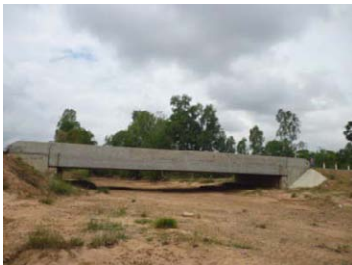
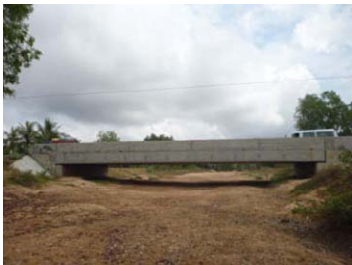
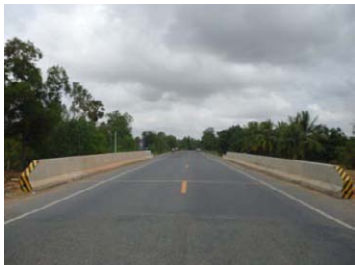
Canal No.: MC	Kind of structure: Bridge number 12	Remarks: Based on National road number 3
Station:	Coordinate< <div style="display: flex; flex-direction: column; margin-left: 10px;"> <span>Northing: 1234513</span> <span>Easting: 465648</span> </div>	
<div style="display: flex; justify-content: space-around; align-items: center;"> <div style="text-align: center;">

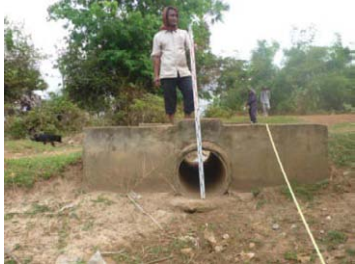
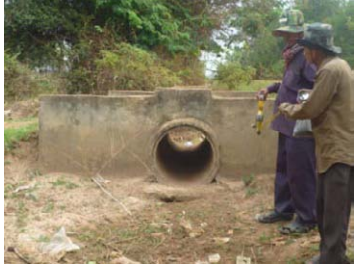
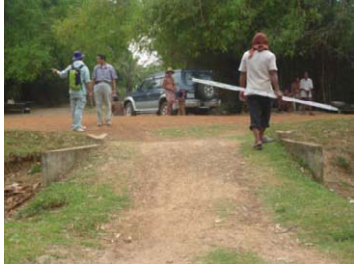
Canal No.: SC-3	Kind of structure: Pipe Culvert	Remarks: B.P. of SC-3 at Main Canal 35
Station:	Coordinate< Northing: 1237748 Easting: 444883

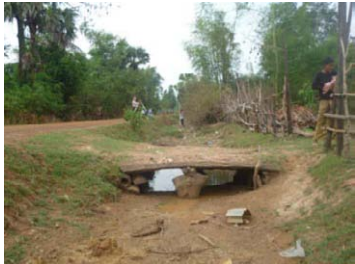
Canal No.: SC-3	Kind of structure: Wooden Bridge	Remarks: Wooden Bridge for entrance
Station:	Coordinate< Northing: 1237630 Easting: 444901

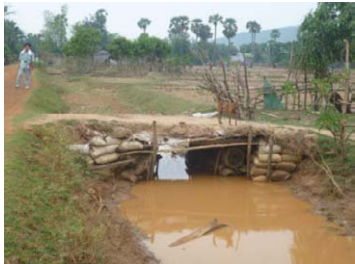
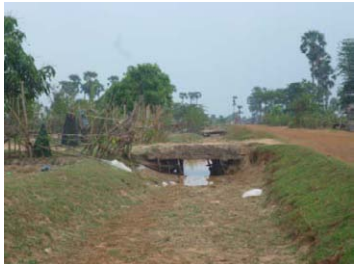
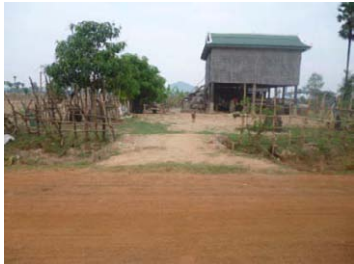
Canal No.: SC-3	Kind of structure: Wooden Bridge	Remarks: Wooden bridge for entrance
Station:	Coordinate< Northing: 1237491 Easting: 444920

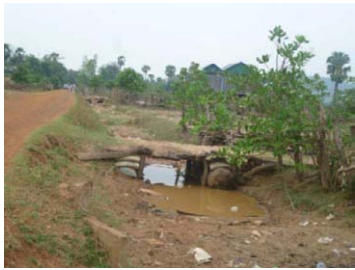
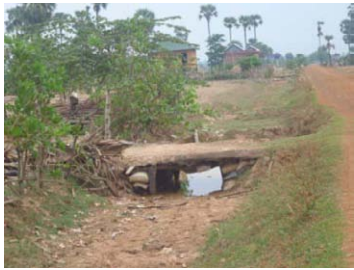
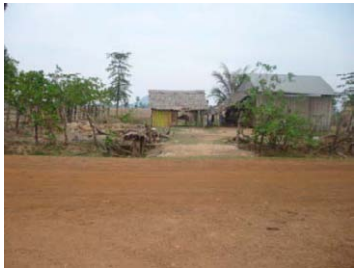
Canal No.: SC-3	Kind of structure: Wooden Bridge	Remarks: Wooden bridge for entrance
Station:	Coordinate< Northing: 1237434 Easting: 444927

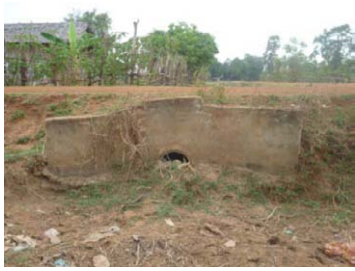
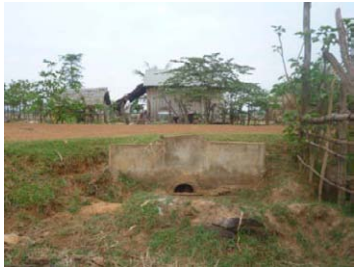
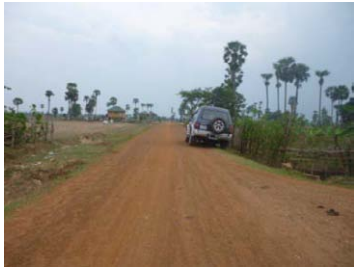
Canal No.: SC-3	Kind of structure: Turnout	Remarks: Pipe culvert (turnout) to the right tertiary canal
Station:	Coordinate< Northing: 1237423 Easting: 444927

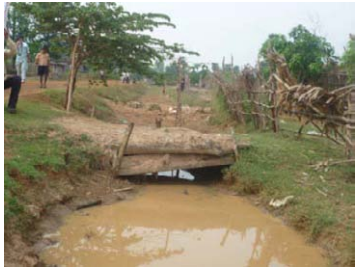
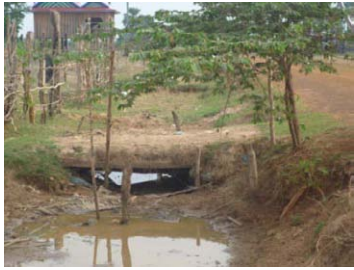
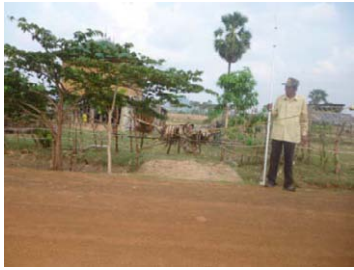
Canal No.: SC-3	Kind of structure: Wooden Bridge	Remarks: Wooden bridge for entrance
Station:	Coordinate< Northing: 1237307 Easting: 444948

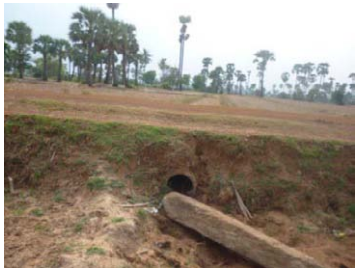
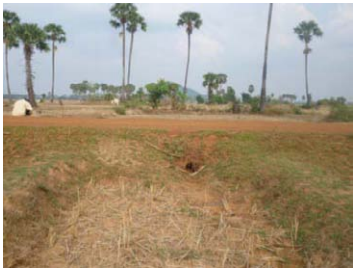
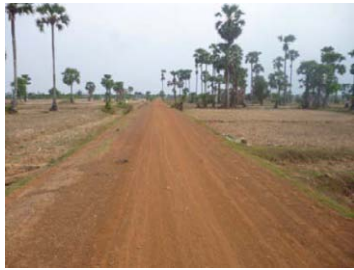
Canal No.: SC-3	Kind of structure: Turnout	Remarks: Pipe culvert (turnout) to the right tertiary canal (L = 300m)
Station:	Coordinate< Northing: 1237210 Easting: 444955

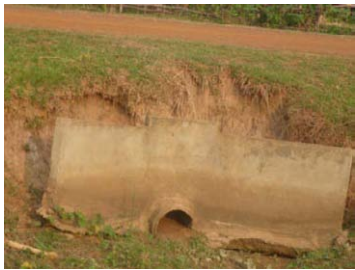
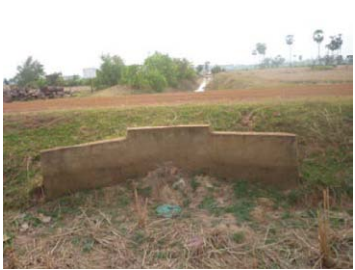
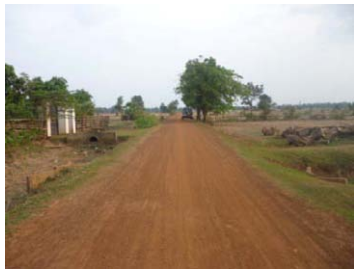
Canal No.: SC-3	Kind of structure: Turnout	Remarks: Pipe Culvert (turnout) to the right tertiary canal (L = 1000m)
Station:	Coordinate< Northing: 1236881 Easting: 444993

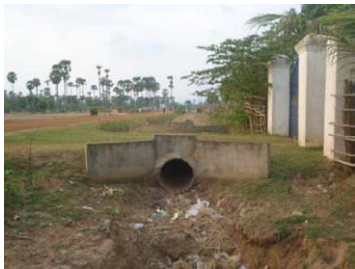
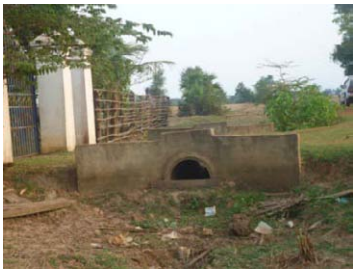
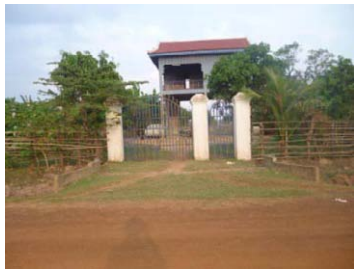
Canal No.: SC-3	Kind of structure: Pipe Culvert	Remarks: Pipe culvert for entrance
Station:	Coordinate< Northing: 1236868 Easting: 444999

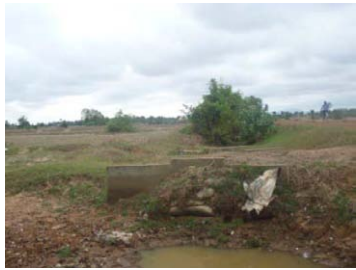
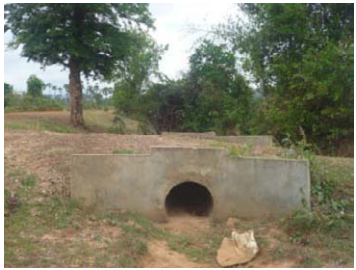
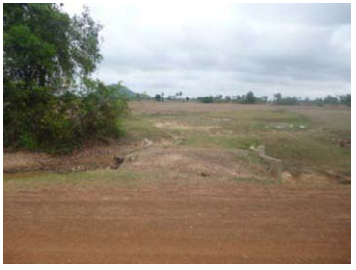
Canal No.: SC-3	Kind of structure: Pipe Culvert	Remarks: Pipe culvert for entrance
Station:	Coordinate< Northing: 1236655 Easting: 445028

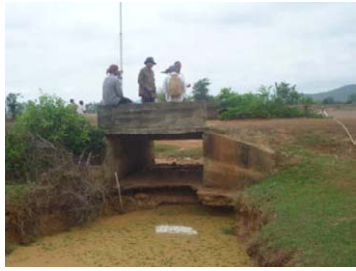
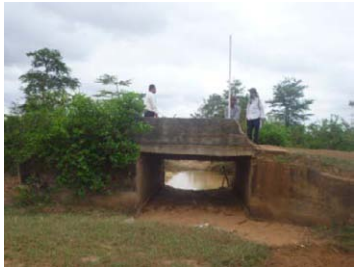
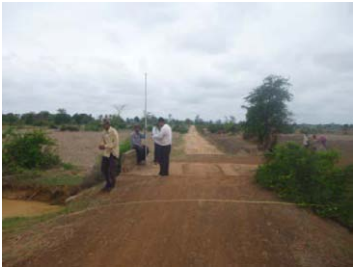
Canal No.: SC-3	Kind of structure: Box Culvert	Remarks: Box Bridge crossing secondary canal
Station:	Coordinate< Northing: 1236338 Easting: 445071

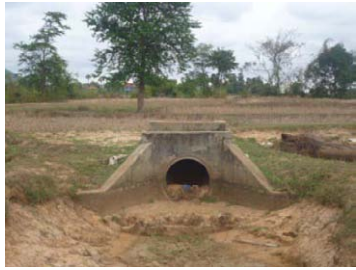
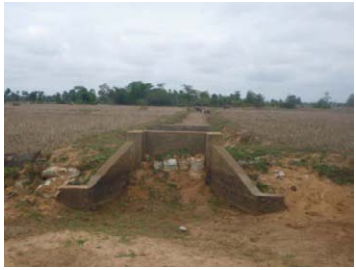
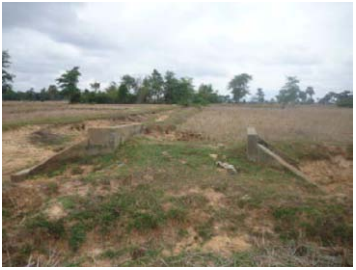
Canal No.: SC-3	Kind of structure: Turnout	Remarks: Pipe Culvert (turnout) to the right tertiary canal (L = 1000m)
Station:	Coordinate< Northing: 1236234 Easting: 445083

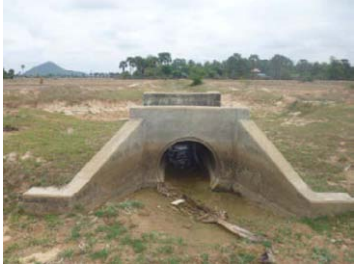
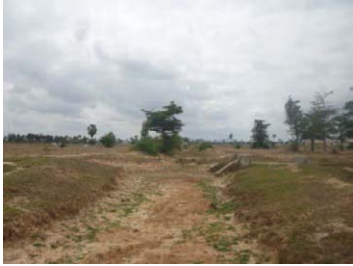
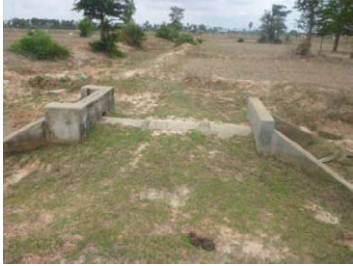
Canal No.: SC-3	Kind of structure: Turnout	Remarks: Pipe Culvert (turnout) to the right tertiary canal
Station:	Coordinate< Northing: 1235812 Easting: 445145

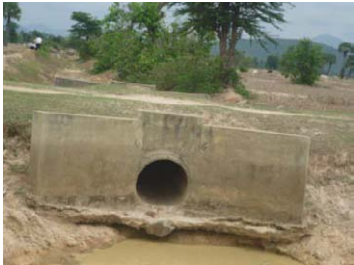
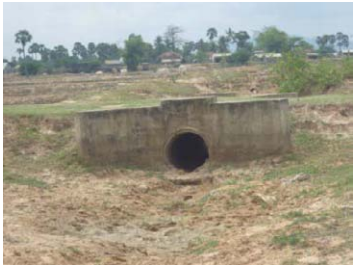
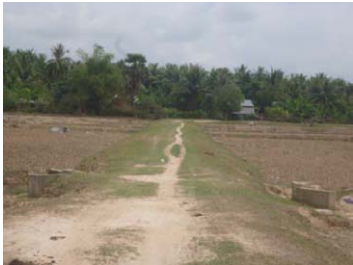
Canal No.: SC-3	Kind of structure: Turnout	Remarks: Pipe Culvert (turnout) to the right tertiary canal
Station:	Coordinate< Northing: 1235713 Easting: 445163

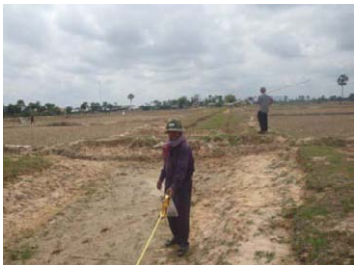
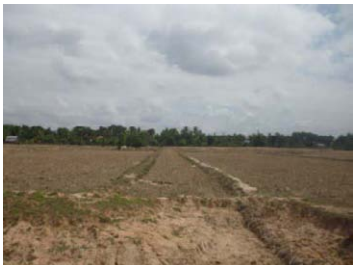
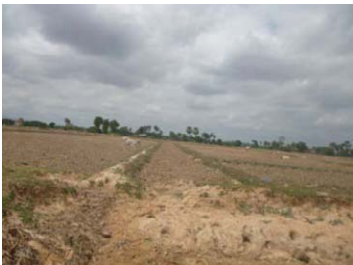
Canal No.: SC-3	Kind of structure: Turnout (no structure)	Remarks: Tertiary canal crossing without structure
Station:	Coordinate< Northing: 1235607 Easting: 445179

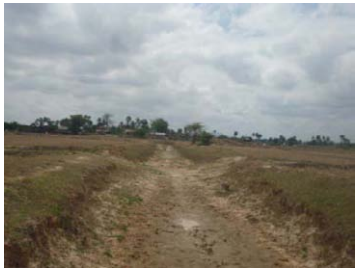
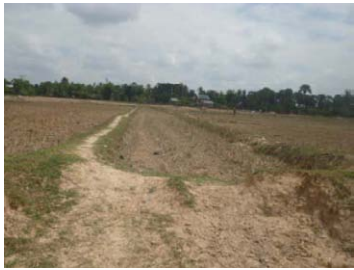
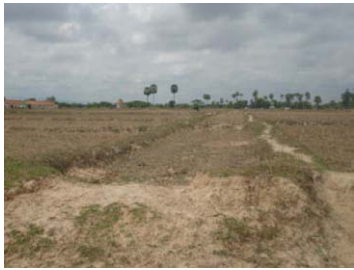
Canal No.: SC-3	Kind of structure: Turnout (no structure)	Remarks: Tertiary canal crossing without structure
Station:	Coordinate< Northing: 1235505 Easting: 445199

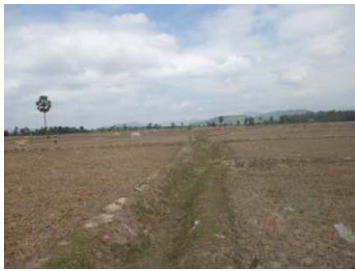
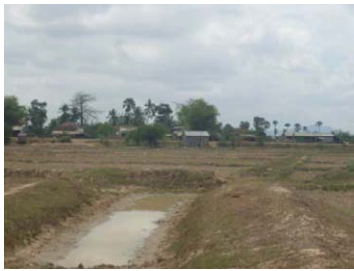
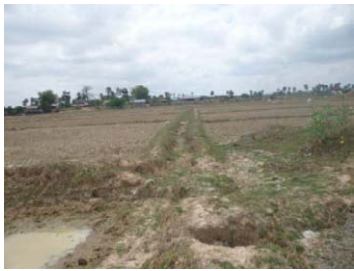
Canal No.: SC-3	Kind of structure: Canal	Remarks: Canal width becomes narrow.
Station:	Coordinate< Northing: 1235453 Easting: 445201

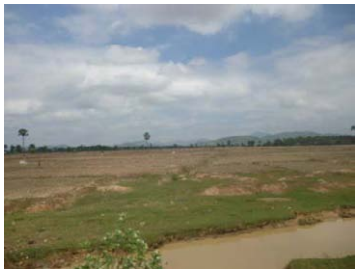
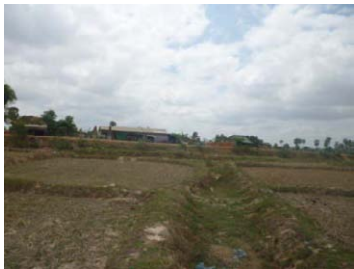
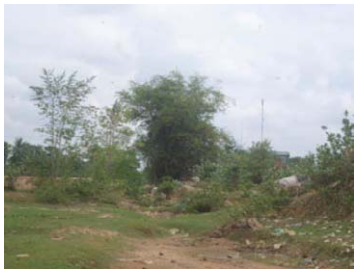
Canal No.: SC-3	Kind of structure: Canal	Remarks: E.P. of SC-3
Station:	Coordinate< Northing: 1235453 Easting: 445201

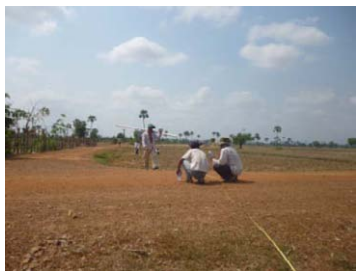
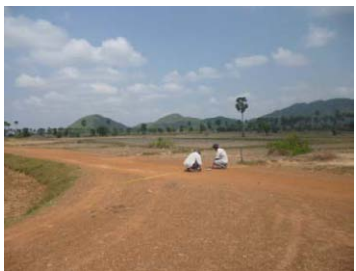
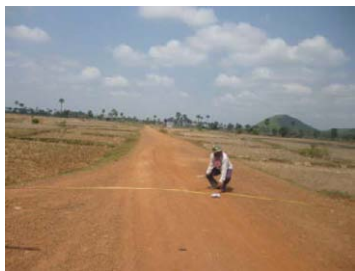
Canal No.: SC-5	Kind of structure: Road	Remarks: B.P. of Secondary Canal No.5
Station:	Coordinate< Northing: 1237765 Easting: 447649

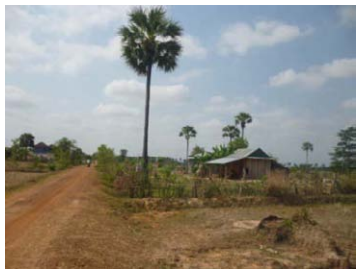
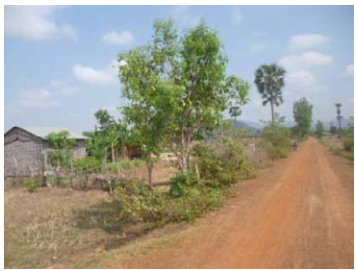
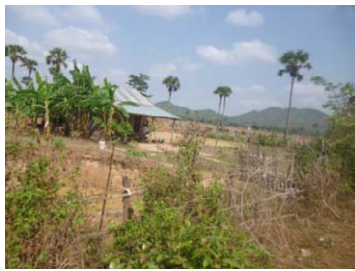
Canal No.: SC-5	Kind of structure: Entrance	Remarks: Entrance without structure
Station:	Coordinate< Northing: 1237237 Easting: 447562

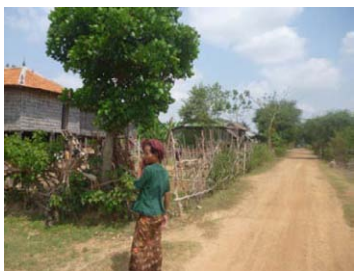
Canal No.: SC-5	Kind of structure: Entrance	Remarks: Entrance without structure
Station:	Coordinate< Northing: 1237237 Easting: 447525

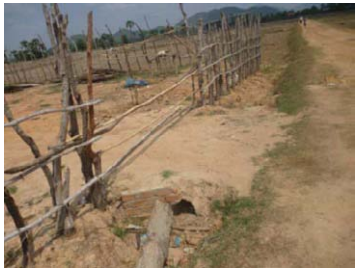
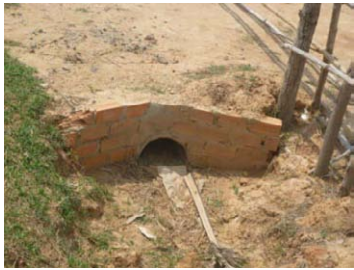
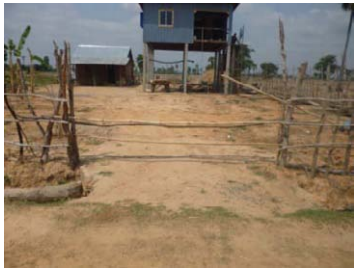
Canal No.: SC-5	Kind of structure: Pipe culvert	Remarks: Entrance with pipe culvert
Station:	Coordinate< Northing: 1236906 Easting: 447523

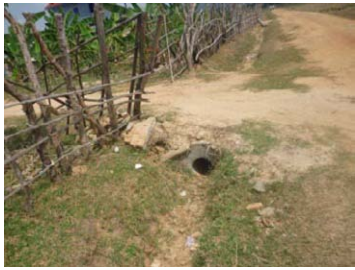
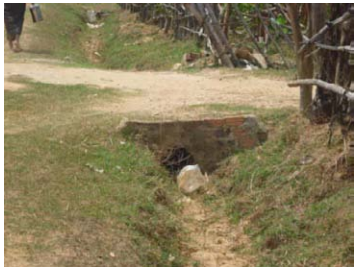
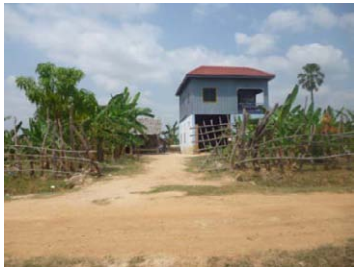
Canal No.: SC-5	Kind of structure: Pipe culvert	Remarks: Entrance with pipe culvert
Station:	Coordinate< Northing: 1236657 Easting: 447497

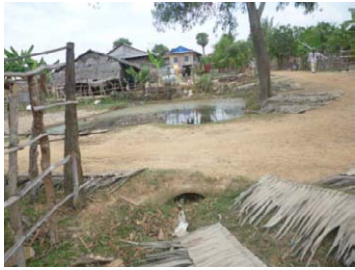
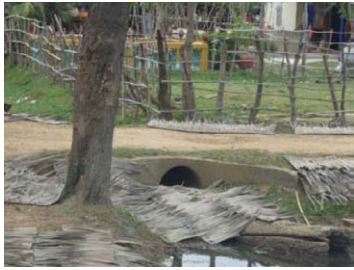
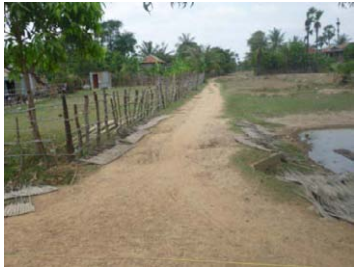
Canal No.: SC-5	Kind of structure: Pipe culvert	Remarks: Road Crossing with pipe culvert
Station:	Coordinate< Northing: 1226638 Easting: 447494

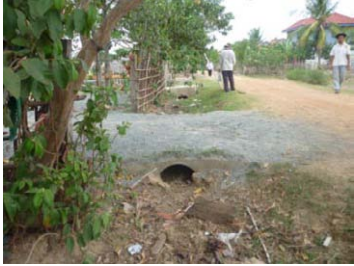
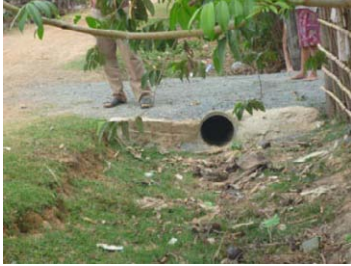
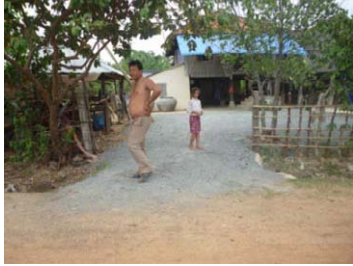
Canal No.: SC-5	Kind of structure: Pipe culvert	Remarks: Entrance with pipe culvert
Station:	Coordinate< Northing: 1236627 Easting: 447492

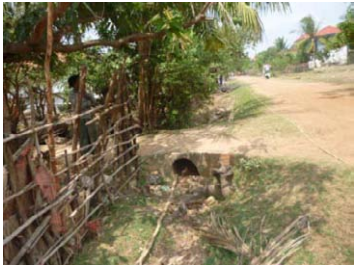
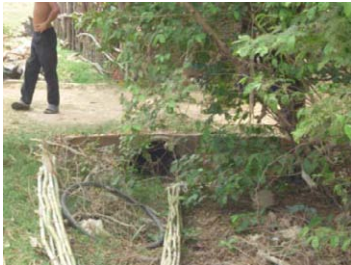
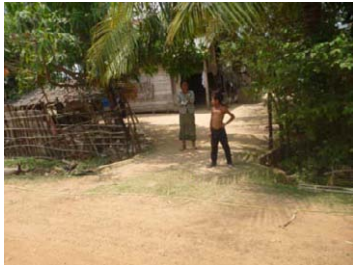
Canal No.: SC-5	Kind of structure: Pipe culvert	Remarks: Entrance with pipe culvert
Station:	Coordinate< Northing: 1236608 Easting: 447490

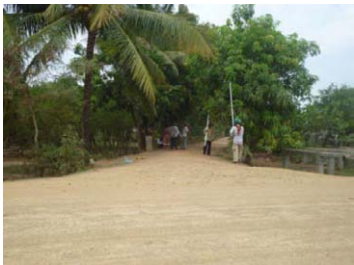
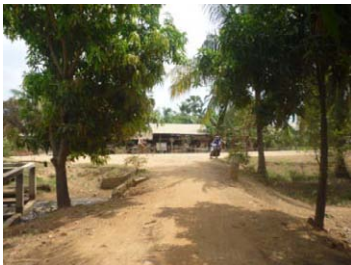
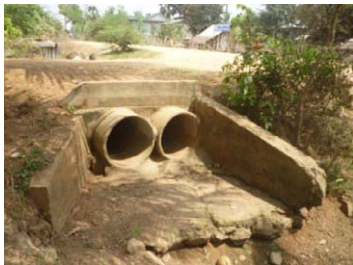
Canal No.: SC-5	Kind of structure: Pipe culvert(E.P.)	Remarks: E.P. of Secondary Canal No.5 with double pipe culvert
Station:	Coordinate< Northing: 1236608 Easting: 447490

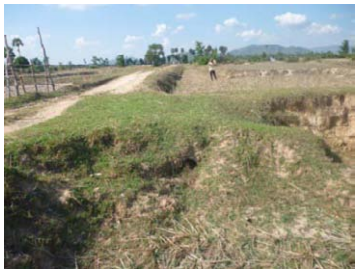
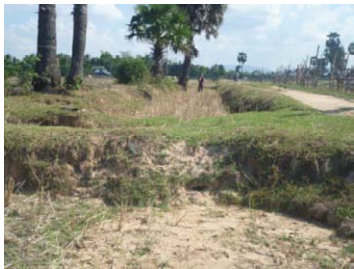
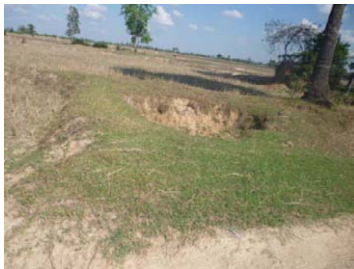
Canal No.: SC-7	Kind of structure: Pipe Culvert	Remarks: B.P. of Secondary Canal No.7 Pipe culvert along canal(D=1m)
Station:	Coordinate< <div style="display: flex; justify-content: space-between; padding: 0 10px;"> <span>Northing: 1235672</span> <span>Easting: 446194</span> </div>

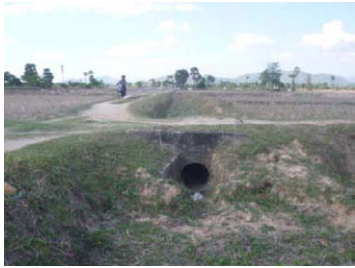
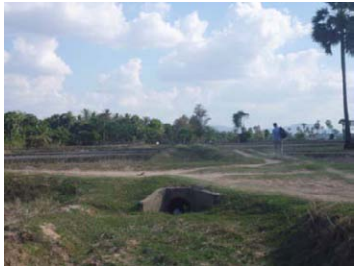
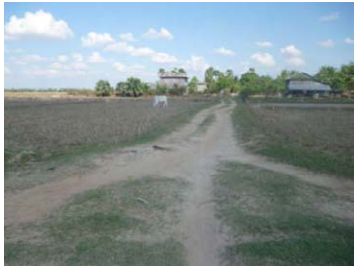
Canal No.: SC-7	Kind of structure: Pipe Culvert	Remarks: Road crossing with pipe culvert
Station:	Coordinate< <div style="display: flex; justify-content: space-between; padding: 0 10px;"> <span>Northing: 1234941</span> <span>Easting: 446274</span> </div>

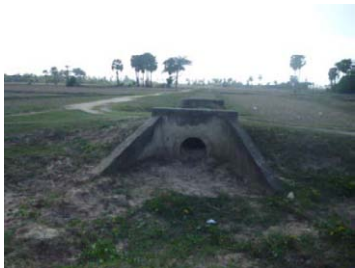
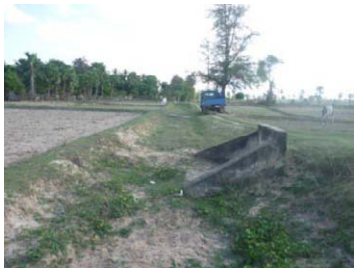
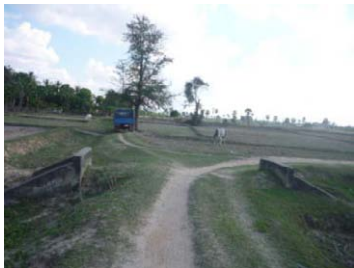
Canal No.: SC-7	Kind of structure: Turnout	Remarks: Pipe culvert (turnout) to the right tertiary canal
Station:	Coordinate< <div style="display: flex; justify-content: space-between; padding: 0 10px;"> <span>Northing: 1234808</span> <span>Easting: 446291</span> </div>

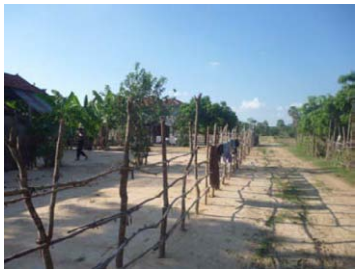
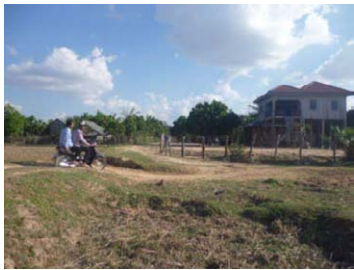
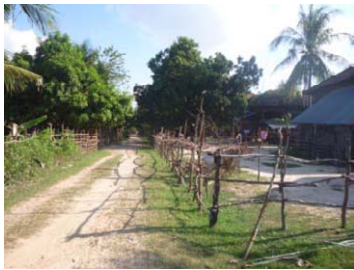
Canal No.: SC-7	Kind of structure: Garden	Remarks: Private garden on Secondary Canal without structure
Station:	Coordinate< Northing: 1234298 Easting: 446363

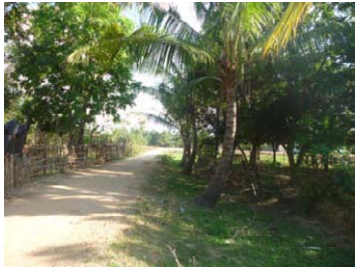
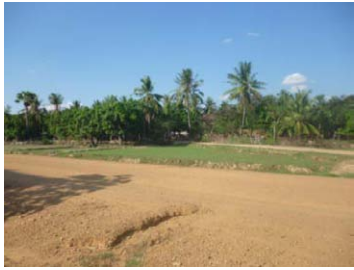
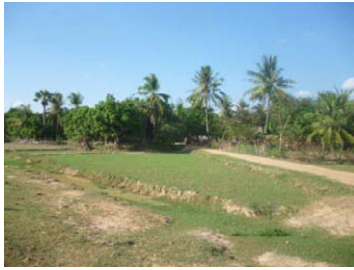
Canal No.: SC-7	Kind of structure: E.P.	Remarks: E.P. of Secondary Canal No.7 without structure
Station:	Coordinate< Northing: 1233979 Easting: 446393

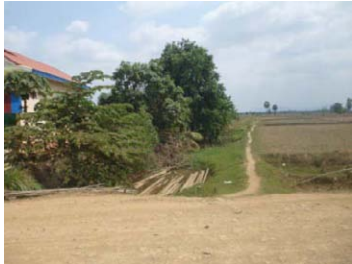
Canal No.: SC-8	Kind of structure: B.P.	Remarks: B.P. of Secondary Canal No.8 without structure
Station:	Coordinate< Northing: 1236105 Easting: 447209

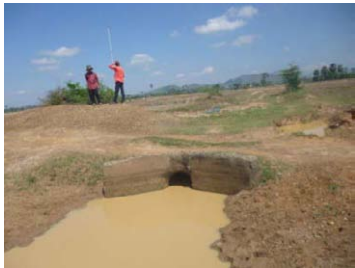
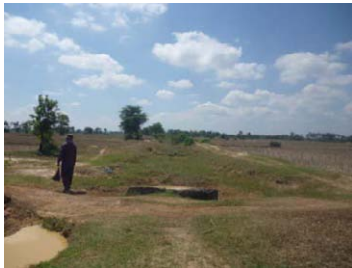
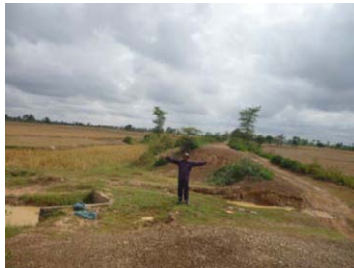
Canal No.: SC-8	Kind of structure: Pipe Culvert	Remarks: E.P. of Secondary Canal No.8
Station:	Coordinate< Northing: 1235272 Easting: 447289

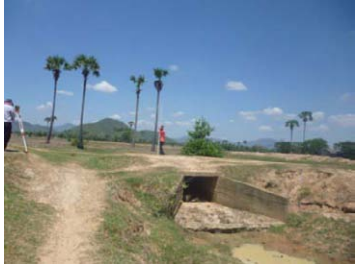
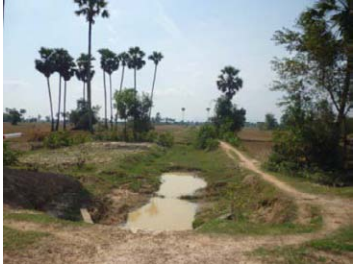
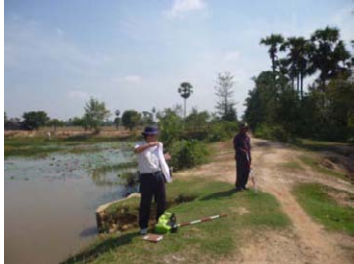
Canal No.: SC-9	Kind of structure: B.P.(Box Culvert)	Remarks: B.P. of Secondary Canal No.9 with box culvert
Station:	Coordinate< Northing: 1235179 Easting: 448338

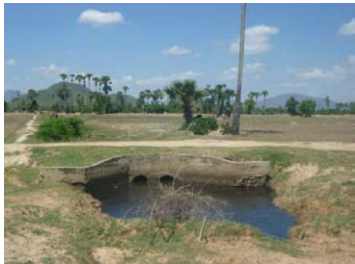
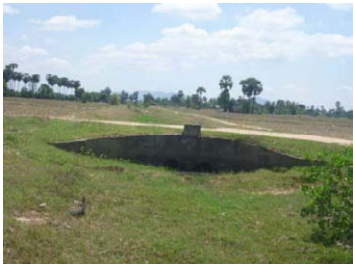
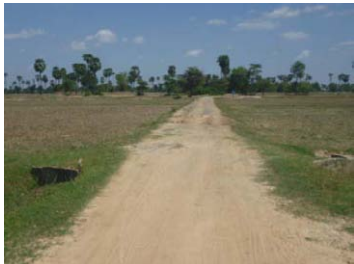
Canal No.: SC-9	Kind of structure: Pipe Culvert (Double)	Remarks: Road Crossing with double pipe culverts.
Station:	Coordinate< Northing: 1234865 Easting: 444838

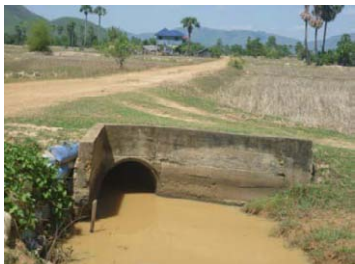
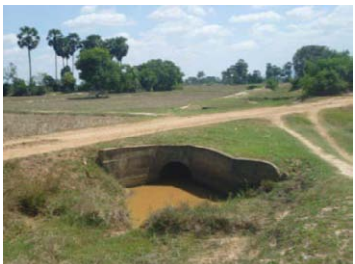
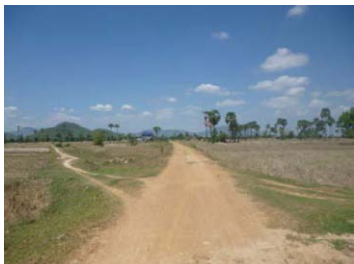
Canal No.: SC-9	Kind of structure: Pipe Culvert	Remarks: Road crossing above pipe culvert
Station:	Coordinate< Northing: 1234537 Easting: 448338

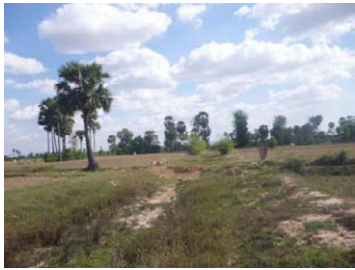
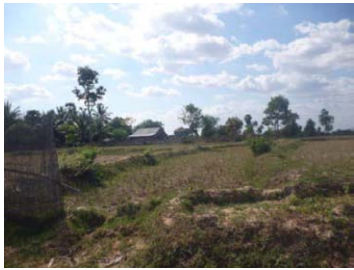
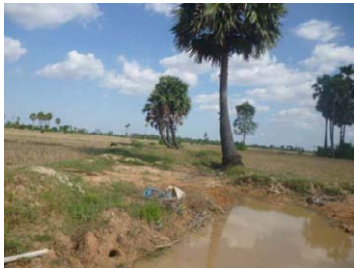
Canal No.: SC-9	Kind of structure: Canal crossing	Remarks: Tertiary canal crossing without structure
Station:	Coordinate< Northing: 1234233 Easting: 448340

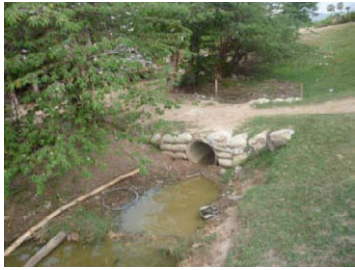
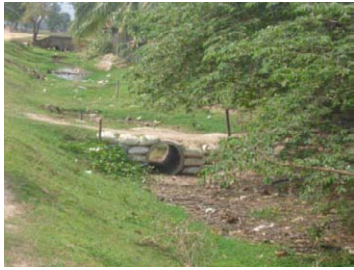
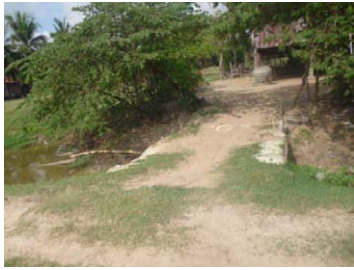
Canal No.: SC-9	Kind of structure: Pipe Culvert	Remarks: Pipe culvert for entrance
Station:	Coordinate< Northing: 12333107 Easting: 448357

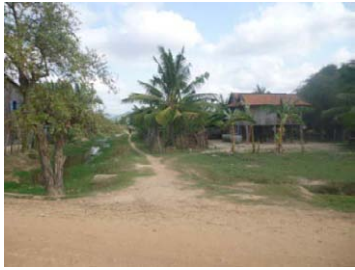
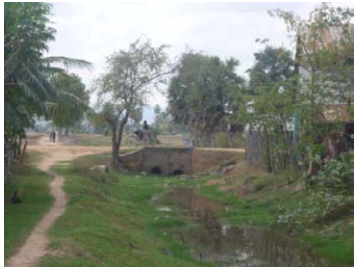
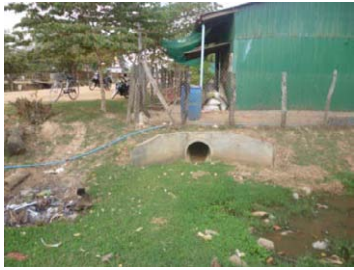
Canal No.: SC-9	Kind of structure: Turnout (Drain Inlet)	Remarks: Canal crossing with both-side pipe culverts.
Station:	Coordinate< Northing: 1233019 Easting: 448357

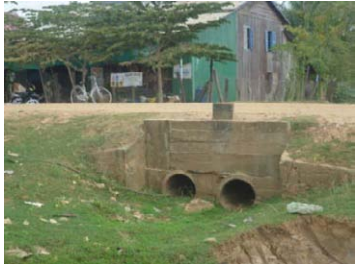
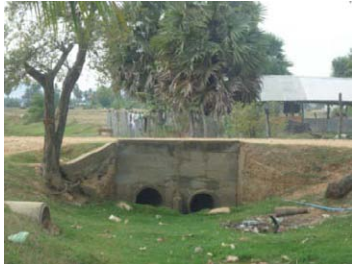
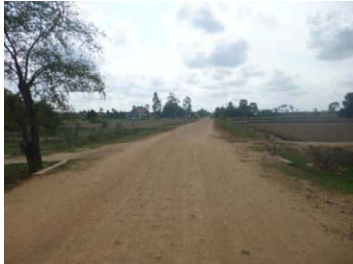
Canal No.: SC-9	Kind of structure: Turnout (Drain Inlet)	Remarks:
Station:	Coordinate< Northing: 1233019 Easting: 448357	E.P. of Secondary Canal No.9 Double pipe culvert under major road

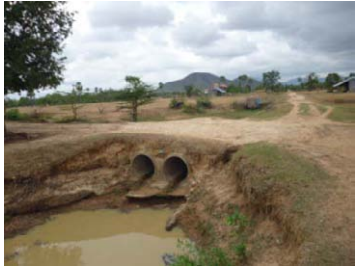
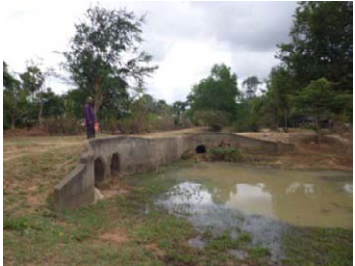
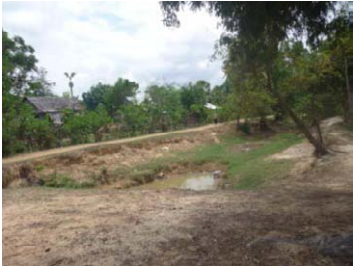
Canal No.: SC-11	Kind of structure: B.P. (Double Pipe Culvert)	Remarks: B.P. of Secondary Canal No.11
Station:	Coordinate< Northing: 1235192 Easting: 449349	Double culvert Turnout from Main Canal 35

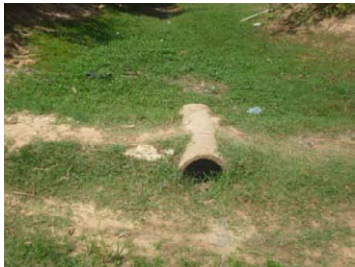
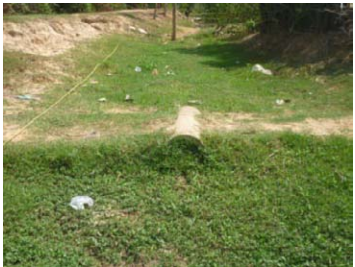
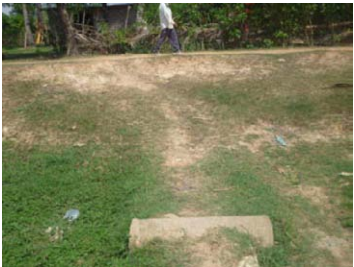
Canal No.: SC-11	Kind of structure: Pipe Culvert	Remarks: Pipe culvert for entrance
Station:	Coordinate< Northing: 1234920 Easting: 449350

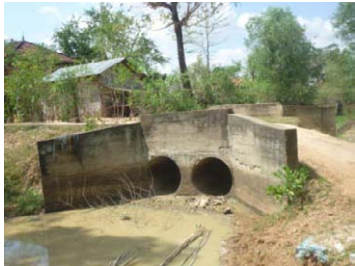
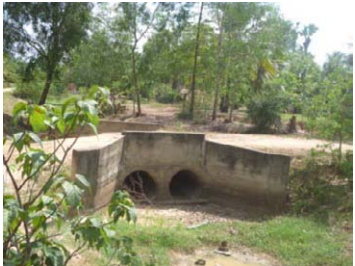
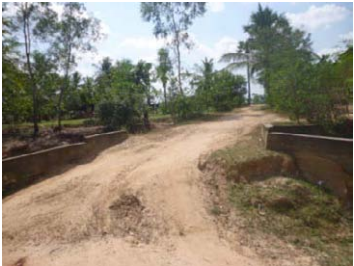
Canal No.: SC-11	Kind of structure: Pipe Culvert (Double)	Remarks: Double pipe culvert under major road
Station:	Coordinate< Northing: 1234747 Easting: 449352

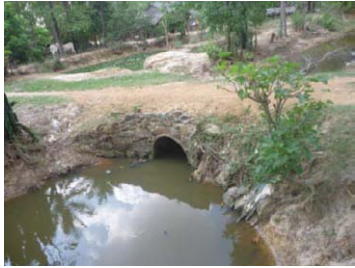
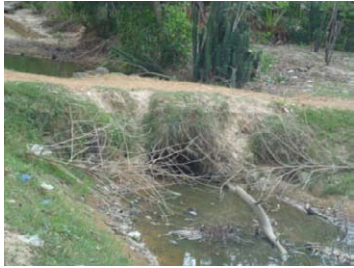
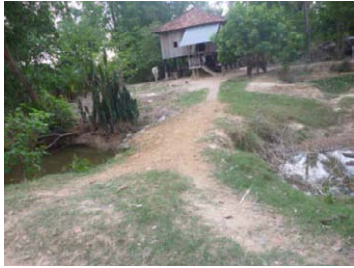
Canal No.: SC-11	Kind of structure: Pipe Culvert	Remarks: Pipe culvert for entrance
Station:	Coordinate< Northing: 1234607 Easting: 449352

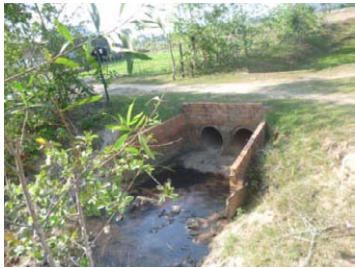
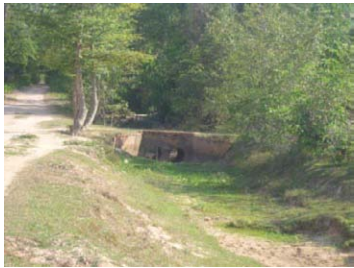
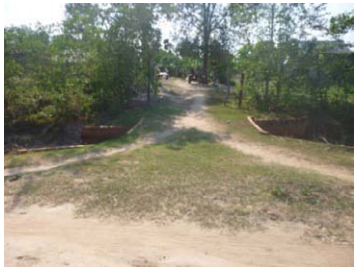
Canal No.: SC-11	Kind of structure: Pipe Culvert	Remarks: Pipe culvert for entrance
Station:	Coordinate< Northing: 1233991 Easting: 449361

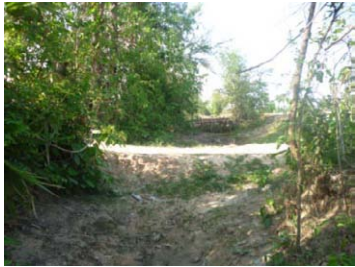
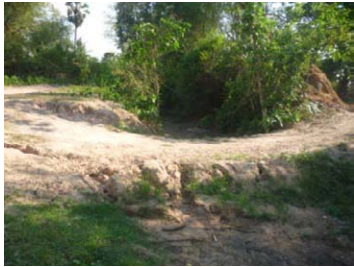
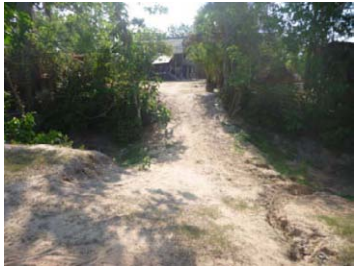
Canal No.: SC-11	Kind of structure: Entrance	Remarks: Entrance without structure
Station:	Coordinate< Northing: 1233957 Easting: 449363

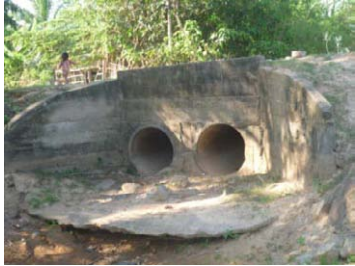
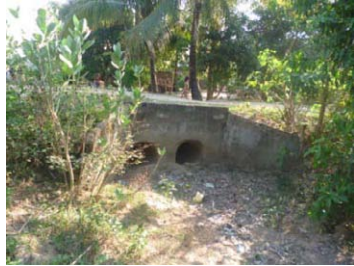
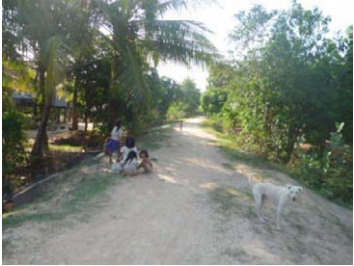
Canal No.: SC-11	Kind of structure: Pipe Culvert (Double)	Remarks:
Station:	Coordinate< Northing: 1233730 Easting: 449370	E.P. of Secondary Canal No.11

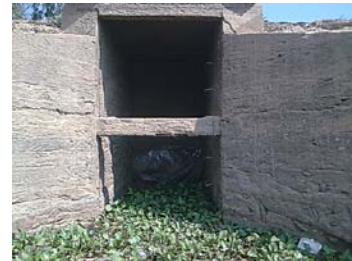
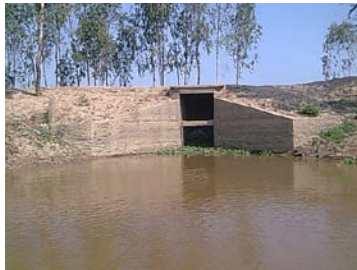
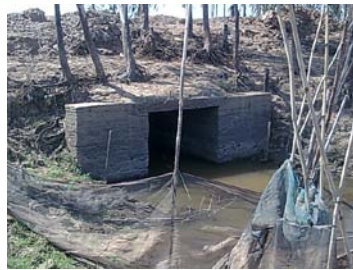
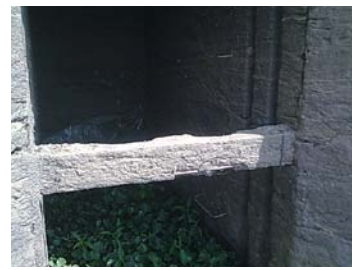
**No.1**

Condition / Problem:

The structure is possible used and constructed in Pol Pot time.

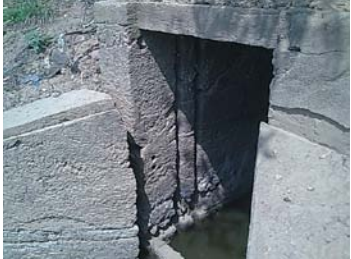
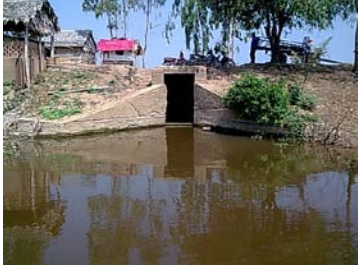
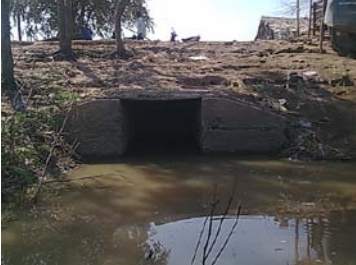
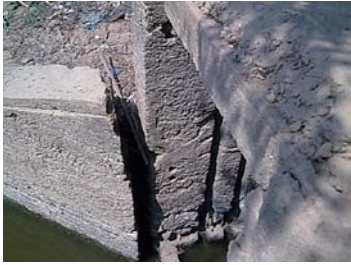
Photo Details			
Condition / Problem: The structure is possible used and constructed in Pol Pot time.			
Dimensions & Sketches:

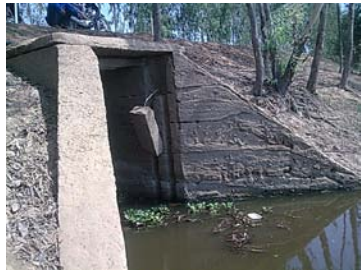
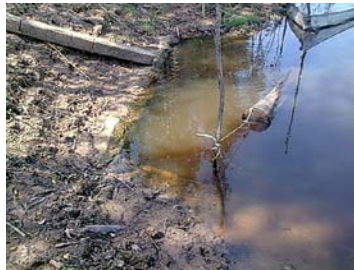
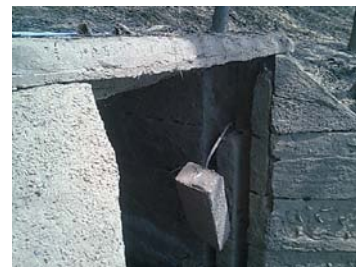
Condition / Problem:

The structure is possible used and constructed in Pol Pot time.

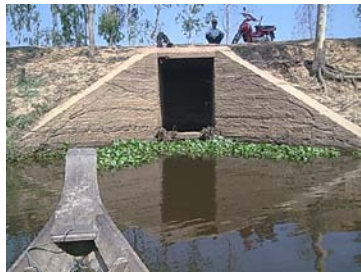
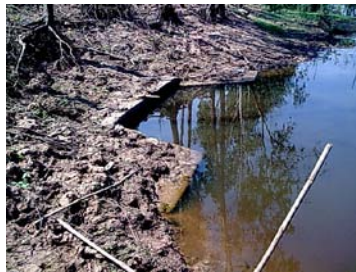
Condition / Problem:

The structure is possible used and constructed in Pol Pot time.

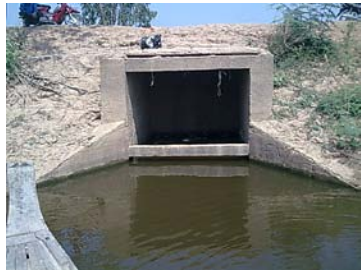
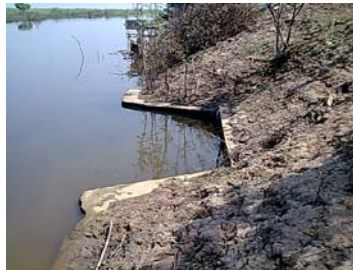
Condition / Problem:

The structure is possible used and constructed in Pol Pot time.

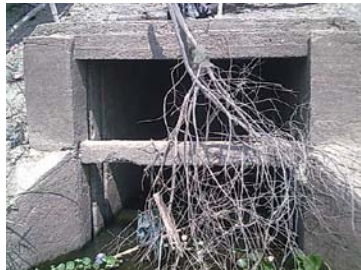
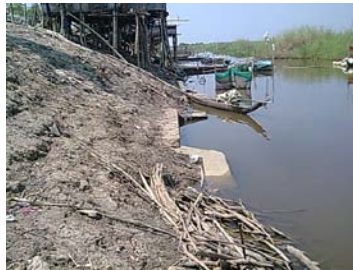
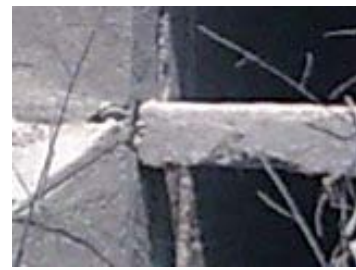
Condition / Problem:

The structure is possible used and constructed in Pol Pot time.
