# ***ANNEX D***

*Results of Inventory Survey for Irrigation and Drainage*

*Facilities in Kandal Stung – Bati Irrigation System*

*Rehabilitation Sub-project*

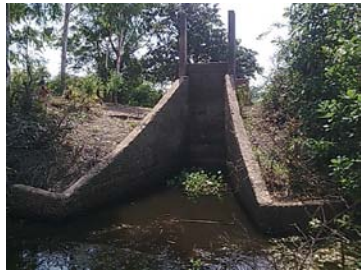
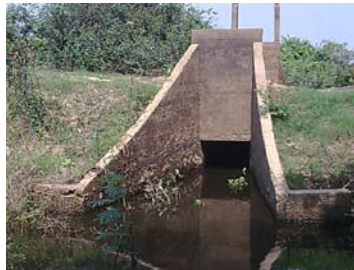
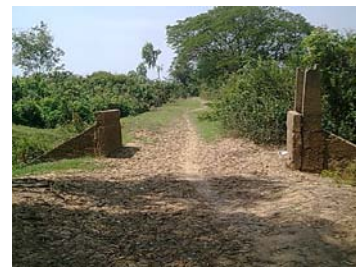
Condition / Problem:

The structure is possible used and constructed in Pol Pot time.

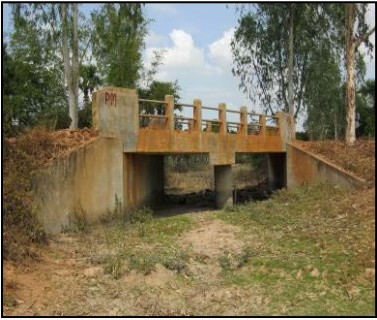
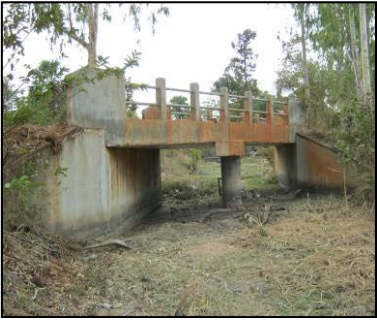
Canal No.: MC	Kind of structure: Pipe Culvert	Remarks: Bridge crossing the Main canal on road to Trapang Khlong Village.
Station:	Coordinate< Northing: 1330320 Easting: 440919

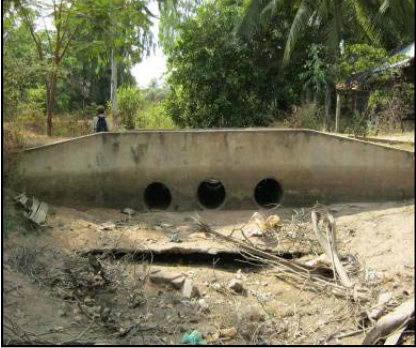
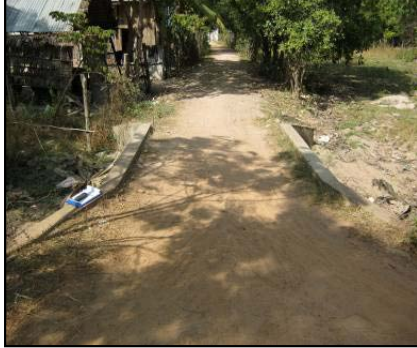
Canal No.: MC	Kind of structure: Pipe Culvert	Remarks: Pipe culvert crossing the canal to Beung Steng Village Dimension: Culvert 0.6m(3row)
Station:	Coordinate< Northing: 1330496 Easting: 441498

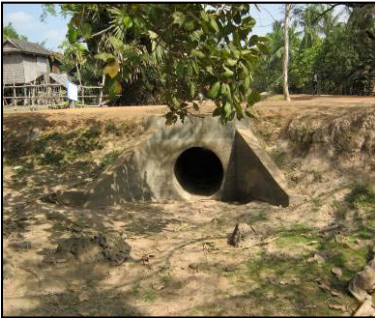
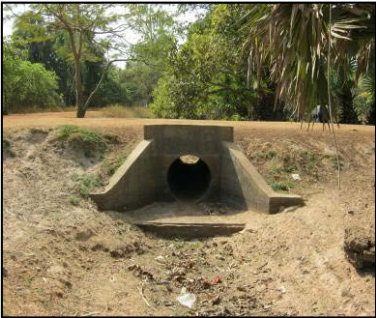
Canal No.: MC	Kind of structure: Pipe Culvert	Remarks: Pipe culvert to Wat village Dimension: Culvert 0.5m (2row)
Station:	Coordinate< Northing: 1330626 Easting: 442129

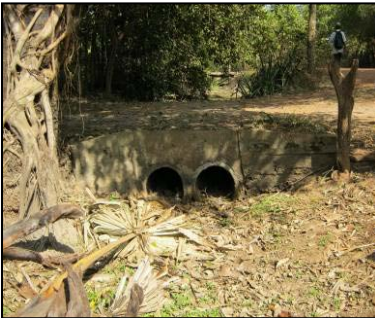
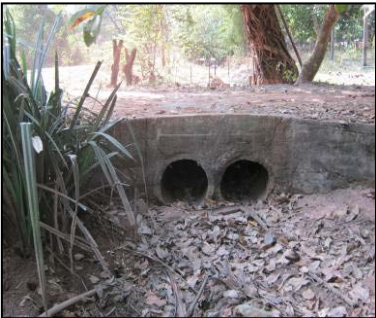
Canal No.: MC	Kind of structure: Pipe Culvert	Remarks: Pipe culvert crossing the canal to Beung Steng Village Dimension: Culvert 0.8m(1row)
Station:	Coordinate< Northing: 1330521 Easting: 441626

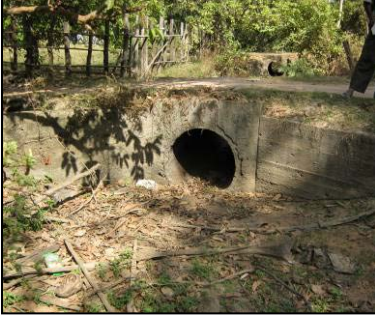
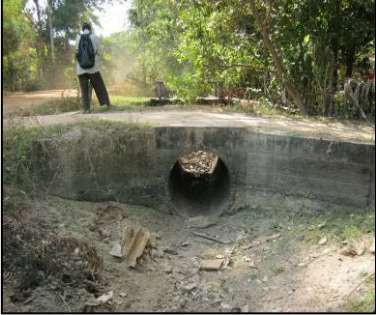
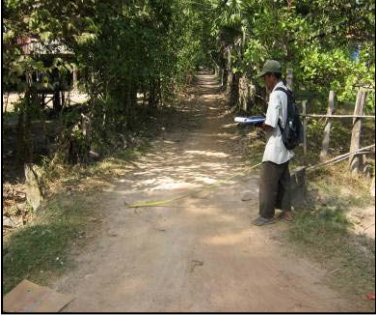
Canal No.: MC	Kind of structure: Pipe Culvert	Remarks: Pipe culvert to Wat village Dimension: Culvert 0.5m (2row)
Station:	Coordinate< Northing: 1330639 Easting: 442198

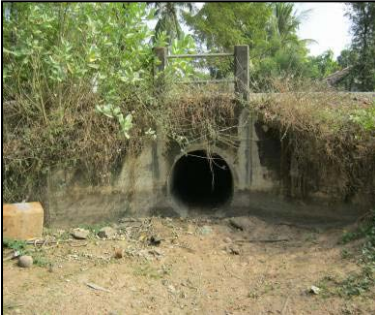
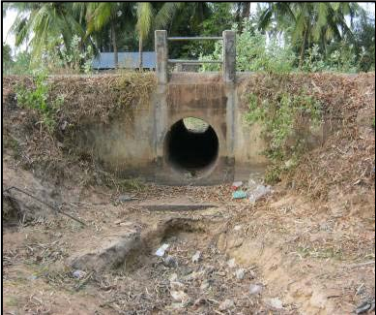
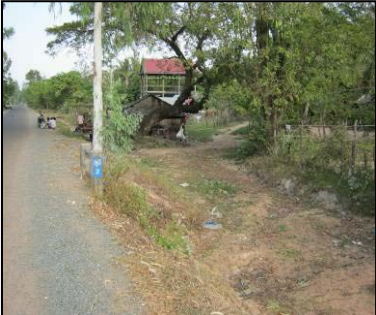
Canal No.: MC	Kind of structure: Pipe Culvert	Remarks: Pipe culvert crossing the canal on the asphalt road. Dimension: Culvert 1m (1row)
Station:	Coordinate< Northing: 1330788 Easting: 442390

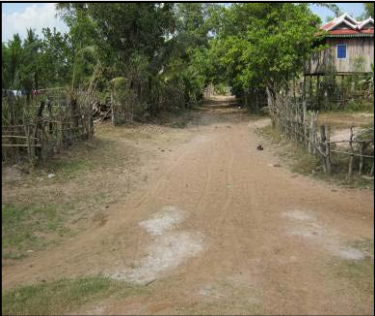
Canal No.: MC	Kind of structure: Road	Remarks: The road crossing the Main canal to Beung Steng Village but without structure.
Station:	Coordinate< Northing: 1330535 Easting: 441720

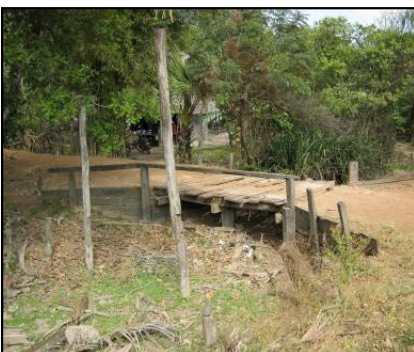
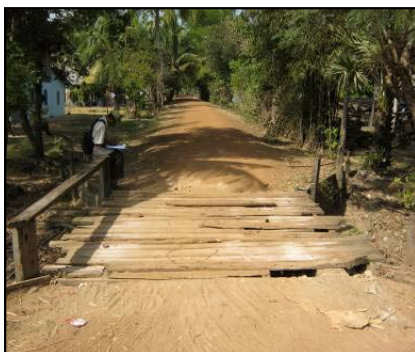
Canal No.: MC	Kind of structure: Wood Bridge	Remarks: Wood bridge crossing the canal to Wat village
Station:	Coordinate< Northing: 1330580 Easting: 441924

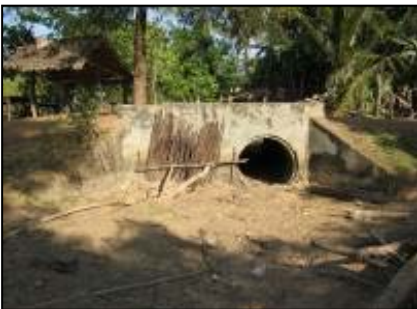
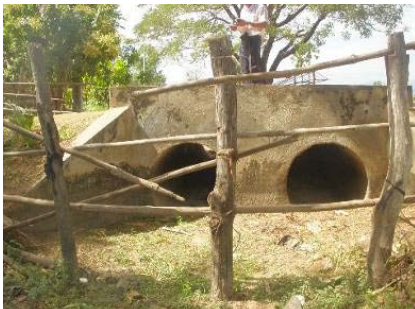
Canal No.: MC	Kind of structure: Pipe Culvert	Remarks: Pipe culvert on the access road crossing Main Canal. Diameter culvert 0,8m x2 (2 rows)
Station:	Coordinate< Northing: 1330833 Easting: 443228

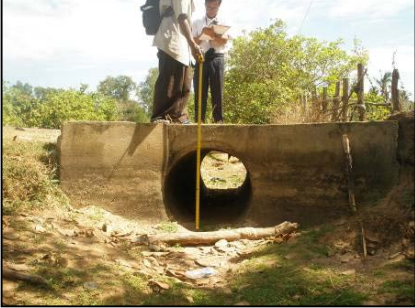
Canal No.: MC	Kind of structure: Pipe Culvert	Remarks: Pipe culvert on the access road crossing Main Canal. Diameter culvert 0.6m (1 row)
Station:	Coordinate< Northing: 1330852 Easting: 443277

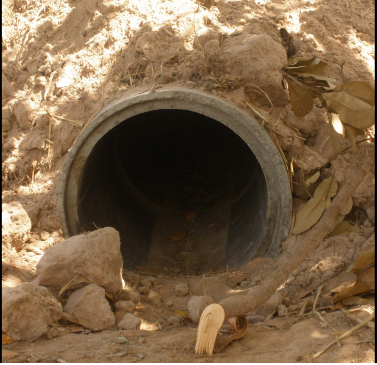
Canal No.: MC	Kind of structure: Pipe culvert	Remarks: Pipe culvert on crossing Main Canal. Diameter culvert 0.6m (1 row)
Station:	Coordinate< Northing: 1330854 Easting: 443307

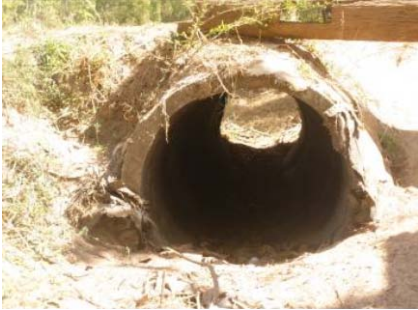
Canal No.: MC	Kind of structure: Pipe Culvert	Remarks: Pipe culvert on crossing Main Canal. Diameter culvert 0.6m (1 row)
Station:	Coordinate< Northing: 1330858 Easting: 443356

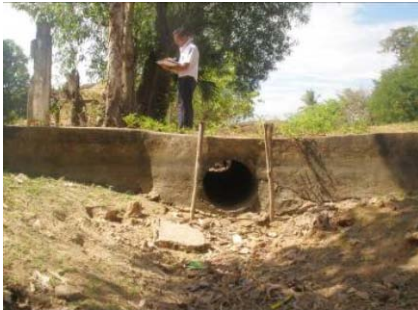
Canal No.: MC	Kind of structure: Pipe Culvert	Remarks: Pipe culvert on crossing Main Canal. Diameter culvert 0,6m (1 row)
Station:	Coordinate< Northing: 1330860 Easting: 443375

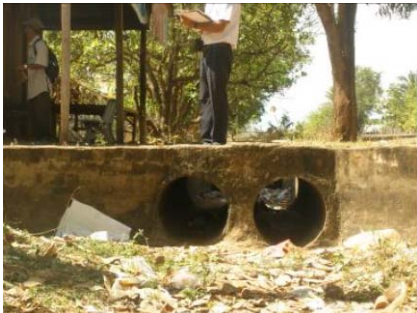
Canal No.: MC	Kind of structure: Pipe culvert	Remarks: Pipe culvert crossing the Main Canal. Diameter culvert 0,8m x 2 (2 rows)
Station:	Coordinate< Northing: 1330870 Easting: 443446

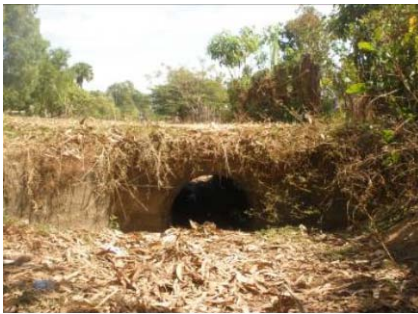
Canal No.: MC	Kind of structure: Pipe culvert	Remarks: Pipe culvert crossing the Main Canal. Diameter culvert 0,7m (1row)
Station:	Coordinate< Northing: 1330873 Easting: 443461

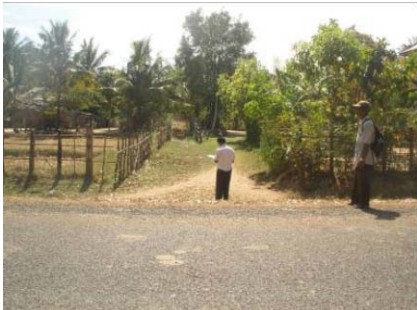
Canal No.: MC	Kind of structure: Access road	Remarks: Access road crossing the Main Canal
Station:	Coordinate< <div style="display: flex; flex-direction: column; margin-left: 10px;"> <span>Northing: 1330870</span> <span>Easting: 443446</span> </div>

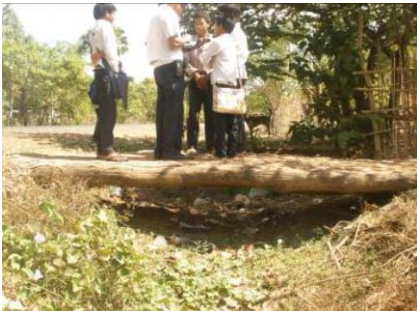
Canal No.: MC	Kind of structure: Wood bridge	Remarks: Wood bright crossing the main canal
Station:	Coordinate< <div style="display: flex; flex-direction: column; margin-left: 10px;"> <span>Northing: 1330879</span> <span>Easting: 443509</span> </div>

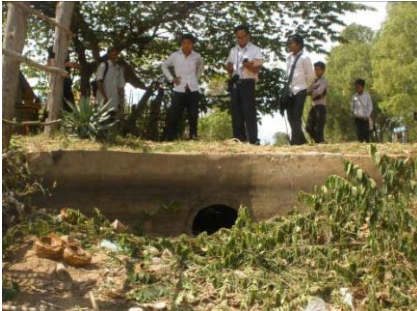
Canal No.: MC	Kind of structure: Pipe culvert	Remarks: Pipe culvert crossing the Main Canal. Diameter culvert 0,5m (1row)
Station:	Coordinate< <div style="display: flex; flex-direction: column; margin-left: 10px;"> <span>Northing: 1330878</span> <span>Easting: 443520</span> </div>

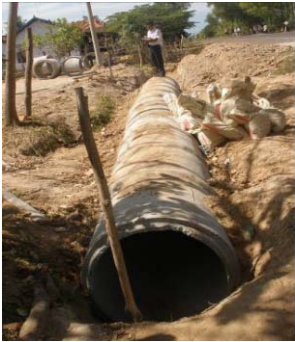
Canal No.: MC	Kind of structure: Pipe Culvert	Remarks: Pipe culvert crossing the Main Canal. Diameter culvert 0,8m (1row)
Station:	Coordinate< Northing: 1330881 Easting: 443550

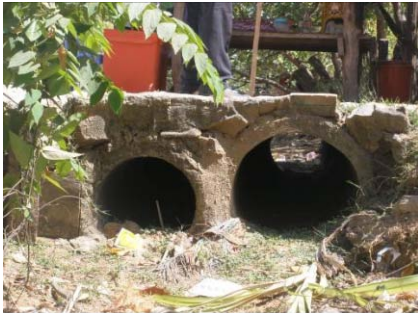
Canal No.: MC	Kind of structure: Pipe Culvert	Remarks: Pipe culvert crossing the Main Canal. Diameter culvert 0,5m, 0.7 x 2 (2 rows)
Station:	Coordinate< Northing: 1330887 Easting: 443550

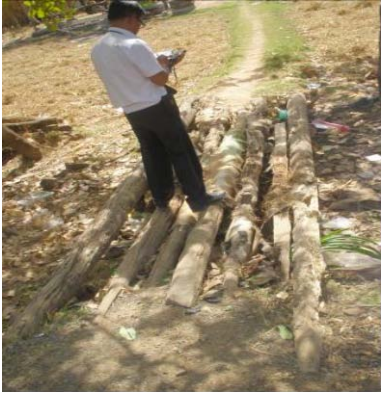
Canal No.: MC	Kind of structure: Wood Bridge	Remarks: Wood Bright crossing the Main Canal.
Station:	Coordinate< Northing: 1330889 Easting: 443597

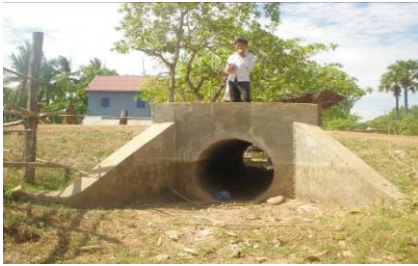
Canal No.: MC	Kind of structure: Pipe culvert	Remarks: Pipe culvert crossing the Main Canal. Diameter culvert 0,8m (1row)
Station:	Coordinate< Northing: 1330891 Easting: 443622

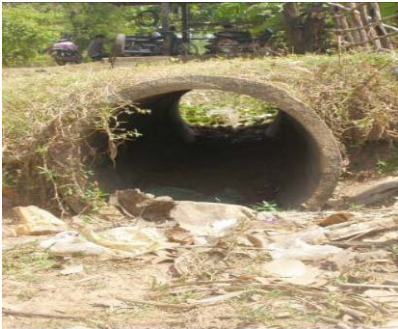
Canal No.: MC	Kind of structure: Pipe culvert	Remarks: Pipe culvert crossing the Main Canal. Diameter culvert 0,8m
Station:	Coordinate< Northing: 1330895 Easting: 443634

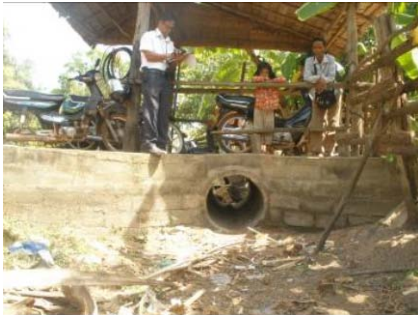
Canal No.: MC	Kind of structure: Pipe culvert	Remarks: Pipe culvert crossing the Main Canal. Diameter culvert 0,8m
Station:	Coordinate< Northing: 1330898 Easting: 443645

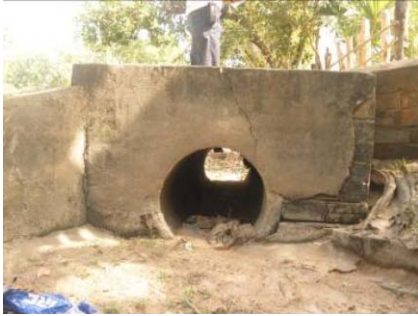
Canal No.: MC	Kind of structure: Pipe culvert	Remarks: Pipe culvert crossing the Main Canal. Diameter culvert 0,5m
Station:	Coordinate< Northing: 1330897 Easting: 443669

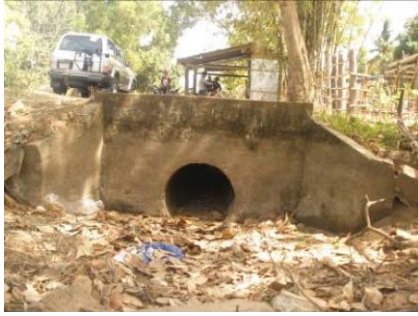
Canal No.: MC	Kind of structure: Pipe culvert	Remarks: Pipe culvert crossing the Main Canal. Diameter culvert 0,5m
Station:	Coordinate< Northing: 1330899 Easting: 443671

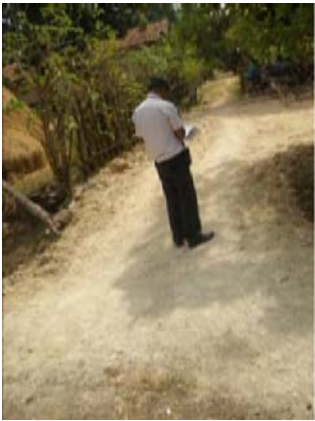
Canal No.: MC	Kind of structure: Road filling	Remarks: Road filling crossing the Main Canal. Diameter 3m x 6m
Station:	Coordinate< Northing: 13309003 Easting: 443693

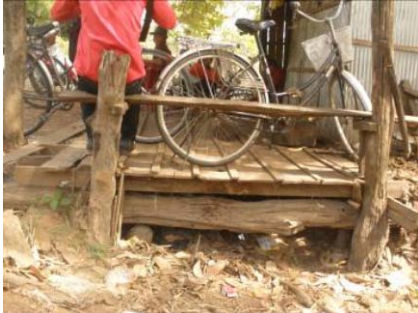
Canal No.: MC	Kind of structure: Wood Bridge	Remarks: Wood right crossing the Main Canal. Diameter culvert 0,8m
Station:	Coordinate< Northing: 1330906 Easting: 443716

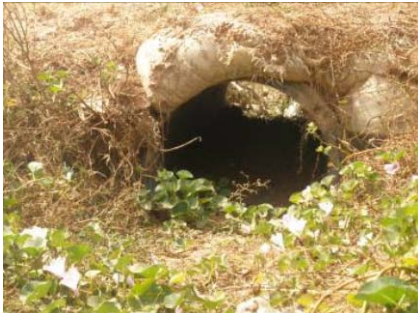
Canal No.: MC	Kind of structure: Pipe culvert	Remarks: Pipe culvert crossing the Main Canal. Diameter culvert 0,6m
Station:	Coordinate< Northing: 1330912 Easting: 443776

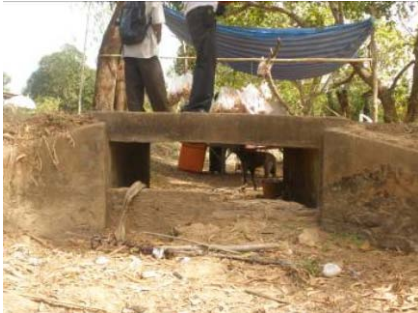
Canal No.: MC	Kind of structure: Box-culvert	Remarks: Box- culvert crossing the Main Canal. Diameter culvert 1.7mx1.0m
Station:	Coordinate< Northing: 1330928 Easting: 443909

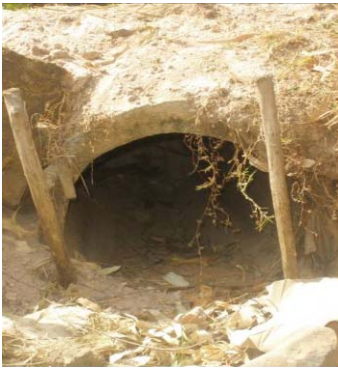
Canal No.: MC	Kind of structure: Pipe culvert	Remarks: Pipe culvert crossing the Main Canal. Diameter culvert 0,6m
Station:	Coordinate< Northing: 1330931 Easting: 443931

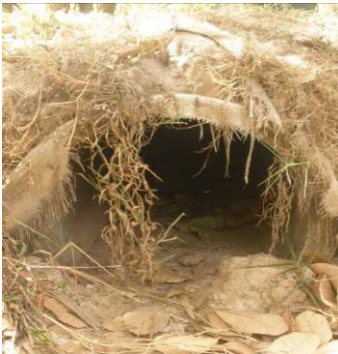
Canal No.: MC	Kind of structure: Pipe culvert	Remarks: Pipe culvert crossing the Main Canal. Diameter culvert 0,5m
Station:	Coordinate< Northing: 1330935 Easting: 443957

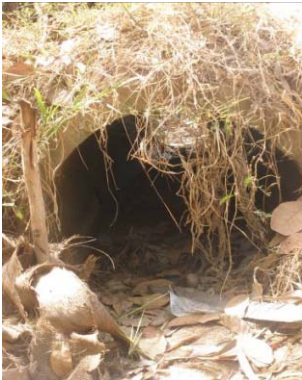
Canal No.: MC	Kind of structure: Pipe culvert	Remarks: Pipe culvert crossing the Main Canal. Diameter culvert 0,6m
Station:	Coordinate< Northing: 1330943 Easting: 444001

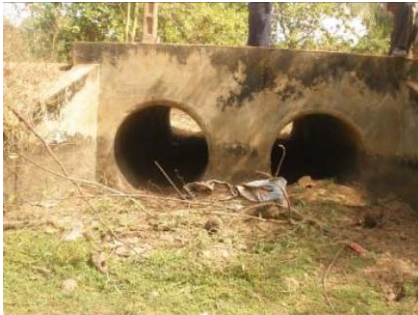
Canal No.: MC	Kind of structure: Pipe culvert	Remarks: Pipe culvert crossing the Main Canal. Diameter culvert 0,8m x2 (2row)
Station:	Coordinate< <div style="display: flex; flex-direction: column; gap: 5px;"> <span>Northing: 1330941</span> <span>Easting: 444030</span> </div>

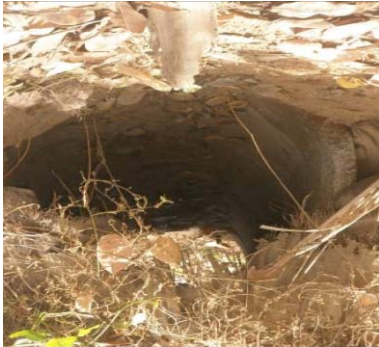
Canal No.: MC	Kind of structure: Pipe culvert	Remarks: Pipe culvert crossing the Main Canal. Diameter culvert 0,7m
Station:	Coordinate< <div style="display: flex; flex-direction: column; gap: 5px;"> <span>Northing: 1330947</span> <span>Easting: 444035</span> </div>

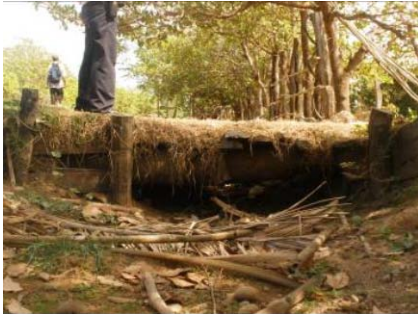
Canal No.: MC	Kind of structure: Wood Bridge	Remarks: Wood bright crossing the Main Canal. Diameter 4mx6m
Station:	Coordinate< <div style="display: flex; flex-direction: column; gap: 5px;"> <span>Northing: 1330948</span> <span>Easting: 444068</span> </div>

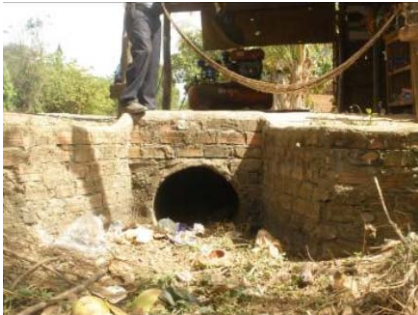
Canal No.: MC	Kind of structure: Pipe culvert	Remarks: Pipe culvert crossing the Main Canal. Diameter culvert 0.7m
Station:	Coordinate< Northing: 1330953 Easting: 444095

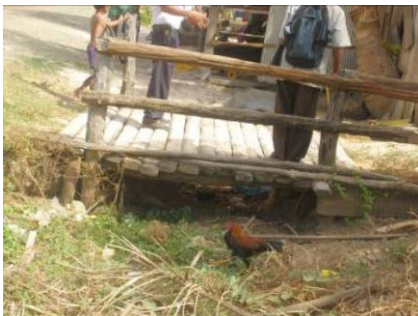
Canal No.: MC	Kind of structure: Wood Bridge	Remarks: Wood bridge crossing the Main Canal. Diameter 4m x 6m
Station:	Coordinate< Northing: 1330931 Easting: 443931

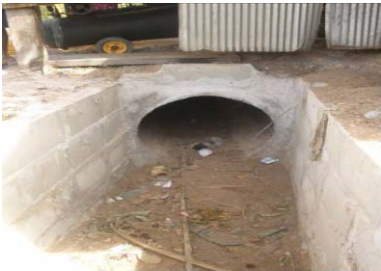
Canal No.: MC	Kind of structure: Pipe culvert	Remarks: Pipe culvert crossing the Main Canal. Diameter culvert 0,7m
Station:	Coordinate< Northing: 1330959 Easting: 444124

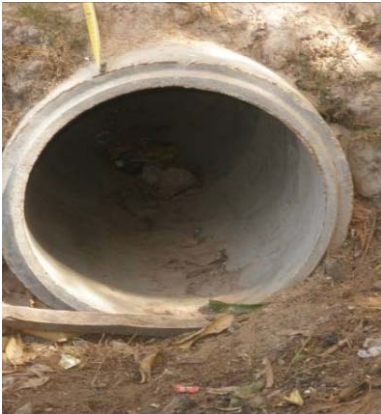
Canal No.: MC	Kind of structure: Pipe culvert	Remarks: Pipe culvert crossing the Main Canal. Diameter culvert 0.6 m
Station:	Coordinate< Northing: 1330960 Easting: 444139

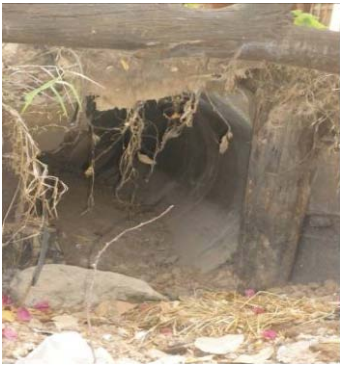
Canal No.: MC	Kind of structure: Pipe culvert	Remarks: Pipe Culvert crossing the Main Canal. Diameter culvert 0.6m
Station:	Coordinate< Northing: 1330970 Easting: 444218

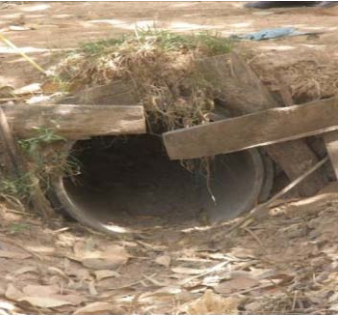
Canal No.: MC	Kind of structure: Pipe culvert	Remarks: Pipe Culvert crossing the Main Canal. Diameter Culvert 0.5m
Station:	Coordinate< Northing: 1330966 Easting: 444188

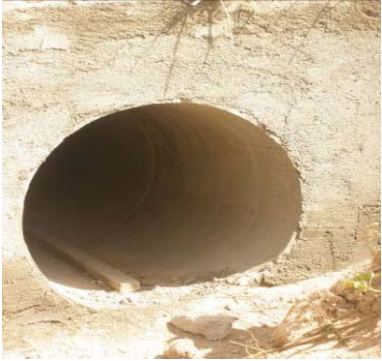
Canal No.: MC	Kind of structure: Pipe culvert	Remarks: Pipe culvert crossing the Main Canal. Diameter culvert 0.8m
Station:	Coordinate< Northing: 1330991 Easting: 444400

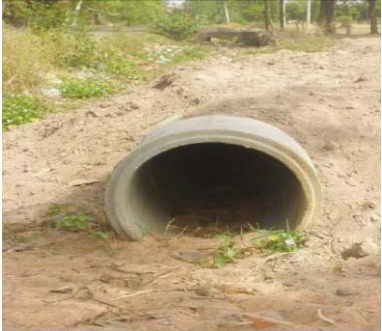
Canal No.: MC	Kind of structure: Pipe culvert	Remarks: Pipe culvert crossing the Main Canal. Diameter culvert 0.6m
Station:	Coordinate< Northing: 1330997 Easting: 444451

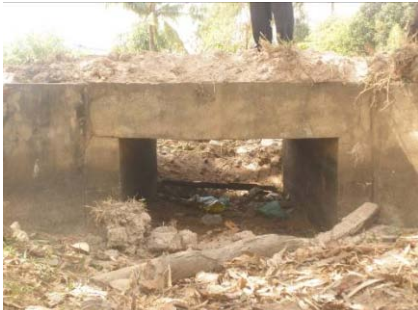
Canal No.: MC	Kind of structure: Box- culvert	Remarks: Box- culvert crossing the Main Canal. Diameter box-covert 1.5m x 0.8m
Station:	Coordinate< Northing: 1331003 Easting: 444483

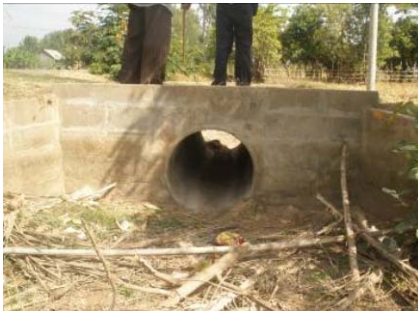
Canal No.: MC	Kind of structure: Pipe culvert	Remarks: Pipe culvert crossing the Main Canal. Diameter culvert 0.6m
Station:	Coordinate< Northing: 1331015 Easting: 444600

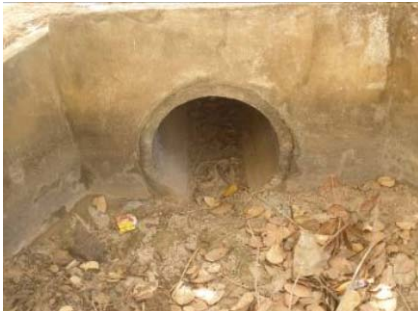
Canal No.: MC	Kind of structure: Pipe culvert	Remarks: Pipe culvert crossing the Main Canal. Diameter culvert 0.6m
Station:	Coordinate< Northing: 1331022 Easting: 444650

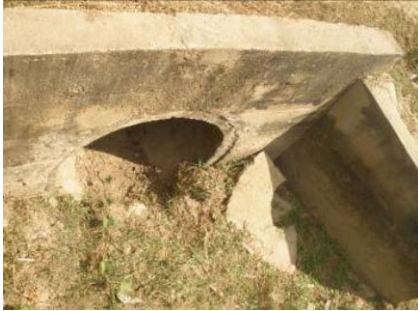
Canal No.: MC	Kind of structure: Pipe culvert	Remarks: Pipe culvert crossing the Main Canal. Diameter culvert 0.6m
Station:	Coordinate< Northing: 1331024 Easting: 444671

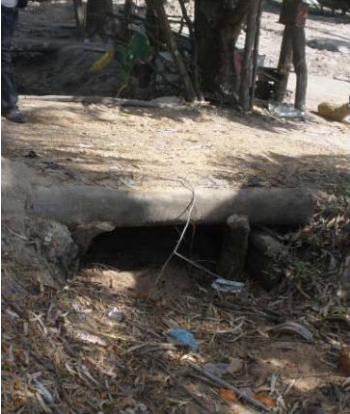
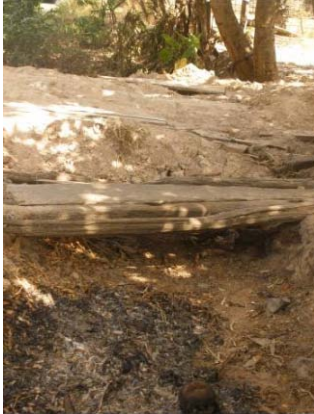
Canal No.: MC	Kind of structure: Wood Bridge	Remarks: Wood bright crossing the Main Canal. Diameter 5m x 3m
Station:	Coordinate< Northing: 1331043 Easting: 444808	
<div style="display: flex; justify-content: space-around;"> <div style="text-align: center;">

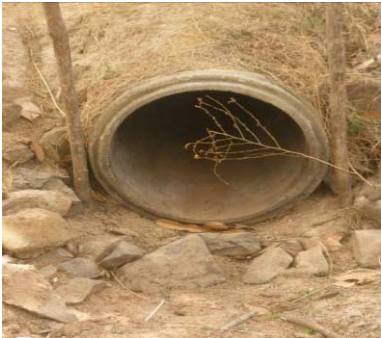
Canal No.: MC	Kind of structure: Pipe culvert	Remarks: Pipe culvert crossing the Main Canal. Diameter culvert 0.5m
Station:	Coordinate< Northing: 1331043 Easting: 444831

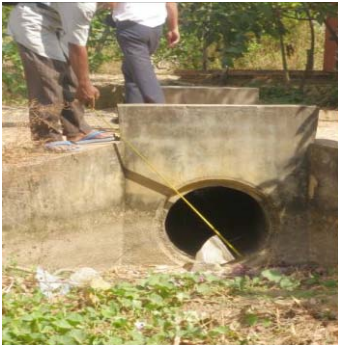
Canal No.: MC	Kind of structure: Pipe culvert	Remarks: Pipe culvert crossing the Main Canal. Diameter culvert 0.5 m
Station:	Coordinate< Northing: 1331047 Easting: 444880

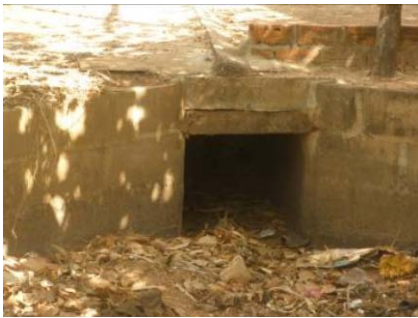
Canal No.: MC	Kind of structure: Box-culvert	Remarks: Box-culvert crossing the Main Canal. Diameter box-culvert 0.5m x 0.5m
Station:	Coordinate< Northing: 1331050 Easting: 444892

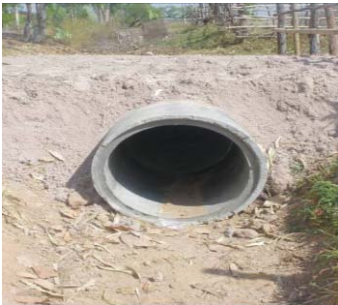
Canal No.: MC	Kind of structure: Pipe culvert	Remarks: Pipe culvert crossing the Main Canal. Diameter culvert 0.6m
Station:	Coordinate< Northing: 1331053 Easting: 444931

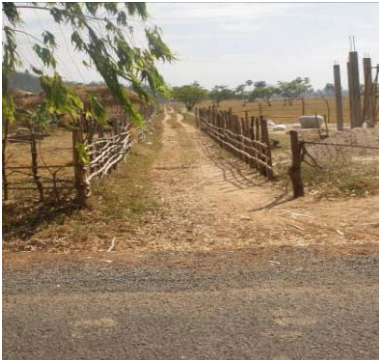
Canal No.: MC	Kind of structure: Secondary canal-7	Remarks: Secondary canal-7 crossing the Main Canal. Diameter b=2.0 m
Station:	Coordinate< Northing: 1331055 Easting: 444937

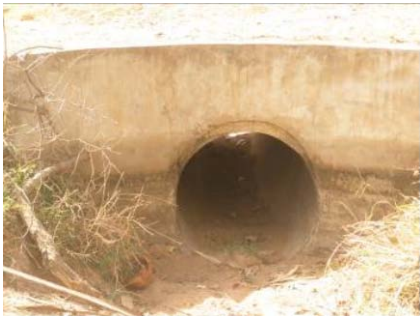
Canal No.: MC	Kind of structure: Pipe culvert	Remarks: Pipe culvert crossing the Main Canal. Diameter culvert 0.7m
Station:	Coordinate< Northing: 1331058 Easting: 444954

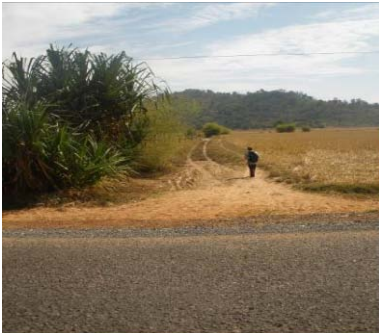
Canal No.: MC	Kind of structure: Secondary canal-6	Remarks: Secondary Canal-6 crossing the Main Canal. Diameter b=1.5m
Station:	Coordinate< Northing: 1330966 Easting: 444188

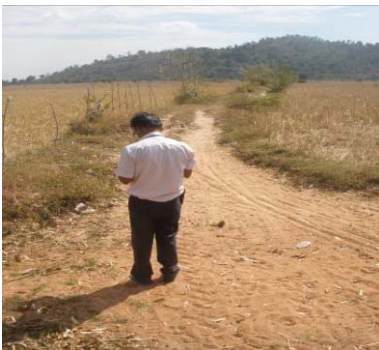
Canal No.: MC	Kind of structure: Road cow	Remarks: Road cow crossing the Main Canal. Diameter b=4 m
Station:	Coordinate< Northing: 1331161 Easting: 445834

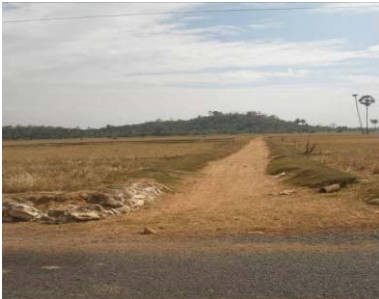
Canal No.: MC	Kind of structure: Secondary Canal-4	Remarks: Secondary canal-4 crossing the Main Canal. Diameter b=3m
Station:	Coordinate< Northing: 1331237 Easting: 446481

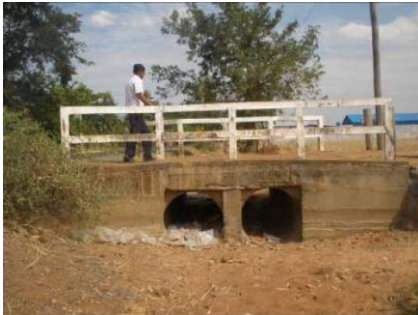
Canal No.: MC	Kind of structure: Pipe culvert	Remarks: Pipe culvert crossing the Main Canal. Diameter culvert 0.9m x 2 (2row)
Station:	Coordinate< Northing: 1331301 Easting: 446998

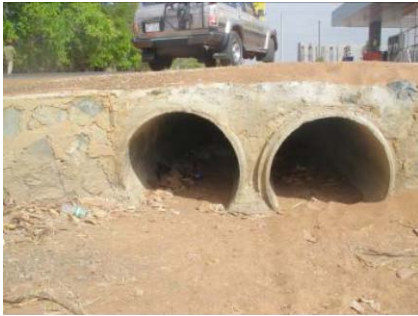
Canal No.: MC	Kind of structure: Pipe culvert	Remarks: Pipe culvert crossing the Main Canal. Diameter culvert 0.8m x 2 (2row)
Station:	Coordinate< Northing: 1331313 Easting: 447106

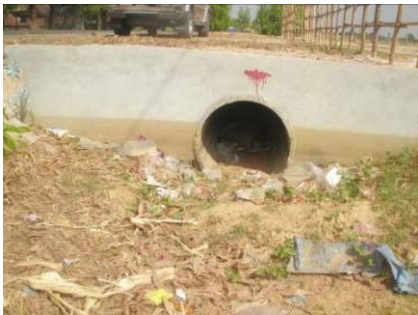
Canal No.: MC	Kind of structure: Pipe culvert	Remarks: Pipe culvert crossing the Main Canal. Diameter culvert 0.8 m
Station:	Coordinate< Northing: 1331339 Easting: 447310

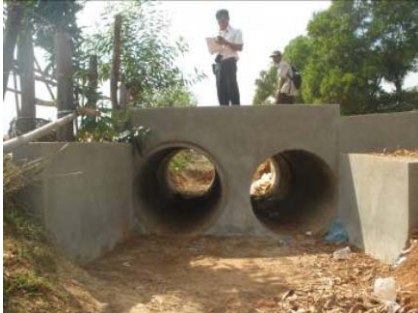
Canal No.: MC	Kind of structure: Pipe culvert	Remarks: Pipe culvert crossing the Main Canal. Diameter culvert 0.8m x 2 (2row)
Station:	Coordinate< Northing: 1331344 Easting: 447377

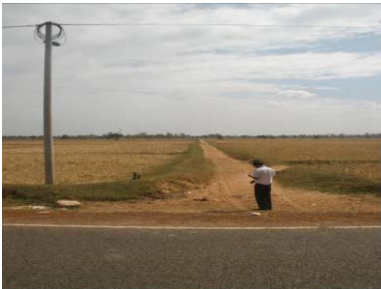
Canal No.: MC	Kind of structure: Secondary canal-3	Remarks: Secondary canal-3 crossing the Main Canal. Diameter b=2.5 m
Station:	Coordinate< Northing: 1331360 Easting: 447509

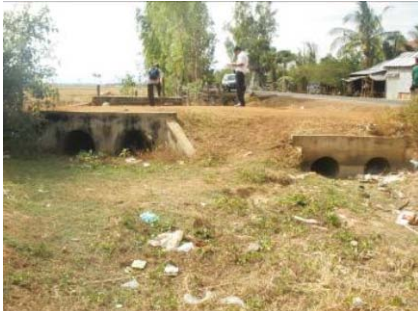
Canal No.: MC	Kind of structure: Pipe culvert	Remarks: Pipe culvert crossing the Main Canal. Diameter culvert 0.8m x 2 (2row)
Station:	Coordinate< Northing: 1331388 Easting: 447767

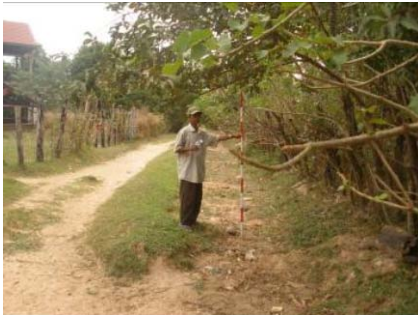
Canal No.: MC	Kind of structure: Secondary canal-2	Remarks: Secondary canal-2 crossing the Main Canal. Diameter b=2 m
Station:	Coordinate< Northing: 1330494 Easting: 442836

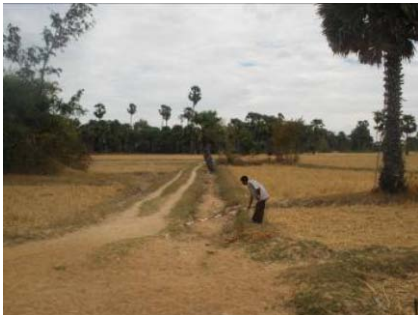
Canal No.: MC	Kind of structure: Secondary canal-1	Remarks: Secondary canal -1crossing the Main Canal. Diameter b=1 m
Station:	Coordinate< Northing: 1329755 Easting: 441228

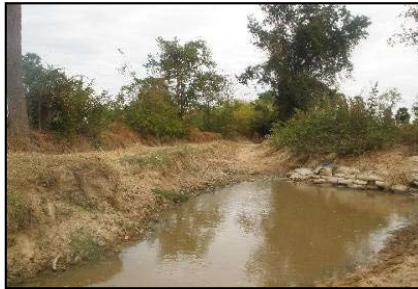
Canal No.: MC	Kind of structure: Secondary canal-1	Remarks: Star point the Main Canal. Diameter b=1 m
Station:	Coordinate< Northing: 1329755 Easting: 441228

<p>Photo View from Upstream</p>

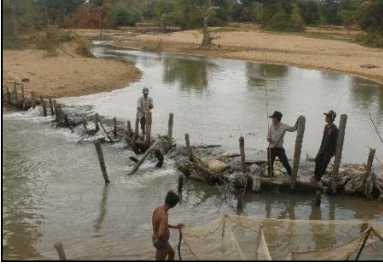
Canal No.: MC	Kind of structure: Secondary canal-1	Remarks: By people check crossing Daun Pue Strea
Station:	Coordinate< Northing: 1329755 Easting: 441228

<p align="center">View from Upstream</p>

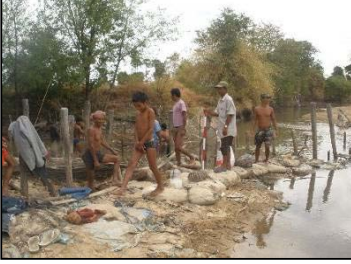
<p align="center">View from Downstream</p>
