FCSEC Technical Report
Volume 3

The Mayon 2006 Debris Flows

The Destructive Path of Typhoon Reming

This paper discusses the result of damage investigation and disaster survey of Region V conducted by Japanese Survey Team together with JICA Experts and staff from FCSEC from 10-16 December 2006.

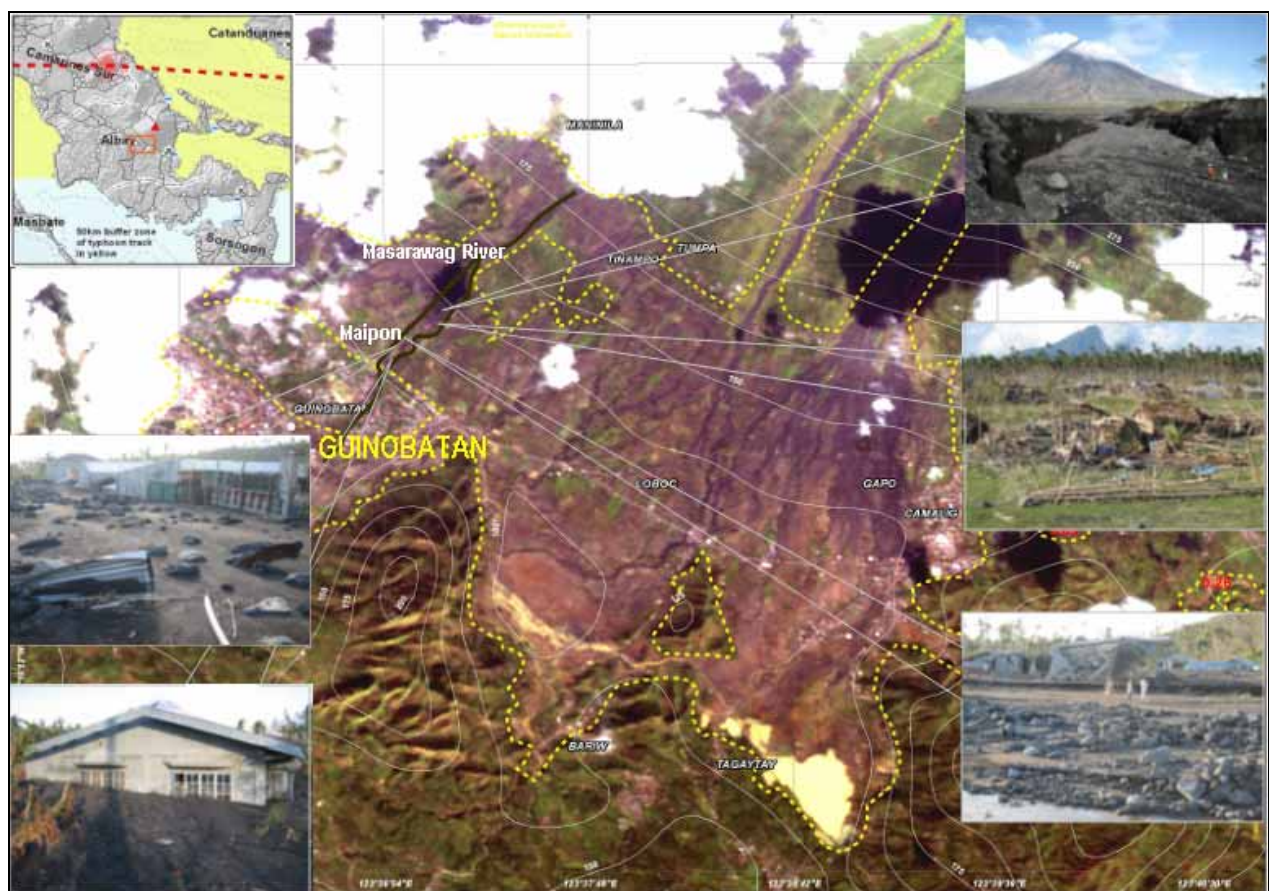
Figure8 Barangays Maipon and Masarawag, Guinobatan, Albay
Source: UNOSAT / JICA-FCSEC-Japan Survey Team December 2006

Debris flow was deviated to Brgy. Maipon when a 50m wide and 10m deep Masarawag gully was formed during the height of typhoon Reming. The said deep gully acted as channel to the convulsive mixture of volcanic debris caused by lateral and vertical erosion. The amount of sediment transported was massive considering the changes in the gully cross section profiles.

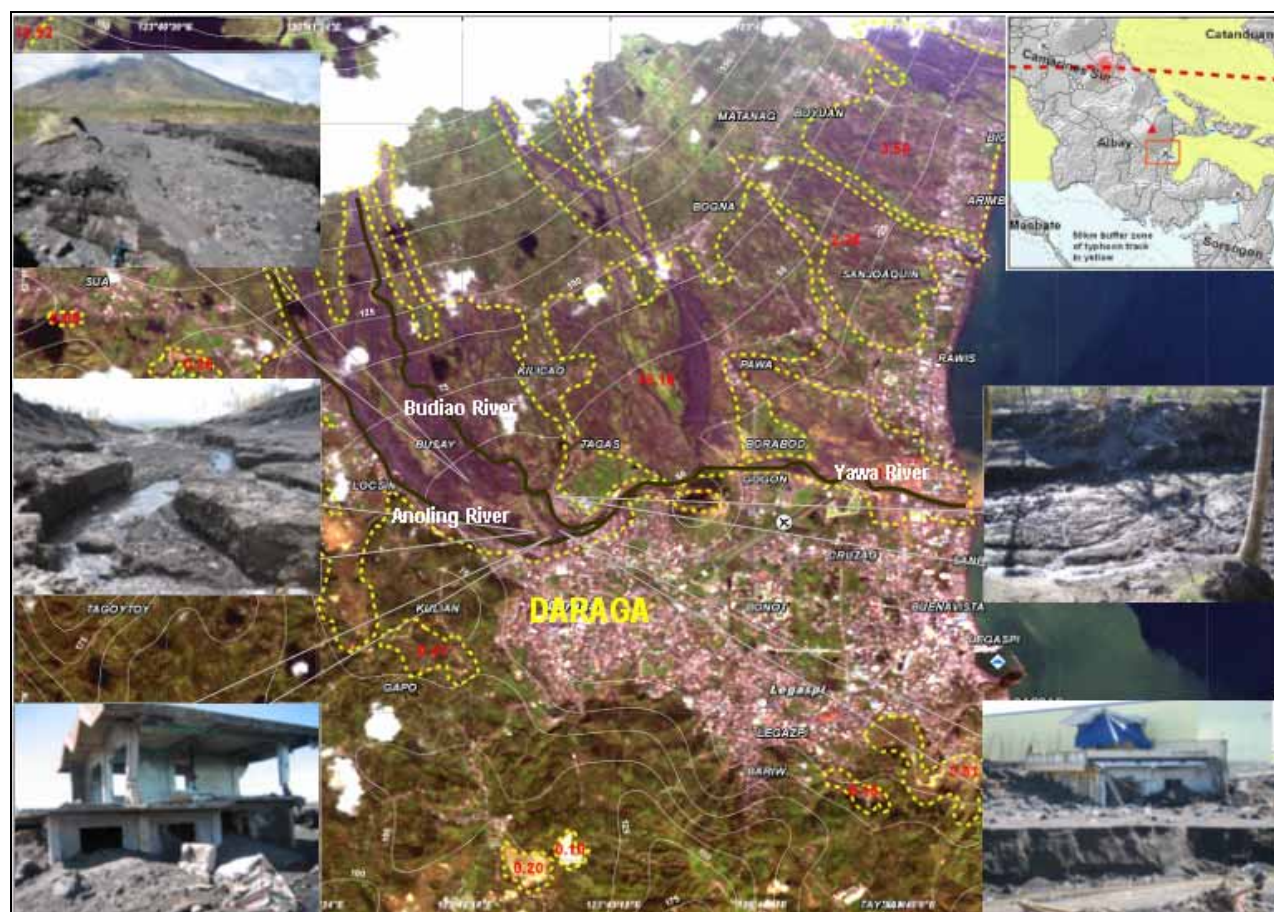
Figure15 Barangays Busay, Salvacion, Budiao and Vanadero, Daraga, Albay

The upstream of the Busay River is the Busay gully, a deep channel running from the slopes of Mt. Mayon, which was easily scoured due to the runoff caused by excess rainfall. Using a Garmin 60 Global Positioning System (GPS), a Nikon Laser Distance Measurement Device and survey rods, the debris flow in the affected the area was measured to be 2.0 m deep, 307m wide and 314 m long. The volume of deposited debris can be calculated as 193,000 cu.m.

The slope of the Busay River was measured using an inclinometer to be 2°. The debris flow, with average diameter of 1.0mø primarily moved as a coherent slump consisting of volcanic materials and boulders. A fast flowing debris velocity was also suggested by eyewitnesses who stated that most residents were unlucky not to outrun the advancing flow. Similarly, the mode of debris flow movement formed as a result of rising ground water levels after deep infiltration of antecedent rainfall.

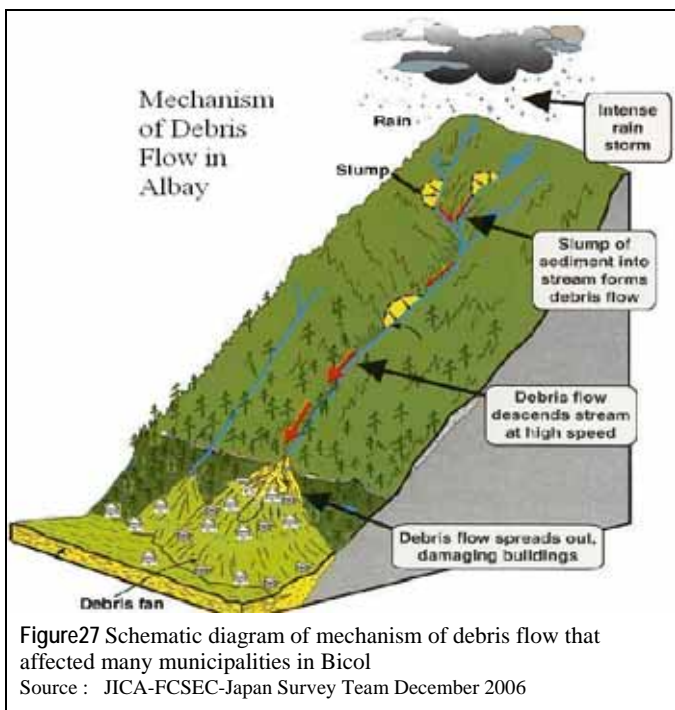
Figure27 Schematic diagram of mechanism of debris flow that affected many municipalities in Bicol

Generally, debris flows in Mayon are generally triggered by intense and prolonged rainfall as a result of the passage of a tropical cyclone in its vicinity. Typhoon Durian after making landfall over Bicol in November 2006 has brought extreme amount of rainfall that supersaturated the thick volcanic soil and highly weathered and sheared bedrocks in on the steep slopes of Mayon. This resulted to the failure of the soil and rock materials that make up the hill slope of Mayon and consequently driven down by gravity.

Such phenomena caused the mass wasting or down slope movement of loosened unconsolidated materials (e.g., weathered rock and thick volcanic soils). High concentration of runoff also added weight to the instability of loose masses of rocks and soil triggering them to slide down steep slopes.

The debris flow occurred due to the weakening of the soil structure caused by near continuous and heavy rainfall on the 30th of November 2006.

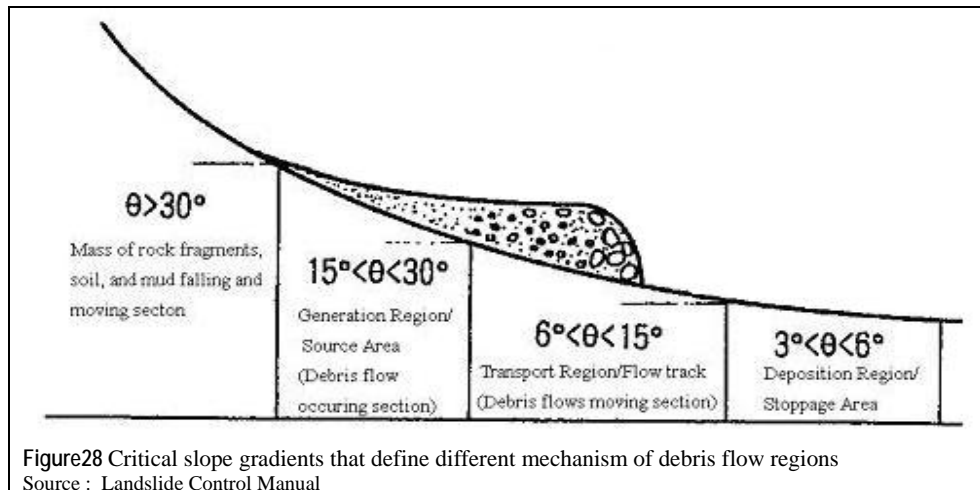
High concentration runoff, transformed from debris slides to debris flows, considering the fluidized movement of volcanic debris (boulders, logs, etc) that flowed in relatively rapid velocity because of lower cohesion due to higher water content. The debris flow have slump blocks at the head, and the cascading debris mass breaks up into smaller and smaller parts as it advances towards the foot, the movement is usually dissipated.

The numerous debris flows that occurred around Mayon happened in rapid progressive failures, and the whole mass coming from steep slopes flowed in rapid velocity - after liquefying due to super saturation - finding its way to stream channels and gullies. This is what observed in several stream channels like those in Brgys. Maipon and Busay. Unsuspecting streams suddenly bulked to debris consistency and buried communities.

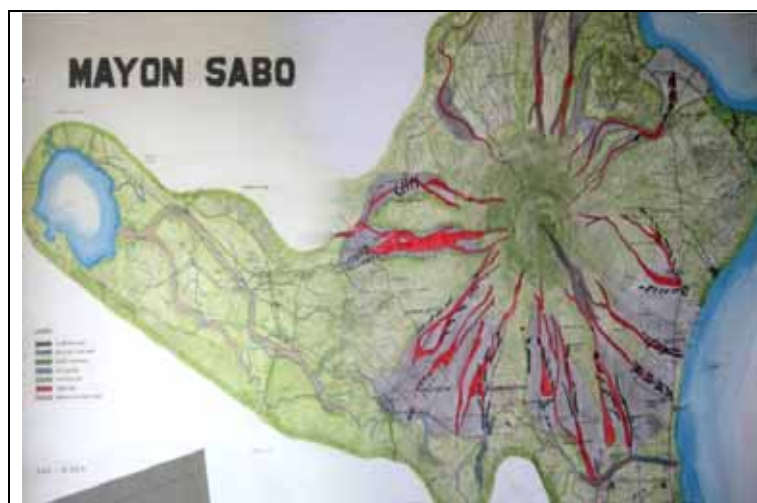
In Masarawag, where the damage to a village was greatly mitigated by the training dike, the effect of the existing training dikes was confirmed. However, as the rate of completed facilities is only 15% in terms of total budget, it is not sufficient to protect lives and properties completely. On the other hand, the condition of the area has changed severely as several catchment captures occurred. Therefore major updating of the plan is necessary based on the lessons from this disaster.

Figure31 The existing Mayon Sabo plan should be updated to address the ever-increasing trends of sediment related disasters in Albay.

In conclusion, not only maintenance but also implementation of additional Sabo facilities according to the updated plan is essential. On the above-mentioned recommendations, this study team proposes that Republic of the Philippines and Japan, both of which are investigating and studying countermeasures against sediment related disasters around active volcanoes, collaborate to mitigate these disasters.

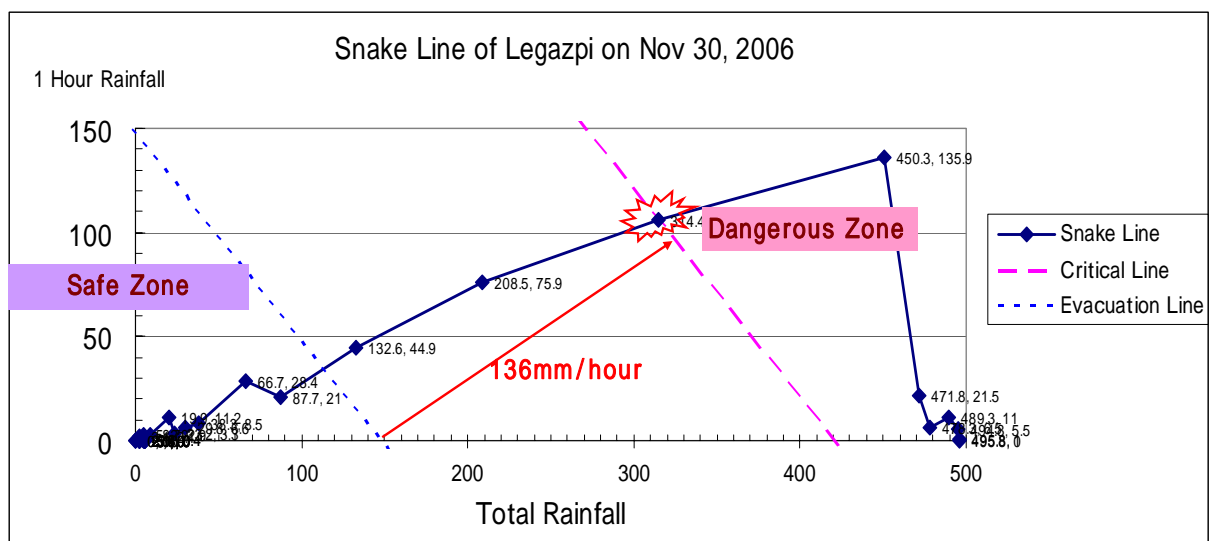
In the case of Snake Line for Legazpi as shown below, we draw critical line based on the interview that the debris flow happened about 2pm. We also draw evacuation line based on the idea that if it rains heavily, people can have an a lead time of at least one (1) hour to evacuate. Data gathering is necessary to establish a more effective warning system.

Figure32 Proposed snake-line for Legazpi that will define critical rainfall criteria for warning and evacuation from sediment related disasters.
