FCSEC TECHNICAL REPORT

**Experiment on the Effective Arrangement of Spur
Dikes as Countermeasure Against Bank Erosion in
Agos River**

St. Bernard, Southern Leyte Landslide Field Report

Volume 2 (2nd Edition)
2007.1

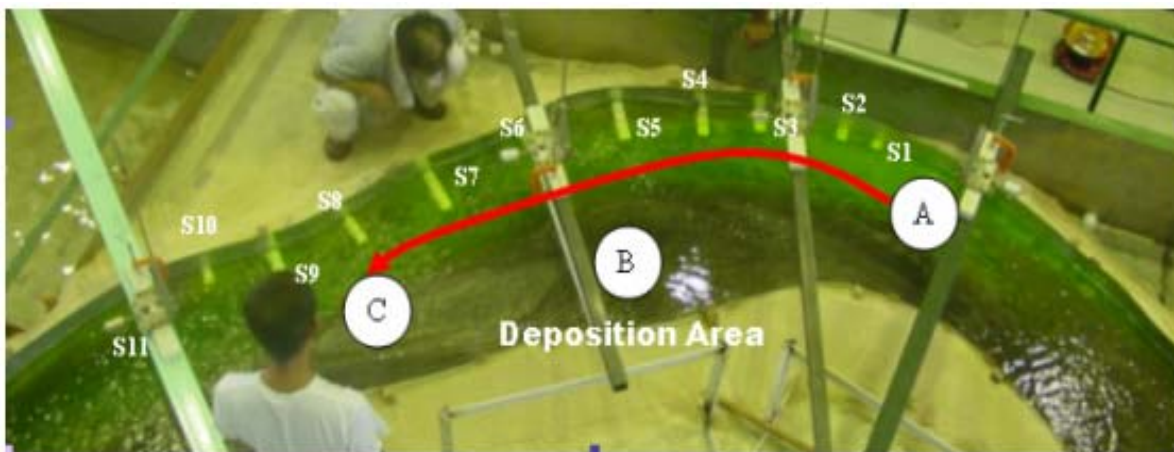
Figure 7, Location and Arrangement of Spur Dikes

The number of spur dikes was reduced at the upstream portion, taking out the shorter ones, which were observed previously to divert the flow and induced sediment deposition negligibly. The spur dike length gradually increased starting from sta 4+000 to downstream of sta 2+000, according to the assumed flow line placing the longer one on the severely scoured sections. Spacing was at twice the length. 11 pieces of spur dikes were laid out from sta 1+200 to 3+800.

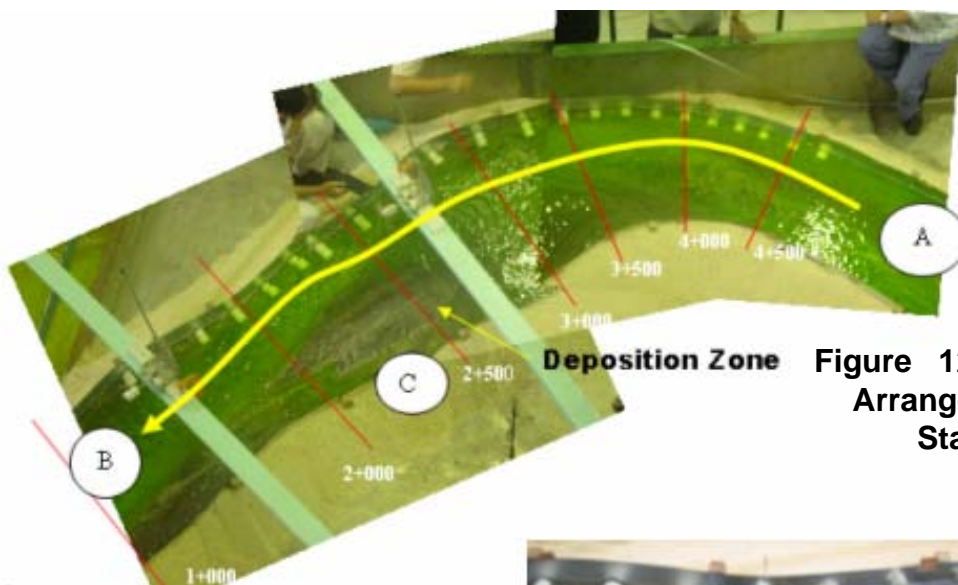
Figure 12, Spur Dike Arrangement Per Standard

On the other hand, the 5 spur dikes from Sta. 3+700 to 3+000 induced sediment deposition in between them. Those upstream of sta. 4+000 were not on the high velocity flow; thus, sediment depositions were induced.

Comparing the result with case 1, the scoured portion was transferred farther downstream and the bank erosion prevention was minimal.

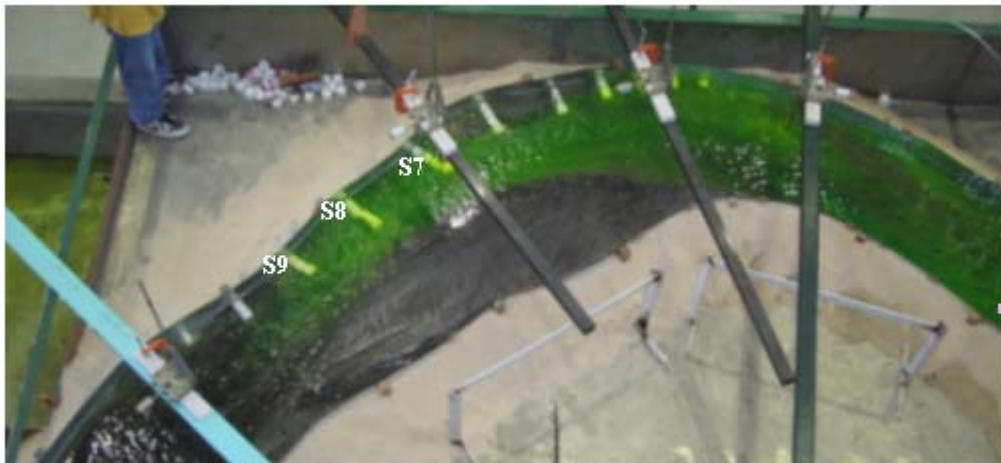
Figure 15, Overview of Flow Pattern of

Two minutes after the discharge, the tip end materials of spur dikes S7 and S8 began to scour. Seven minutes later, S7 was disarranged, while S6 deflected the flow away from the bank.

Although, S8 was disarranged and toppled, sediments were still deposited on the upstream of spur dike. This suggests that spur dikes have significant beneficial effects to prevent riverbank erosion.

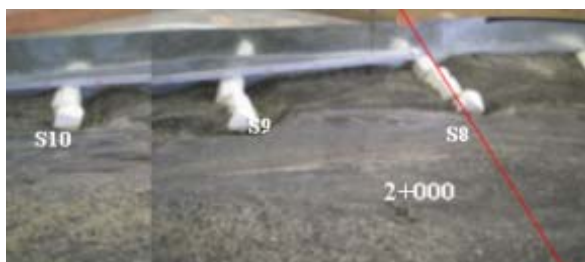
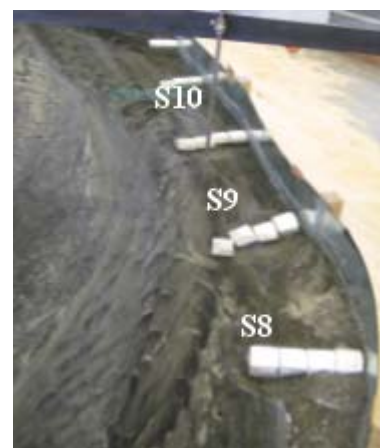
Figure 16 (a)

From S7 to S9, there was heavy scour around spur dikes; however, compared to case 2, this was relatively smaller. Near the boundaries of spur dikes, heavy scour was observed but longitudinal bed incision due to series of spur dikes was reduced significantly.

Relatively, the scour was transferred from the riverbank farther over the tip of the spur dikes, Figure 16(b); thereby, reducing the degree of erosion along the riverbank.

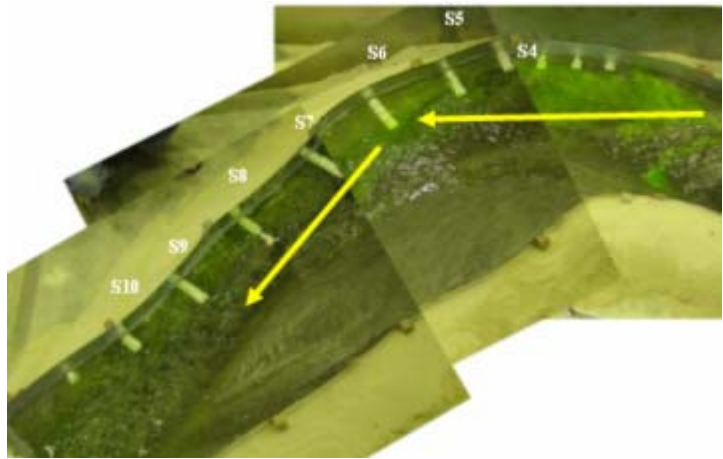
Figure 18, Flow Pattern, Case 4

S8 was effective to deflect the water away from the bank; however, without added protection it was easily toppled.

The effect of spur dike deviated the water effectively especially from S6 to S8. Please refer to the green color on the opposite figures showing considerable distance from the river bank of the main flow.

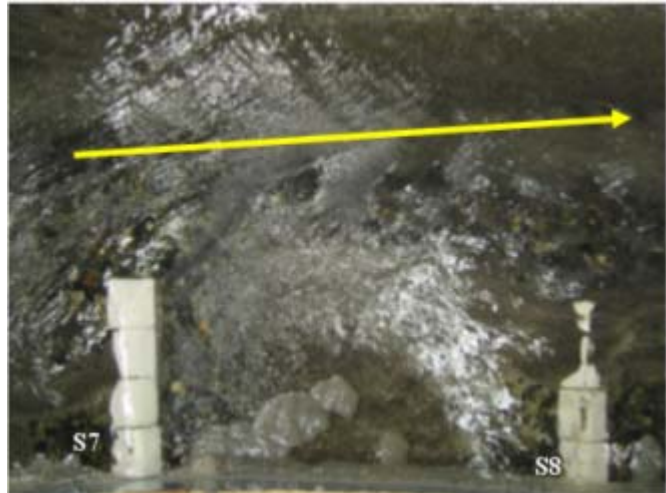
Figure 21, Effect on S7 and S8, Spur Dike with Foot Protection

Comparing the without and with countermeasures, specifically cases 2 and 3, the scour changed drastically as the spur dikes were installed. The scour around spur dikes and near riverbank was mitigated as the foot and the base were protected. Generally, the flow deflected near the ends of spur dikes causing longitudinally incision along the river channel forming thalweg, the deepest portion of the river bed. This case was the most effective among all the cases in this experiment. S8 captured sediment effectively. Also in case 2, where there was no foot protection, the upstream and downstream of spur dikes scoured. This is not evident in case 3, where there were foot or base protections.

Under normal condition, deep scours occur at the tip of spur dikes forming longitudinal scour at the ends of series of spur dikes as the flow is deflected from the river bank. The protection at the tip end may be another subject of interest for the next research to have more ostensible effect of spur dikes.

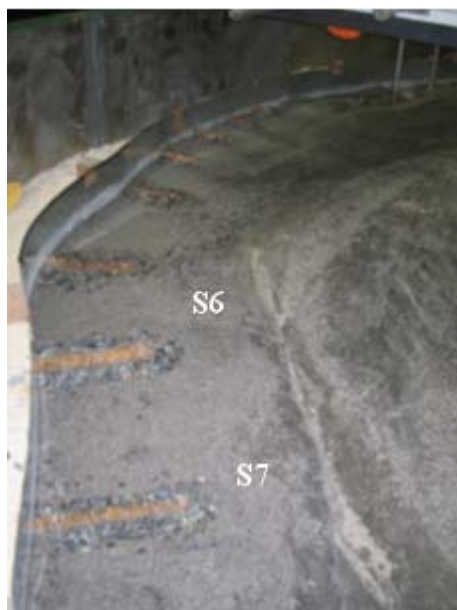
Figure 23, Depositional Pattern at S6 and S7

Permeable pile spur dikes when partially damaged can lead to the damaged of the succeeding spur dikes downstream, in some cases more serious.

Similar to Case 5, after the the main flow passed directly by S6, the velocity was slightly reduced downstream. Then when the flow reached S7, the flow deflected away from the bank. Please refer to Figure 22.

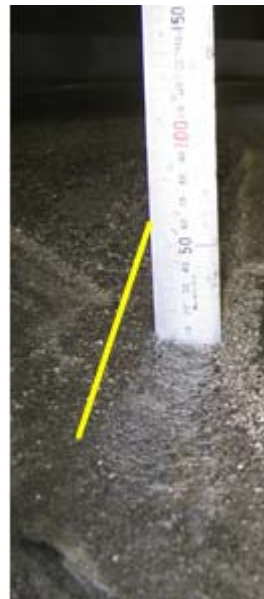
Figure 26, Depth of Scour

Ten minutes after the discharge, the opening or the intake of the cut off channel started to erode especially on the right side while the sediment deposited on the immediate downstream bed. Please refer to Figure 25, sluggish movement of the sediment came with marginal inflow (A direction), to the channel while the main flow (B direction), veered toward the outer bank. Progressive erosion took place as discharge continued until the original cut off channel was filled with sediment deposits. The bed accretion reduced the inflow and its discharge capacity. After the run, the deposition was measured at 1 cm, Figure 26.

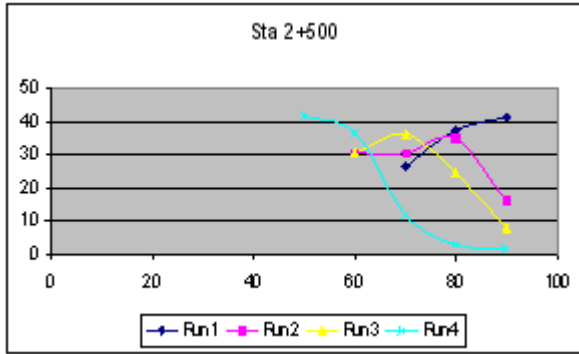
Figure 27, Velocity at 2+500

From the velocity distribution at station 2+500, Figure 27, case 4 dissipated velocity significantly and diverted the flow farthest from the bank. Although, cases 2 and 3 reduced the velocity at the bank most part, the control of scour was not as great as that of case 4.

Case 5 has somewhat big scour near the bank since most pile members of the spur dike models were carried by the water flow. Case 6, permeable type spur dikes with foot protection starting from 2+500, has good results comparably at par with case 4.

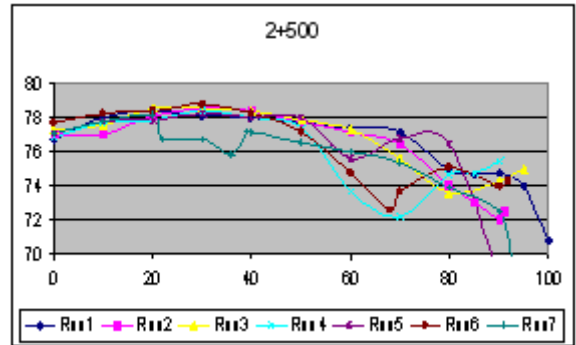
Figure 28, Bed Elevation at 2+500

The lowest bed elevation at case 4 tended to move to the center, while in cases 2 and 3 it was near the bank, and in case 1 without countermeasure, it was at the rightmost.

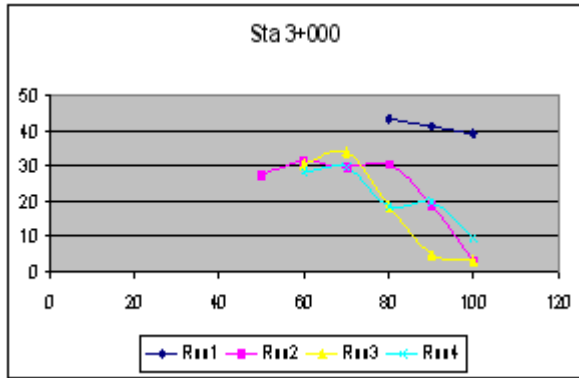
Figure 29, Velocity at 3+000

For Cases 4 and 6, Figure 29, sta 3+000 had no foot protections. Case1 exhibited high velocity at the right bank. Cases 2, 3 and 4 have low velocities at the far right. Farther 10 cm from right bank, case2 and 4 have slight differences. Case 3 still has low velocity and almost equal beyond 20 cm to 20 cm from the bank.

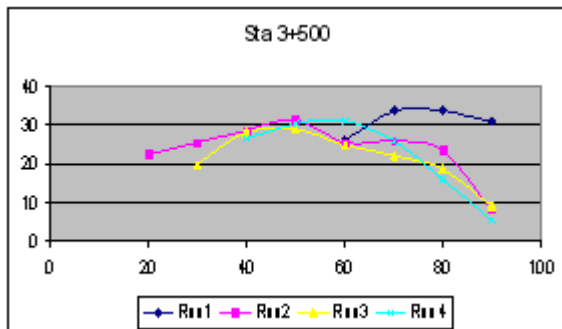
Figure 31, Velocity at Sta. 3+500

Velocity distributions among the cases depicted in Figure 31 show similar trends except for without countermeasures. Decreasing velocity could be observed towards the right bank whereas in the without countermeasure velocity increased

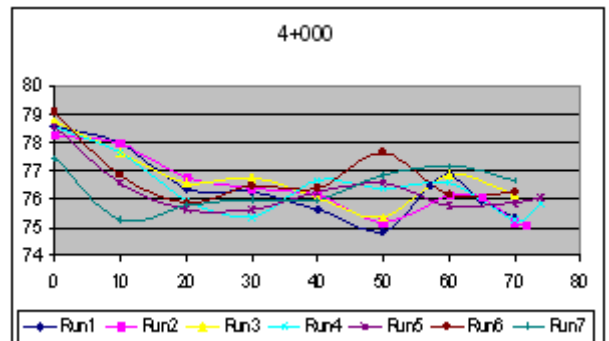
Figure 34, Bed Elevation at Sta 4+000

Sta 4+000 was located at the beginning of the series of spur dikes. It can be noted from figure 33, that the velocity of case 1, no countermeasures case, is highest while its bed elevation is lowest at 20 cm from the right bank. The velocity from case 2 to case 4 show similar pattern, which gradually increase from 20 cm to 50 cm from the right bank.
