# GROYNE TO PREVENT RIVERBANK EROSION ON MEKONG RIVER

Hirotsada MATSUKI, Dr.Eng.

Ministry of Land, Infrastructure, Transport and Tourism (JICA Expert 1997-2000 for Laos/2013- for Vietnam)

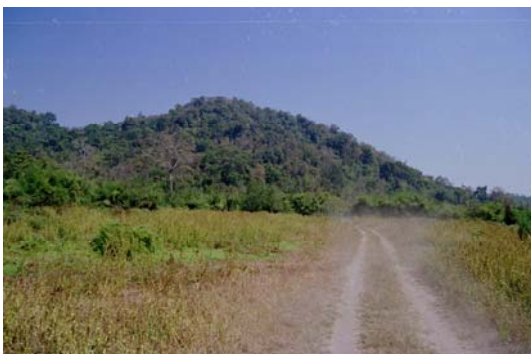
Photo 4 Small triangular hill of granite (February 1998)

As a result of searching trips, a triangular hill was discovered in 10 km north form the village (**Photo 4**). It was an outcrop of less weathered granite with 2.8 in the density. The rock was minable and transportable by local workers who had experience of road construction.

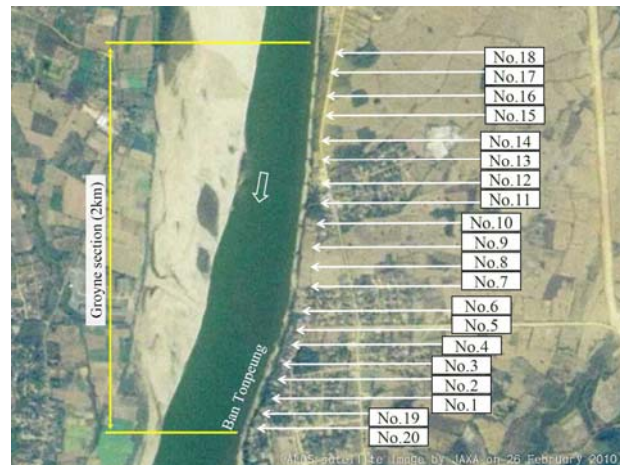
**Photo 8** Work sequence of 20 groynes  
(ALOS satellite image by JAXA on 26 February 2010)

The result was acceptable for Lao government so that they determined to continue the groyne project. Since that, Lao engineers constructed 2-4 masonries in every low-water season (**Photo 7**) and finally 20 in 7 years. The situation in February 2010 could be checked in the satellite image (**Photo 8**).
