X. RISK STUDY AND PREVENTION AND CONTINGENCY PLAN

This chapter contains the risk analysis for the SAN MIGUEL TRUNK ROAD Project to respond to the natural, socio-environmental and anthropogenic hazards, according to the vulnerability of the Project site. The first part presents the concept base that supports the work. After there is a summary of the risk and vulnerability condition of the project area of influence. Following are the scope and methodology of the analysis and the results obtained. Finally, in the last part are the conclusions and the **RISK PREVENTION PLAN**, which is incorporated into the Project ENVIRONMENTAL MANAGEMENT PROGRAM, as environmental measures.

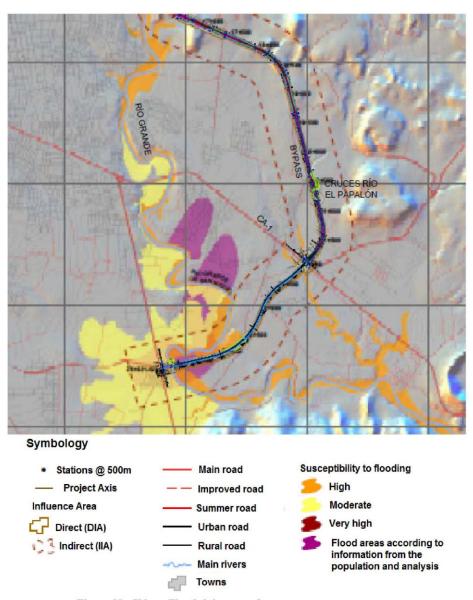
Another one of the points that presents no problems is the zone of El Papalon river between station 20+200 to 20+600. It is not in the floodable zones as shown in the following drawing X-1.

Figure No. X.l. Floodplain map of survey area

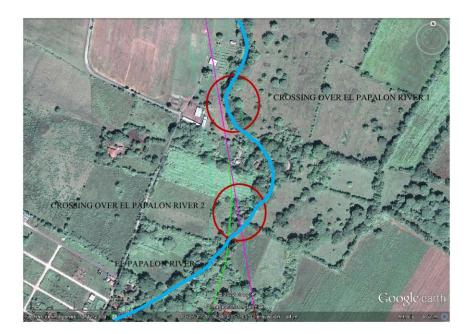
In addition, in the zone there are grasslands and crops, mainly without having a direct impact on the river Banks as can be seen in Figure X.2 where the aerial photography shows the sites where the Trunk Road crosses with El Papalon River.

Figure No. X.2.CROSSING OVER EL PAPALÓN RIVER

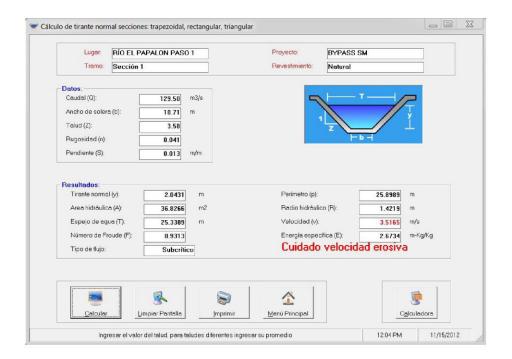
To analyze the *El Papalon* River as a response to the concerned expressed during one of the public consultations, the dimensions of the section were calculated using Auto CAD, as well as the slope, which was calculated based on the river main line.

The HCANALES Version 3.0 software was used to calculate the maximum flood of El Papalon river for the mainstream area. The figure shows the result of the hydraulic calculation of the section of the river considering a base equal to 10.71 m, which results in a maximum of 2.04 m.

Figure No. X.3. Calculations for El Papalón River

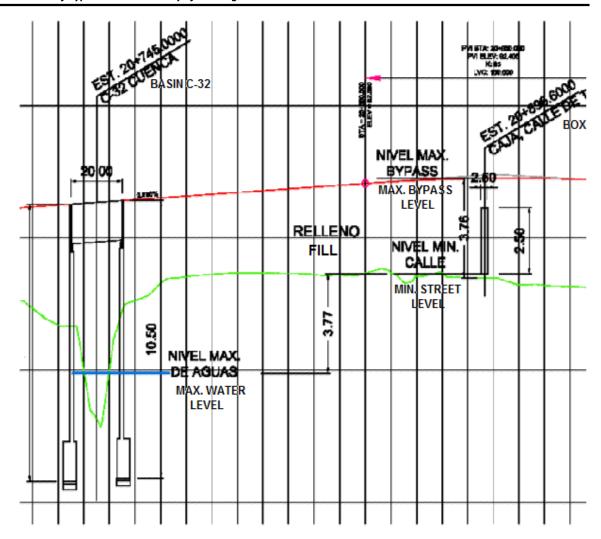
In addition, with the calculation of the maximum water levels, as can be seen in the next figure, show that the level of the water of the El Papalon River compared to the low part of the road projected has a difference of 3.77 m, and therefore there is no flooding risk in this point.

Figure No. X.4. CROSS -SECTION OF EL PAPALON RIVER BRIDGE AND BOX
