Sharing the Japanese experience towards Build Back Better Recovery and Reconstruction

23 Jan. 2025@Port Vila Vanuatu

JICA Senior Advisor (Disaster Reduction Strategy)

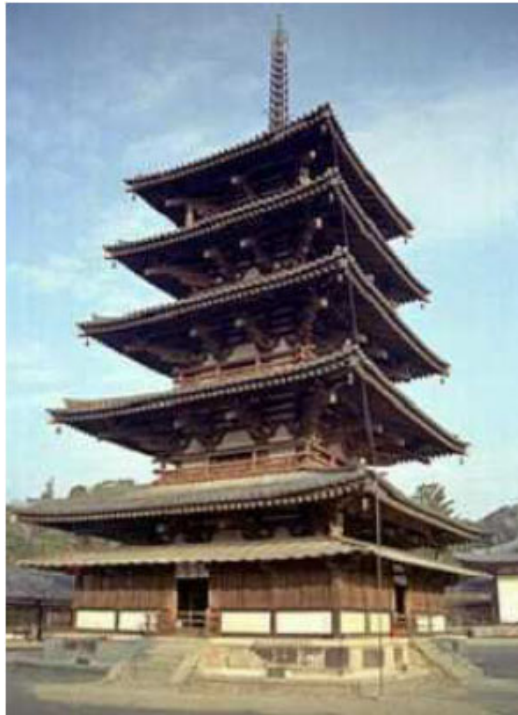
Pagoda of Horyuji Temple built 680A.D. The Oldest Wooden “High-Rise” Building in Japan withstood numerous Earthquakes over the Centuries

5 layered, 32m high

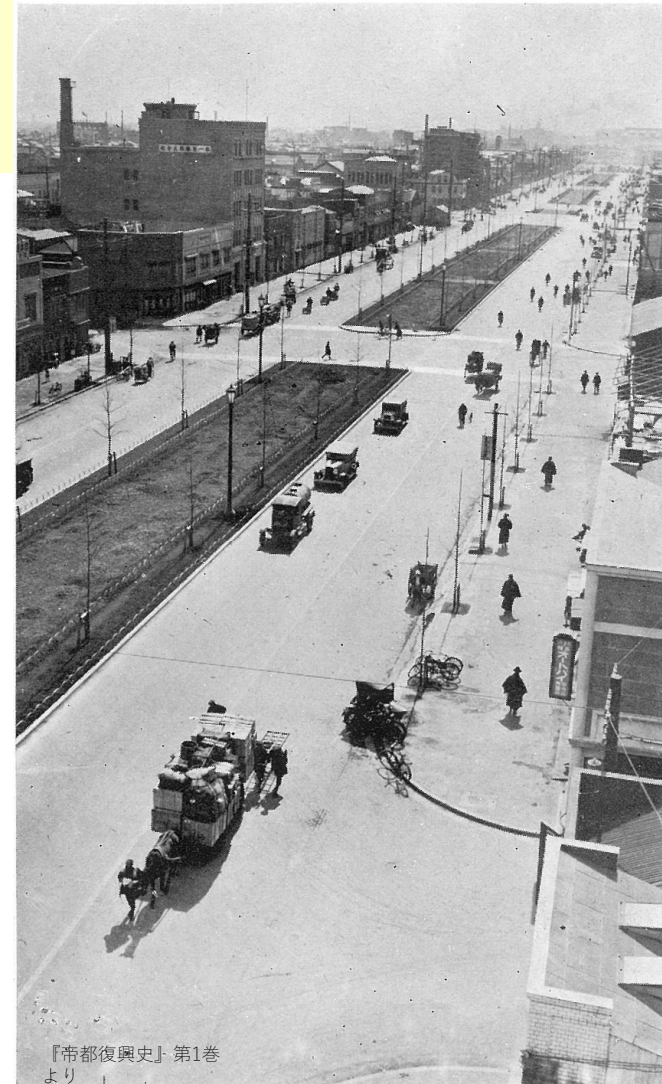
Arterial road
No. 1 Showa
Dori Avenue
→
44meters wide

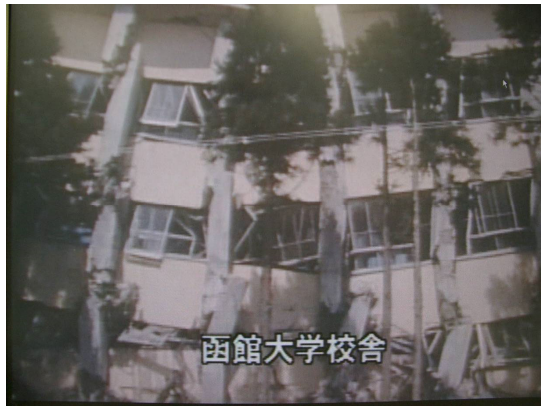
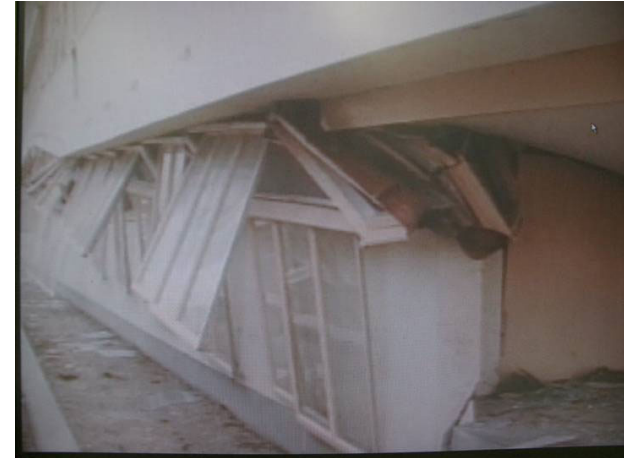
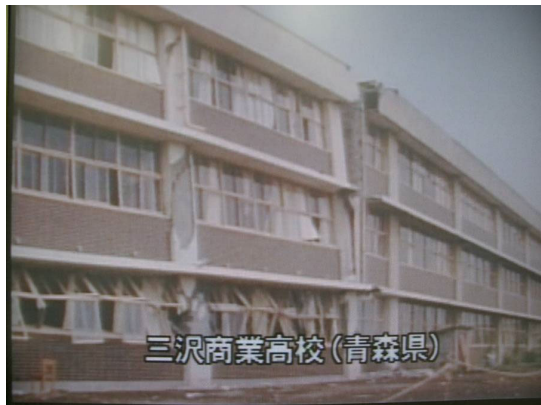
Collapsed RC buildings

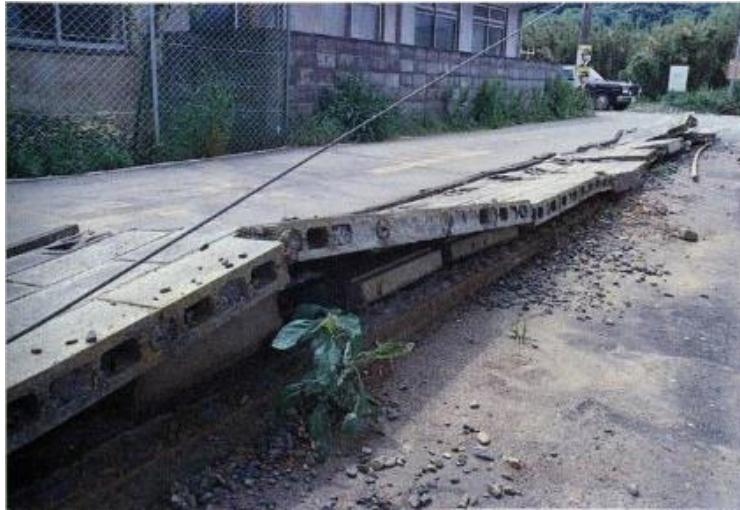
Crashed concrete block wall
**school children crushed
to death**

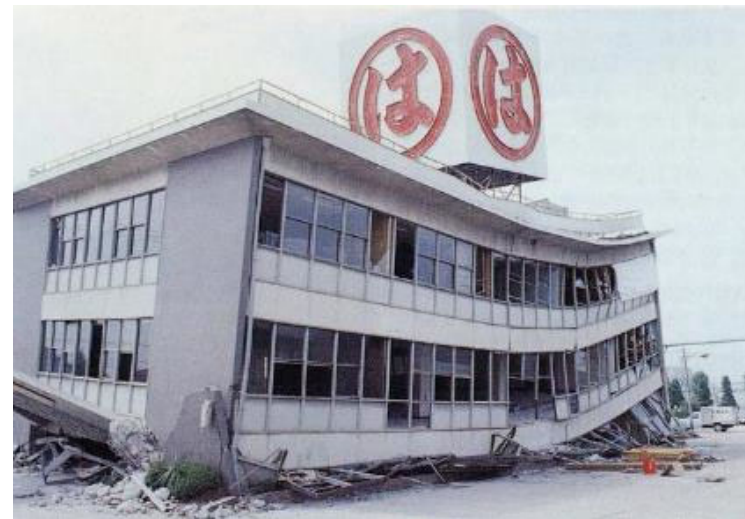
Pancake-collapsed building

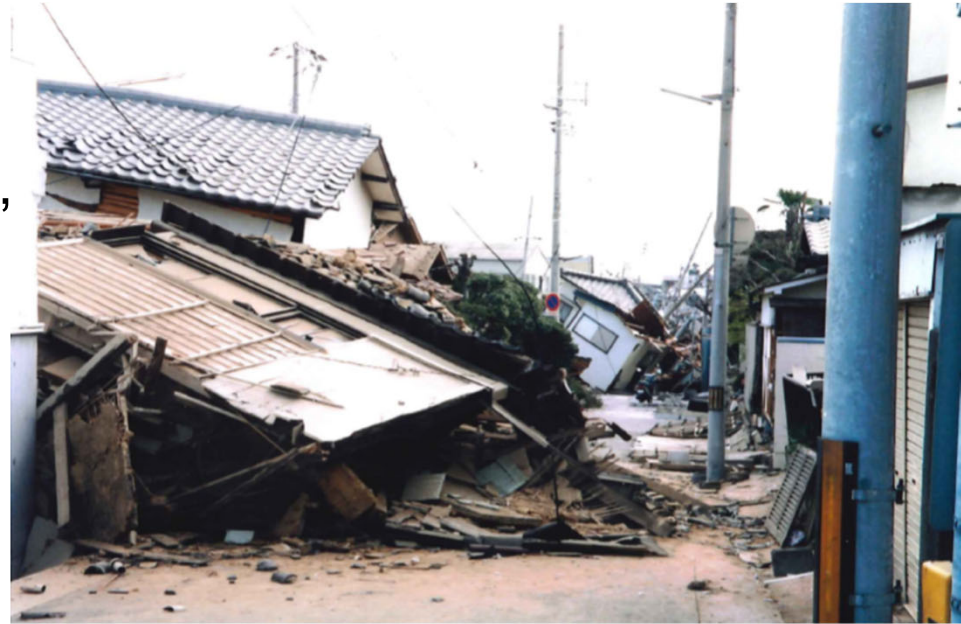
Old timber structure with heavy tile roofs collapsed, crushing residents to deaths, Blocked the streets.

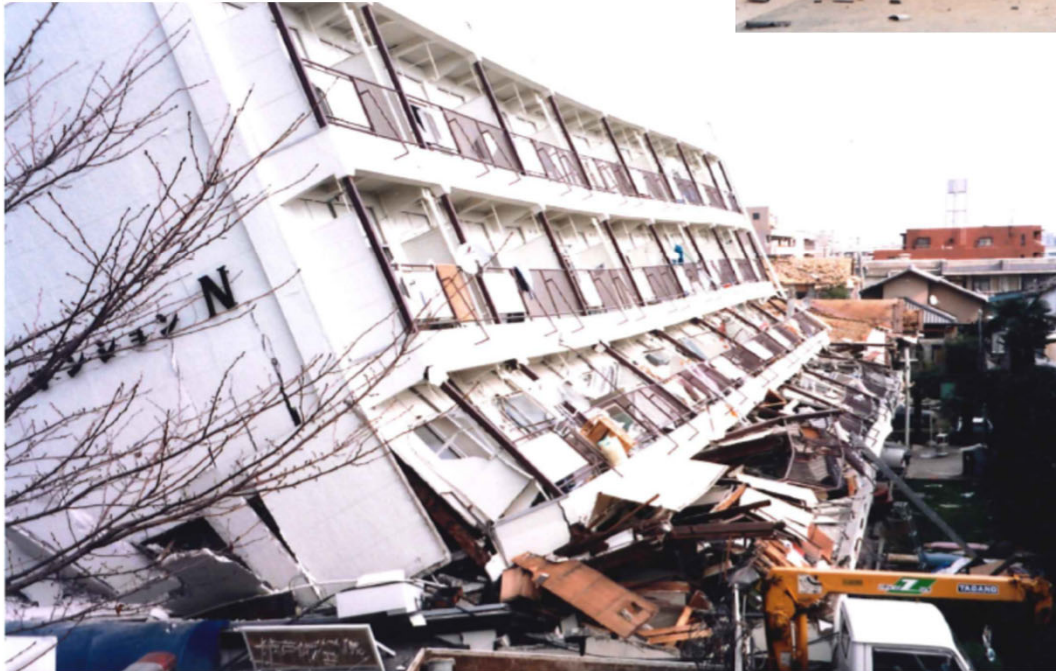
Old RC structure condominiums built before 1981 collapsed

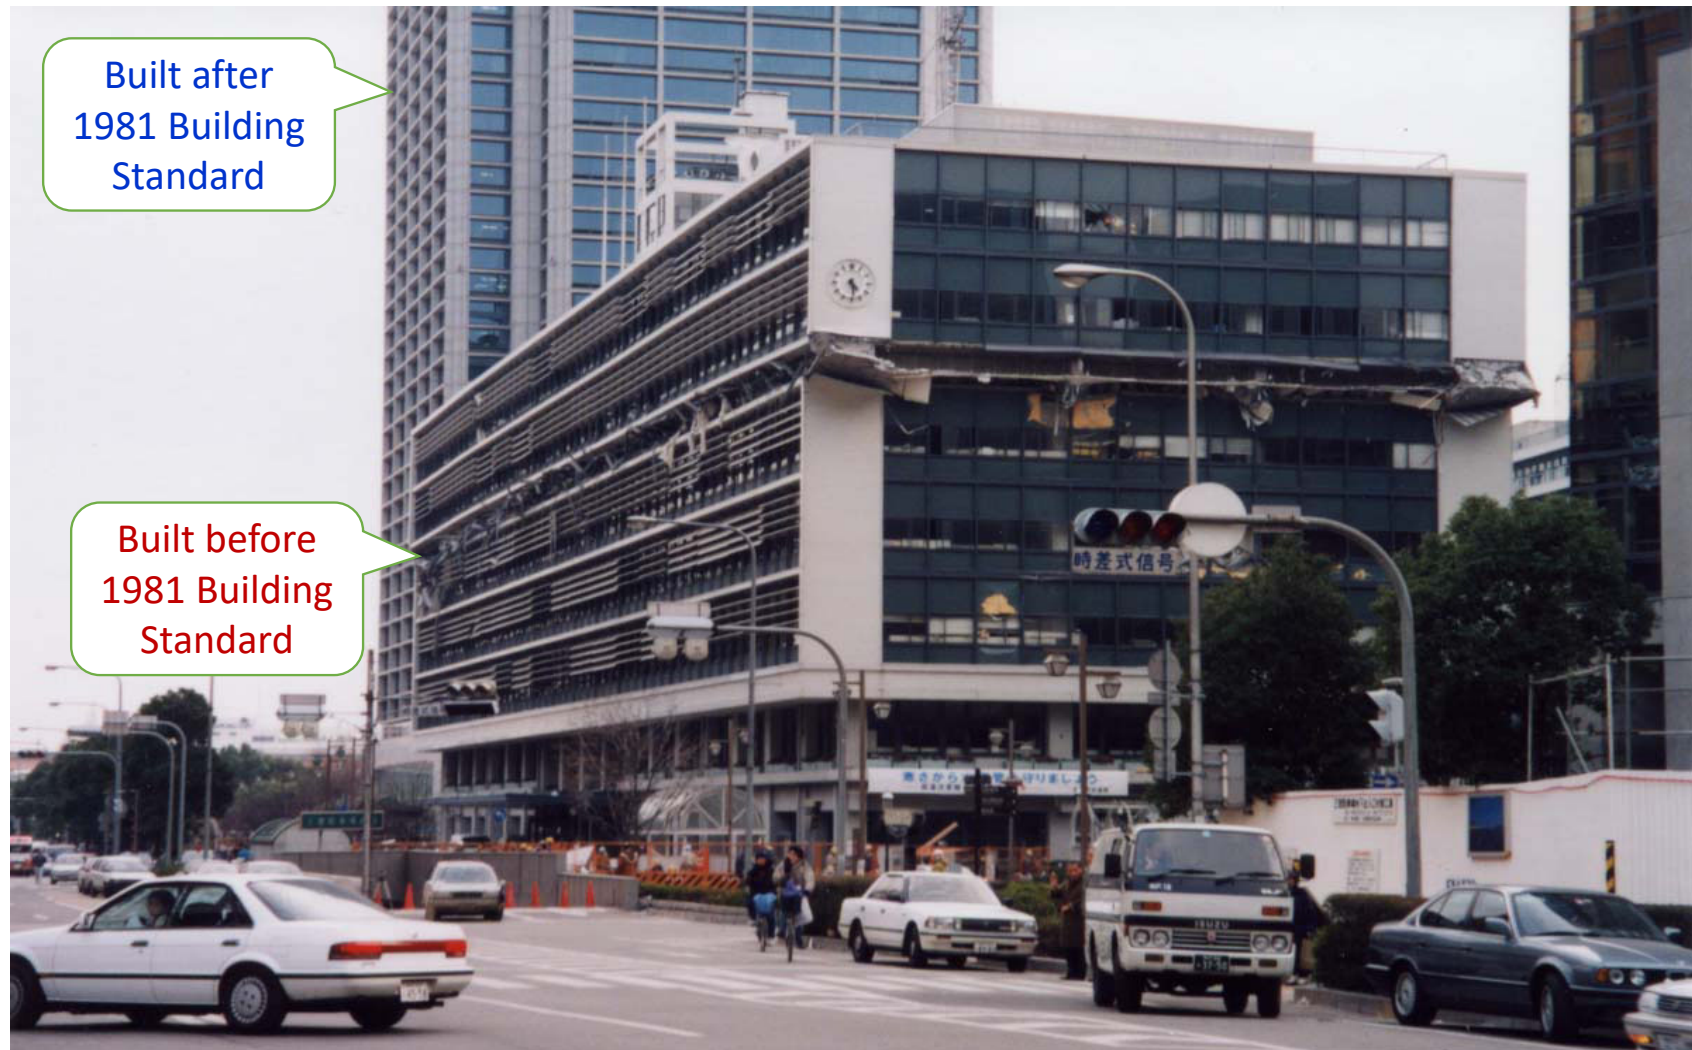
Kobe Municipal Government Headquarter

Built after
1981 Building
Standard

Built before
1981 Building
Standard

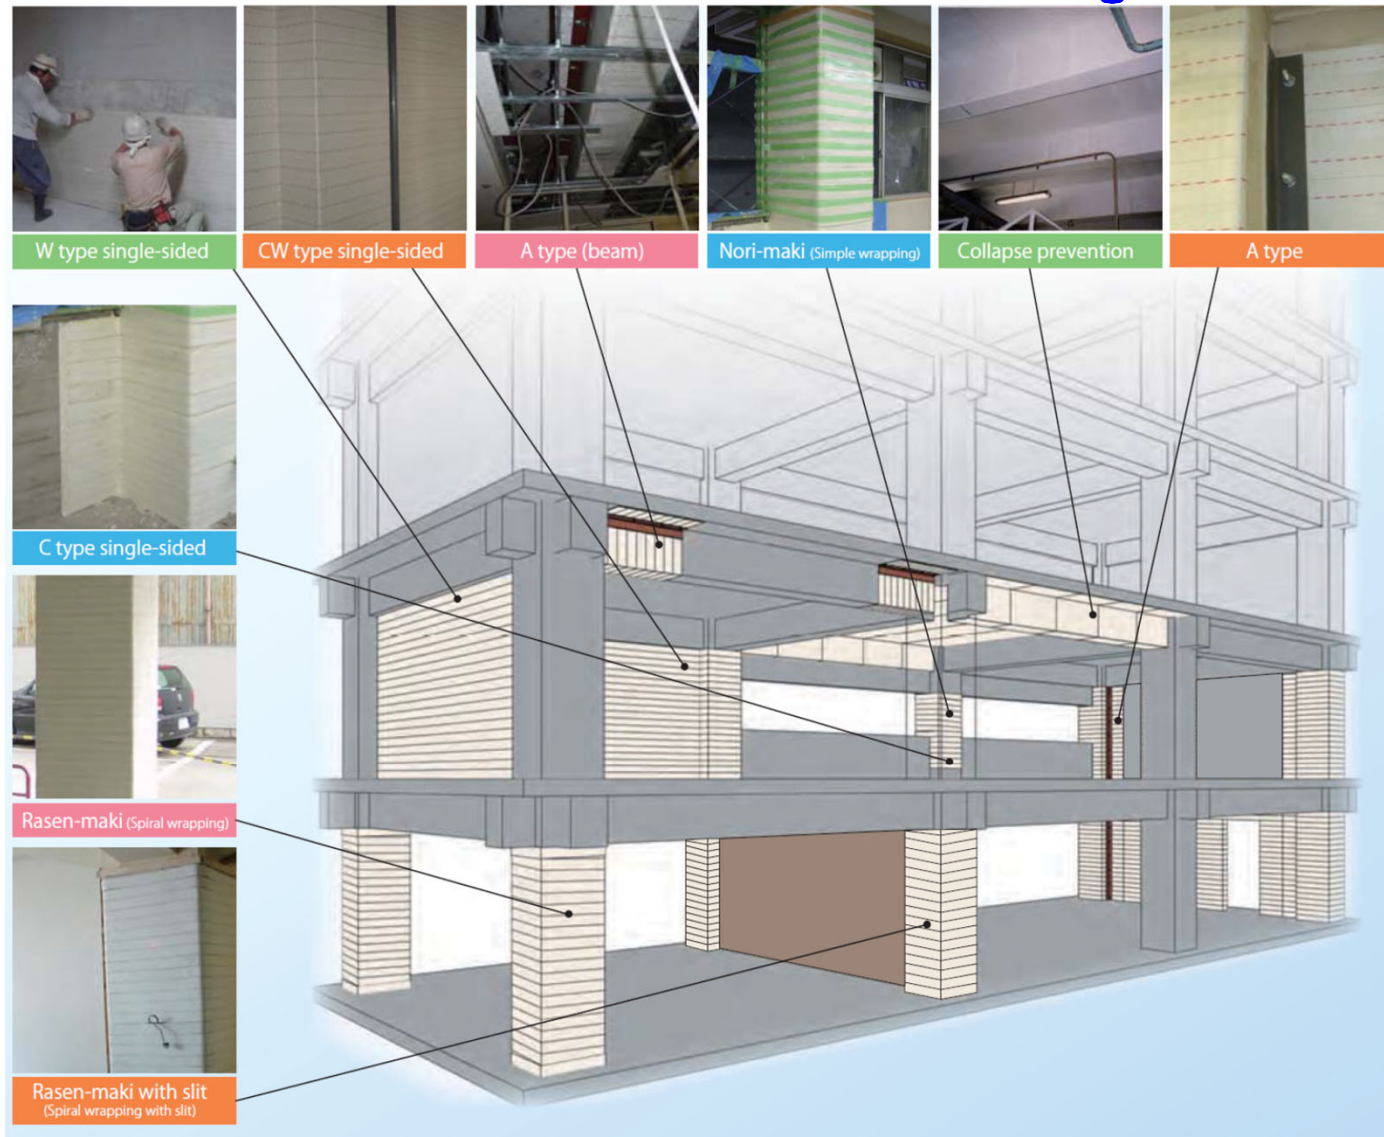
Alternate methods for Seismic Retrofitting of Buildings

This high ductility material is made of polyester fibers which are woven together densely. There are various belts, tapes, and sheets as well as widths and thicknesses. For example, the thickness of 4 mm (0.15 inch) has 16 tons of horizontal strength. It is flexible and can be bent easily with the hands. In earthquakes, it follows the deformation of concrete and wooden materials while resisting cracks which invite collapse.

Tube-type materials (SRF30) are used for joint connection of wooden structures.

This high ductility material is made of polyester fibers which are woven together densely. There are various belts, tapes, and sheets as well as widths and thicknesses. For example, the thickness of 4 mm (0.15 inch) has 16 tons of horizontal strength. It is flexible and can be bent easily with the hands. In earthquakes, it follows the deformation of concrete and wooden materials while resisting cracks which invite collapse.

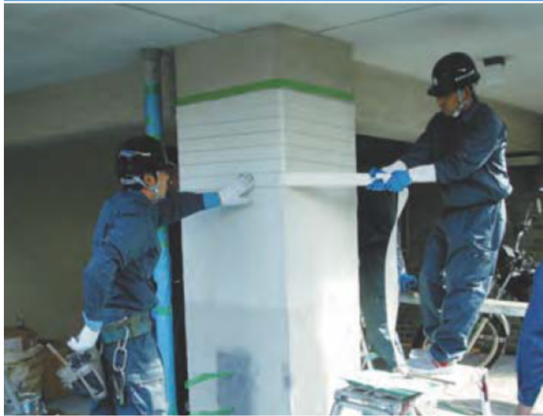
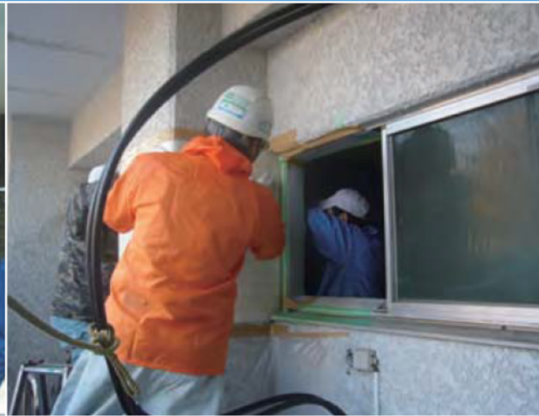
Case of SRF Reinforcement

Wrapping the main columns with SRF allows it to maintain its shape in spite of big transformations and also prevents collapse. While steel plate reinforcement, carbon fiber, and aramid fiber are realistically impossible, SRF prevents collapse and shows high-tensile strength even for short columns or columns exposed to a large compressive force (high axial force). It has been technically evaluated by The Japan Building Disaster Prevention Association.

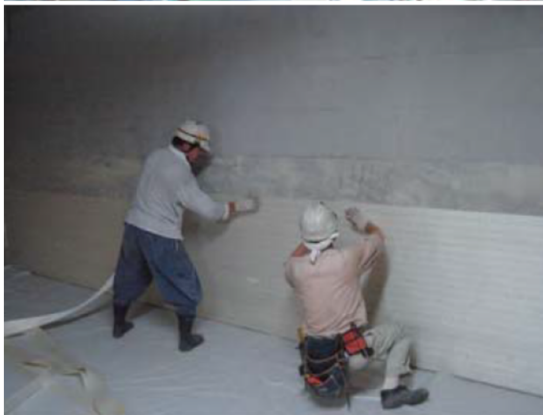
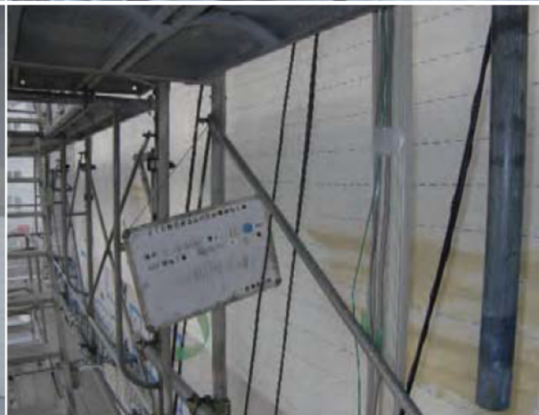
Pasting strip-type SRF belts on shear walls provides elastic stability to cracks, absorbs large amounts of energy, and prevents collapse. Steel plates, carbon fiber, and aramid fiber resist the compression forces and eventually peel off easily, producing almost no effect at all. SRF elastically resists tensile forces and avoids compressive forces. It is the first to be able to achieve this reinforcement effect.

Pasting strip-type SRF belts on shear walls provides elastic stability to cracks, absorbs large amounts of energy, and prevents collapse. Steel plates, carbon fiber, and aramid fiber resist the compression forces and eventually peel off easily, producing almost no effect at all. SRF elastically resists tensile forces and avoids compressive forces. It is the first to be able to achieve this reinforcement effect.

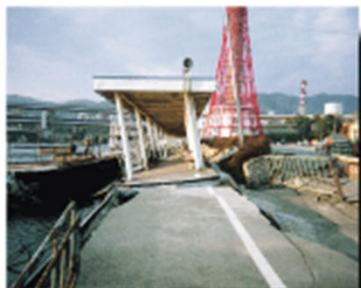
● -5.5m Berth

Damage Example of Port Facilities in Kobe Port

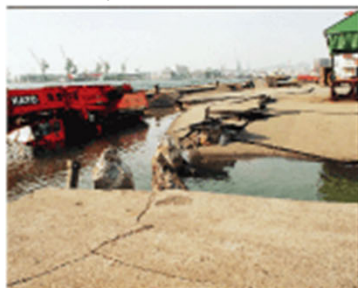
● New port area

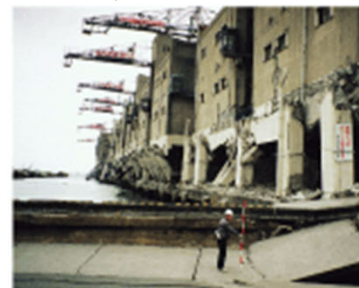
● New port area

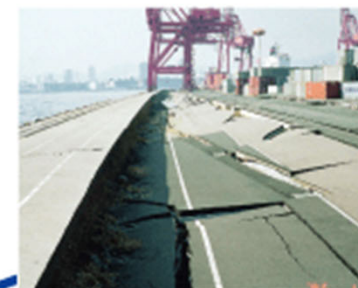
● -12m Berth

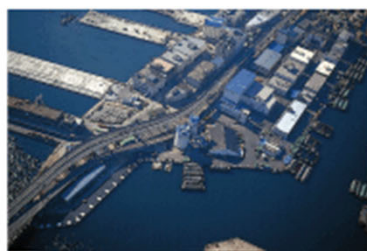
●新港地区：新港北物揚場外復旧工事
本物揚場背後には土留が設置していたため、土留に出来るだけ影響を与えない方法として、方格及びL型ブロックによる前出工法が採用された。復旧工事は9月末に完了し、供用されている。

Reconstruction Example of Port Facilities in Kobe Port

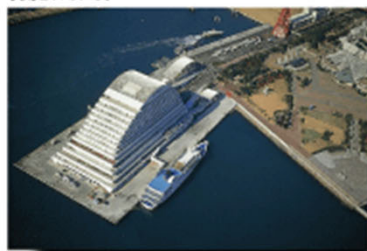
●中突地区：中突・一9m岸壁外復旧工事
中突の復旧工事では構造物の前出しをできるだけおさえる方法として、通常石積み工法などで用いられるジャケット杭工法（前出工法）が採用された。復旧工事は9月末に全て完了し、供用されている。

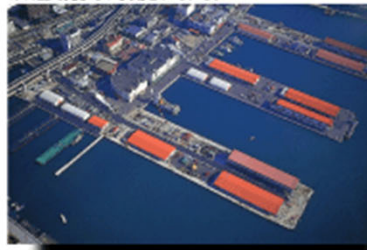
●新港地区：新港第2突堤外復旧工事
新港突堤西側に当たる本地区は神戸港の開港時の面影をとどめる地区で、復旧工事でも歴史性の保存・再生に配慮するため、上段工に御影石を使用して復旧を行っている。復旧工事は3月末に全て完了し、供用されている。

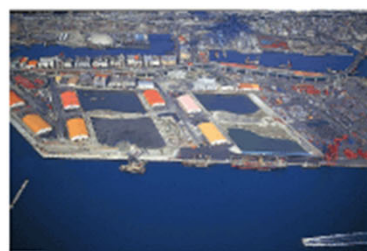
●摩耶地区：岸壁（-12m）等築造工事
摩耶埠頭南側の岸壁にはケーソンタイプの重力式構造と鋼管杭による橋脚構造が採用された。本工程区域はケーソンタイプの構造が採用されている。工事は摩耶2突～3突間前出の岸壁2バースが完成し、残りは平成9年2月末に完成する予定。

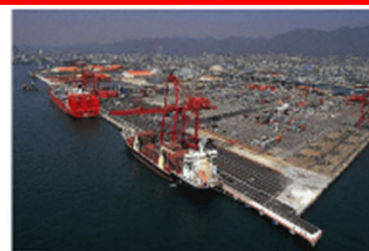
●摩耶地区：岸壁-12m②外復旧工事
摩耶埠頭南側の岸壁にはケーソンタイプの重力式構造と鋼管杭による橋脚構造が採用された。本工程区域は鋼管杭による橋脚構造が採用されている。復旧工事は3月末に完了し、供用されている。

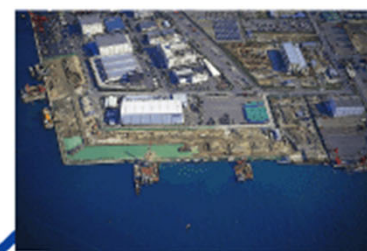
●六甲アイランド地区：-10m岸壁②外復旧工事
本岸壁は被災が比較的軽微であったため、既存ケーソンをそのまま利用するかわりに、ケーソン背後の土圧を低減（事前混合処理工法）する工法が採用された。岸壁の復旧は既に4バースが完成しており、残りの岸壁も9年3月末に完成する予定。

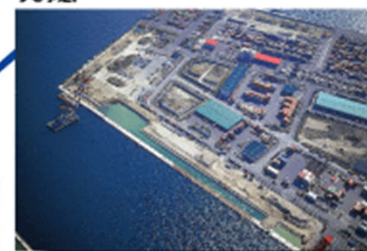
●六甲アイランド地区：岸壁-12m②外復旧工事
スリップに面する当岸壁は前面の水域を確保する必要があるため、ケーソン面直し工法が採用された。岸壁の復旧は既に2バースが完成しており、残りの岸壁も9年3月末に完成する予定。

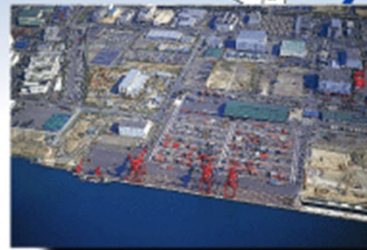
●六甲アイランド地区：岸壁-7.5m外復旧工事
本岸壁は南側隣接のコンテナバース（RC-1）と同様に既存ケーソン前面に新設のケーソンを前出しするデタッチド工法が採用された。復旧工事は5月末に完了し、供用されている。

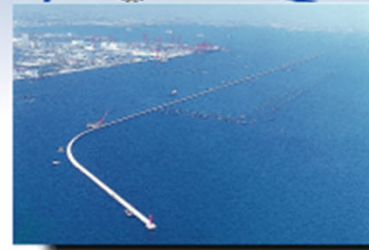
●防波堤：第7防波堤復旧工事
防波堤は地震の影響により躯体が最大2mもの沈下が生じ

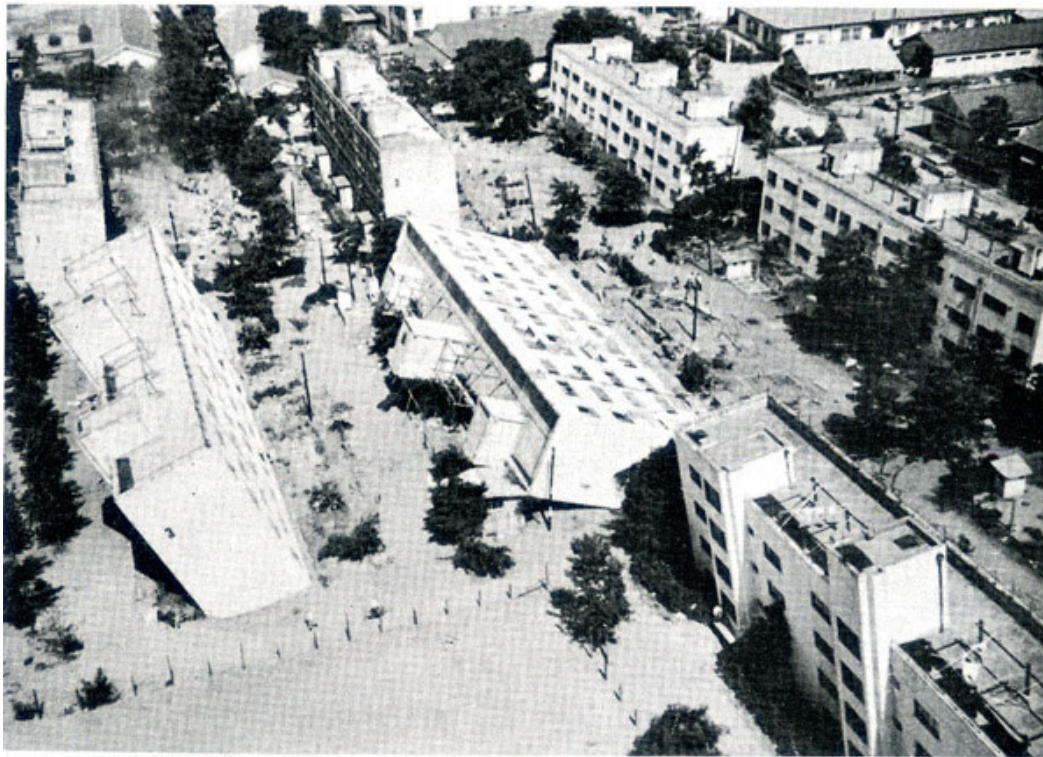
1964 Photo of RC apartments tilted by Ground Liquefaction

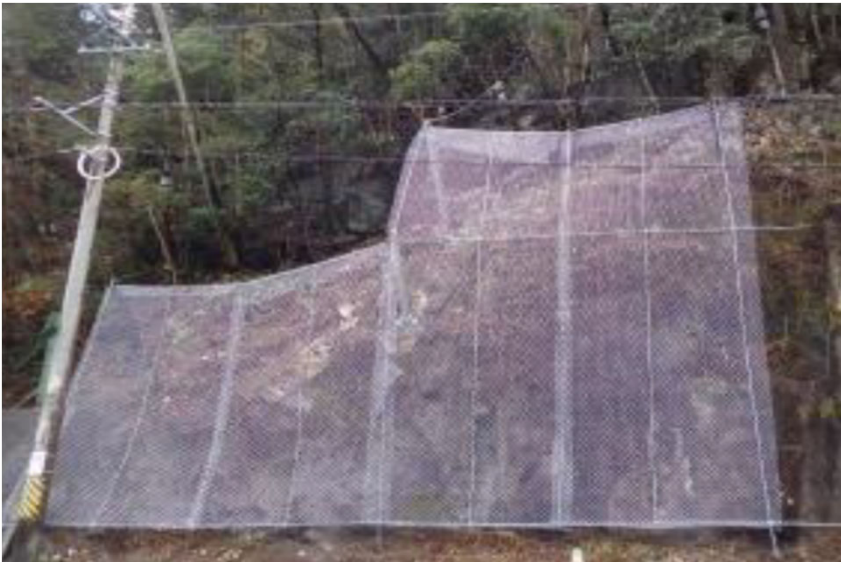
Rock fall prevention

Pocket type rockfall prevention net work

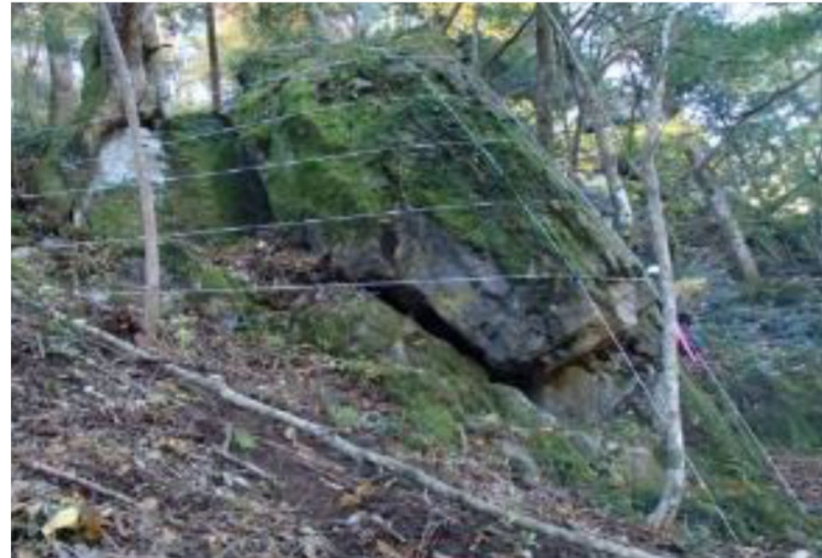
Wire rope hanging work

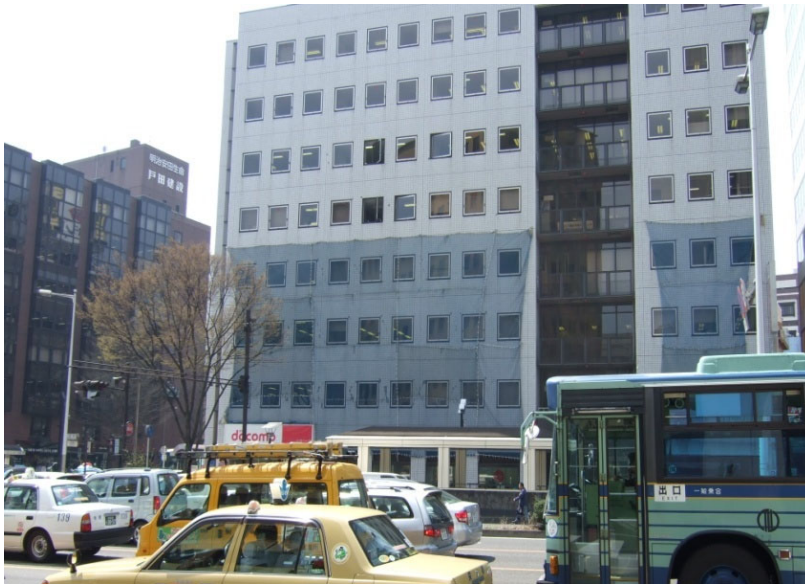
The M9 Great East Japan Earthquake hit Sendai City, but there was no structural collapse of buildings.

Office building in Sendai, photo by Satoru Nishikawa, Apr 15 2011

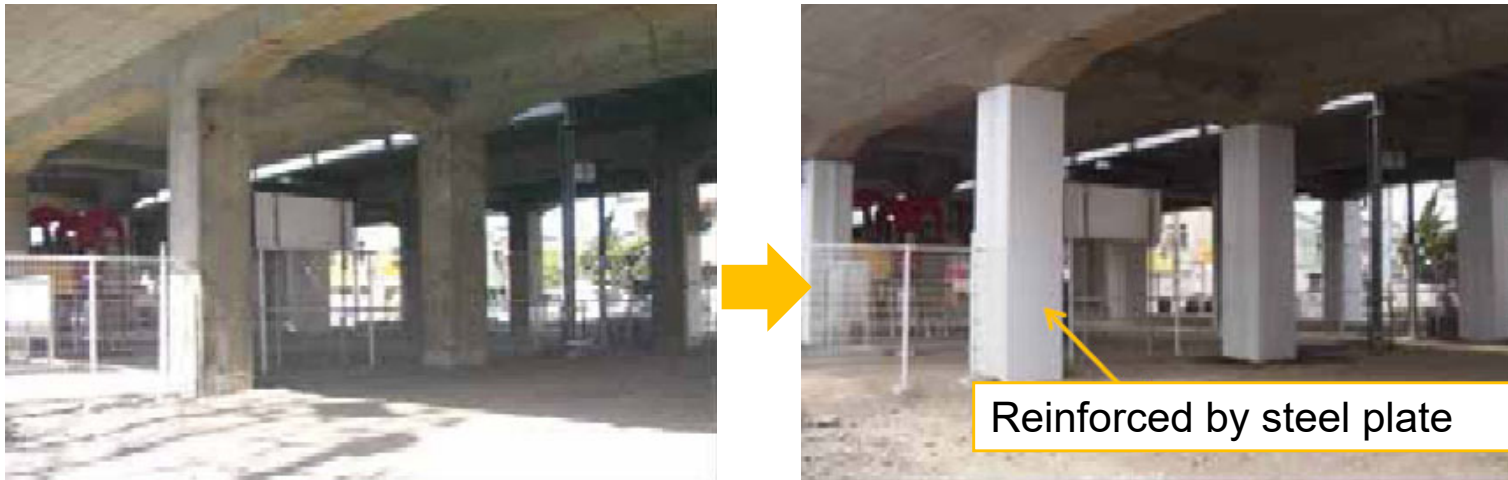
- * Reinforced Shinkansen bullet train elevated rail bed columns

These reinforcements based on the bitter lessons of 1995 Hanshin-Awaji Earthquake and 2004 Niigata-Chuetsu Earthquake

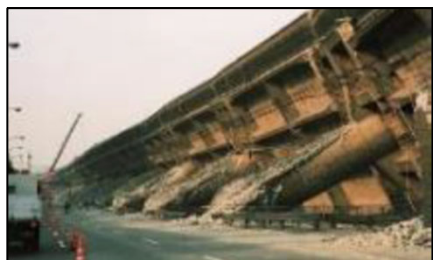
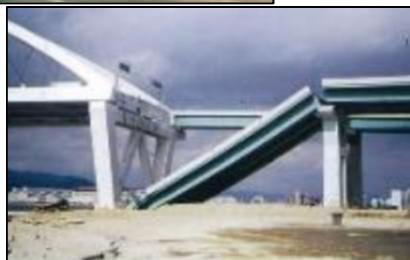
Many bridges were damaged in the 1995 Great Hanshin-Awaji Earthquake.

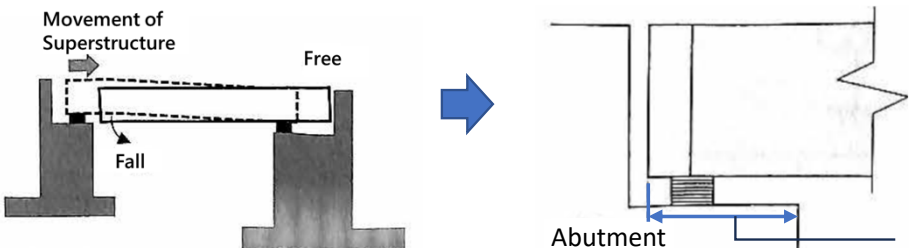
Substructure		
	<p>Widening bearing seat</p> <p>Secure enough length of bearing seat even bearing collapsed.</p>

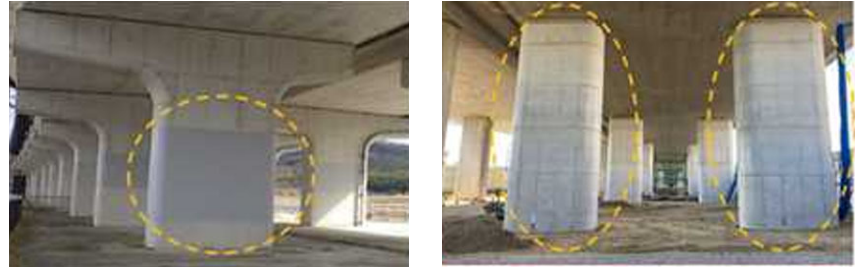
<p>Reinforcement of bridge piers</p> <p>Wrap by RC or Steel plate or Carbon fiber sheet.</p>

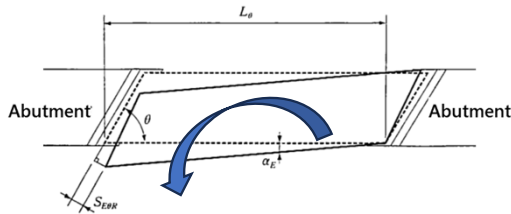
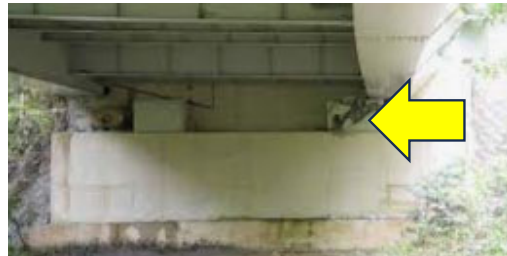
Others		
	<p>Prevention of superstructure rotation</p> <ul style="list-style-type: none"> - Geometry check for rotation - Lateral displacement restraining structure 	<p>Geometry check</p>

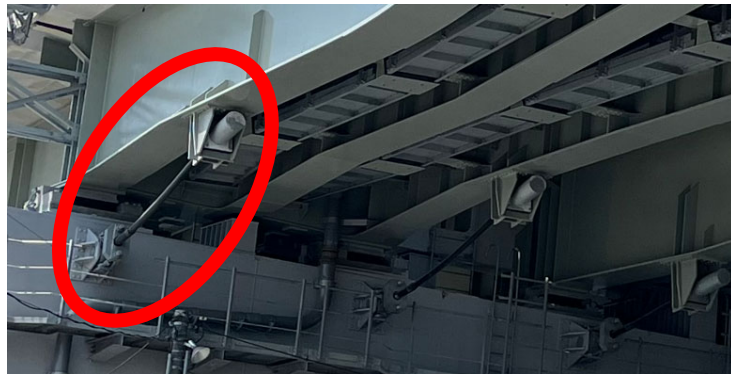
<p>Stop lateral displacement</p>
	<p>Bridge fall prevention device (generally bridges of 2 spans or more)</p>

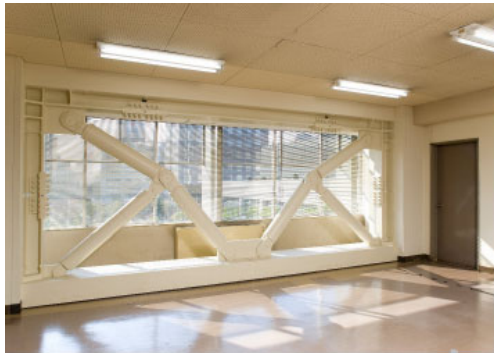
Seismic Brace with vibration damper inserted.

Seismic retrofit work done in 2007 to 2008

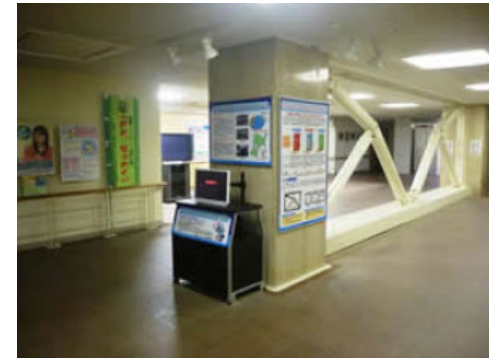
Seismic Brace & Seismometer installed on ground floor hall.

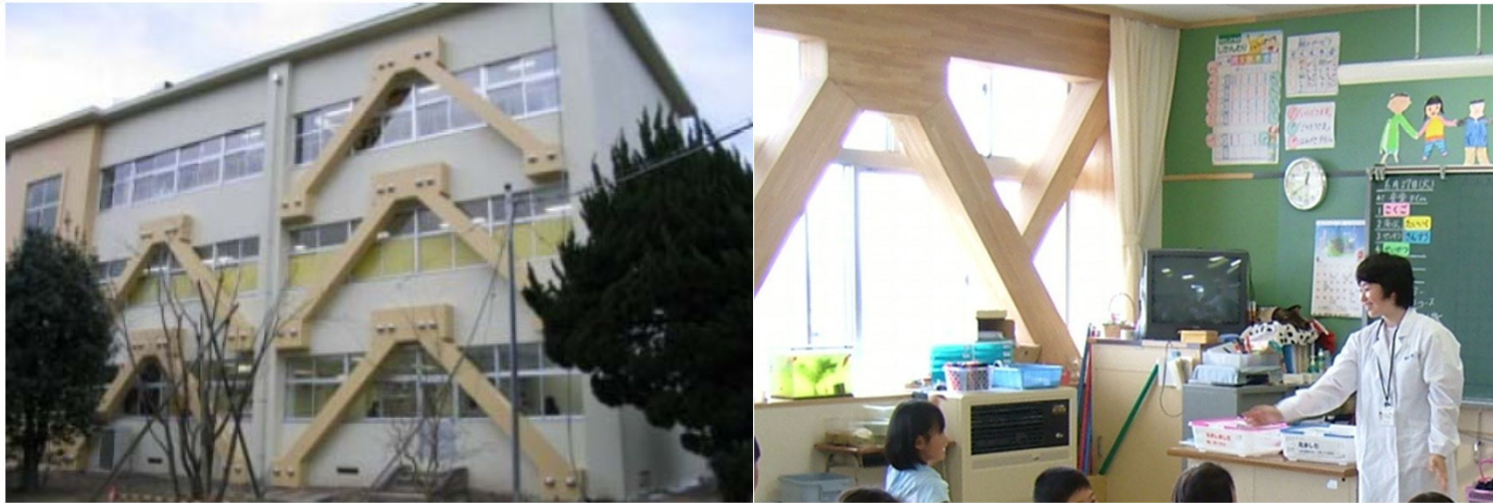
Seismic retrofit of schools based on
Sendai City Earthquake Resilience Policy April 2008

Progress of school seismic retrofitting : 99.6% done by April 2010

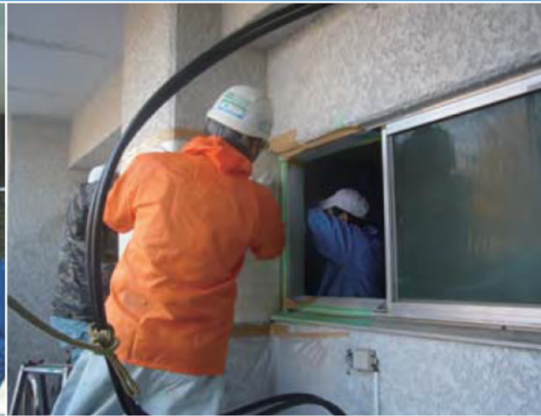
Case of SRF Reinforcement

Wrapping the main columns with SRF allows it to maintain its shape in spite of big transformations and also prevents collapse. While steel plate reinforcement, carbon fiber, and aramid fiber are realistically impossible, SRF prevents collapse and shows high-tensile strength even for short columns or columns exposed to a large compressive force (high axial force). It has been technically evaluated by The Japan Building Disaster Prevention Association.

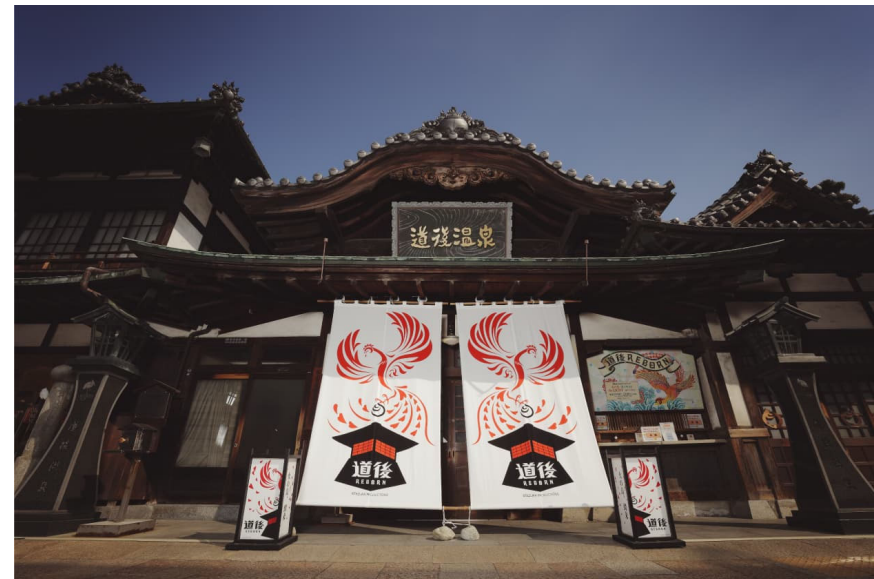
The oldest Hot Spring Spa in Japan: Dogo
Hot Spring Undergoing Seismic Renovation

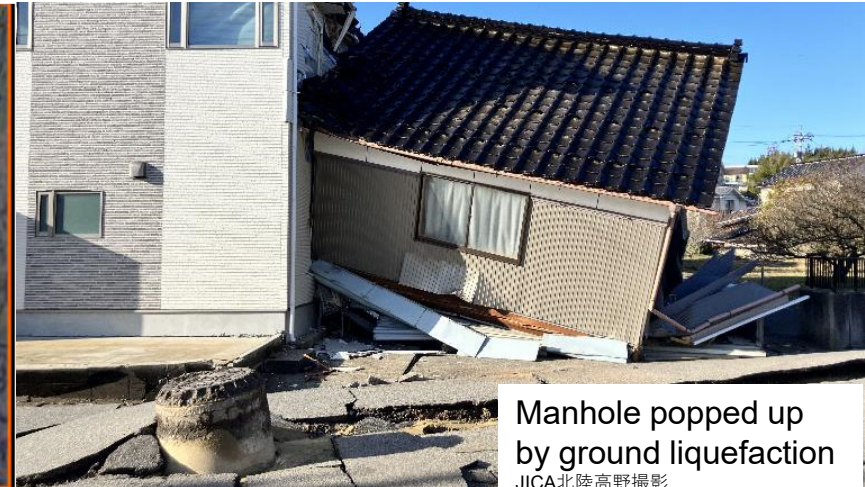
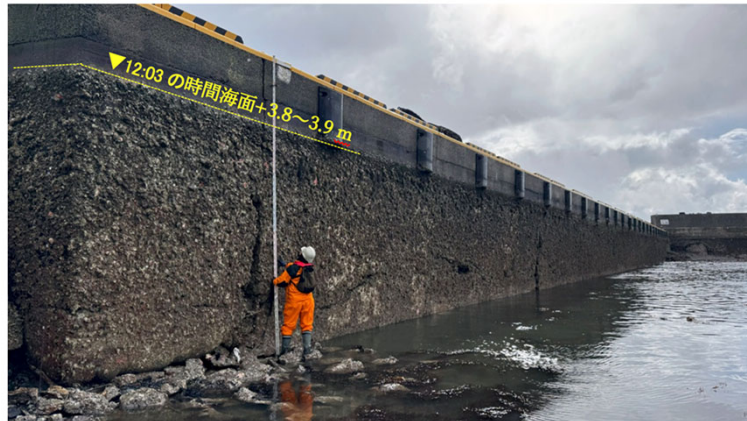
Port Warf rose 4m by ground upheaval

鹿磯漁港の防潮堤に固着した生物遺骸が示す隆起の様子。人が持っている標尺の長さは5m

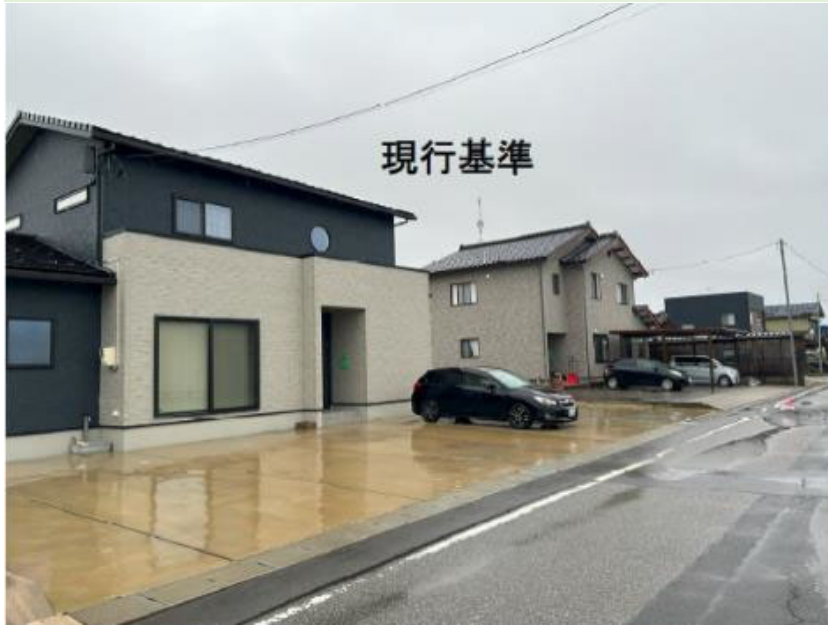
Built according to the 2000 standard

Comparison of two neighboring wooden houses in Suzu City.

Wooden houses built according to the 2000 standard showed its strength

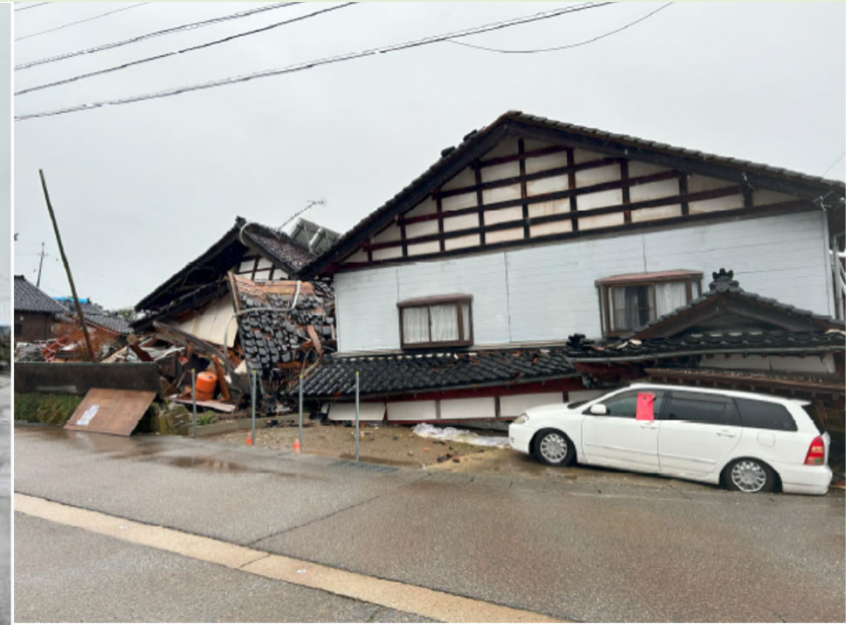
Built before the 2000 standard

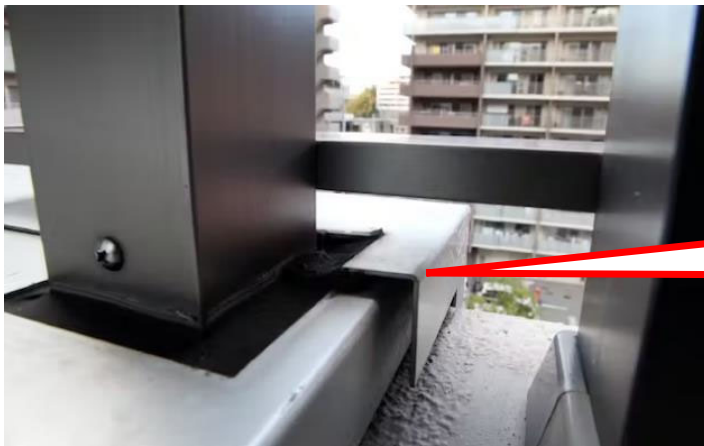
2014 Residents noticed a 2cm gap in the corridor!
Residents found that the condominium was slightly tilted!

2cm Gap

Real estate developer investigated and found that ground piles were short and did not reach the solid base rock.

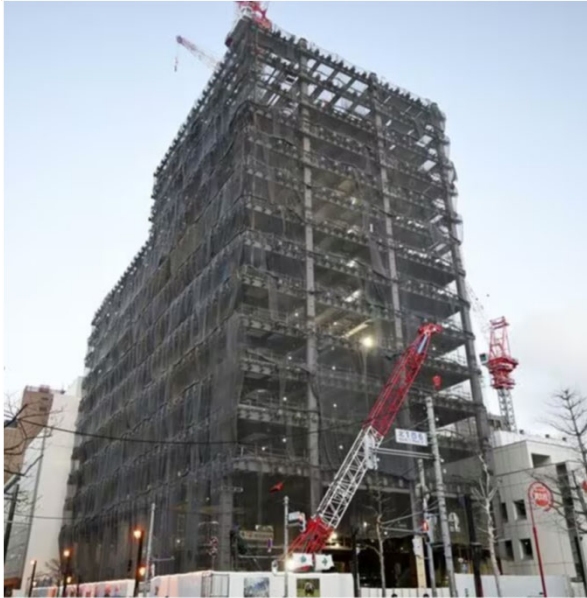
札幌市で建築中の高層ビルで精度不良などが発覚した。組み上がった鉄骨を解体して建て直す異例の事態に（写真：共同）

In Jan. 2023, at the construction site of a large hotel/office/commercial complex (26 stories above, 2 stories underground) in Sapporo, the client company's in-house engineer noticed that the holes for the bolt joints are distorted and smaller than what they should be.

The construction company HQ quality control office was called to inspect the assembled structure regarding accuracy of each steel column, beams and floors and reported that 77 points in the steel structure were found to exceed the tolerance by 21mm maximum, 245 points were found to exceed the tolerance of concrete floor slab thickness.
