# **Bohol Irrigation Project (Stage 1)**

#### Report Date: March 2000

# 1 Project Summary and Japan's ODA Loan

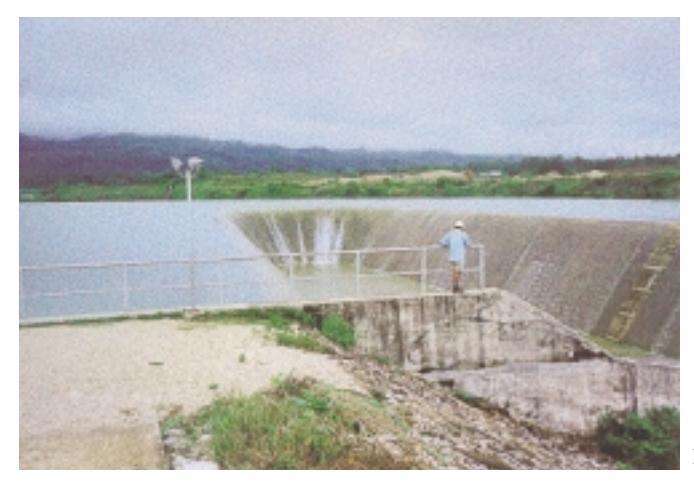
Malinao Dam Spillway

The dam spillway was changed from the side-channel type to the bath-tub type for hydraulic reasons. The total length of irrigation canals was reduced for reasons of alignment, and the drainage canals were lengthened for the same reasons, but the area irrigated was largely unchanged. Some of the service access roads were built by the local government, which reduced the portion covered by the ODA loan.

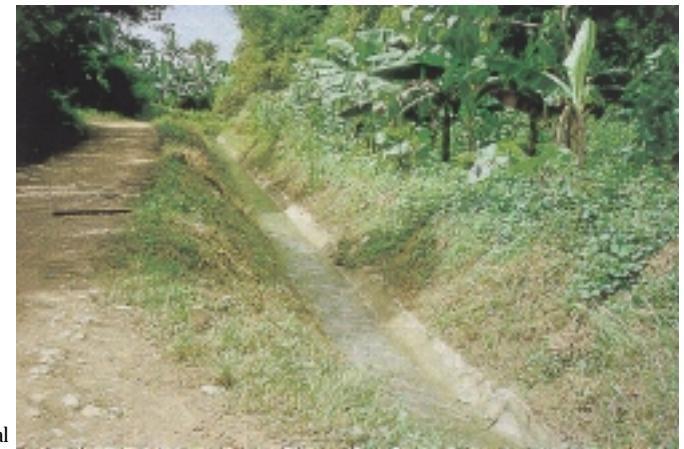
Tailend of Lateral Canal

The operations and maintenance of the dam, the irrigation canals, the drainage canals and other facilities is good. However, due to the lie of the land, some of the lateral canals exceed 1km. Therefore, when the volume of irrigation water is being adjusted, the volume at the downstream ends of the canals can be inadequate if the permeability of the canals is not considered. If the lateral canals were lined it would prevent water losses, make it possible to guarantee the amount of water supplied downstream and make maintenance easier.

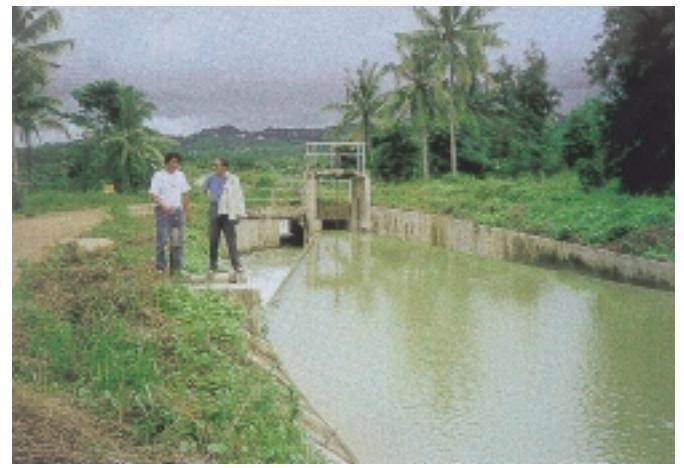
Sluice Gate in Main Canal
