Quaternary Report No. 10

2017 (October, November and December)

**NEW BOHOL AIRPORT CONSTRUCTION AND
SUSTAINABLE ENVIRONMENTAL PROTECTION PROJECT**

Quaternary Environmental Monitoring Report

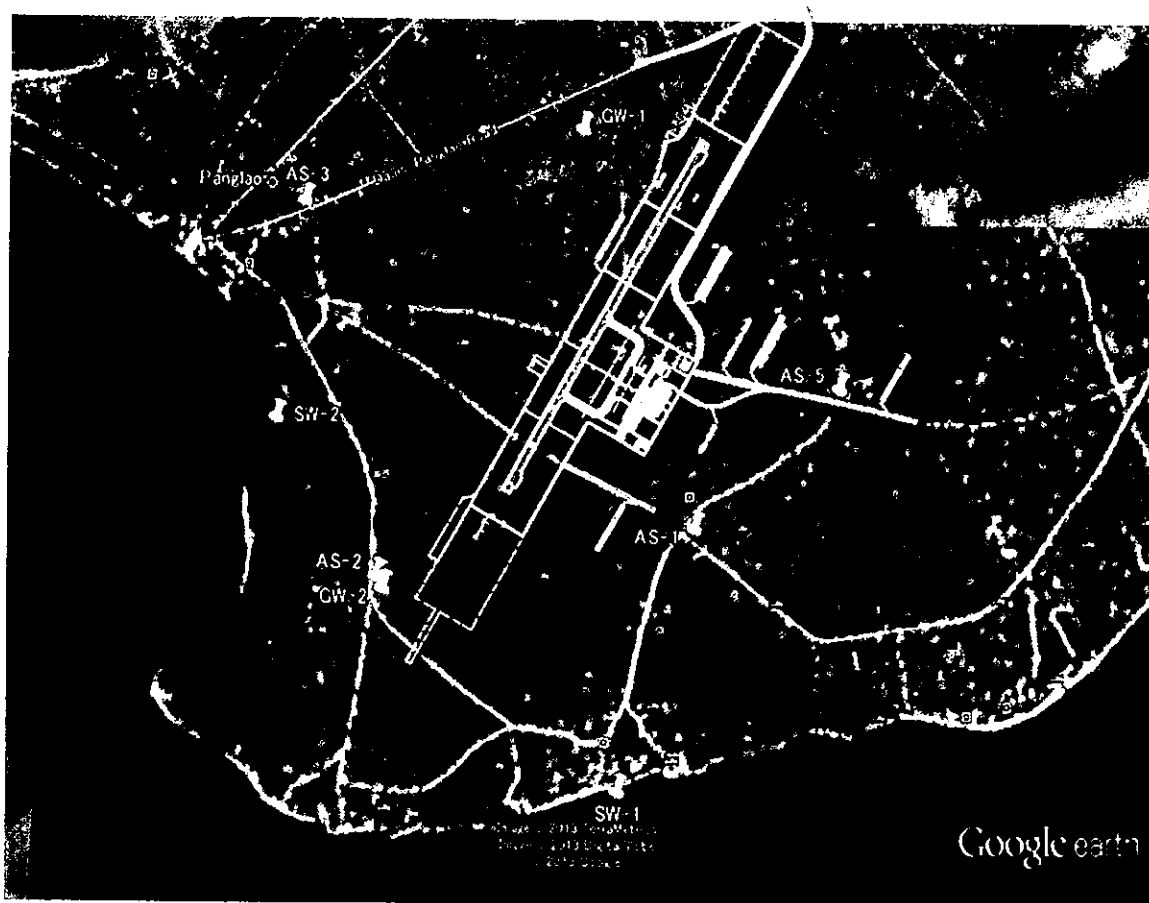
Figure 1. Location of Samplings and Measurement

Sta. ID No.	GPS Reading		Description of Sampling Stations
	Longitude	Latitude	
GW-1	N 09°35'05.7"	E 123°46'14.5"	It is located at Airport Site Brgy. Tawala, Panglao, Bohol. Owned by deceased Mr. Leoncio Boncaron.
GW-2	N 09°33'30.6"	E 123°45'28.4"	It is located inside the compound of former Brgy. Captain Mr. Avito Arcay which is in front of the Brgy. Hall of Brgy. Danao crossing the municipal road in the municipality of Panglao, Bohol.
SW-1	N 09°32'51.1"	E 123°46'22.2"	This is situated about 100 meters away from the seashore which is in front of the Alona Kew Beach in Brgy. Tawala, Panglao, Bohol.
SW-2	N 09°34'05.0"	E 123°45'03.1"	This is located inside mangrove trees about 150 meters away from seashore in Brgy. Danao, Panglao, Bohol

Sta. ID No.	GPS Readings		Description of Sampling Station
	Longitude	Latitude	
Sta-1	N 09°33'42.3"	E 123°46'40.1"	It is located in front of Tawala Elementary School in Brgy. Tawala, Panglao, Bohol. It is situated about 10 meters away from center of the municipal road and about 35 meters from the classrooms.
Sta-2	N 09°33'32.9"	E 123°45'27.0"	It is situated almost in front of the Brgy Hall of Brgy Danao, Panglao, Bohol. It is about 7 meters away from the center of the municipal road.

Sta. ID No.	GPS Readings		Description of Sampling Station
	Longitude	Latitude	
Sta-3	N 09°34'50.4"	E 123°45'08.4"	It is about 30 meters away in front of the municipal hall building of Panglao and about 25 meters from center of the municipal road.
Sta-4	N 09°34'19.9"	E 123°46'28.9"	The original location. It is located along the access road of the New Bohol Airport in Brgy Tawala, Panglao, Bohol.
	N 09°35'37.7"	E 123°47'04.0"	A relocated station. It is located about 2.4 km Northeast of the original station (Access Road to Airport). It is situated in front of Ericflo Inn/restaurant and is about 10 meters away from the center of the national road.
Sta-5	N 09°34'10.4"	E 123°47'14.5"	It is located in front of Bohol Elementary School in Brgy Bolod, Panglao. It is about 2 meters away from the perimeter fence of the school and 5 meters away from center of the municipal road.

Remarks: Measurement Point-shown in **Figure 1**. Frequency – once a month, Method-High Volume Sampler/Gravimetric Method

Remarks: Measurement Point-shown in **Figure 1** (there is no water in soaking area), Frequency – once a month
