Quaternary Report No. 4

**New Bohol Airport Construction
and
Sustainable Environmental Protection Project**

Quaternary Environmental Monitoring Report

July 2016

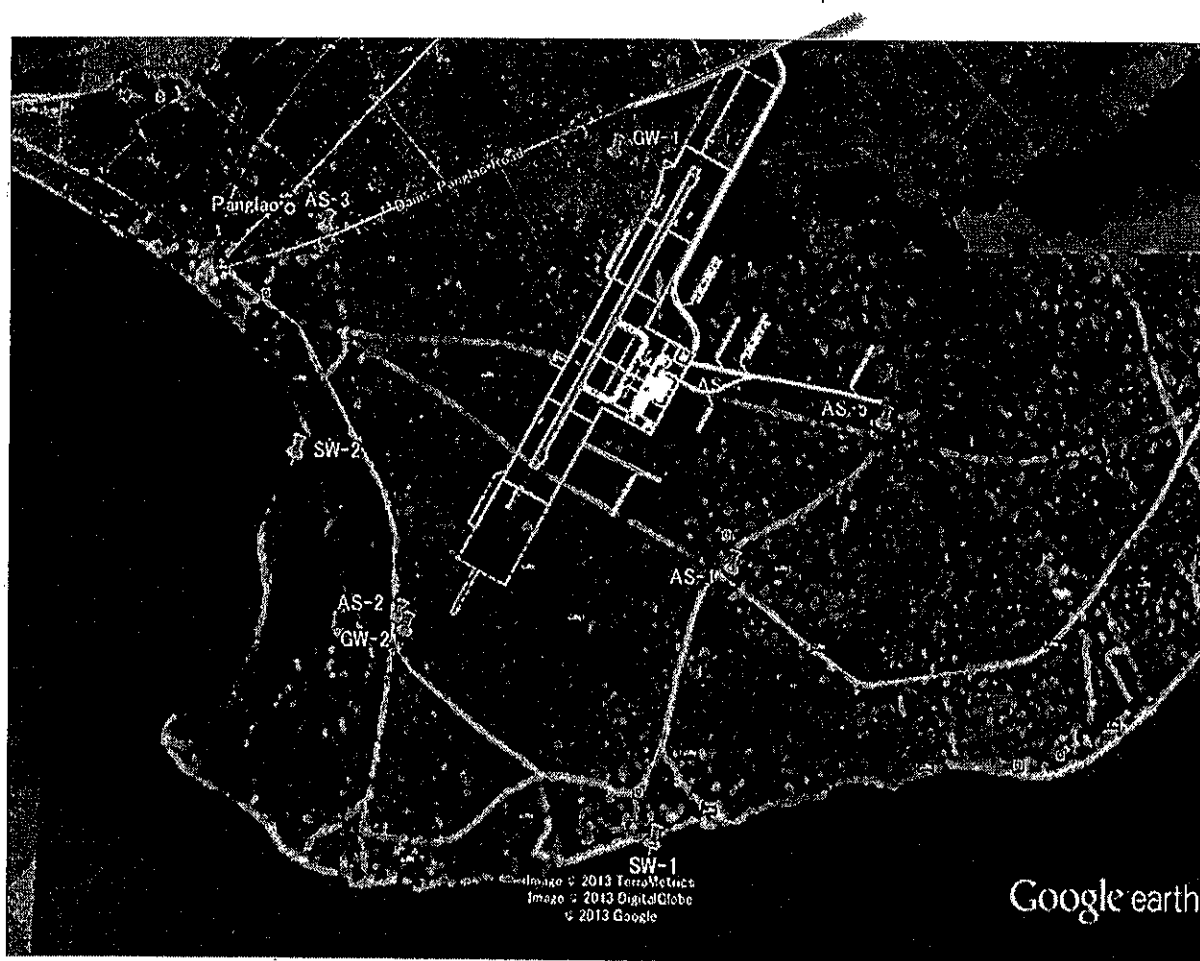
Figure 1. Location of Samplings and Measurement

Sampling Points of Water

Air Quality, Noise Level and Dust

Remarks: Measurement Point-shown in Figure 1, Frequency – once a month, Method-High Volume Sampler/Gravimetric Method

Remarks: Measurement Point-shown in Figure 1 (there is no water in soaking area), Frequency – once a month
