**Ministry of Environment and Communications**

**The Project for Upgrade of Wharf for  
Domestic Transport**

**Environmental Impact Assessment Report**

**January 2015**

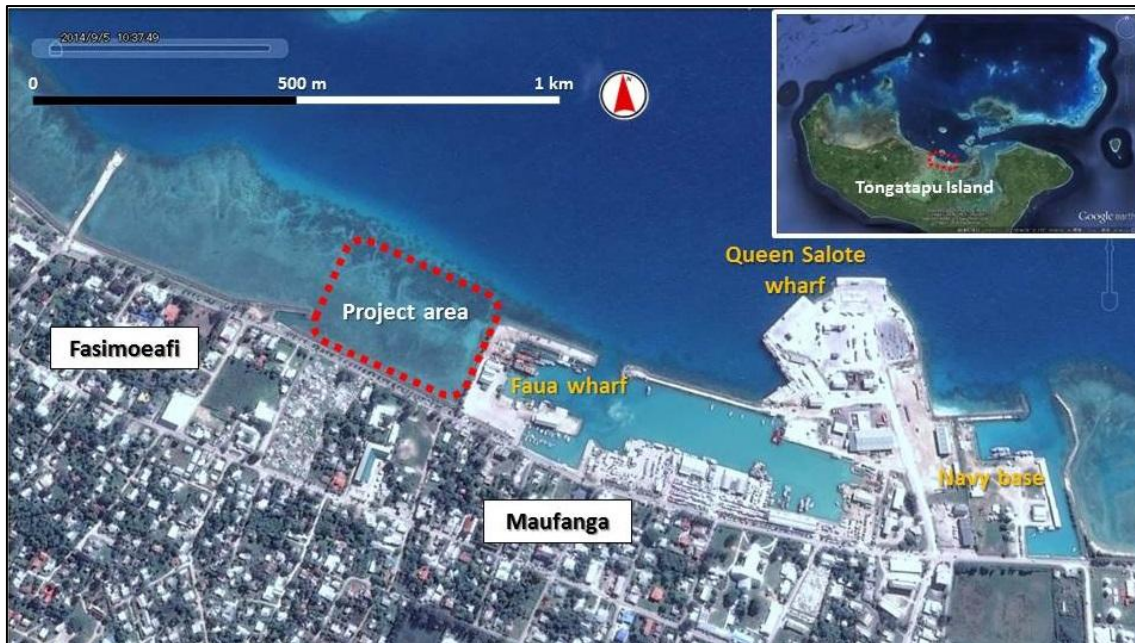
**Figure 3-1 Location of the new domestic wharf (red-dotted line)**

The new domestic wharf is located in Tongatapu Island, Nukualofa, the capital of Tonga. It is in front of Maufanga, one of the coastal villages in Nukualofa. Figure 3-1 shows the location of the new domestic wharf.

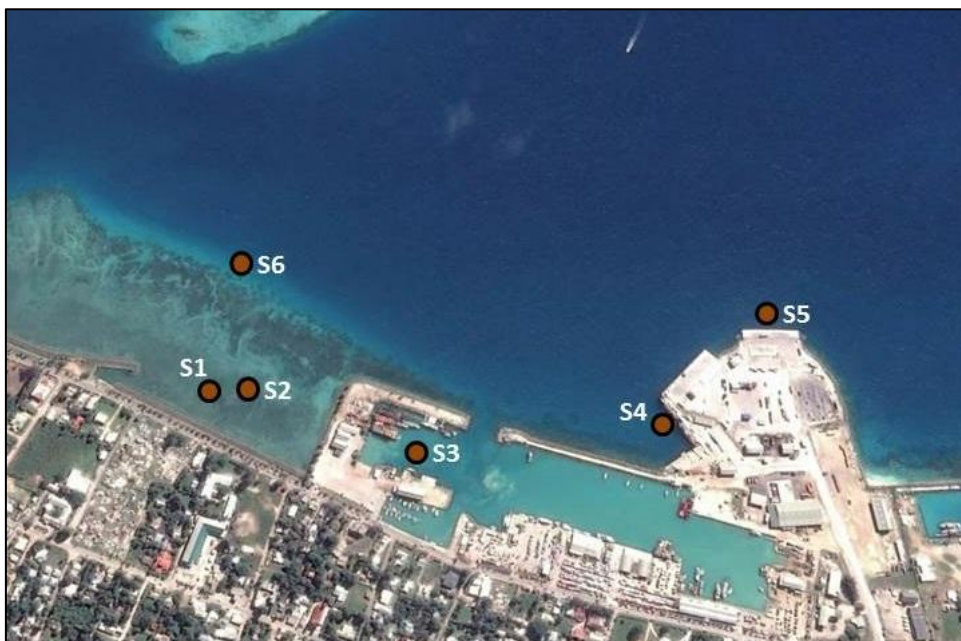
**Figure 4-3 Location of the sediment quality survey sites**

Sediment quality survey was conducted on September 3<sup>rd</sup>, 2014 to understand the sediment quality status of the planned dredging area and around Nukualofa port. Table 4-4 shows the survey parameters and analysis method. All chemical parameters were analyzed in New Zealand at Hill Laboratories Ltd., which is a laboratory accredited by International Accreditation NZ. Particle size analysis was conducted at Geotechnics Ltd., laboratory. Figure 4-3 shows the location of the survey sites. Sediment samples were collected by a diver from the surface layer only.

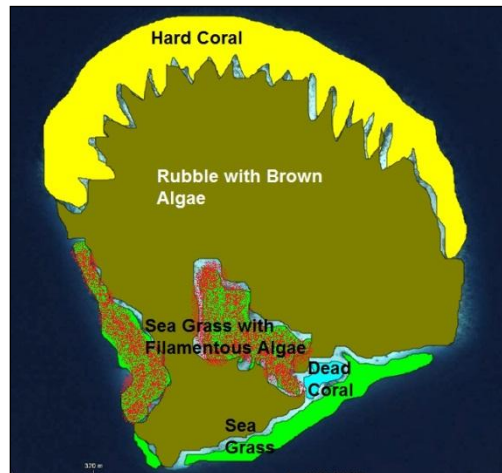
Figure 4-8 shows the coral and seagrass distribution at the offshore reef. Corals were mainly distributed in the outer reef flat and reef slope of the north side of the reef. Seagrass were mainly distributed in the west and east side of the reef.

**Figure 4-8 Coral and seagrass distribution at the offshore reef**

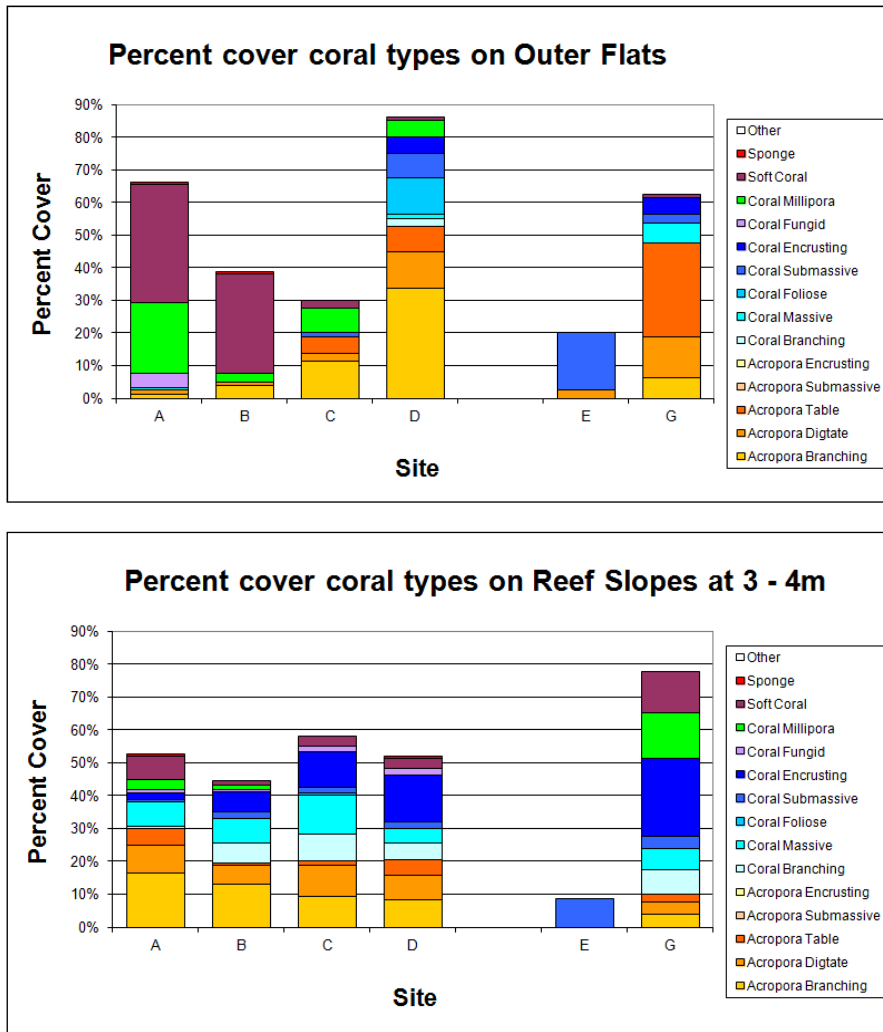
In the outer reef flat, lifeform diversity of hard corals at transects A and B were lower compared to the other transects. Transects A and B were dominated by soft (purple bar) and fire (green bar) corals, whereas the other transects were comprised of diverse lifeforms of hard corals, most notably various forms of *Acropora* corals (yellow-orange bars).

In the reef slope, lifeform diversity of hard corals were more or less uniform between transects. In addition to *Acropora* corals, there were diverse ranges of non-*Acropora* corals, most notably encrusting and massive corals (bluish bars).

Figure 4-11 Lifeform diversity of hard corals in the project area and offshore reef

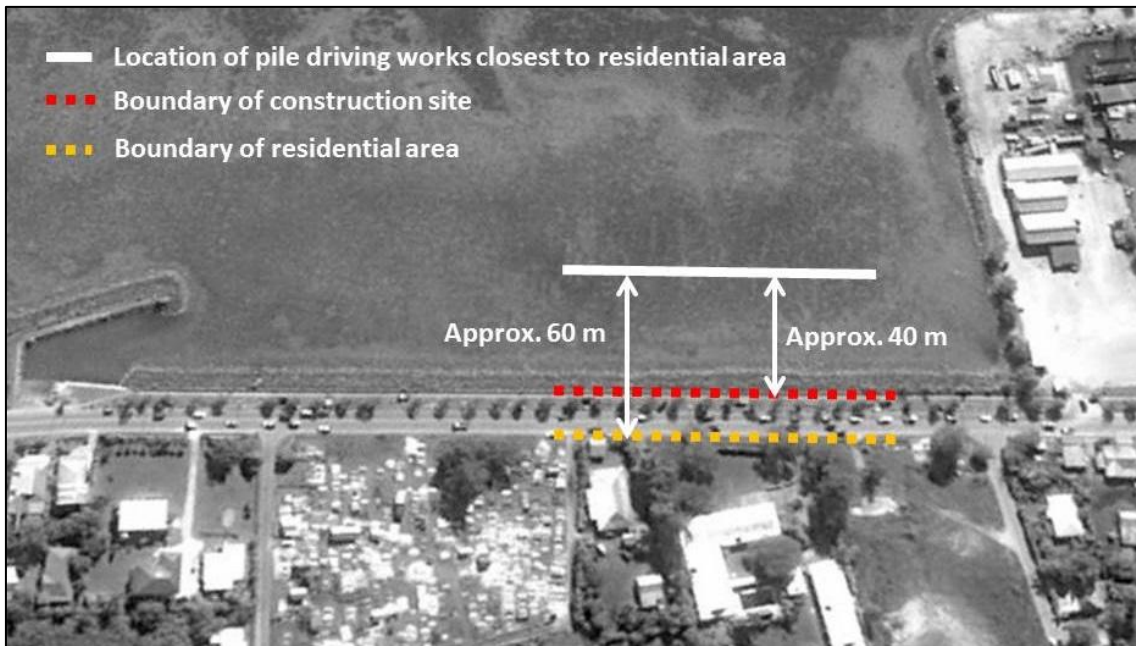
The worst-case scenario will be when pile-driving works are conducted along the south side of the wharf, as it will be closest to the residential area. In such case, distance to the boundary of the construction site and residential area will be approximately 40 m and 60 m respectively. Figure 6-1 shows the distance between pile-driving works and the boundary of construction site and residential area, under worst-case scenario.

**Figure 6-1 Distance between pile-driving works and the boundary of construction site and residential area (under worst-case scenario)**

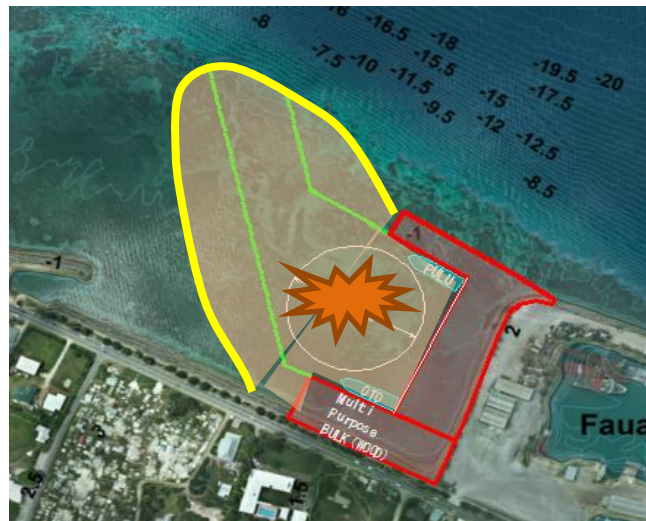
Dredging works will degrade the water quality, as it will suspend/disperse significant amount of seabed sediments into the surrounding waters. Such dispersion of sediments may affect the surrounding ecosystem through increasing water turbidity. To minimize sediment dispersion, silt curtain will be installed around the construction site, which will block the sediments to a certain extent. Figure 6-2 shows an image of how silt curtain will be installed.

Note: The yellow line is the silt curtain

**Figure 6-2 Image of silt curtain installation**

In addition, turbidity levels will be monitored in the adjacent waters as sediments can leak out through the silt curtain. Additional measures will be implemented if turbidity levels exceed the set threshold value (see Section 7.2.3 for details).

vulnerable to high turbidity and if it persists for long duration there is a high risk that these corals will be significantly affected. To minimize such risk, silt curtain will be installed around the construction site to minimize sediment dispersion. Coral health will also be regularly monitored and additional measures will be considered if any significant coral health degradation are identified (see Section 7.2.4 for details).
