Northern provincial agricultural office exhibited various crops and cooked food, also they introduced E-COBSI activities in own booth.

### Monitoring of Permanent Weir Construction

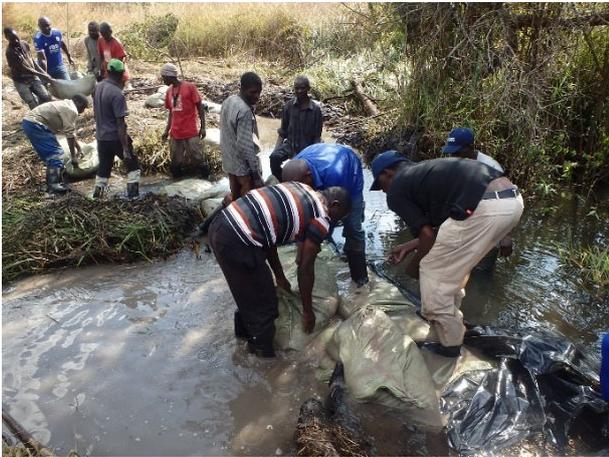
Farmers putting sandbags to make a temporary coffer dam (Mufulira District, Copperbelt Province). The master of trainers taught how to install the coffer dam using sandbags.

- After the site cleaning, the farmers put pegs in a location where a permanent weir and canals will be constructed. Since the excavation and the construction works should be done in the dry, the farmers excavated a diversion canal and installed a coffer dam. Because access road is located on the left bank, the diversion canal should be constructed on the right bank. The farmers installed the coffer dam by using 150 sandbags at the upstream side of the permanent weir.
- Although the coffer dam was installed, water remains at the permanent weir site. Thus, farmers should drain the water by using a pump or buckets and continue excavation and construction works in the dry.

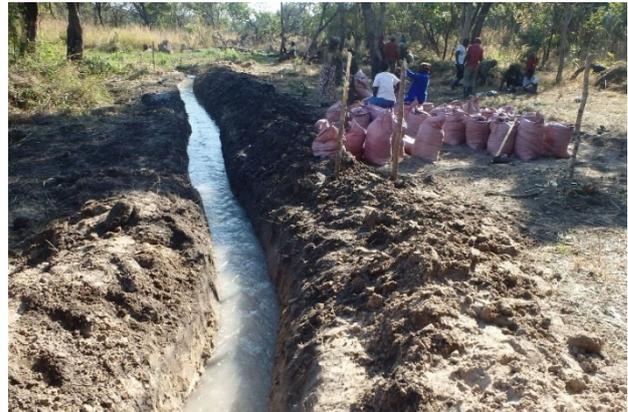
- Since farmers have already collected more than a half of necessary stones, they started carrying them.
- Location of the permanent weir were being moved 20m upstream. Along with this, the elevation at actual construction should correspond to the elevation displayed on the design drawing plus 0.55m.
- Since the location of the construction site was shifted, the farmers again conducted site cleaning and then put pegs in a place where a permanent weir and canals are constructed. To excavate the site and construct the weir in the dry, they excavated a diversion canal and installed a coffer dam. Since the access road is located on the left

bank, the diversion canal was constructed on the right bank. The farmers installed the coffer dam at the upstream of the permanent weir site by using 30 sandbags.

Farmers constructed a diversion canal (Kasempa District, Northwestern Province).

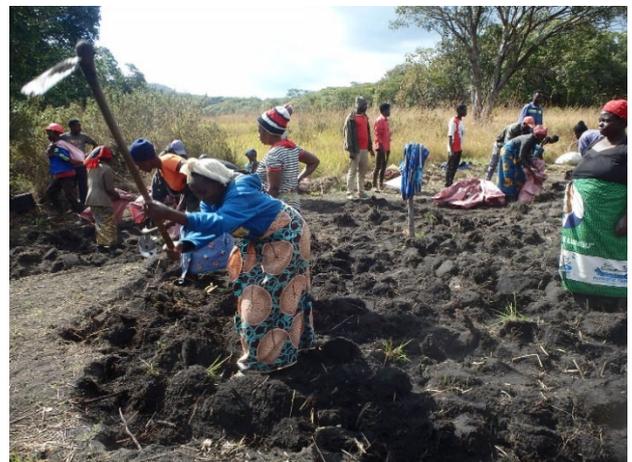
- Although the farmers used to collect stones on the left bank, those stones included weak ones. After that, the farmers found a good collection point which can provide high quality stones and started the collection again.
- Location of the construction has never changed since the planning. Since there were many fallen trees, the farmers required long time for the site cleaning. Same as the other sites, the farmers finished putting pegs, excavation of a diversion canal and installation of a coffer dam. A second temporary coffer dam was installed because groundwater seeps out downstream of the temporary coffer dam.
- Although farmers can keep the site in the dry by draining using buckets, there are some points where groundwater upwells. Farmers needs attention when excavating, and sometime may require use of a pump.

Female farmers made sandbags for construction of a diversion canal (Mukusi District, Central Province).
